## INCOMING INSPECTION REPORT

<b>Customer</b>	Nghi Son Refinery & Petrochemical, LLC.	<b>UNEW Work Order No.</b>	<b>825088</b>
<b>Customer P.O. No.</b>	1003946086	<b>Report Date</b>	27 April 2026
<b>Engine Type</b>	MS6001FA (GE Frame 6FA)	<b>Component</b>	Combustion Liner MNQC
<b>Component Part No.</b>	119E9620G001	<b>Qty. Received</b>	6 Units (1 Complete Set)
<b>Material</b>	Hastelloy-X (Body, Cowl Cap, End Ring, Floating Collar, Liner Stop)   Haynes 188 (Crossfire Collar)   Inconel X-750 (Spring Seal / Hula Skirt)   SS304 (Collar Retainer)	<b>As-Received Coating</b>	TBC Coating — Inside Body & Inside Cowl Cap (Primary Fuel Nozzle Collar and Center Bore)
<b>Repair Classification</b>	<b>HEAVY REPAIR</b>	<b>Coating Requirement</b>	Chrome Carbide Coating (Hula Skirt) + Class C TBC (Internal Surface)
<b>Total Initiated Starts</b>	476	<b>Total Emergency Trips</b>	<b>125</b>

### 1. EXECUTIVE SUMMARY:

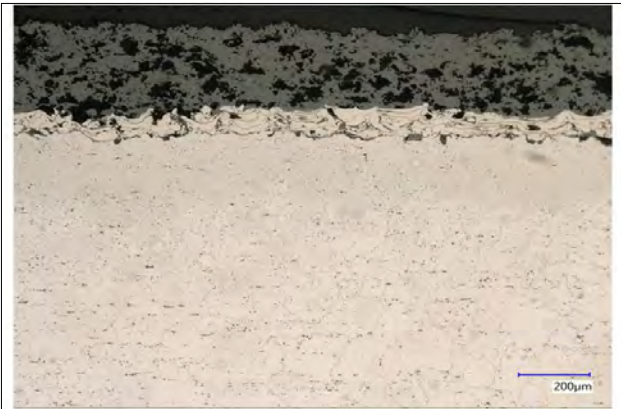
<p>Fig.1 Showing the hot gas path coating and substrate condition.(Etched)</p>						<p>Fig.2 Showing the typical microstructure at higher magnification.(Etched)</p>

The internal coating system is degraded, and inspection shows oxidation and localized material loss on the combustion surface. These conditions require full removal of coating and affected material during repair.

Based on the evaluation, the base material remains suitable for heavy repair. All degraded areas, including cracks, oxidation, and weakened sections, will be completely removed, followed by weld reconstruction using compatible high-temperature filler material.

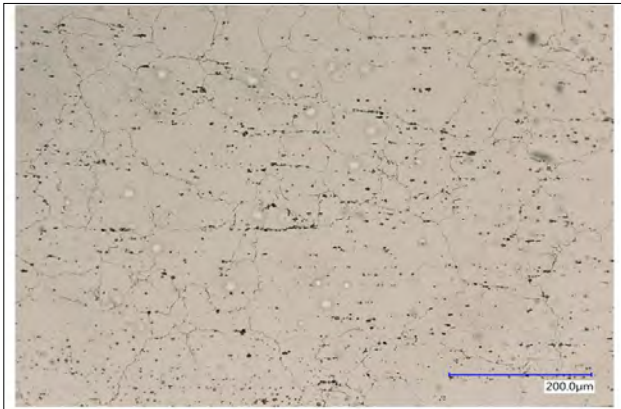
A metallurgical sample was taken from the liner body to assess the condition of the base material. The analysis confirms the material as Hastelloy-X with a stable gamma matrix and normal carbide distribution. No abnormal metallurgical degradation was observed.

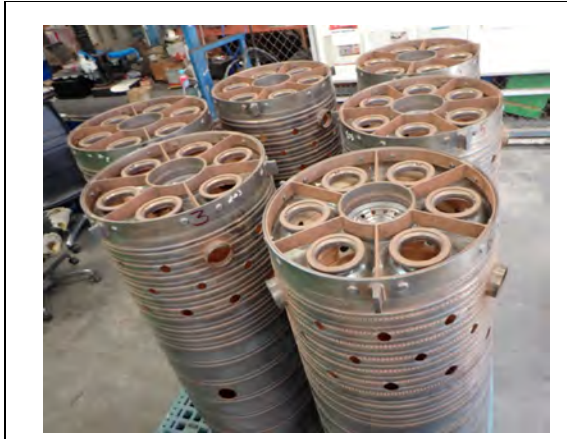
Fig.1 As-received condition.

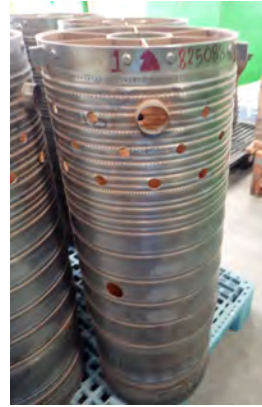
Fig.2 As-received condition.

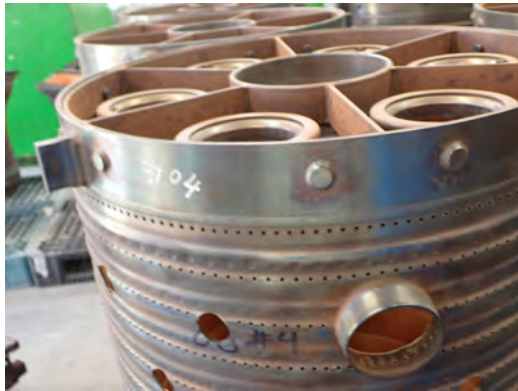
Fig.3 As-received condition.

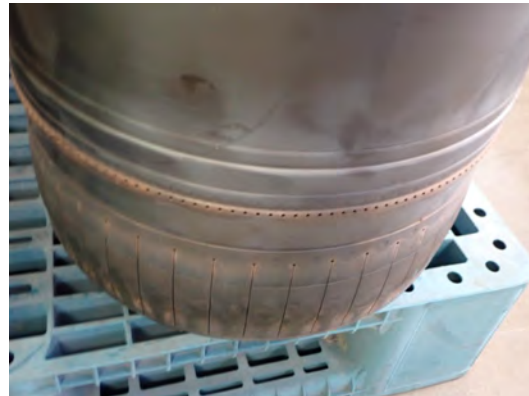
Fig.4 As-received condition.

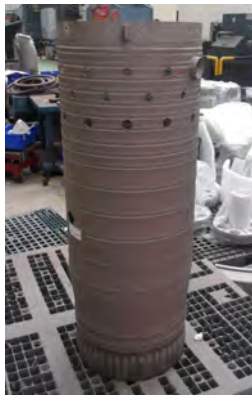
Fig.5 Typical condition of body.

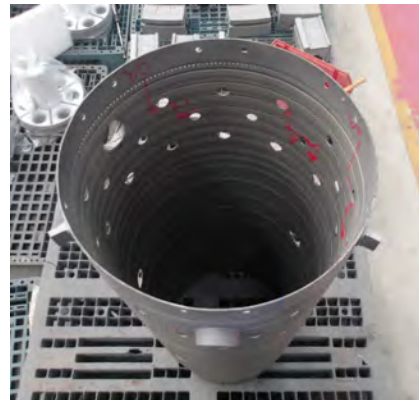
Fig.6 Typical condition of body

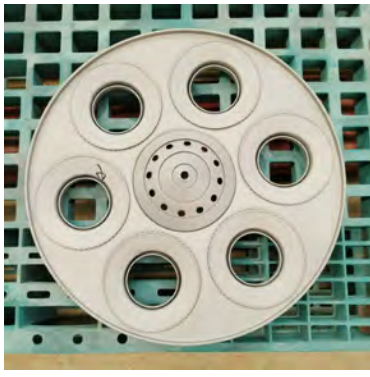
<p>Fig.7 Severely degraded condition of cowl cap</p>	<p>Fig.8 Severely degraded condition of cowl cap</p>

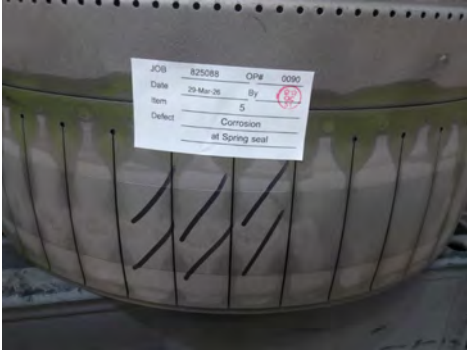
- Spring seals: Heavy fretage confirmed on all spring seals across all 6 liners (Figs. 9 and 10). This directly affects the fit and stability of the liner during operation and must be fully repaired.

<p>Fig.9 Heavy frettage on spring seals.</p>	<p>Fig.10 Heavy frettage on spring seals.</p>

- All fretted areas will be fully rebuilt by weld build-up and re-machined to restore original fit dimensions in accordance with UNEW approved repair procedures.

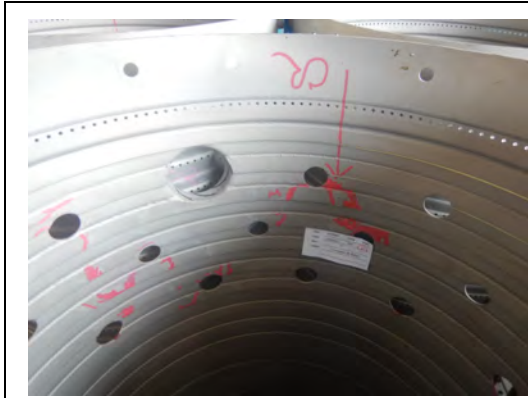
- Heavy corrosion on the internal body surface has caused serious base metal loss and dangerous thinning of the liner wall across all 6 liners. This condition puts the structural integrity of the liner at critical risk during high temperature operation.
-

Fig.13 Several heavy corrosion on internal body.

- Heavy corrosion damage is confirmed across the full internal combustion surface area and cannot be removed by blending alone. Weld build-up and material restoration is required to recover original wall thickness and structural strength.
- The severity of corrosive attack is consistent with extended high temperature operation without repair intervention, combined with the high emergency trip count of 125 trips which accelerates

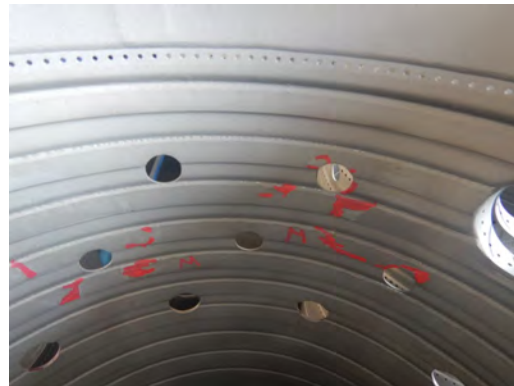
Fig.14 Several heavy corrosion on internal body.

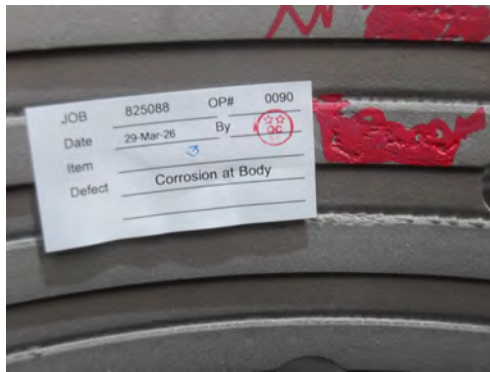
Fig.15 Heavy corrosion across body.

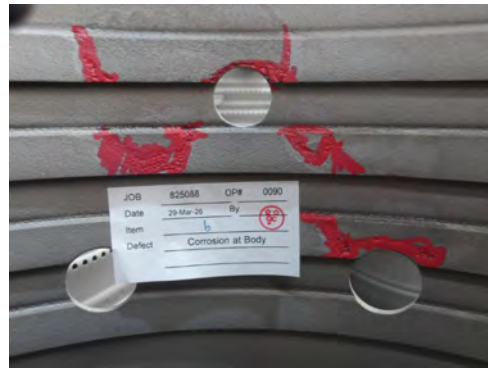
Fig.16 Heavy corrosion across body.

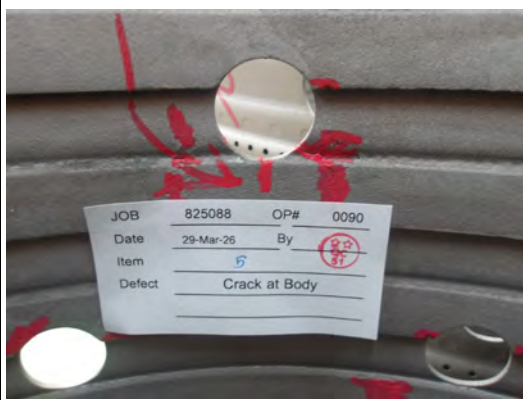
- Liner body cracking: Deep cracks of 2 to 4 mm confirmed across all 6 liners. Cracks are located in high temperature zones and extend beyond surface level. Simple blending or minor weld repair is not sufficient. Full excavation of all cracked material and complete weld reconstruction is required.
- Cowl cap cracking: A 2 mm crack was confirmed at the cowl cap on Item 5. Severely degraded cowl cap condition was observed across the full set as confirmed in photographs (Figs. 7 and 8). Weld repair and rebuild is required.
- All cracking confirmed in this set extends beyond the level that can be addressed by standard or medium repair methods. Full Heavy Repair intervention with GTAW weld reconstruction is mandatory across all 6 liners.

Fig.17 Crack across entire body.

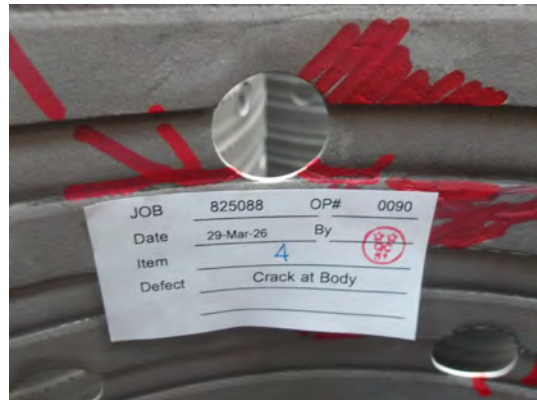
Fig.18 Crack across entire body.

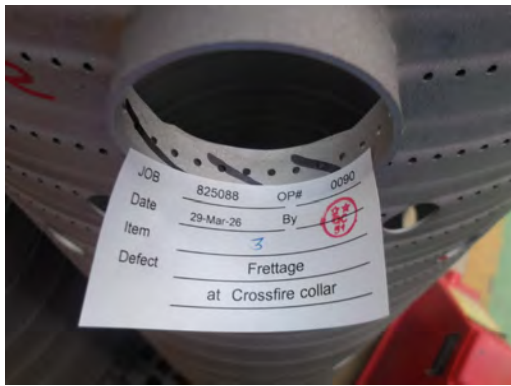
- Crossfire collars: Heavy fretage confirmed on crossfire collars (2 per liner) across the complete set (Fig. 19). Fretage wear at these locations affects the crossfire tube sealing and inter-liner combustion stability.

Fig.19 Heavyfrettage on crossfire collar.

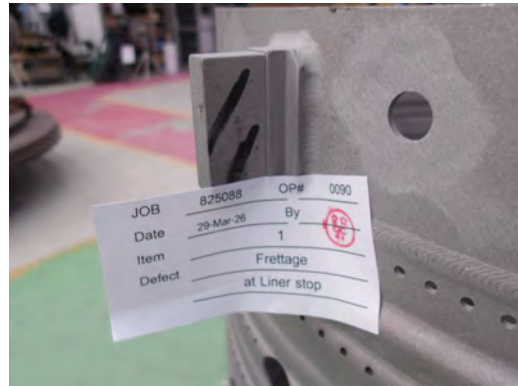
- Liner stops: Heavy fretage confirmed on liner stops across all 6 liners (Figs. 20 and 21). Wear damage affects liner positioning and structural fit at this critical interface.

Fig.20 Heavy frettage on liner stop.

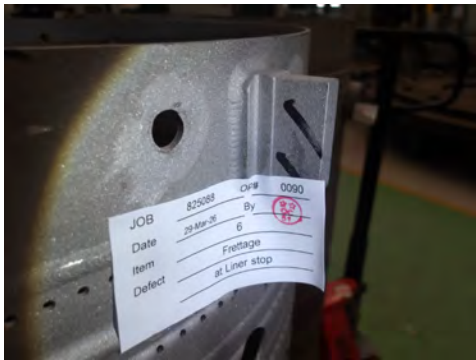
Fig.21 Heavy frettage on liner stop.

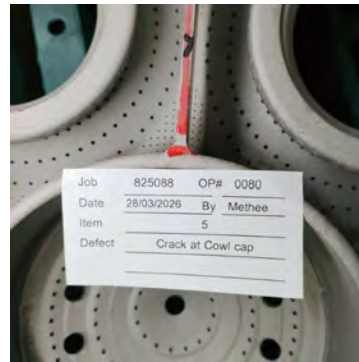
Fig.22 Heavy crack on cowl cap.

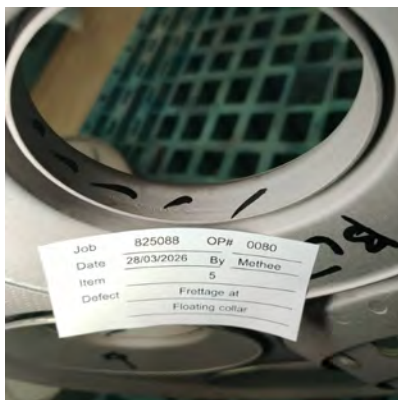
- Floating collars: Fretage wear confirmed on floating collars (6 per liner) across all 6 liners (Figs. 23 and 24). Wear at these locations affects component fit and sealing effectiveness.

Fig.23 Frettage on floating collar.

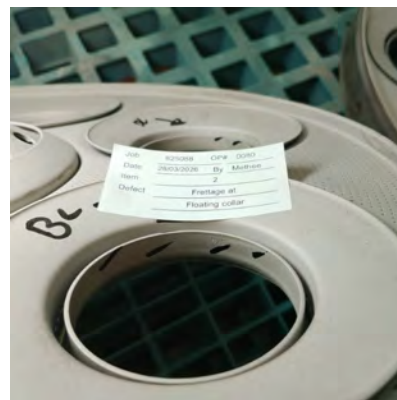
Fig.24 Frettage on floating collar.
