INCOMING INSPECTION REPORT

Customer	Nghi Son Refinery & Petrochemical LLC	UNEW Work Order No.	825089
Customer P.O. No.	1003946086	Report Date	April 30, 2026
Engine Type	MS6001FA (GE Frame 6FA)	Component	MS6001FA Transition Piece
Component Part No.	119E9674G002	Qty. Received	6 Units (1 Complete Set)
Material	Nimonic263 (Body, Picture Frame, Inlet Bore) Hastelloy-X (Forward Support Ring) FSX-414 (Lug / H-Block) SS304 (Impingement Sleeve, Bracket, Strip, Impingement Belt) L605 (Floating Seals — Inner, Outer)	As-Received Coating	TBC Coating — Inside Body & Inside Picture Frame Chrome Carbide Coating (Forward Support Ring) No Coating (Inlet Bore, H-Block)
Repair Classification	Standard (Standard (Mechanical))	Coating Requirement	Chrome Carbide Coating (Inlet End & Support Ring) MCrAlY / TBC Internal Body
Total Initiated Starts	476	Total Emergency Trips	125

Work Order: 825089	MS6001FA TRANSITION PIECE
---------------------------	----------------------------------

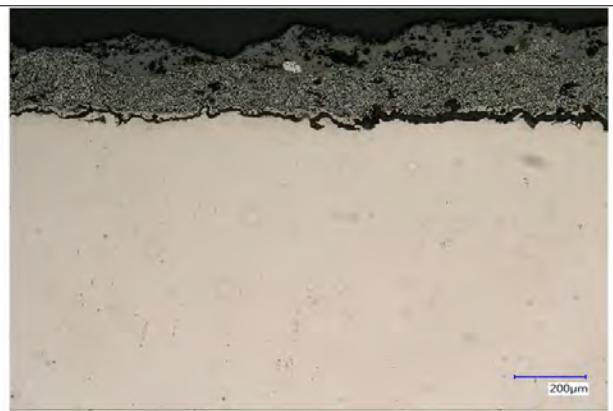
Fig.1 Showing the hot gas path coating and substrate condition.(Etched)

A metallurgical specimen was extracted from Item 1 at the outlet bore location and submitted under Report No. L11385 to evaluate the base material condition and confirm suitability for repair. Examination confirmed that the hot gas path surface was protected by TBC coating, as shown in Fig.1. The base material was confirmed as Nimonic263 alloy, comprising fine grain boundary carbide and a gamma matrix with fine gamma prime, primary carbide, and dispersed secondary carbide, as shown in Fig.2. It should be noted that the gamma prime of this alloy is very fine in nature and can be further characterised by scanning electron microscopy (SEM) if required.

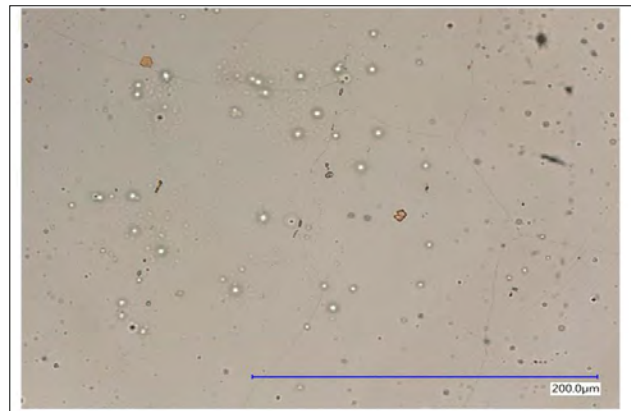
Fig.2 Showing the typical microstructure at higher magnification.(Etched)

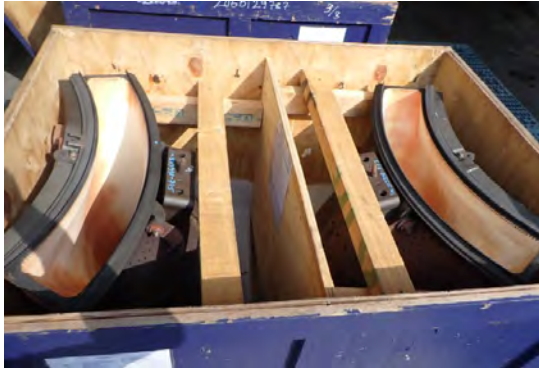
Fig.1 As-received condition.

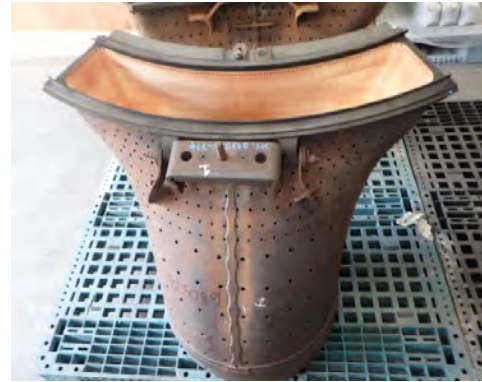
Fig.2 As-received condition.

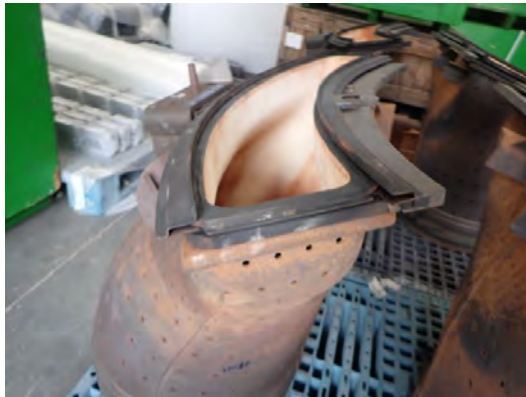
Fig.3 As-received condition.

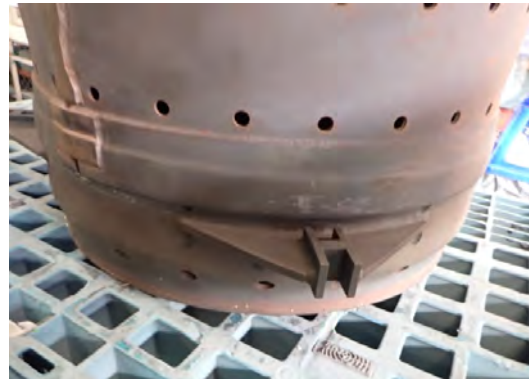
Fig.4 As-received condition.

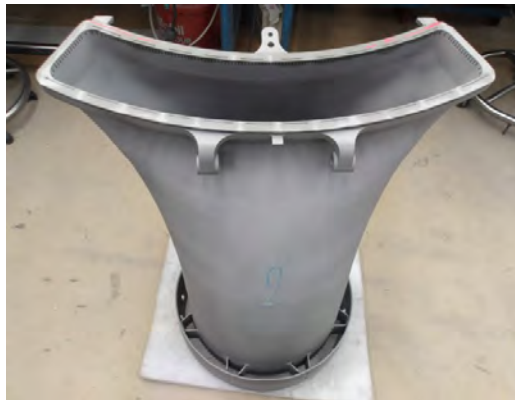
Fig.5 Typical condition of body.

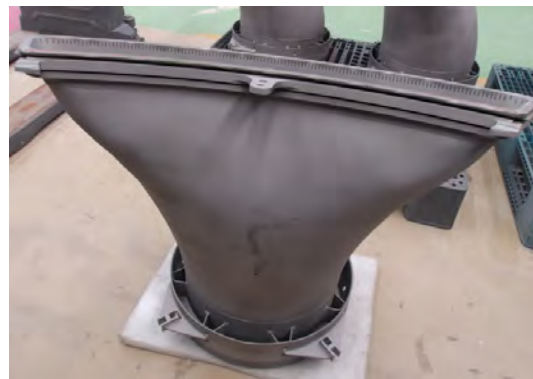
Fig.6 Typical condition of body.

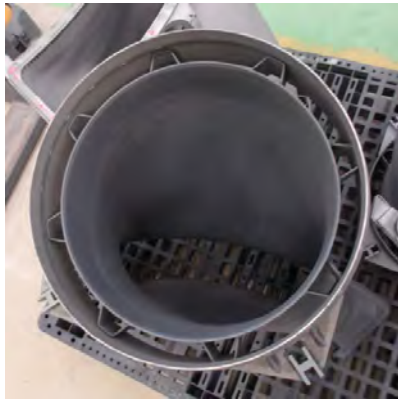
Fig.7 Typical condition of body.

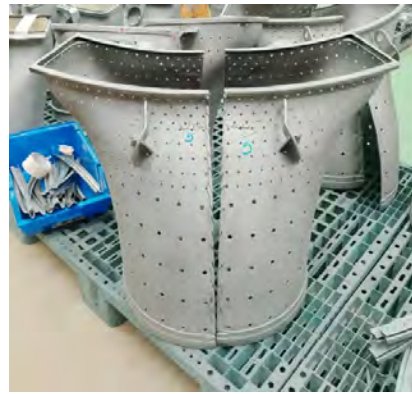
Fig.8 Typical condition of impingement sleeve.

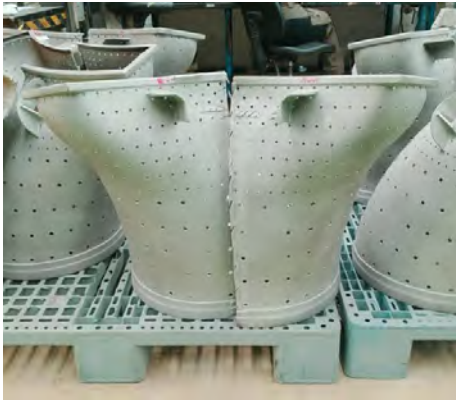
Fig.9 Typical condition of impingement sleeve.

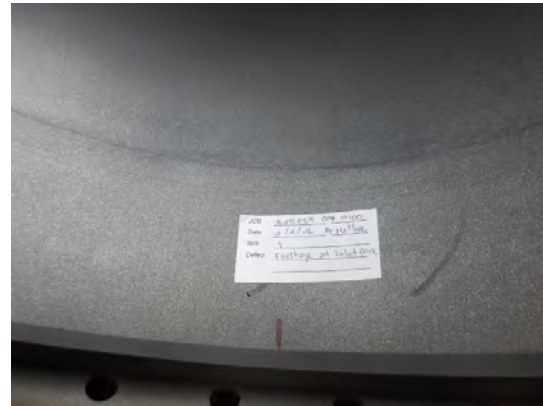
Damage Category	Finding (As Inspected)	Disposition
Frettage at Inlet Bore	Light frettage confirmed on all inlet bores across all 6 units. Inlet bore ID and roundness recorded as REJECT on units 1, 4, and 6.	Blend Repair
Wear and Cracking at Impingement Sleeve	Light to Standard (Medium) frettage confirmed across all 12 impingement sleeves. Cracks of 2 to 5 mm confirmed across the set. Weld and blend repair required to restore sleeve profile.	Weld and Blend
Frettage and Cracking at Inner Picture Frame Wear Strip	Standard (Medium) frettage confirmed on all inner picture frame wear strips across all 6 units. A 10 mm crack confirmed on unit 6. All inner wear strips require replacement.	Replace / Weld and Blend
Cracking at Outer Picture Frame Wear Strip	Cracks of 5 to 10 mm confirmed on outer picture frame wear strips of units 1, 3, 4, and 5. Weld and blend repair required at all affected locations.	Weld and Blend

Fig.10 Frettage on inlet bore.

No.	Defect / Condition	Location / Affected Items	Repair Method	Action
1	Frettage at inlet bore	Light frettage confirmed on all 6 inlet bores. Inlet bore ID and roundness REJECT on units 1, 4, and 6.	Blend Repair	REQUIRED
2	Wear and cracking at impingement sleeve	Light to Standard (Medium) frettage cracks of 2 to 5 mm confirmed across all 12 impingement sleeves on all 6 units.	Weld and Blend	REQUIRED
3	Cracking at inner picture frame wear strip	10 mm crack confirmed on inner picture frame wear strip of unit 6. Standard (Medium) frettage on all 6 all inner wear strips to be replaced.	Replace / Weld and Blend	REQUIRED

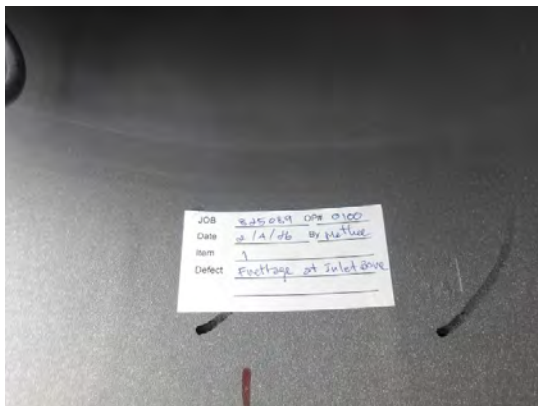
Fig.11 Frettage on inlet bore.

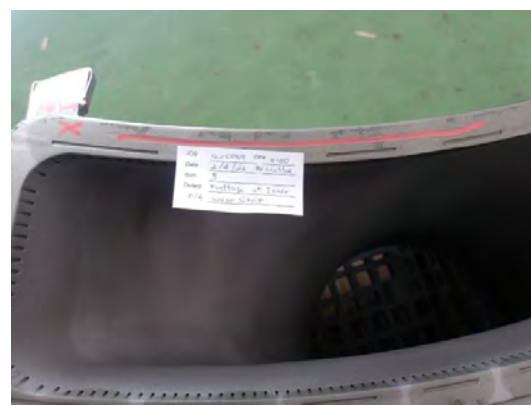
Fig.12 Frettage on inner picture frame wear strip.

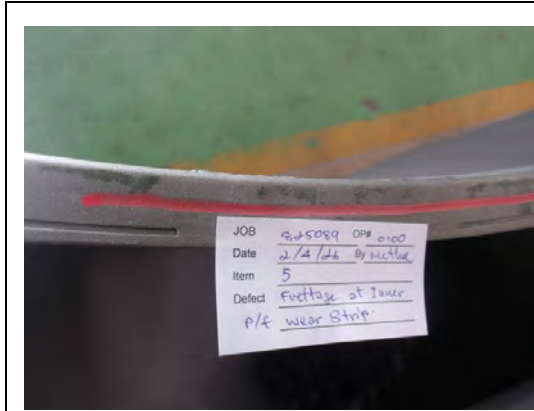
Fig.13 Fretage on inner picture frame wear strip.

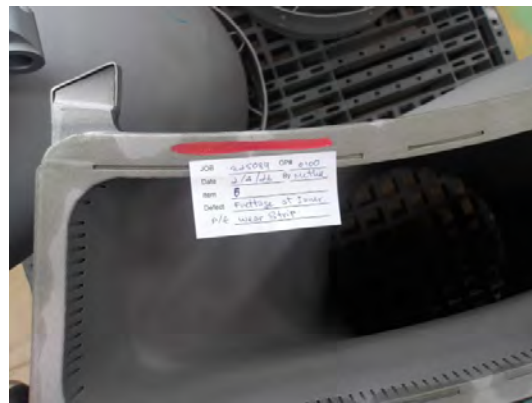
Fig.14 Fretage on inner picture frame wear strip.

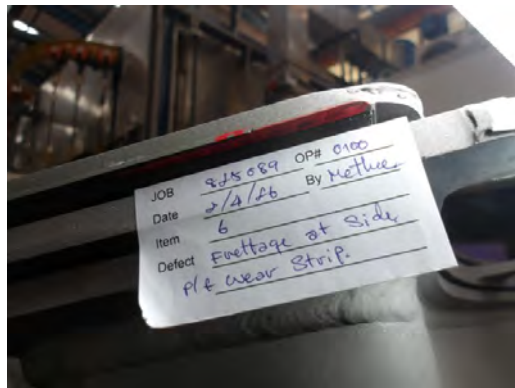
Frettage at Side Picture Frame Wear Strip	Light to Standard (Medium) frettage confirmed on all side picture frame wear strips (2 per unit) across all 6 units. All side wear strips require replacement.	Replace
Frettage and Wear at H-Blocks	Light frettage confirmed on all H-blocks (2 per unit) across all 6 units. H-block dimensions remain within acceptable limits. Blend repair sufficient to restore contact surfaces.	Blend Repair
Deformation and Wear at Inner Floating Seals	Deformation and wear confirmed on all inner floating seals across all 6 units. All inner floating seals require replacement.	Replace
Deformation and Wear at Outer Floating Seals	Deformation and wear confirmed on all outer floating seals across all 6 units. All outer floating seals require replacement.	Replace
Exit End Dimensional Deviation	Exit end dimensions recorded as REJECT on all 6 units. Cold press correction required to reinstate blueprint geometry prior to coating.	Cold Press and Reshape

Fig.15 Fretage on side picture frame wear strip.

4	Cracking at outer picture frame wear strip	Cracks of 5 to 10 mm confirmed on outer picture frame wear strips of units 1, 3, 4, and 5.	Weld and Blend	REQUIRED
5	Fretage at side picture frame wear strip	Light to Standard (Medium) fretage confirmed on all side picture frame wear strips (2 per unit) across all 6 units. All to be replaced.	Replace	REQUIRED
6	Fretage and wear at H-blocks	Light fretage confirmed on all H-blocks (2 per unit) across all 6 units. H-block dimensions within acceptable limits.	Blend Repair	REQUIRED
7	Deformation and wear at inner floating seals	Deformation and wear confirmed on all inner floating seals across all 6 units. All to be replaced.	Replace	REQUIRED
8	Deformation and wear at outer floating seals	Deformation and wear confirmed on all outer floating seals across all 6 units. All to be replaced.	Replace	REQUIRED
9	Exit end dimensional deviation	Exit end dimensions recorded as REJECT on all 6 units. Cold press correction required to reinstate blueprint geometry.	Cold Press and Reshape	REQUIRED

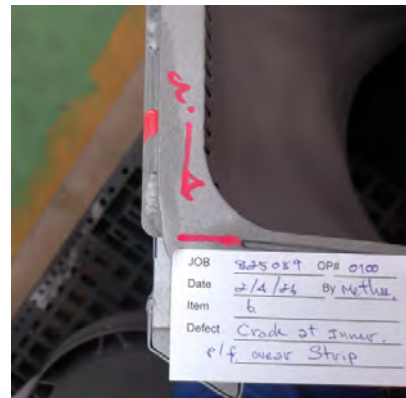
Fig.16. Crack on inner picture frame wear strip.

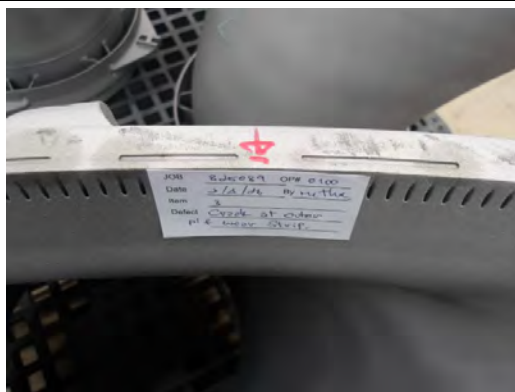
Fig.17 Crack on outer picture frame wear strip.

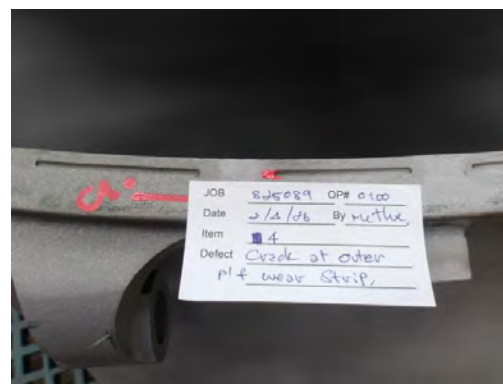
Fig.18 Crack on outer picture frame wear strip.

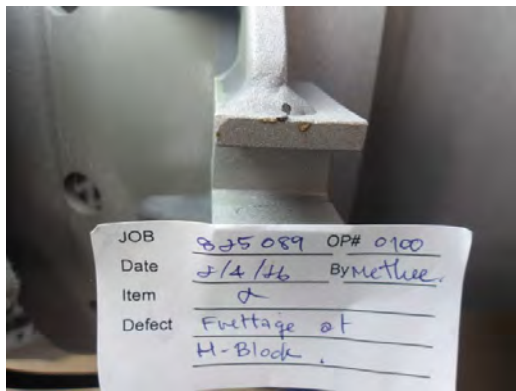
Fig.19 Fretting on H-Block.

20	Repair by welding and blending H-blocks to restore dimensional acceptance.	All 6 Units
21	Blend all repaired areas to restore component profile.	All 6 Units
22	Perform post-repair heat treatment to restore material properties.	All 6 Units
23	Assemble matched aft bracket to TP body.	All 6 Units
24	Perform final age heat treatment.	All 6 Units
25	Set in fixture and perform dimensional inspection.	All 6 Units
26	Weld in place new extender wear strips.	All 6 Units
27	Perform local NDT inspection at wear strip locations.	All 6 Units
28	Apply Chrome Carbide hard face coating by APS process to inlet end.	All 6 Units
29	Apply Chrome Carbide hard face coating by APS process to forward support ring.	All 6 Units
30	Set up and reassemble matched TP jackets. Assemble new U frames.	All 6 Units
31	Perform fluorescent penetrant inspection.	All 6 Units
32	Apply MCrAlY bond coat and TBC topcoat by APS process to internal body surface.	All 6 Units

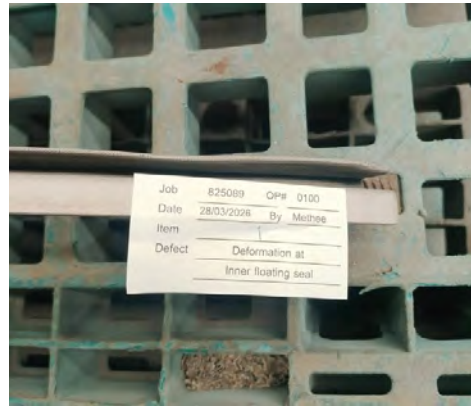
Fig.20 Deformation on inner floating seal.

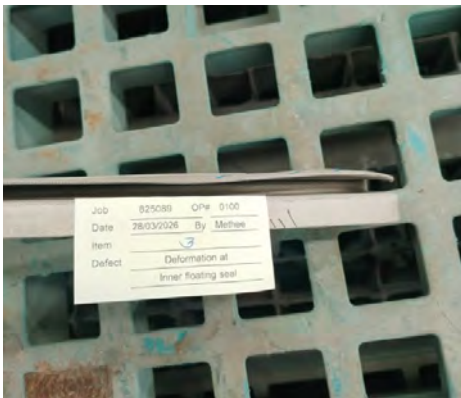
Fig.21 Deformation on inner floating seal.

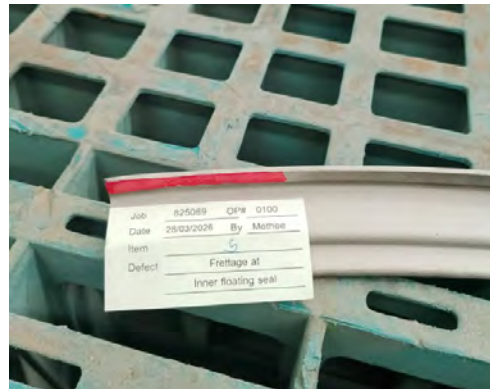
Fig.22 Fretting on inner floating seal.

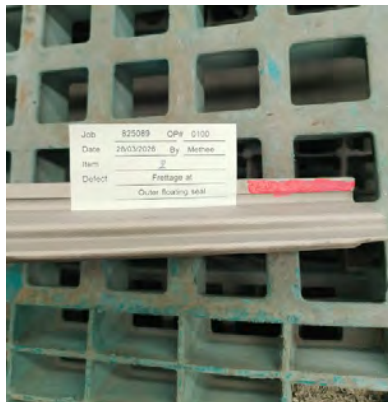
Fig.23 Fretting on outer floating seal.

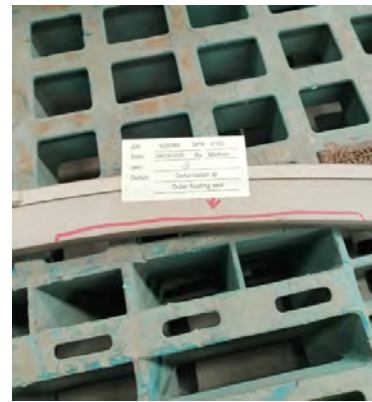
Fig.24 Deformation on outer floating seal.

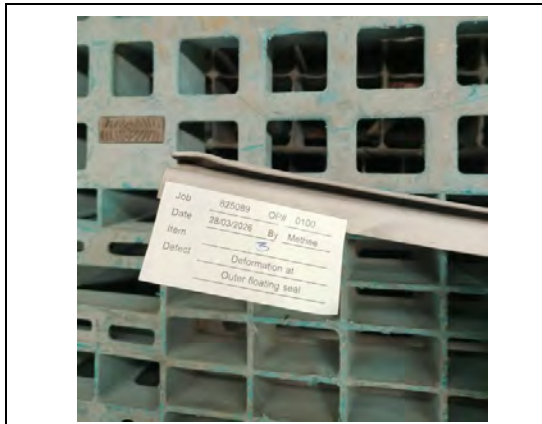
Fig.25 Deformation on outer floating seal.

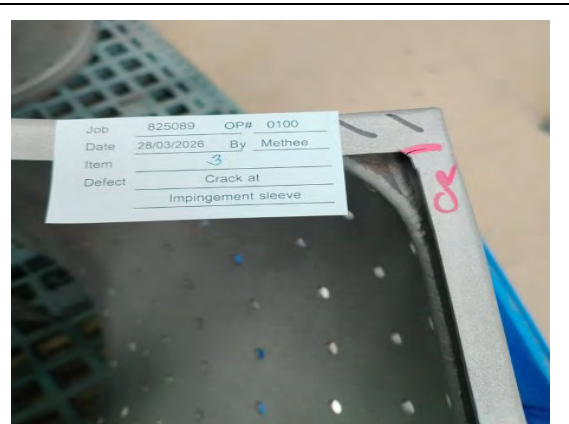
Fig.26 Crack on impingement sleeve.

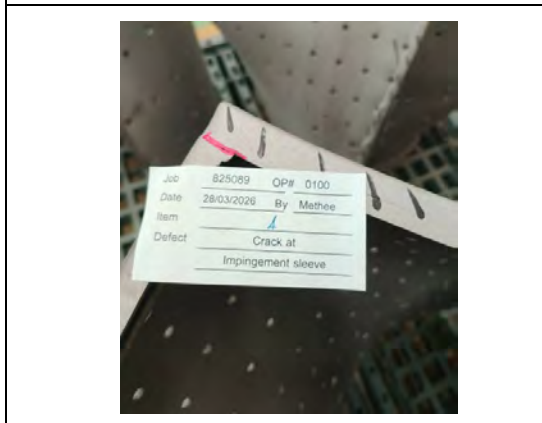
Fig.27 Crack on impingement sleeve.

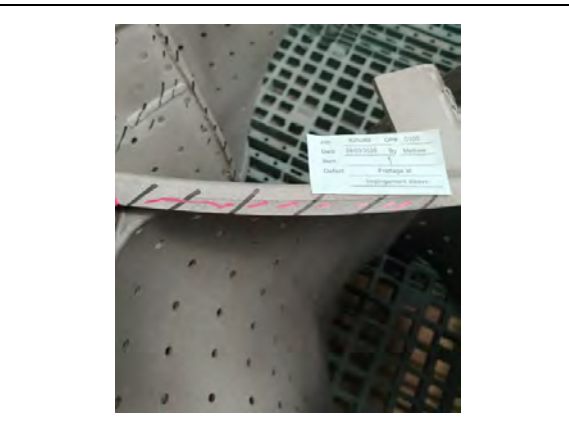
Fig.28 Fretting on impingement sleeve.

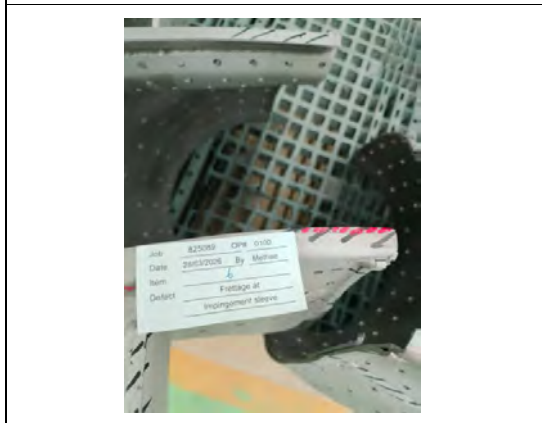
Fig.29 Fretting on impingement sleeve.
