# INCOMING INSPECTION REPORT

<b>Customer</b>	Nghi Son Refinery & Petrochemical, LLC.	<b>UNEW Work Order No.</b>	825091
<b>Customer P.O. No.</b>	1003986864	<b>Report Date</b>	27 April 2026
<b>Engine Type</b>	MS6001FA (GE Frame 6FA)	<b>Component</b>	1st Stage Nozzle
<b>Part Number (Casting)</b>	129E9734 P002	<b>Part Number (Ring)</b>	143E5711G02
<b>Material</b>	FSX-414 Cobalt Superalloy	<b>Qty. Received</b>	24 Segments (1 Complete Set)
<b>As-Received Coating</b>	HVOF MCrAlY + Full TBC Top Coat	<b>Repair Classification</b>	<b>HEAVY REPAIR</b>
<b>Total Initiated Starts</b>	476	<b>Total Emergency Trips</b>	125

Twenty-four (24) MS6001FA 1st stage nozzle segments were received and inspected. The inspection identified multiple severe damage mechanisms affecting both airfoil sections and structural components, including extensive cracking, heavy corrosion, wall thinning, deformation, and coating degradation.

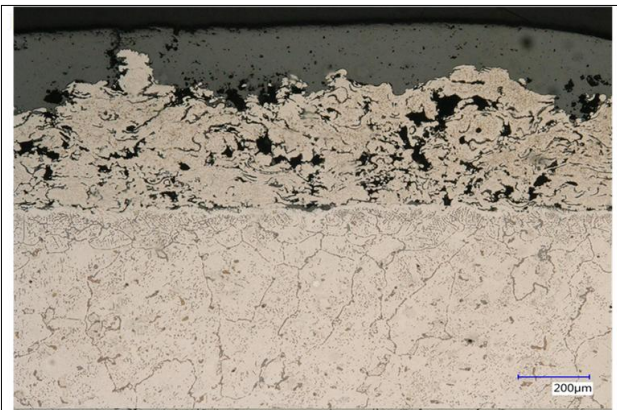
Fig.1 Heavy coating degradation exposing base metal

Specimen L11383 was prepared and examined to assess material condition for repair eligibility. The following was observed. Hot gas path coating (TBC) showed severe degradation with heavy breakdown at the coating-substrate interface, refer to Fig.1. Base material confirmed as FSX-414 alloy, exhibiting heavy grain boundary carbide coarsening, detrimental phase precipitation, and a gamma matrix with advanced primary and secondary carbide deterioration, Fig.2.

Based on the examination above, the base material exhibits severe microstructural degradation consistent with extended high-temperature service under heavy cyclic loading. Heavy grain boundary carbide coarsening and detrimental phase precipitation are confirmed throughout the substrate. The material condition requires mandatory full vacuum solution heat treatment prior to any weld repair to restore microstructural integrity. Subject to successful heat treatment recovery, the base material is considered eligible for Heavy Repair. All repair activities shall be performed strictly in accordance with UNEW approved procedures for FSX-414 alloy.

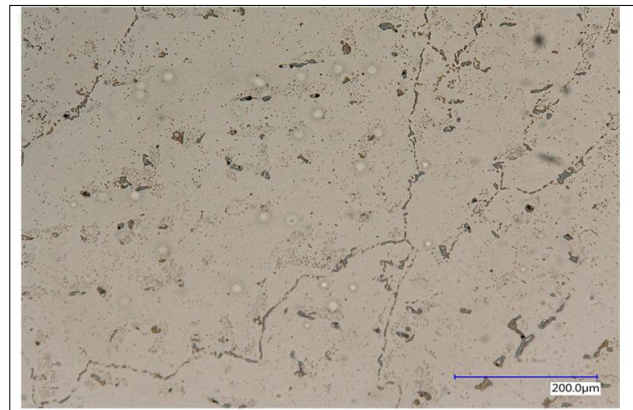
Fig.2 Heavy grain boundary damage at high magnification (Etched)

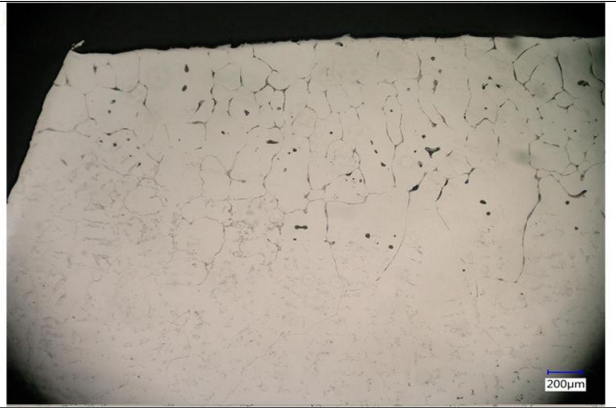
<p>Fig.1 Heavy microstructural damage requiring mandatory heat treatment intervention (Etched)</p> <p>Fig.2 Severe grain boundary attack and carbide deterioration at high magnification (Etched)</p>

<p>Specimen L11383-1 was prepared and examined to evaluate base material microstructure in pre-weld solution heat treated condition. Examination confirmed that the severely degraded microstructure has been recovered through mandatory heat treatment intervention. The heavily coarsened grain boundary carbides and detrimental phases previously identified as critical damage indicators in report L11383 have been successfully refined to an acceptable condition for Heavy Repair welding operations. (Fig.1 and 2)</p>											
Recommendation											
<p>Based on the examination above, the badly damaged base material has been successfully restored by the pre-weld heat treatment process. The heavy grain boundary damage and harmful phases — which were confirmed as serious damage in the as-received condition — have been reduced to an acceptable level for Heavy Repair welding. Hardness test result is 30.9 HRC, which is acceptable for GTAW weld repair on FSX-414 alloy. The material is now approved to proceed with Heavy Repair welding and all work must follow UNEW approved weld repair procedures for FSX-414 alloy. A full heat treatment process is still required after all welding and TPR work is completed.</p>

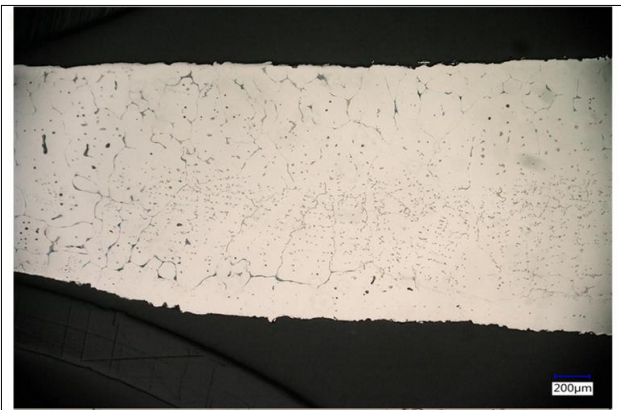
<p>Fig.1 Critical base metal damage condition prior to heat treatment (Etched)</p> </div> <div style="text-align: center;">

<p>Specimen L11383-2 was prepared and examined to evaluate the base metal condition at the Trailing Edge one of the most severely damaged areas in this set. The heavy grain boundary damage and harmful phases confirmed as critical damage in the as-received condition (report L11383) were so severe that mandatory pre-weld heat treatment was required before any repair work could proceed. Following heat treatment, the badly damaged microstructure has been sufficiently restored to allow Heavy Repair welding operations to begin. This confirms that the damage level in this set is beyond normal repair and requires full Heavy Repair intervention. (Fig.1 and 2)</p>											
<b>Recommendation</b>											
<p>Based on the examination above, the badly damaged base metal at the Trailing Edge has been successfully restored by the pre-weld heat treatment process. The heavy grain boundary damage and harmful phases which were confirmed as critical damage in the as-received condition have been reduced to an acceptable level for Heavy Repair welding. This area required special attention due to the combination of heavy cracking, severe wall thinning below the minimum limit of 2.03 mm, and bowing all confirmed across all 24 segments. Hardness test result is 27.1 HRC, which is acceptable for GTAW weld repair on FSX-414 alloy. The material is now approved to proceed with Heavy Repair welding. All work must follow UNEW approved weld repair procedures for FSX-414 alloy. A full heat treatment process is still required after all welding and TPR work is completed. In addition, all 48 Trailing Edge positions require PSP application to restore wall thickness to the minimum acceptable level before coating can proceed.</p>

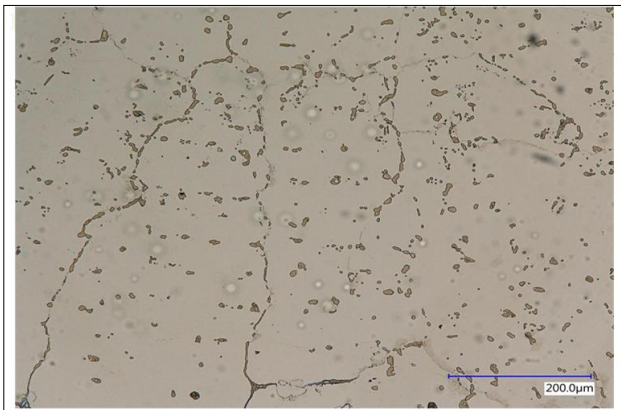
<p>Fig.2 Critical base metal damage confirmed at high magnification (Etched)</p> </div> </div>

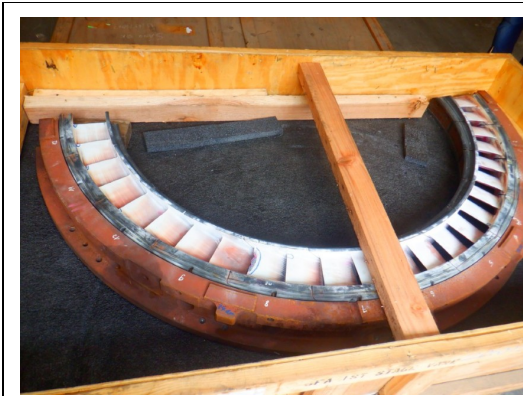
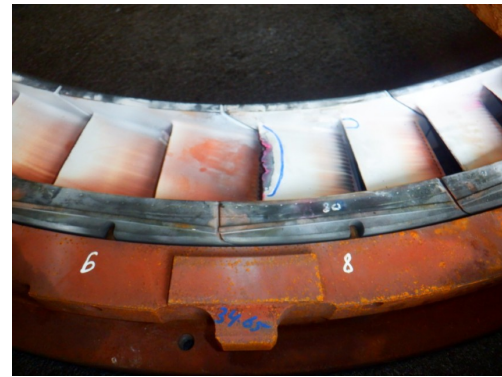
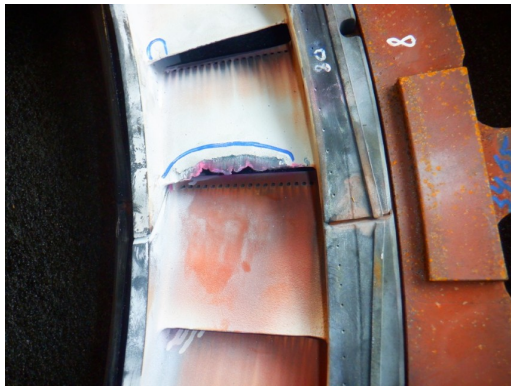
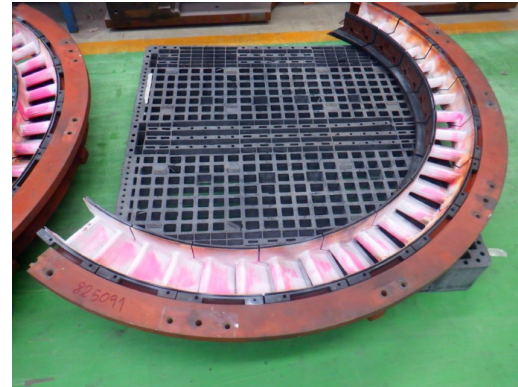
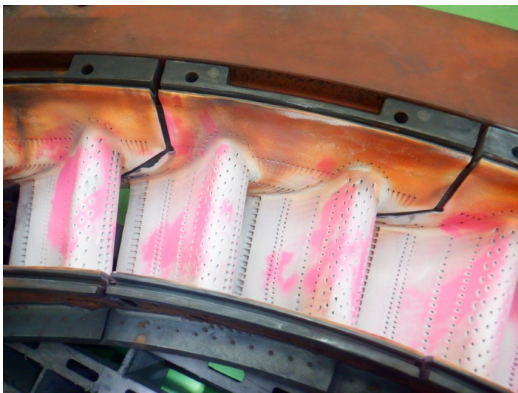
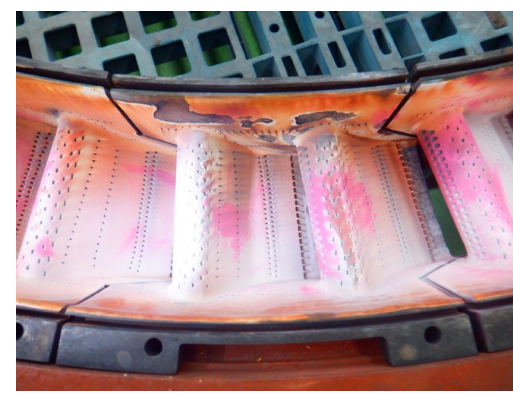
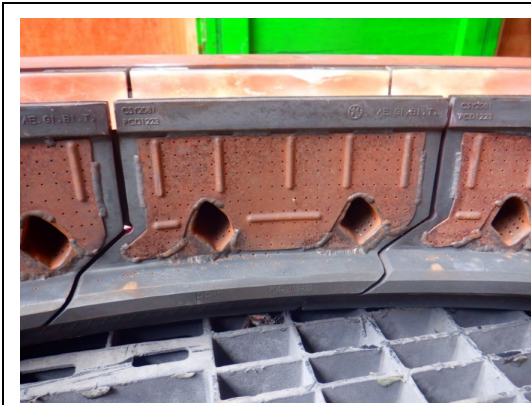
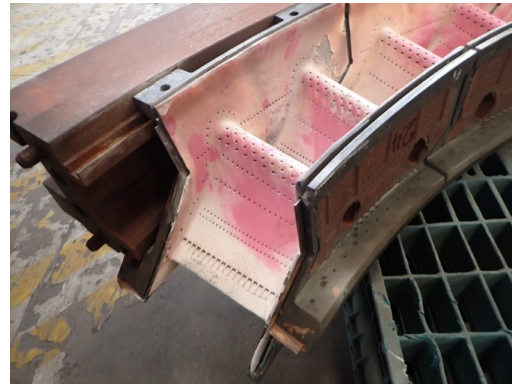
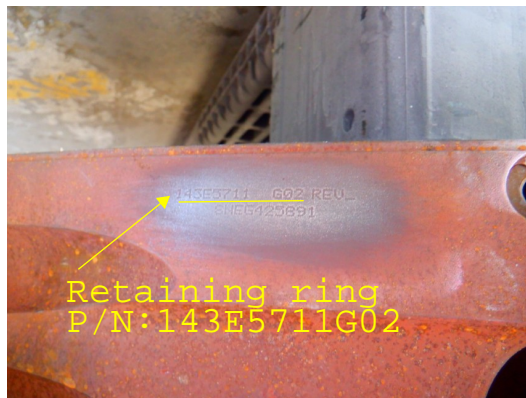
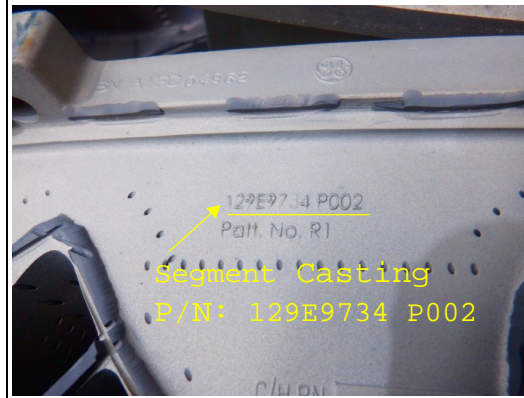
Fig.1 Received as heavy damage condition

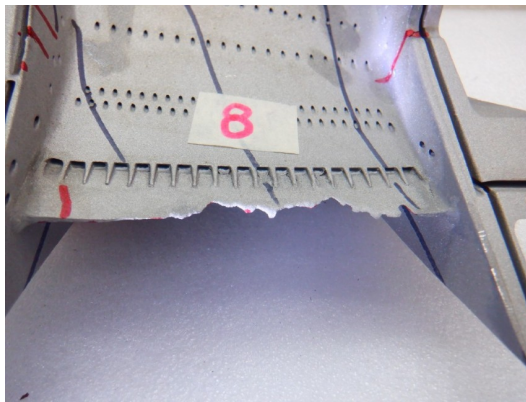
- Trailing edge (T/E): Extensive cracks ranging C5–75 mm at the O/D wall and C5–25 mm at the I/D wall across all segments (Items 1–24). Photographs (Figs. 11–13) show severe crack networks with associated heavy corrosion at the T/E.
- Airfoil body — multi-cracking: Crack networks C15×40 mm<sup>2</sup> to C30×120 mm<sup>2</sup> covering the concave, convex, leading edge, and trailing edge surfaces — all 24 segments. Requires Transient Phase Restoration (TPR).
- Non-gas-path I/D and O/D walls: C8–20 mm cracks (non-gas path) on all segments; C8–15 mm on O/D wall at Items 1, 3, 22, and 23.
- Individual segment anomalies: Item 19 exhibits a C50 mm crack at the concave (c/c) face — a non-typical defect warranting specific weld repair attention.

Fig.11 Extensive crack and heavy corrosion on trailing edge.

The extent and distribution of cracking present on every single segment of the set definitively require heavy repair on all structural weld repair (GTAW), Transient Phase Restoration (TPR), and subsequent vacuum solution heat treatment.

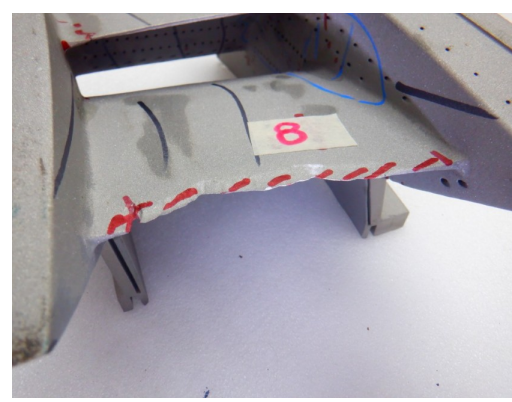
Fig.12 Extensive crack and heavy corrosion on trailing edge.

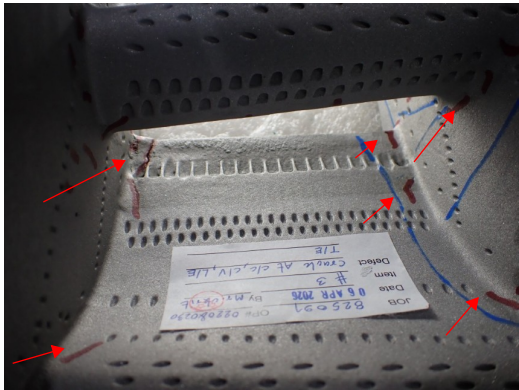
<p>Fig.13 Extensive crack and heavy corrosion on trailing edge.</p>

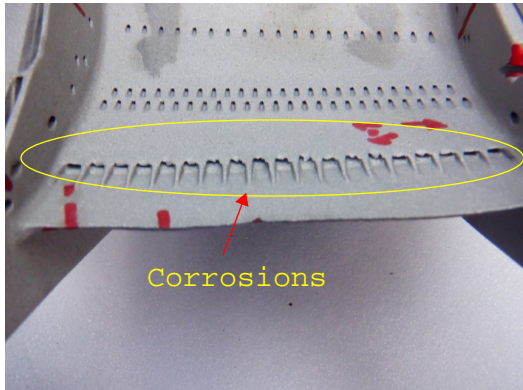
- Heavy corrosion on the concave airfoil face and trailing edge, resulting in significant metal loss and surface pitting (Items 1–24).
- Heavy oxidation on the outer shroud (O/D) wall structurally significant as it affects load-bearing and sealing surfaces.
- Light to medium corrosion on the I/D wall and non-gas-path surfaces across all 24 segments requiring blending and restoration.

The severity of corrosive attack, combined with trailing edge thinning, is consistent with Type I or Type II hot corrosion from sulfur-bearing fuel species and elevated operating temperatures, conditions that are only addressable through heavy repair intervention.

<p>Corrosions</p> <p>Fig.14 Heavy corrosion on concave airfoil and trailing edge</p>

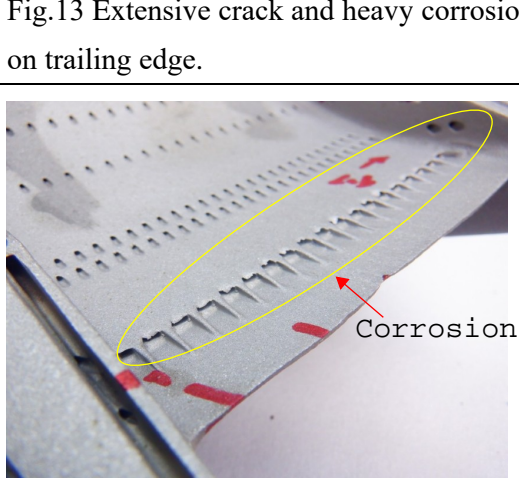
<p>Corrosions</p> <p>Fig.15 Heavy corrosion on concave airfoil and trailing edge.</p>

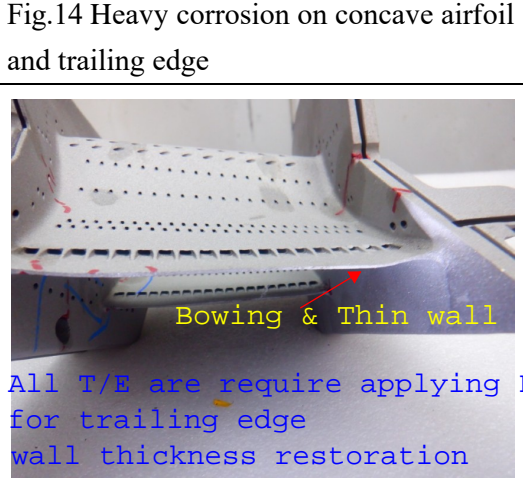
Visible bowing and permanent deformation of the trailing edge walls were documented in Fig. 16, with accompanying annotation confirming thin-wall condition requiring PSP. Cold straightening and planishing will be performed on all affected trailing edge and airfoil sections prior to weld repair.

<p>Bowing &amp; Thin wall</p> <p>All T/E are require applying PSP for trailing edge wall thickness restoration</p> <p>Fig.16 Critical Bowing and thin wall on trailing edge.</p>

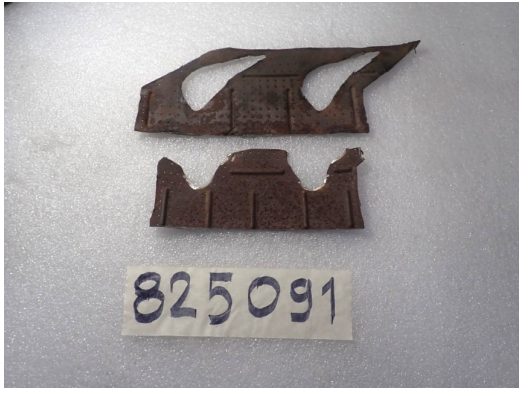
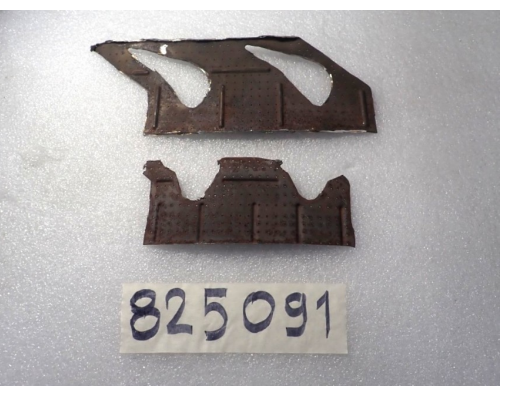
<p>Fig.19 As received condition of Impingement Cover plates .</p>	<p>Fig.20 As received condition of Impingement Cover plates.</p>

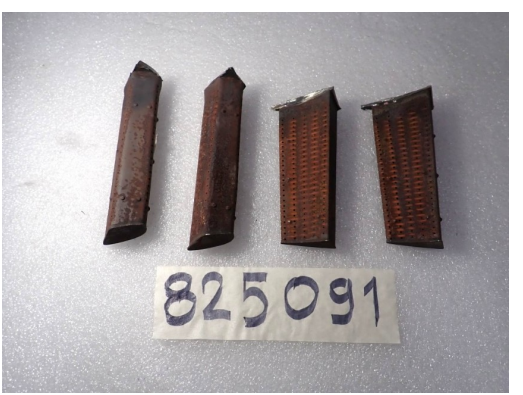
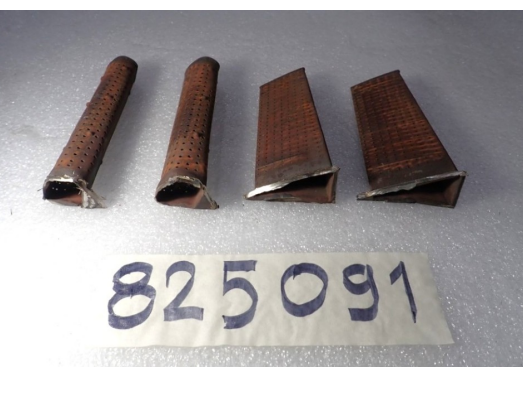
<p>Fig.21 As received condition of core plugs</p>	<p>Fig.22 As received condition of core plugs</p>

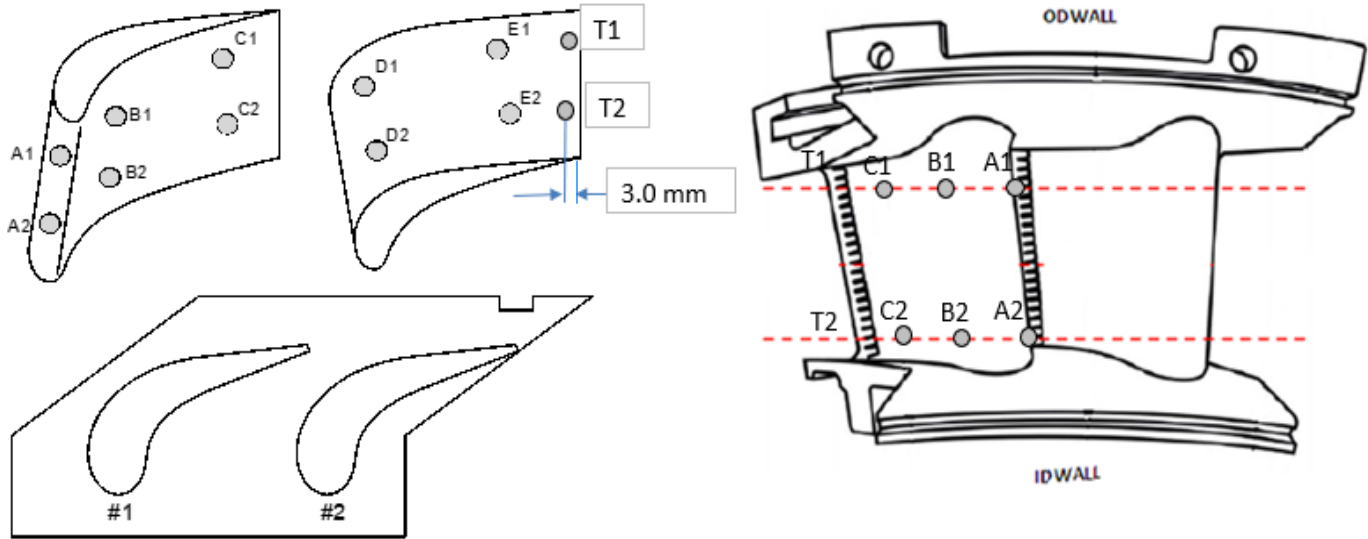
### WALL THICKNESS CHECK

Segment	Airfoil # 1												Airfoil # 2												Result
	A1	A2	B1	B2	C1	C2	D1	D2	E1	E2	T1	T2	A1	A2	B1	B2	C1	C2	D1	D2	E1	E2	T1	T2	
1	2.78	2.83	2.49	2.64	2.31	2.27	3.73	3.18	2.95	2.87	1.18	1.21	2.84	2.86	2.44	2.63	2.38	2.49	3.74	3.22	2.85	2.92	1.50	1.22	Rej
2	2.68	2.97	2.52	2.81	2.27	2.22	3.82	3.68	3.60	2.96	1.99	2.05	3.02	3.11	2.98	2.95	2.56	2.64	3.51	3.33	3.40	3.35	1.71	2.06	Rej
3	2.87	2.82	2.69	2.78	2.41	2.30	3.16	2.68	2.79	2.36	1.36	1.68	2.86	3.05	2.58	2.66	2.29	2.28	3.04	3.31	2.77	3.06	2.05	1.81	Rej
4	3.05	3.07	2.55	2.68	2.45	2.92	3.18	3.11	3.44	3.17	1.90	2.26	2.96	2.98	3.08	3.24	2.45	2.88	3.41	3.57	3.43	3.42	1.87	1.93	Rej
5	2.88	3.11	2.71	3.15	2.30	2.48	3.36	3.51	3.51	3.44	1.25	1.26	2.91	3.04	2.60	2.48	2.48	2.76	3.37	3.30	3.11	3.09	1.63	1.60	Rej
6	3.03	3.39	3.16	3.23	3.18	3.45	3.20	3.46	3.69	3.52	1.75	1.90	3.02	3.45	2.91	3.20	3.01	3.11	3.57	3.42	4.15	3.93	1.94	1.93	Rej
7	3.05	3.24	2.46	2.94	2.36	2.70	3.58	2.75	2.95	2.85	1.29	1.53	2.64	3.23	2.50	2.94	2.59	2.97	3.50	2.83	3.14	3.23	1.74	1.68	Rej

8	3.02	3.76	2.62	2.98	2.24	2.46	3.55	3.02	33.90	3.13	1.80	1.96	3.01	3.62	2.36	2.78	2.47	3.12	3.48	3.12	3.76	3.80	Missing	Missing	Rej
9	3.03	3.48	2.60	2.89	2.65	2.94	3.53	3.18	3.54	3.21	1.37	1.38	2.93	3.43	2.57	2.97	2.55	3.14	3.75	3.16	3.32	3.12	1.30	1.43	Rej
10	2.96	3.39	2.48	2.73	2.42	2.47	3.29	3.52	3.45	3.43	1.52	1.60	2.98	3.41	2.81	3.17	2.35	2.60	3.43	3.03	3.44	3.08	1.86	1.88	Rej
11	3.06	3.60	2.78	2.96	2.27	2.46	3.95	3.55	3.03	3.12	1.73	2.10	2.94	3.15	2.63	2.68	2.27	2.51	3.32	3.42	3.55	3.40	1.93	1.79	Rej
12	2.95	3.46	2.38	2.69	2.61	2.42	3.07	3.11	3.47	3.25	1.53	1.64	2.89	3.04	2.64	2.68	2.26	2.56	3.02	3.05	3.57	3.49	1.61	1.59	Rej
13	3.03	3.55	2.28	2.48	2.68	2.54	3.29	2.86	3.70	3.23	1.65	1.61	3.02	3.06	2.44	2.53	2.57	2.63	3.57	2.85	3.52	3.44	1.60	1.36	Rej
14	3.02	3.45	2.57	2.68	2.56	2.30	3.21	3.16	3.35	3.29	1.27	1.50	3.01	3.47	2.68	2.48	2.30	2.50	3.21	3.04	3.42	3.38	1.40	1.18	Rej
15	2.96	2.93	2.53	2.79	2.40	2.48	3.55	3.26	2.80	3.11	1.56	1.73	2.86	2.94	2.51	2.78	2.27	2.39	3.01	2.86	3.07	3.36	1.23	1.35	Rej
