INCOMING INSPECTION REPORT

Customer	Nghi Son Refinery & Petrochemical LLC	UNEW Work Order No.	825092
Customer P.O. No.	1003986864	Report Date	27 April 2026
Engine Type	MS6001FA (GE Frame 6FA)	Component	MS6001FA 1st Stage Shroud Block
Component Part No.	Body: 119E4234 G001 Inner plate (Tip shoe): 176D3829 P001	Qty. Received	24 Units (1 Complete Set)
Material	Body: SS310 Inner plate (Tip shoe): Inconel 738	As-Received Coating	Body: No coating Inner plate (Tip shoe): TBC Abradable coating
Repair Classification	HEAVY REPAIR	Coating Requirement	TBC Abradable plus ceramic compound
Total Initiated Starts	476	Total Emergency Trips	125

Twenty-four (24) MS6001FA 1st stage shroud blocks were received from Nghi Son Refinery and Petrochemical LLC and subjected to full incoming inspection, including visual inspection, fluorescent penetrant inspection (FPI), dimensional measurement, and metallurgical evaluation of both the shroud body and inner plate (tip shoe) components.

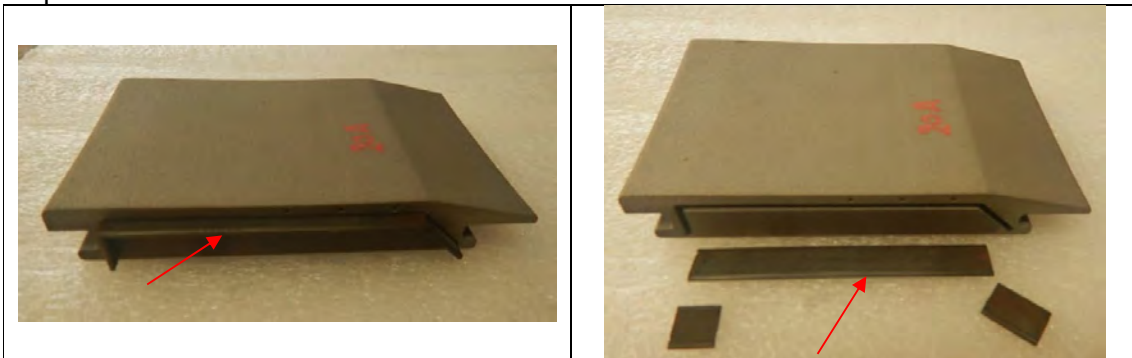
All shroud blocks were received with inner plate side seals (cloth seal type) in damaged and non-serviceable condition, with loss of sealing function. Replacement with new inner plate side seals (L605 flat and bone type) is required for heavy repair and is not included in the standard repair scope.

Figure 1–2. As-received cloth-type side seals in damaged and non-serviceable condition with loss of sealing function; replacement with new inner plate side seals (L605 flat and bone type) is required outside standard repair scope (heavy repair).

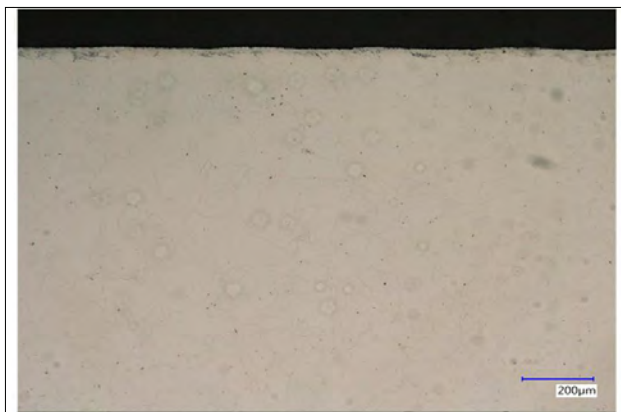
Fig.1 Showing the hot gas path surface condition.(Etched)

The component was evaluated to determine the condition of the base material for repair. The internal combustion surface is uncoated and exhibits surface degradation from service exposure, including localized oxidation, wear, and material loss in high temperature regions. The base material was confirmed as SS310 alloy, consisting of a gamma matrix with primary and secondary carbide distribution along grain boundaries. Abnormal metallurgical transformation is observed in the base material, indicating degradation of microstructural stability under service conditions. Based on these findings, all degraded and affected material must be fully removed, followed by restoration through weld build-up and controlled heat treatment as part of the heavy repair scope.

All degraded surface layers, including oxidation, worn material, and areas affected by metallurgical transformation, will be fully removed. Damaged and material-loss regions will be restored by weld build-up using compatible high-temperature filler material. Repaired areas will be machined and contoured to recover original geometry and dimensional requirements. Deformed components will be corrected through mechanical straightening and geometry restoration. Critical interface surfaces will be re-established to ensure proper fit-up and load distribution. Post-weld heat treatment will be applied to relieve residual stress and stabilize material properties. All repaired areas will undergo repeated non-destructive testing to verify integrity. Internal surfaces will be recoated with TBC & ceramic abrasion coating to restore thermal protection and performance.

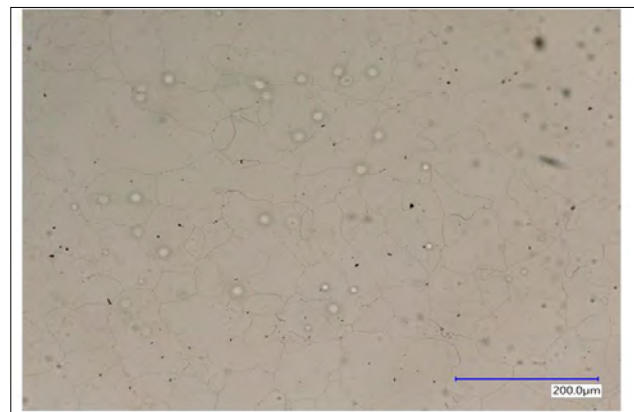
Fig.2 Showing the typical microstructure at higher magnification.(Etched)

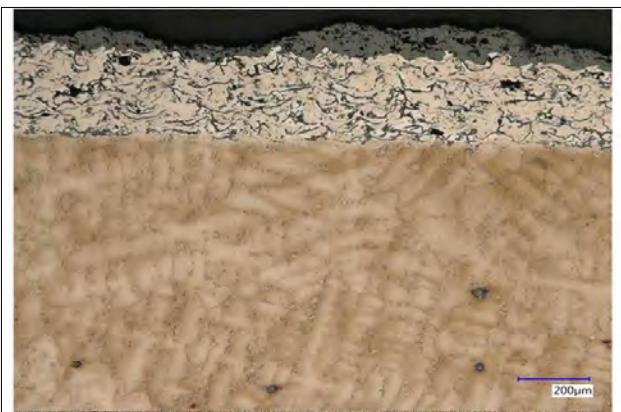
Fig.1 Showing the hot gas path coating and substrate condition.(Etched)

The component was evaluated to determine the condition and suitability of the base material for repair. The internal combustion surface is protected by TBC abrasion coating; however, inspection indicates coating degradation and localized damage associated with service exposure, including wear and material loss in critical areas. The base material was confirmed as Inconel 738 alloy, consisting of a gamma matrix with fine gamma prime, primary carbide, and dispersed secondary carbide along grain boundaries. Abnormal metallurgical transformation is observed, indicating degradation of microstructural stability under high temperature service conditions. Based on these findings, all affected coating and degraded material must be fully removed, followed by restoration through weld build-up, controlled heat treatment, and reapplication of the coating system as part of the heavy repair scope.

The TBC abrasion & ceramic coating shall be fully removed from all affected areas to expose and assess the base material condition. Any degraded coating, oxidized material, worn surface, or material-loss region shall be completely removed before repair.

Damaged areas on the Inconel 738 inner plates shall be restored by controlled weld build-up using compatible high-temperature filler material. Repaired surfaces shall be machined and contoured to restore original profile, clearance control, and assembly fit-up.

Post-weld heat treatment shall be performed to relieve residual stress and stabilize the repaired material. After dimensional verification and FPI confirmation, the repaired surfaces shall be recoated with TBC abrasion coating to restore thermal protection and operating clearance performance.

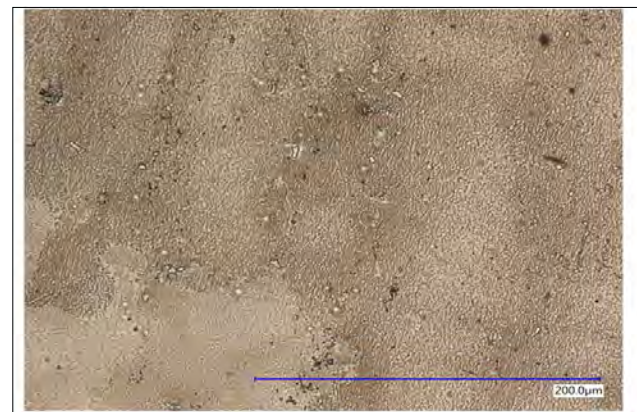
Fig.2 Showing the typical microstructure at higher magnification.(Etched)

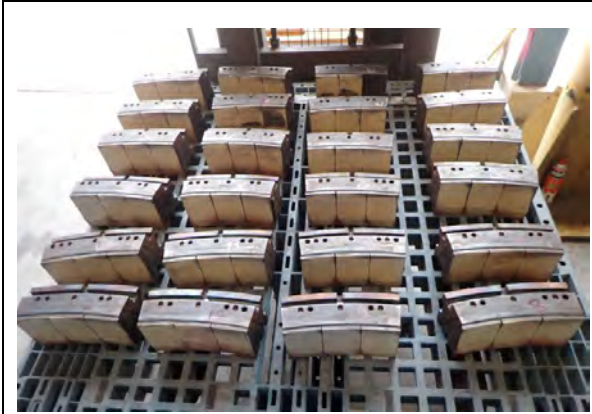
Fig.1 As received condition.

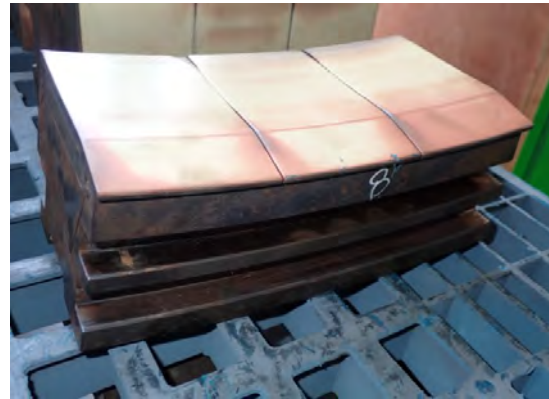
Fig.2 As received condition.

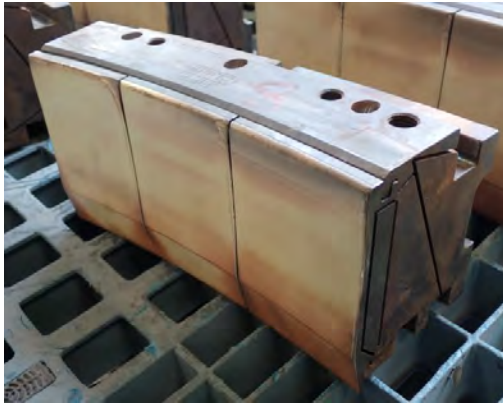
Fig.3 Heavy damaged as received condition.

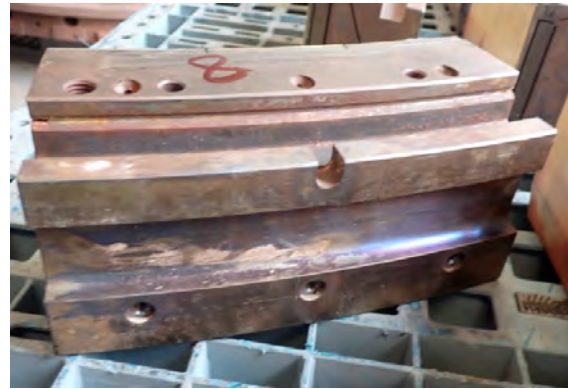
Fig.4 Heavy damaged as received condition.

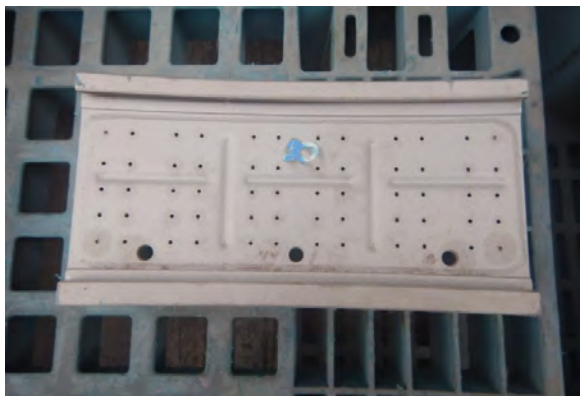
Fig.5 Tear & wear shroud block body.

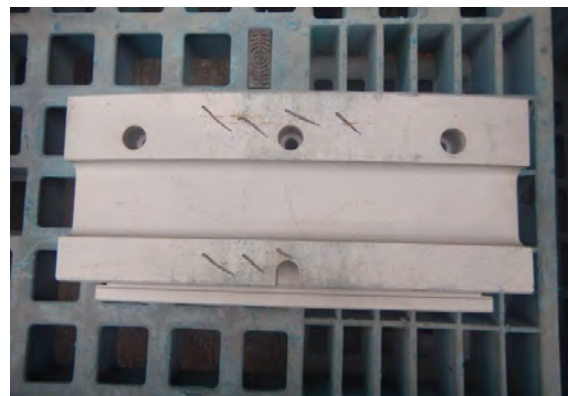
Fig.6 Tear & Wear shroud block body

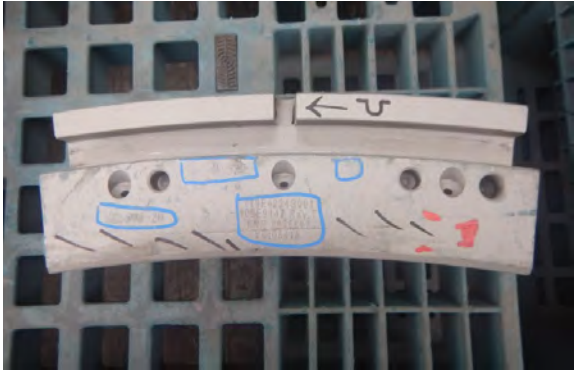
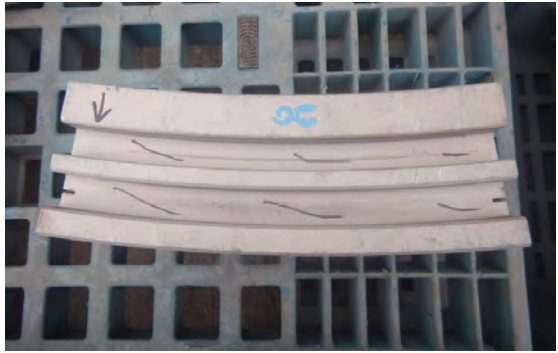
<p>Fig.7 Heavy wear and surface degradation.</p>	<p>Fig.8 Heavy wear and surface degradation.</p>

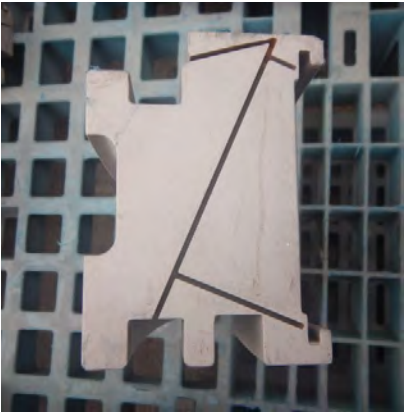
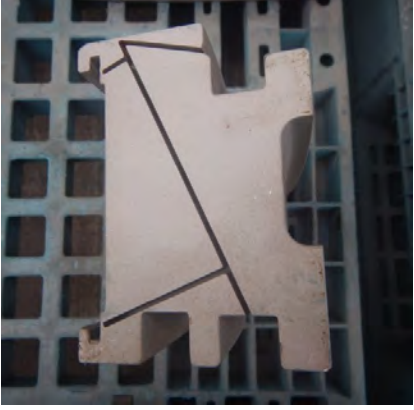
<p>Fig.9 Heavy tear/wear of shroud block body.</p>	<p>Fig.10 Heavy tear/wear of shroud block body.</p>

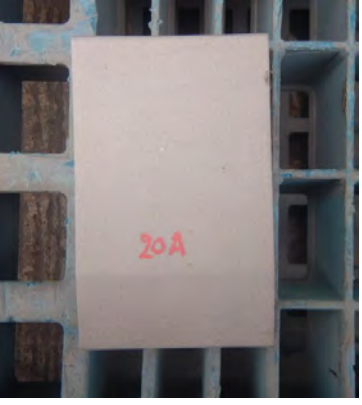
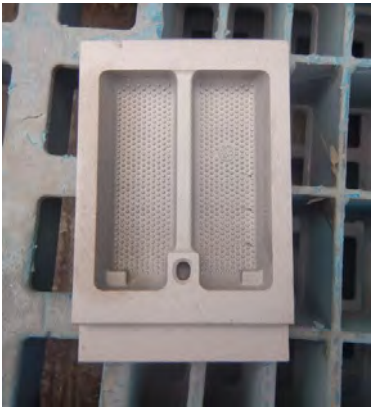
<p>Fig.11 Severe degradation on tip shoe (inner plate).</p>	<p>Fig.12 Severe degradation on tip shoe (inner plate).</p>

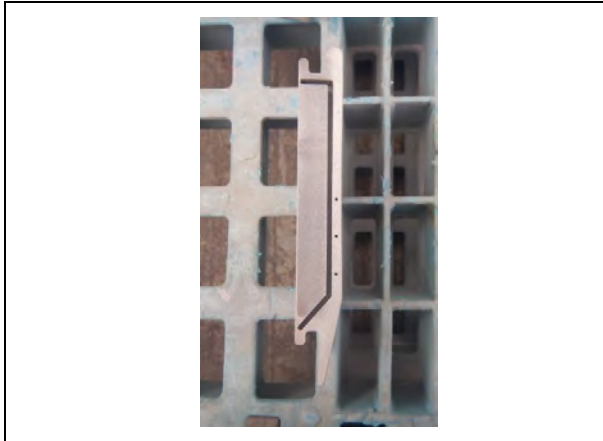
Fig.13 Severe degradation on tip shoe (inner plate).

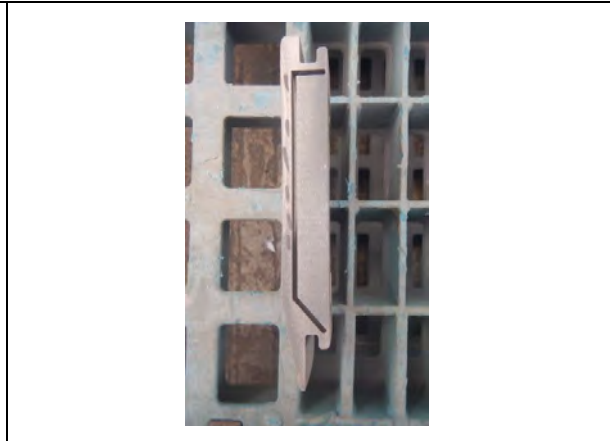
Fig.14 Severe degradation on tip shoe (inner plate).

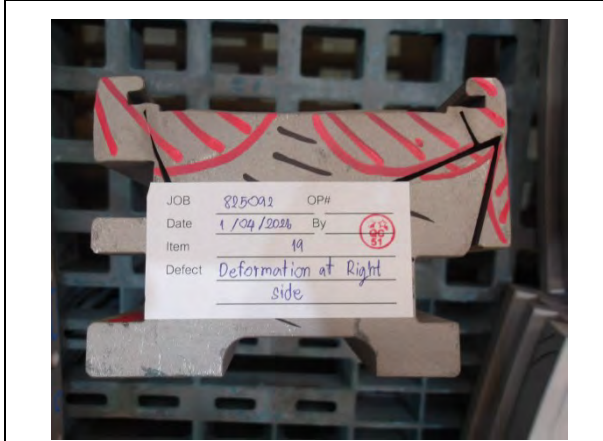
- **Structural Deformation:** Deformation of the shroud body is identified on the left and right side regions of multiple units, resulting in loss of original geometry. This directly affects assembly fit, inner plate interface alignment, and sealing effectiveness. Items requiring jacking and contouring (JK) are identified in the Defect Legend Table.

Fig.15 Heavy deformation on right side-Body.

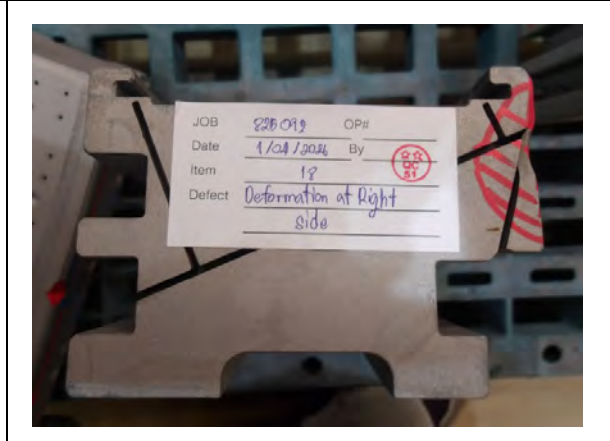
Fig.16 Heavy deformation on rightside-Body.

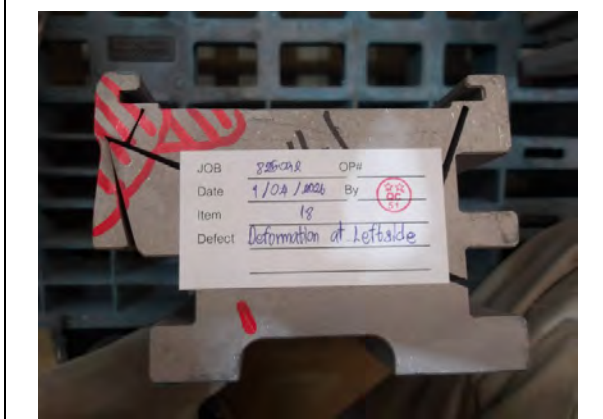
Fig.17 Heavy deformation on left side-Body.

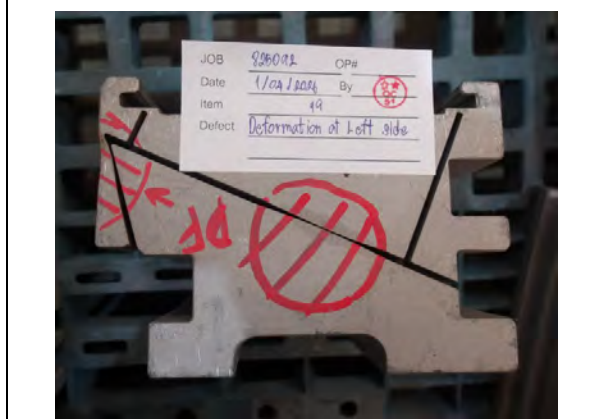
Fig.18 Heavy deformation on left side-Body.

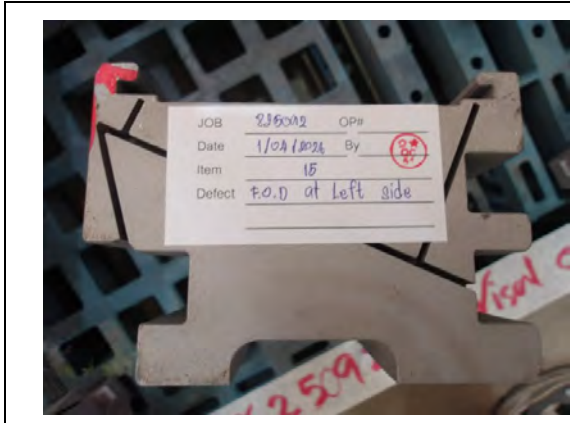
- **Foreign Object Damage (FOD):** FOD is confirmed on exposed surfaces of multiple shroud body units, creating localised surface damage and stress concentration points. Combined with fretting, FOD significantly increases the risk of crack initiation during operation.

Fig.19 Heavy FOD damaged on left side-Body.

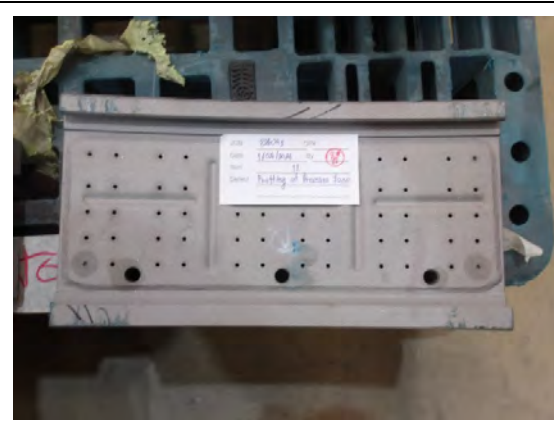
Fig.20 Heavy frettage on pressure face-Body.

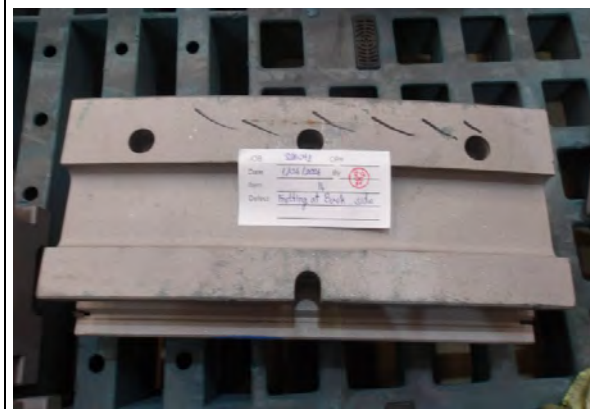
Fig.21 Heavy frettage on back side - Body.

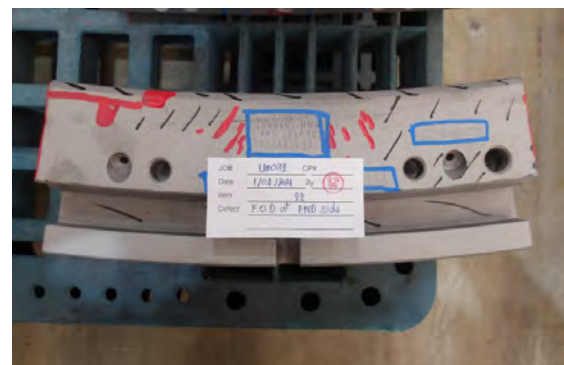
Fig.22 Heavy FOD damage on FWD side-Body.

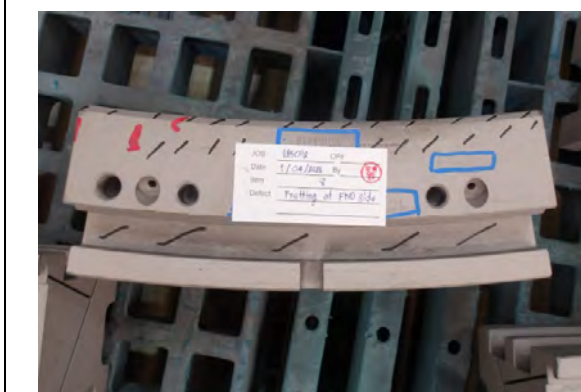
Fig.23 Heavy frettage on FWD side-Body.

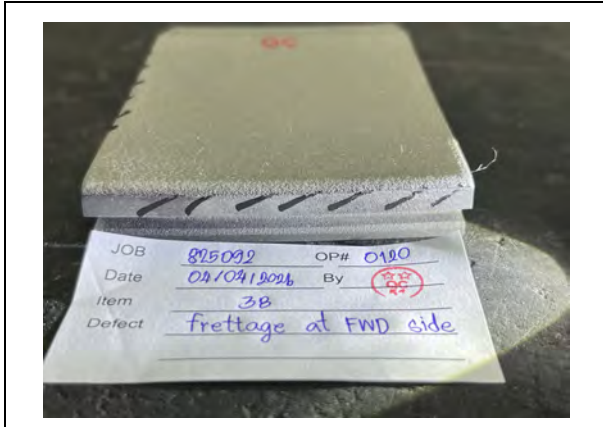
Fig.25 Heavy fretting on FWD side-Tip shoe.

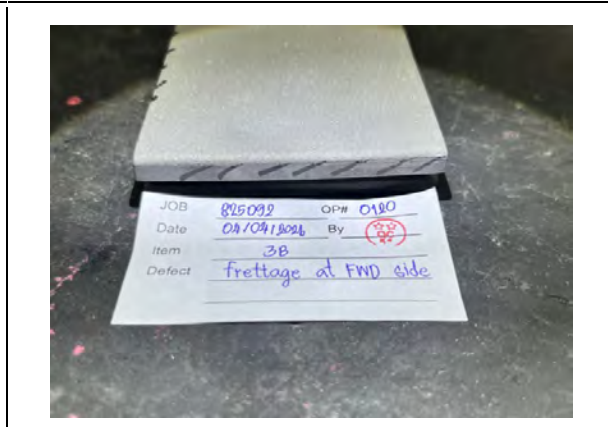
Fig.26 Heavy fretting on FWD side-Tip shoe.

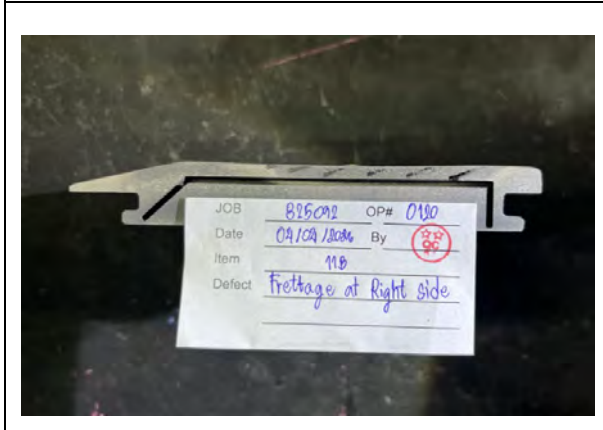
Fig.27 Heavy fretting on right side-Tip shoe.

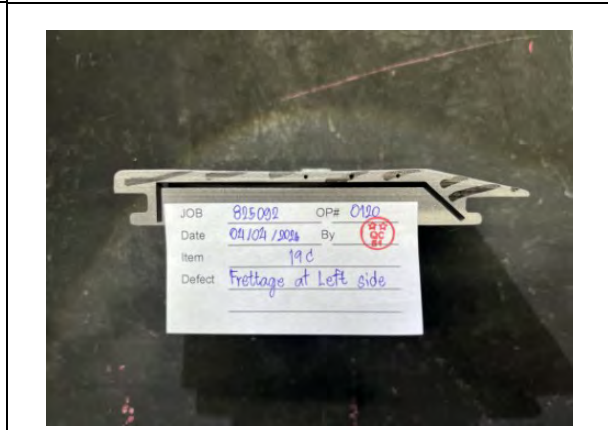
Fig.28 Heavy fretting on left side-Tip shoe.

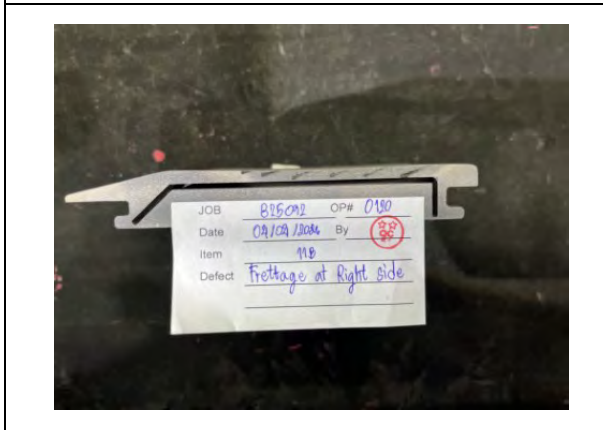
Fig.29 Heavy fretting on right side-Tip shoe.

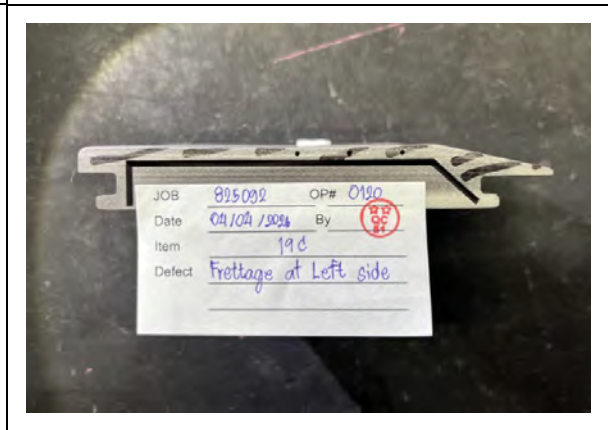
Fig.30 Heavy fretting on left side-Tip shoe.

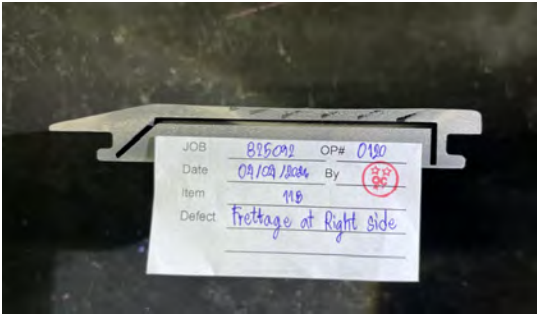
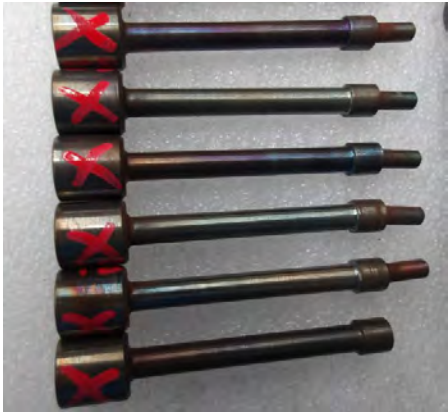
- **Tile Retention Pins & Side Seals:** All tile retention pins are received in deformed condition and cannot be reused. All inner plate side seals (cloth type) are in non-serviceable condition with complete loss of sealing function. Full replacement of both items is mandatory.

<p>Fig.31 Heavy fretting on right side-Tip shoe.</p>	<p>Fig.32 Deformation on Tile retention pins which require replacement with new.</p>

- Replacement of all tile retention pins and inner plate side seals (L605 flat and bone type) — mandatory items outside standard repair scope.
