FINAL INSPECTION REPORT & CERTIFICATE OF CONFORMANCE

Customer Name: Nghi Son Refinery & Petrochemical, LLC.

Component type: MS6001FA 1st STAGE BUCKET

Date of Report: October 15, 2025

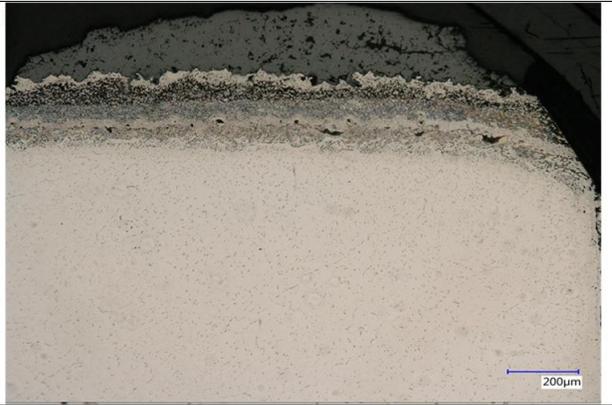
<p>Fig.1 Showing the hot gas path coating and substrate condition.(Etched)</p> </div> <div style="text-align: center;">

<p>The sample was mounted in L11073 to assess if the material would be acceptable for repair. The following was observed. Hot gas path was protected by MCrAlY (HVOF) and TBC top-coating, refer to Fig.1. Base material was confirmed as GTD111 alloy, Fig.2. (Please note the sample was taken from squealer tip where have full weld. Attempting to take one more sample low in the airfoil may affect the blade and is therefore not recommended. Material type can be confirmed by material code on shank wall and XRF inspection as shown above.)</p>											
Recommendation											
<p>Based on the finding above, the base material was considered suitable for repair following coating removal by grit blast and acid stripping respectively.</p>

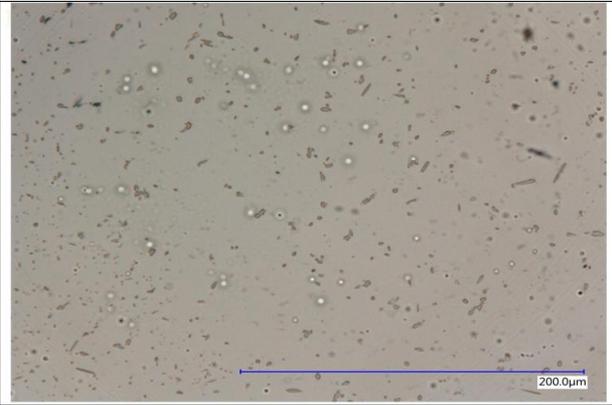
<p>Fig.2 Showing the typical microstructure at higher magnification.(Etched)</p> </div> </div>

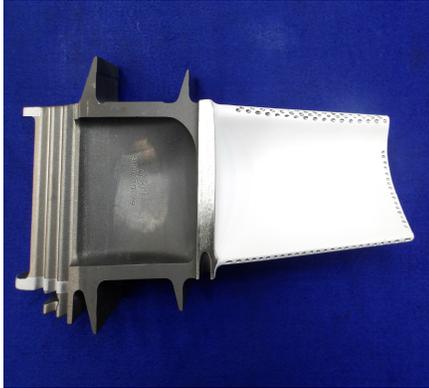
Figure 1. Final inspection.

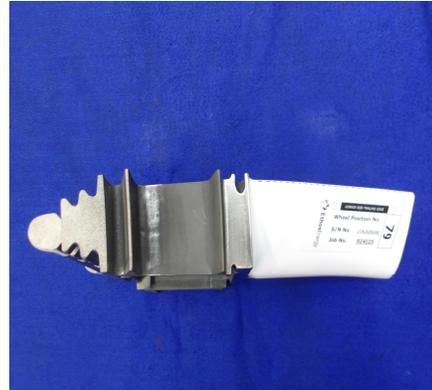
Figure 2. Final inspection.

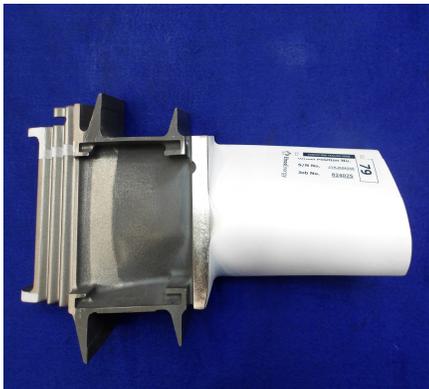
Figure 3. Final inspection.

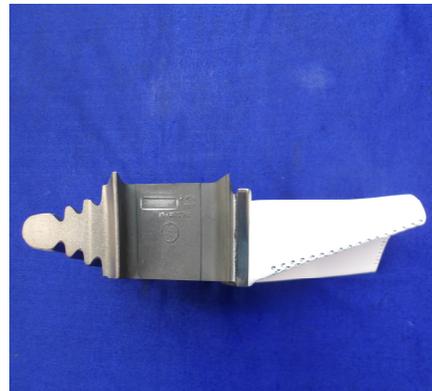
Figure 4. Final inspection.

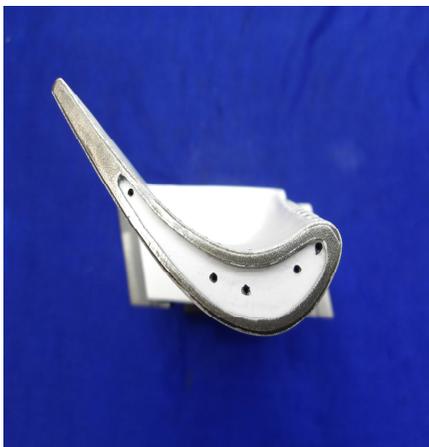
Figure 5. Final inspection.

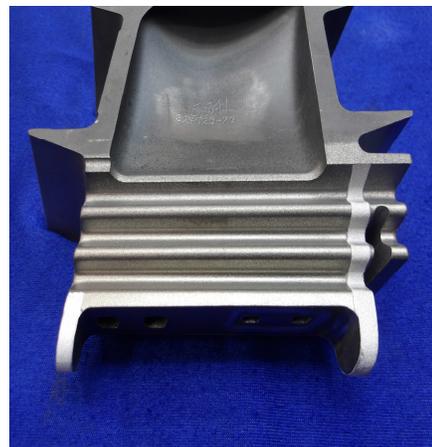
Figure 6. Final inspection.

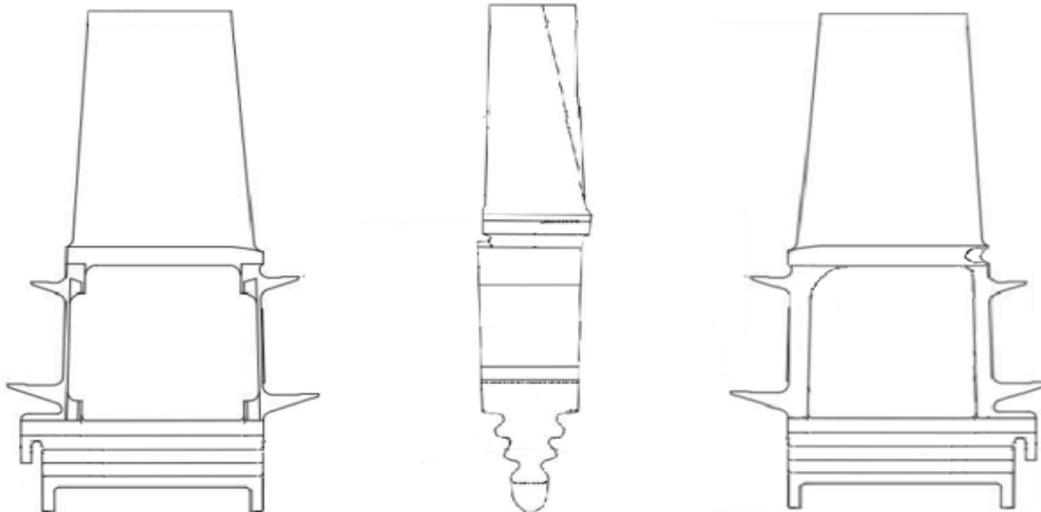
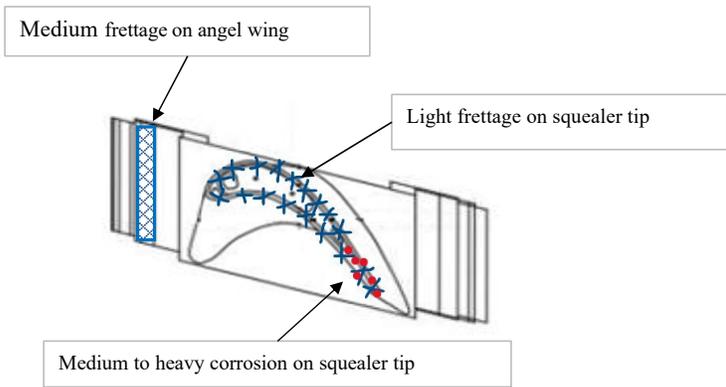
TYPICAL DEFECT

(Incoming condition)
