FINAL INSPECTION REPORT & CERTIFICATE OF CONFORMANCE

Customer Name: Nghi Son Refinery & Petrochemical, LLC.

Component type: MS6001FA 2nd STAGE NOZZLE

Date of Report: October 30, 2025

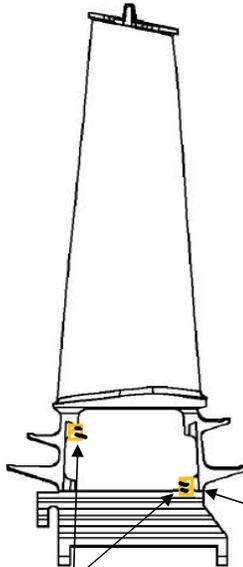
2-3 MM Crack on seal fin item.1,10 33,43,48,91.

2 MM Crack on z-notch item.9,33

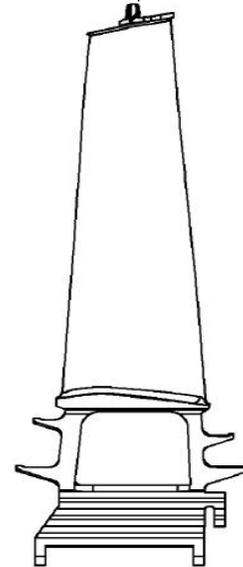
2-3 MM Crack on location pin slot item.30,84.
