## FINAL INSPECTION REPORT & CERTIFICATE OF CONFORMANCE

**Customer Name: Nghi Son Refinery & Petrochemical, LLC.**

**Component type: MS6001FA 3rd STAGE NOZZLE**

**Date of Report: October 30, 2025**

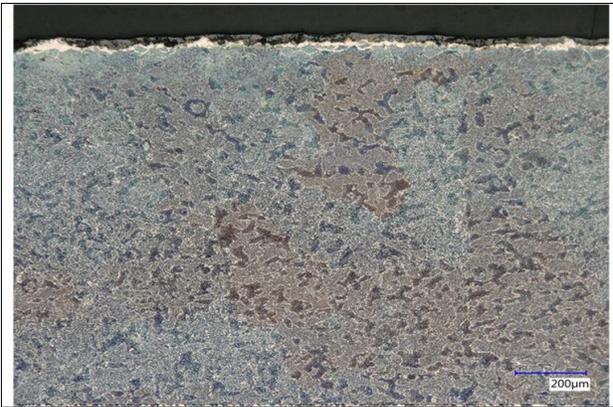
Fig.1 Showing the hot gas path surface condition.(Etched)

The sample was mounted in L11075 to evaluate material integrity and determine the required repair classification. Analysis revealed that the hot gas path surface is uncoated and exhibits severe oxidation-corrosion, with evidence of substrate alloy depletion extending into the base metal, refer to Fig.1. Due to the extent of material loss and thermal degradation, this condition requires a UNEW-classified heavy repair to restore serviceability. The base material was confirmed as GTD111 alloy, consisting of fine grain boundary carbides within a gamma matrix, with well-dispersed primary and secondary gamma prime carbides, refer to Fig.2.

Based on the findings above, the base material has been evaluated and confirmed suitable for heavy repair. Restoration will require complete surface cleaning using controlled grit blasting, followed by advanced repair processes, including extensive weld restoration, dimensional recovery, and full reapplication of UNEW's proprietary protective coatings to return the component to a fully serviceable condition.

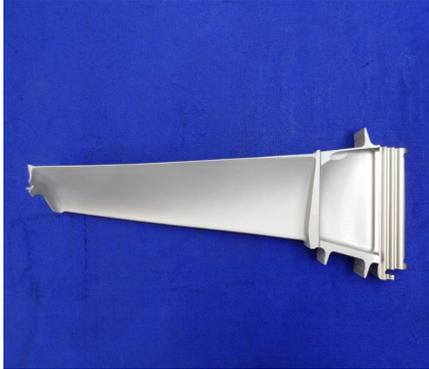
Figure 1. Final inspection.

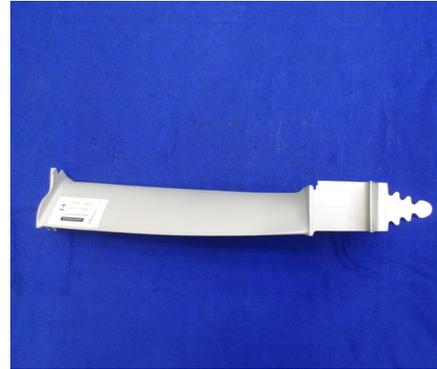
Figure 2. Final inspection.

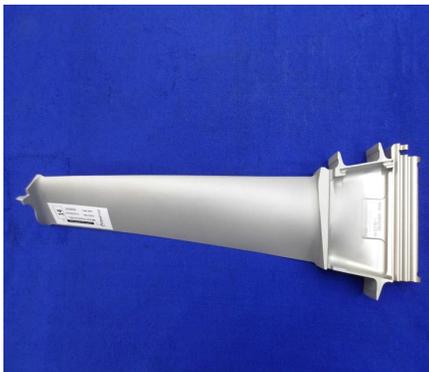
Figure 3. Final inspection.

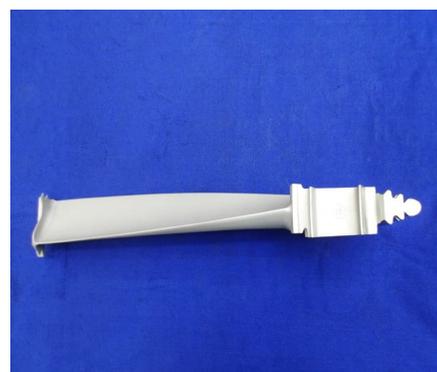
Figure 4. Final inspection.

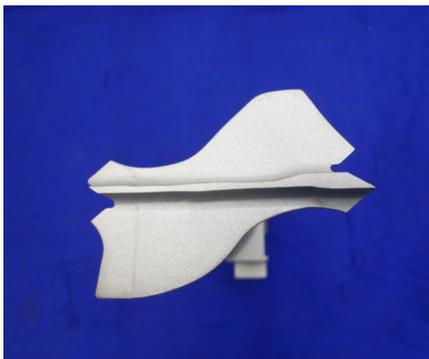
Figure 5. Final inspection.

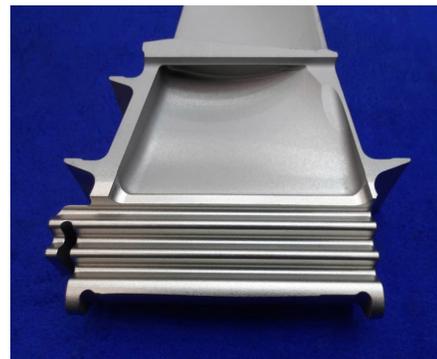
Figure 6. Final inspection.

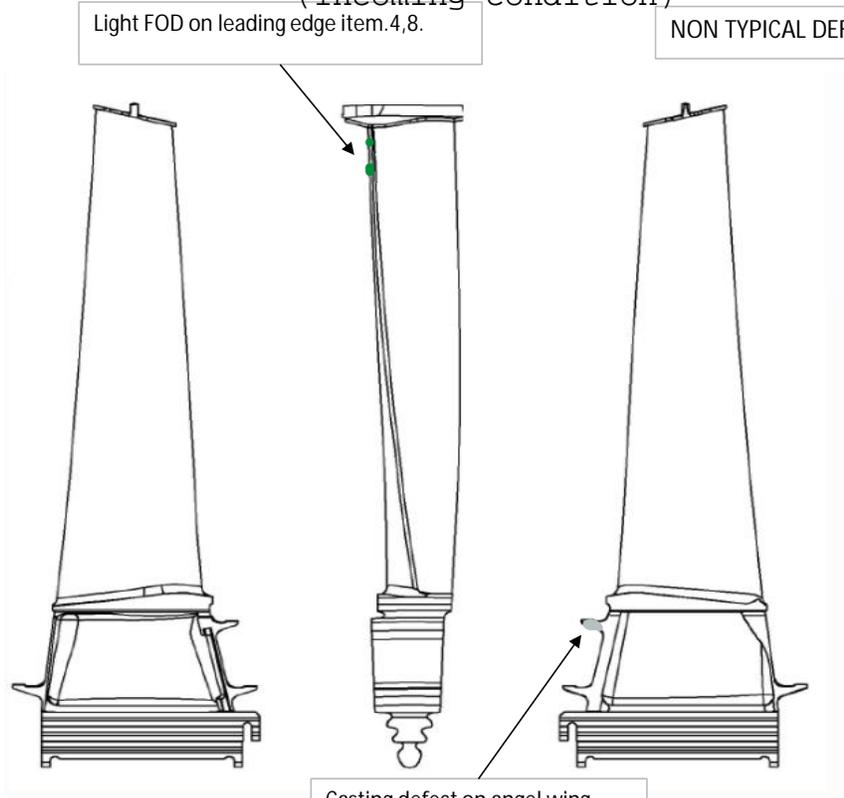
(Incoming condition)

Light FOD on angel wing item.3,5,45,51,58,92

Casting defect on angel wing item.15,51,75.

Cut sample on shroud item.92.
