## FINAL INSPECTION REPORT & CERTIFICATE OF CONFORMANCE

**Customer Name: Nghi Son Refinery & Petrochemical, LLC.**

**Component type: MS6001FA 1st STAGE NOZZLE**

**Date of Report: October 30, 2025**

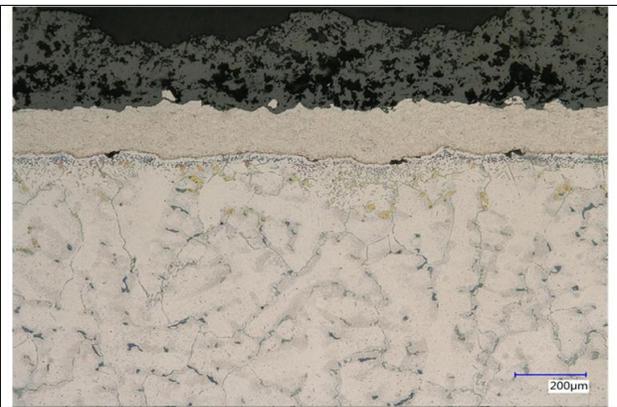
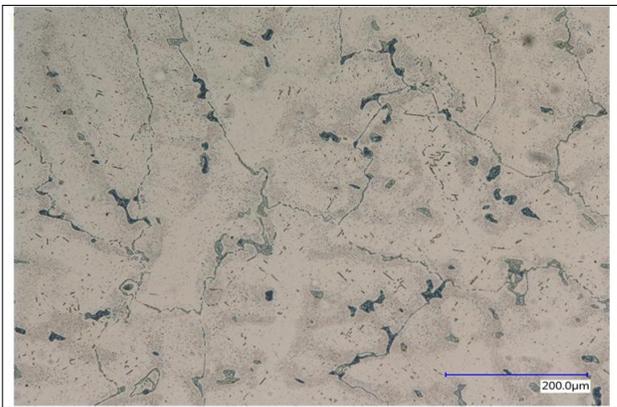
Fig.1			Showing the hot gas path coating and substrate condition.(Etched)			Fig.2			Showing the typical microstructure at higher magnification.(Etched)		
<p>The sample was mounted in L11058 to assess if the material would be acceptable for repair. The following was observed. Hot gas path was protected by MCrAlY (HVOF) and TBC top-coating, refer to Fig.1. Base material was confirmed as FSX-414 alloy, comprising of fine grain boundary carbide and a gamma matrix with primary carbide and dispersed secondary carbide, Fig.2.</p>

<b>Recommendation</b>											
<p>Based on the finding above, the base material was considered suitable for repair following coating removal by grit blast and acid stripping respectively.</p>

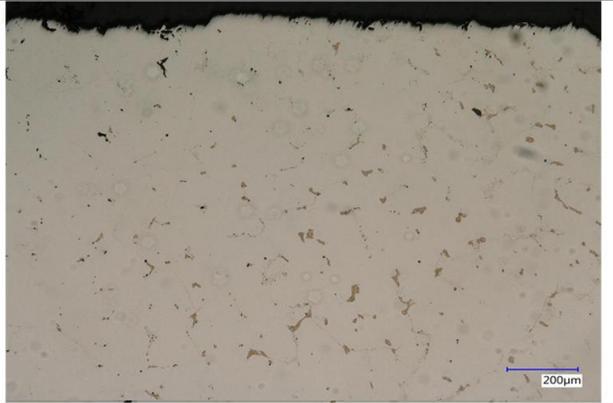
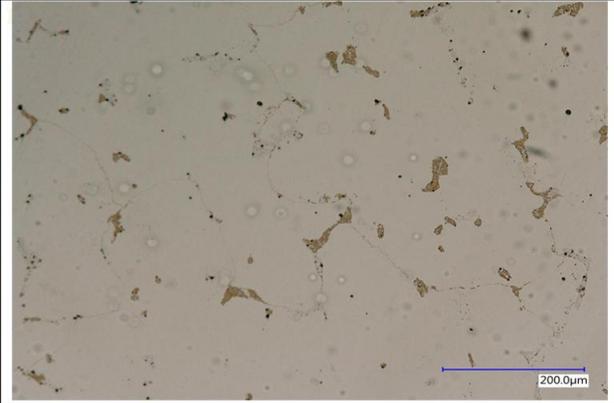
Fig.1 Showing heat treated material condition. (Etched)			Fig.2 Showing the typical microstructure at higher magnification.(Etched)								
<p>The sample was mounted in L11058-1 to assess the material microstructure in pre-weld solution heat treated condition. Examination revealed that the base material has been significantly improved. The grain boundaries carbide and detrimental phase was satisfyingly refined (compare with the as-received microstructure in the report no.L11058). (Fig.1 and 2)</p>

Recommendation											
<p>The base material was satisfyingly recovered by the used solution heat treatment program.</p>

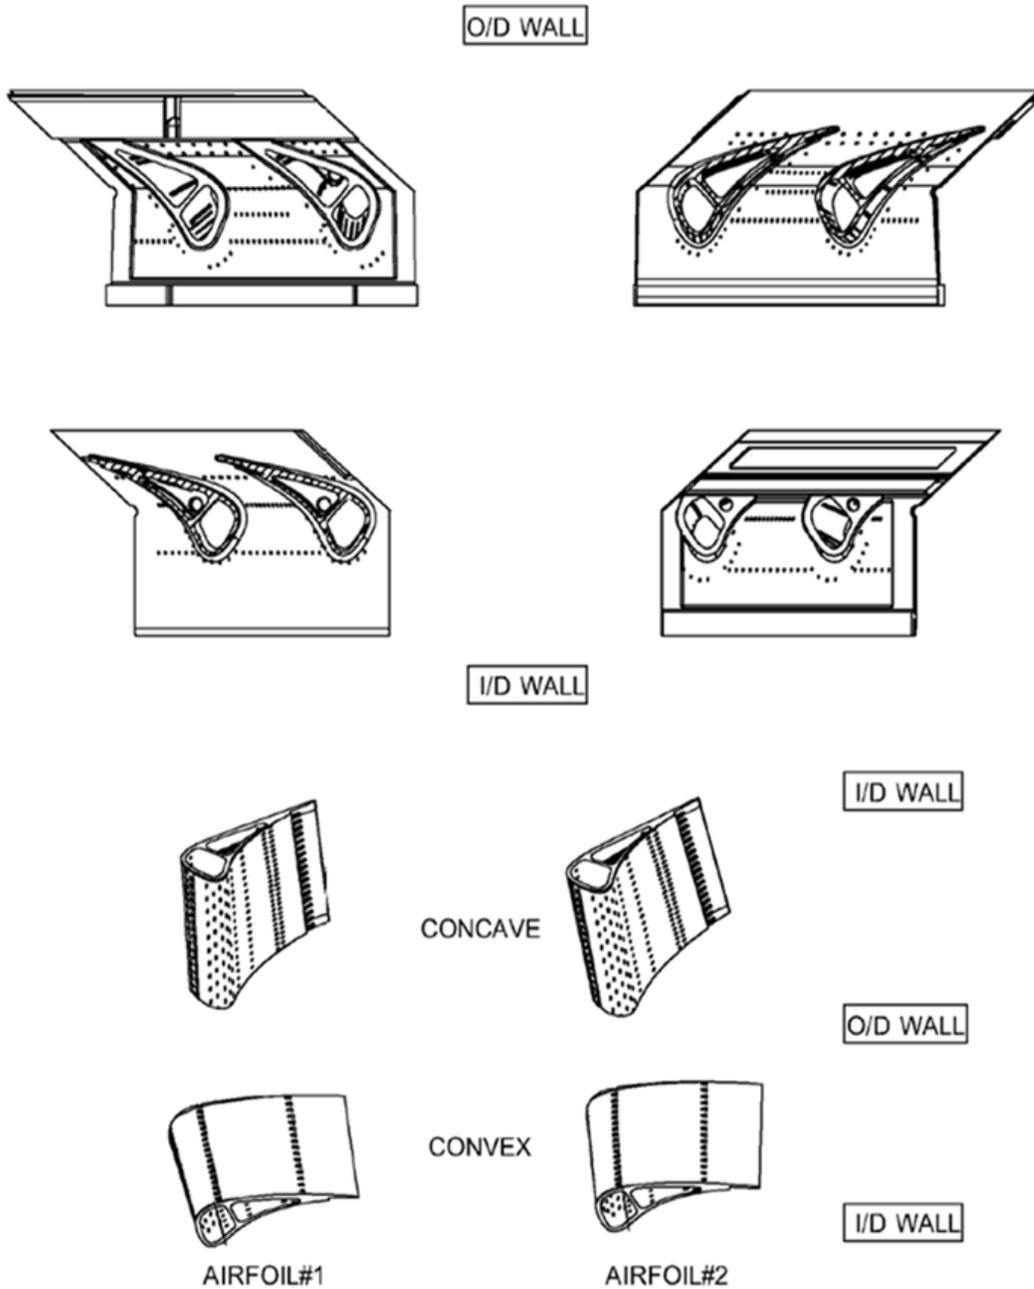
**11.DEFECT TABLE:**

Information		Non- Gas path Inner & Outer shrouds										Core Plug Cavity			
Segment No.	S/N	Corr / Erosion		Cracks		FOD		Deform.		Frettage		Cracks		Missing material	
		Inner	Outer	Inner	Outer	Inner	Outer	Inner	Outer	Inner	Outer	A/F #1	A/F #2	C.C - A/F	C.V - A/F
1	A1FC 07293			TPR	TPR						B				
2	G1FC 00796				TPR						B				
3	A1FC 07299			TPR	TPR						B				
4	A1FC 07296			TPR	TPR						B				
5	G1FC 00813			TPR	TPR						B				
6	G1FC 00807			TPR	TPR						B				
7	G1FC 00260			TPR	TPR						B				
8	G1FC 00797			TPR	TPR						B				
9	G1FC 00814										B				
10	G1FC 00808			TPR	TPR						B				
11	A1FC 07263			TPR	TPR						B				
12	A1FC 07264			TPR	TPR						B				
13	A1FC 07277			TPR	TPR						B				
14	G1FC 00798				TPR						B				
15	A1FC 07294			TPR	TPR						B				
16	A1FC 07278			TPR	TPR						B				
17	A1FC 07196			TPR	TPR						B				
18	A1FC 07297				TPR						B				
19	A1FC 07291			TPR	TPR						B				
20	G1FC 00801			TPR	TPR						B

21	G1FC 00657			TPR	TPR						B				
22	G1FC 00597			TPR	TPR						B				
23	A1FC 07288			TPR	TPR						B				
24	A1FC 07295			TPR	TPR						B

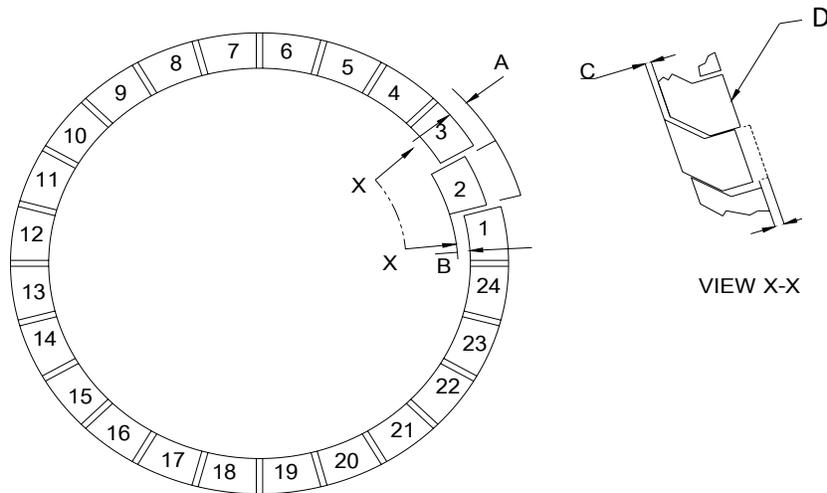
**ALIGNMENT CHECK**

SEGMENT No.	Horizontal(mm)		Vertical (mm)		Result
	A	B	C	D	
1-2	0.31	0.36	0.48	0.24	ACC
2-3	0.43	0.48	0.60	0.35	ACC
3-4	0.46	0.42	0.77	0.68	ACC
4-5	0.44	0.38	0.71	0.61	ACC
5-6	0.39	0.47	0.74	0.62	ACC
6-7	0.47	0.36	0.53	0.65	ACC
7-8	0.45	0.29	0.57	0.52	ACC
8-9	0.36	0.41	0.70	0.77	ACC
9-10	0.42	0.43	0.42	0.60	ACC
10-11	0.48	0.34	0.53	0.47	ACC
11-12	0.37	0.46	0.56	0.53	ACC
12-13	0.43	0.41	0.28	0.62	ACC
13-14	0.41	0.44	0.35	0.68	ACC
14-15	0.53	0.46	0.51	0.87	ACC
15-16	0.47	0.48	0.70	0.80	ACC
16-17	0.46	0.39	0.78	0.16	ACC
17-18	0.34	0.47	0.63	0.24	ACC
18-19	0.45	0.45	0.46	0.35	ACC
19-20	0.39	0.41	0.68	0.52	ACC
20-21	0.42	0.34	0.46	0.57	ACC
21-22	0.42	0.44	0.30	0.68	ACC
22-23	0.40	0.39	0.39	0.59	ACC
23-24	0.47	0.45	0.57	0.46	ACC
24-1	0.48	0.36	0.52	0.34	ACC

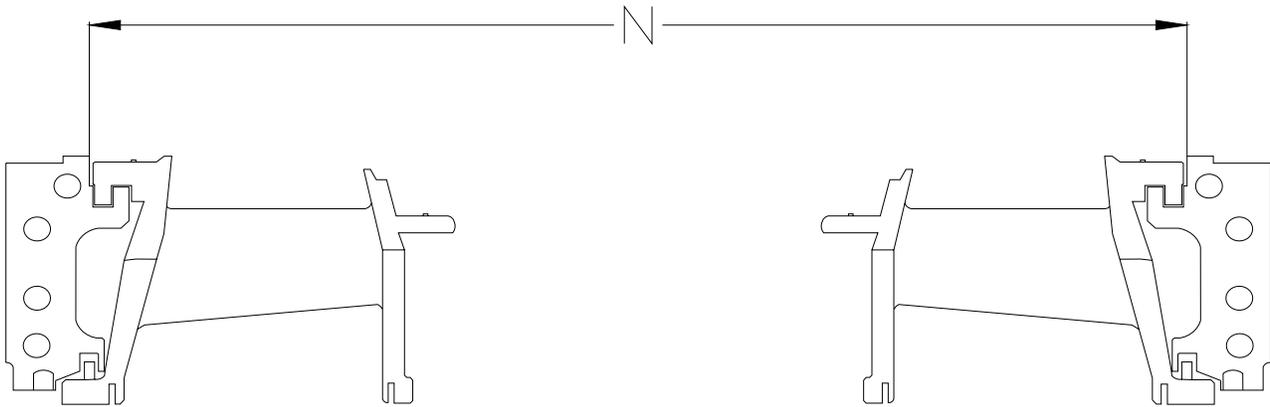
**ROUNDNESS CHECK**

No.	A-A	B-B	C-C	D-D	Roundness	Result
FINAL	1733.31	1734.31	1734.21	1733.27	1.04	ACCEPTED

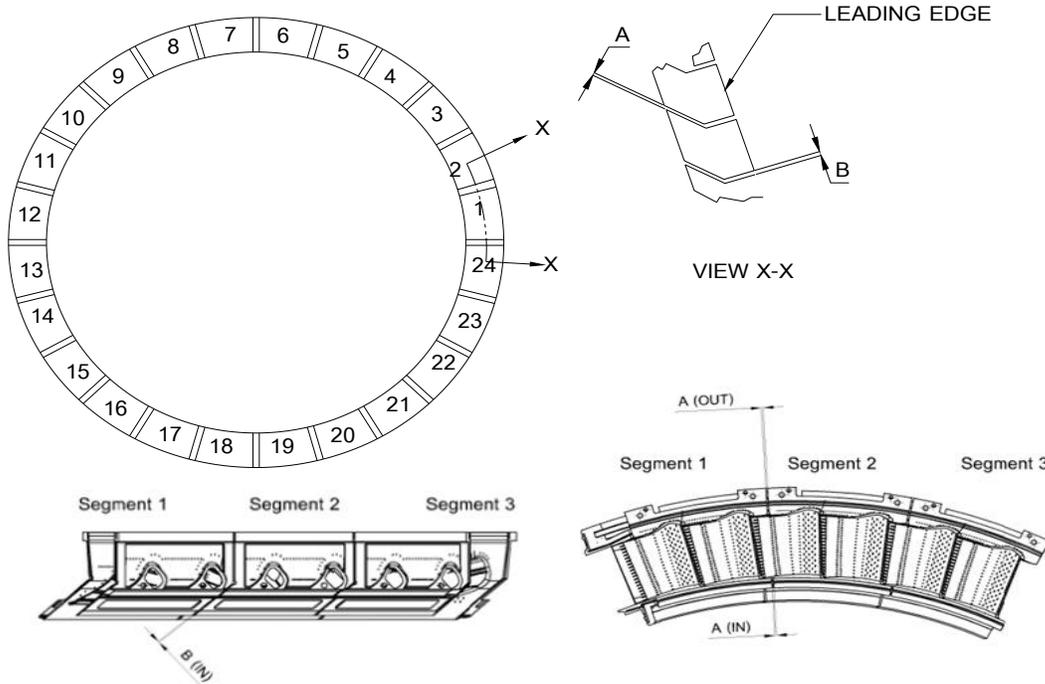
**GAP MEASUREMENT CHECK**

SEGMENT NO.	I/D Wall		O/D Wall		Result
	A (mm.)	B (mm.)	A (mm.)	B (mm.)	
1-2	2.03	3.45	2.26	3.50	ACC
2-3	2.03	3.47	2.17	3.58	ACC
3-4	2.03	3.27	2.39	3.27	ACC
4-5	2.11	3.52	2.30	3.50	ACC
5-6	2.13	3.55	2.01	3.57	ACC
6-7	2.05	3.38	2.22	3.59	ACC
7-8	2.32	3.37	2.01	3.57	ACC
8-9	2.18	3.40	2.29	3.60	ACC
9-10	2.25	3.37	2.33	3.32	ACC
10-11	2.38	3.61	2.09	3.45	ACC
11-12	2.18	3.36	2.39	3.32	ACC
12-13	2.40	3.51	2.39	3.61	ACC
13-14	2.07	3.30	2.41	3.52	ACC
14-15	2.20	3.53	2.29	3.59	ACC
15-16	2.24	3.51	2.37	3.27	ACC
16-17	2.11	3.39	2.22	3.42	ACC
17-18	2.17	3.30	2.32	3.50	ACC
18-19	2.07	3.50	2.40	3.60	ACC
19-20	2.39	3.26	2.36	3.59	ACC
20-21	2.16	3.24	2.26	3.57	ACC
21-22	2.39	3.24	2.14	3.59	ACC
22-23	2.06	3.55	2.27	3.27	ACC
23-24	2.16	3.31	2.03	3.24	ACC
24-1	2.02	3.61	2.40	3.61	ACC

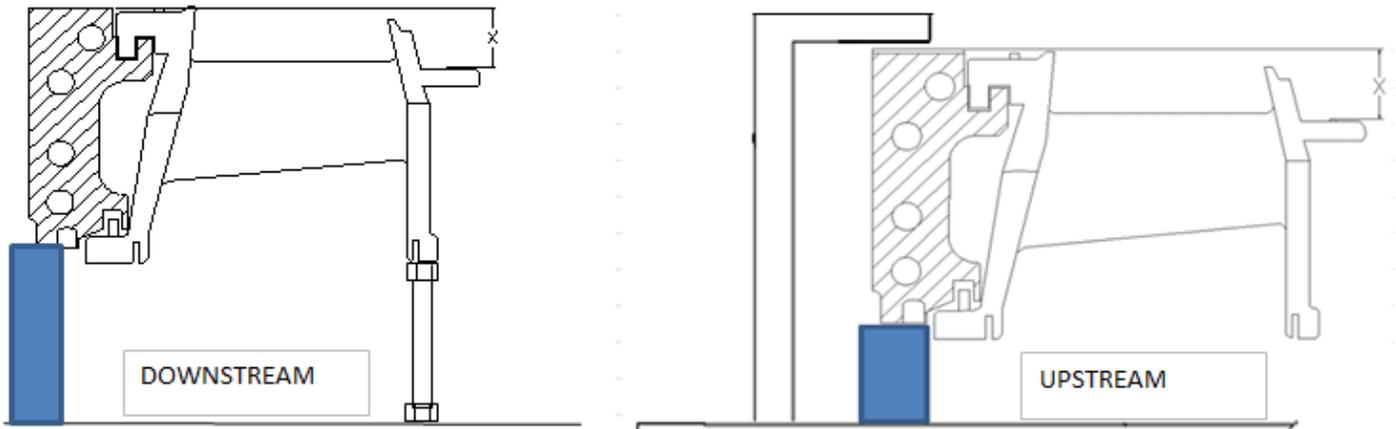
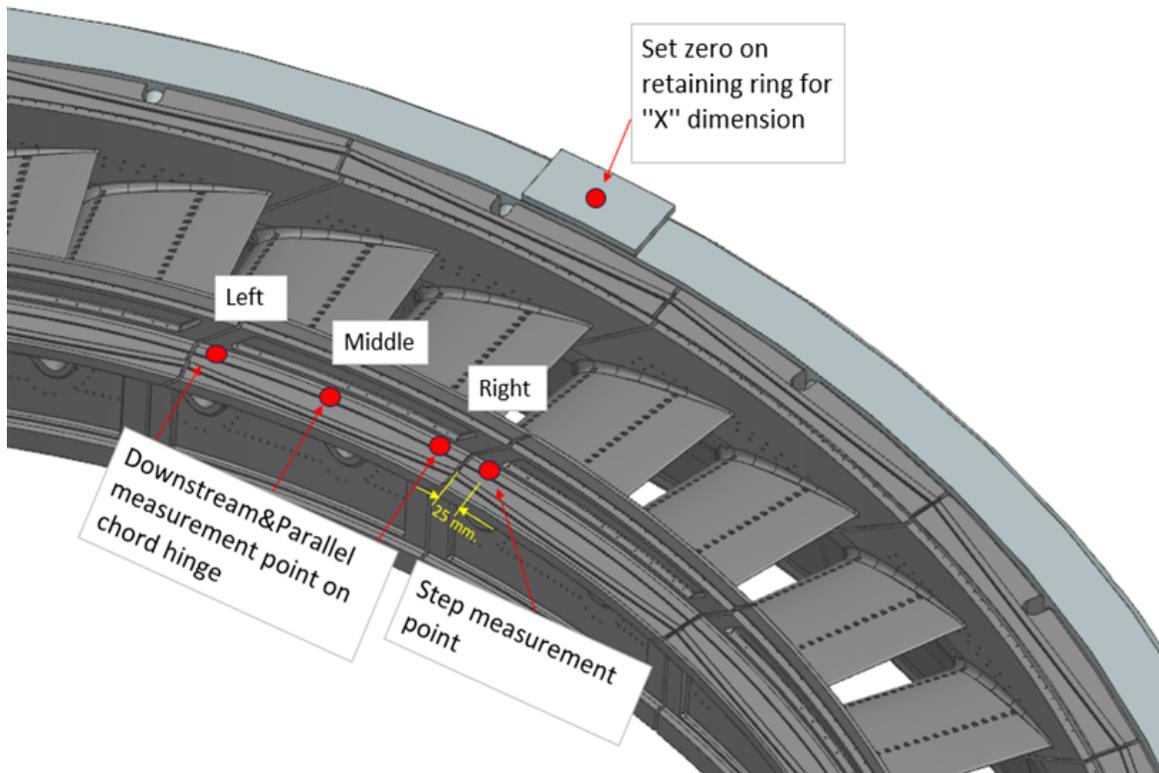
**DROP CHECK**

Downstream Deflection Check (Drop Check)														
SEGMENT	X' Downstream (mm)					X' Upstream (mm)					Flexible 'X' (mm)			Result
	Left	Middle	Right	Parallel	Step	Left	Middle	Right	Parallel	Step	Left	Middle	Right	
1	29.32	29.22	29.10	-0.22	-0.09	30.48	30.25	30.21	-0.27	-0.17	1.16	1.03	1.11	ACC
2	29.19	29.17	29.25	0.06	0.04	30.38	30.24	30.37	-0.01	-0.13	1.19	1.07	1.12	ACC
3	29.21	29.26	29.42	0.21	0.21	30.50	30.56	30.59	0.09	0.26	1.29	1.30	1.17	ACC
4	29.21	29.19	29.23	0.02	0.00	30.33	30.33	30.36	0.03	-0.12	1.12	1.14	1.13	ACC
5	29.23	29.36	29.21	-0.02	-0.10	30.48	30.49	30.54	0.06	-0.04	1.25	1.13	1.33	ACC
6	29.31	29.13	29.31	0.00	-0.02	30.58	30.48	30.65	0.07	0.06	1.27	1.35	1.34	ACC
7	29.33	29.25	29.32	-0.01	0.07	30.59	30.55	30.49	-0.10	-0.42	1.26	1.30	1.17	ACC
8	29.25	29.15	29.11	-0.14	0.01	30.91	30.79	30.49	-0.42	-0.24	1.66	1.64	1.38	ACC
9	29.10	29.02	29.45	0.35	0.25	30.73	30.71	30.96	0.23	0.45	1.63	1.69	1.51	ACC

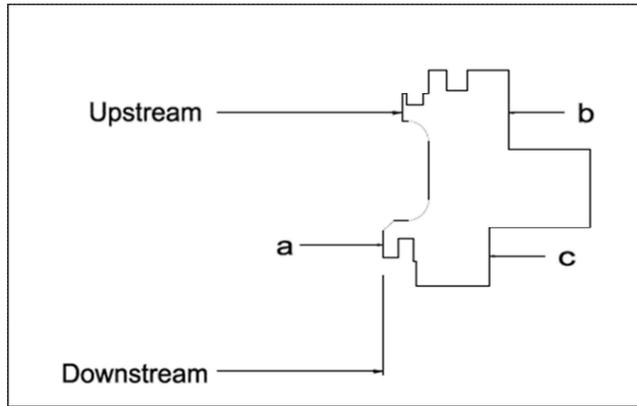
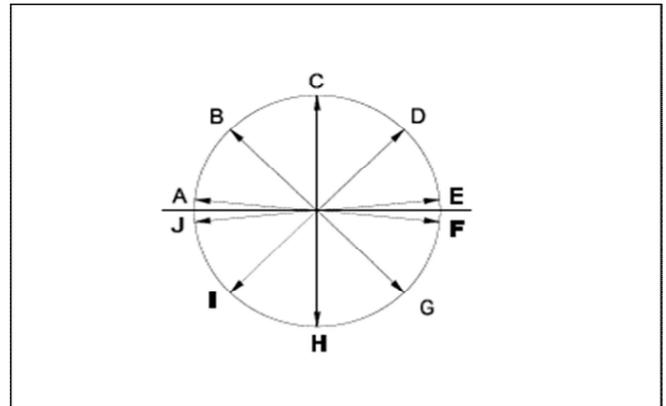
**RETAINING RING ROUNDNESS**

A-F	B-G	C-H	D-I	E-J	Roundness	Result
A-Upstream	1715.29	1716.26	1716.82	1716.51	1715.53	1.53	ACCEPTED
A-Downstream	1687.86	1688.19	1688.63	1688.21	1687.84	0.79	ACCEPTED

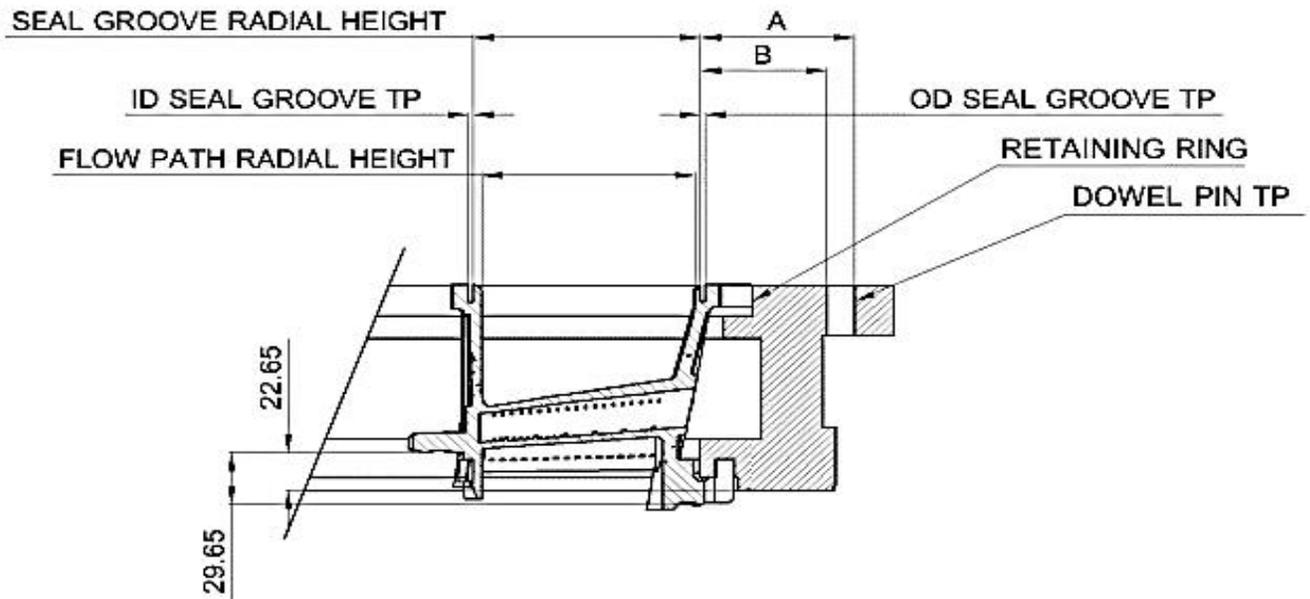
**RADIAL HEIGHTS**

Item	Dowel OD to Outer seal groove	Dowel ID to Outer wall flow path	Result
	A	B	
1	87.12	70.98	ACC
2	87.17	70.91	ACC
3	87.12	70.90	ACC
4	87.04	70.92	ACC
5	87.09	71.08	ACC
6	87.25	71.16	ACC
7	87.05	71.00	ACC
8	87.20	71.15	ACC
9	87.05	70.96	ACC
10	87.08	70.91	ACC
11	87.25	70.98	ACC
12	87.12	70.95	ACC

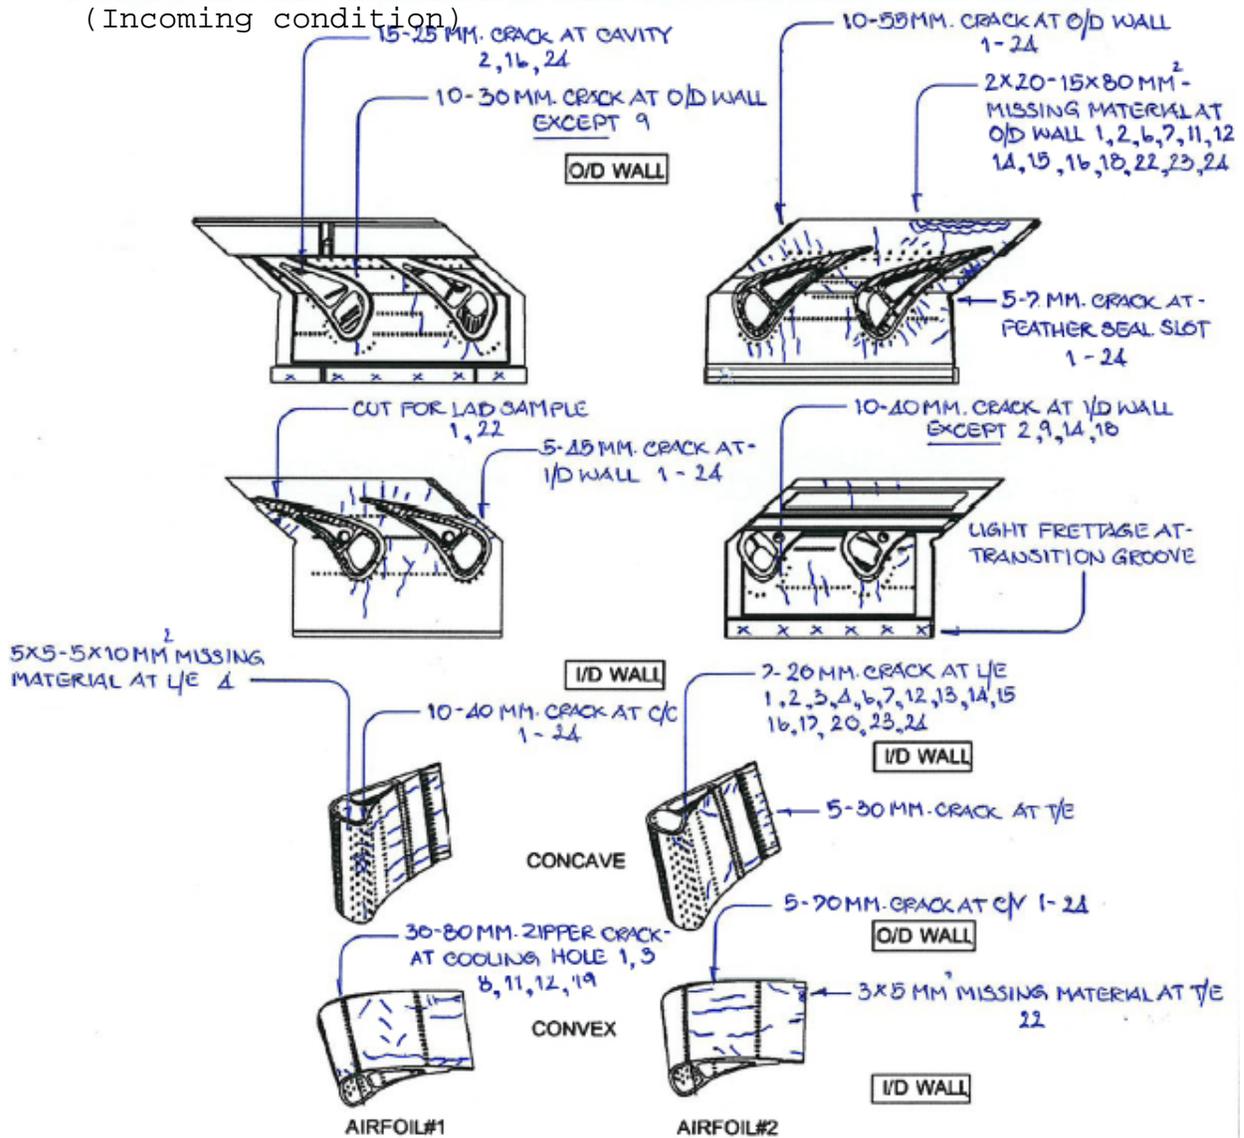
(Incoming condition)

INSPECTION AND PROCESS RECORD SHEET	MS6001FA 1st STAGE NOZZLE		IPRS NO. 3062-110
	PART NUMBER : GENZ01M6FA		REV. 02
CUSTOMER :	Nghi Son Refinery &	CUSTOMER PO :	PO04102025-HGP
JOB NUMBER :	824028	OP.	0230
INSPECTED BY :	Pisut Kh	DATE :	14 July 2025
DEFECT MAP RECORD SHEET

\*Bowing Airfoil indicate in Light (L), Medium (M), Heavy (H) (At Trailing edge)
