**FINAL INSPECTION REPORT
&
CERTIFICATE OF CONFORMANCE**

Customer Name: Nghi Son Refinery & Petrochemical, LLC.
Component type: MS6001FA 2nd STAGE NOZZLE 824029
Date of Report: October 30, 2025

FINAL INSPECTION REPORT

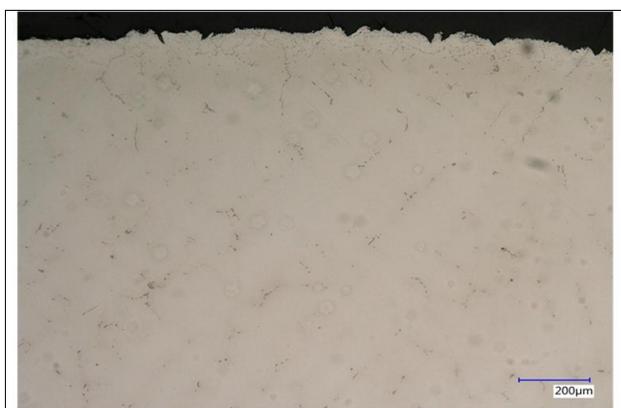
Fig.1 Showing heat treated material condition. (Etched)

The sample was mounted in L11053-1 to assess the material microstructure in pre-weld solution heat treated condition. Examination revealed that the base material has been significantly improved. The grain boundaries carbide and detrimental phase was satisfyingly refined (compare with the as-received microstructure in the report no.L11053). (Fig.1 and 2)

The base material was satisfyingly recovered by the used solution heat treatment program.

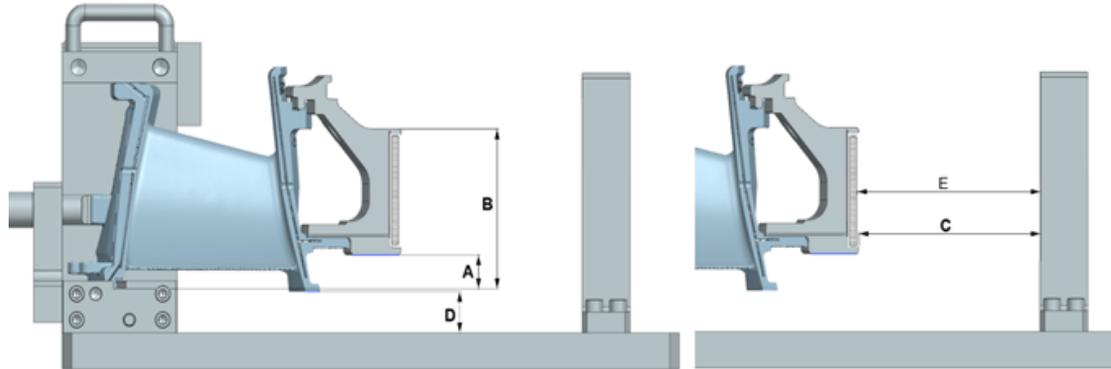
DOWNSTREAM CHECKING WITH DIAPHRAGM

Location Segment no.	A		B		C Diaphragm radius	D Base plate to	E Honeycomb	Result
	L	R	L	R				
1	32.80	32.89	153.39	153.79	200.71	39.96	202.32	ACC
2	32.66	32.74	154.13	154.15	200.52	40.20	202.46	ACC
3	32.13	32.27	153.57	153.70	200.76	39.93	202.40	ACC
4	32.57	32.57	153.90	153.95	200.59	40.22	202.33	ACC
5	32.45	32.55	153.78	153.86	200.64	40.22	202.33	ACC
6	32.78	32.82	153.44	154.01	200.74	40.03	202.39	ACC
7	32.48	32.33	153.94	153.72	200.43	40.21	202.69	ACC
8	32.79	32.75	153.86	153.92	200.60	40.16	202.45	ACC
9	32.74	32.79	153.78	153.87	200.70	40.07	202.44	ACC
10	32.48	32.70	154.01	154.14	200.49	40.17	202.59	ACC
11	32.87	32.88	153.67	153.68	200.70	39.85	202.40	ACC
12	32.85	32.89	153.67	153.68	200.70	39.85	202.40	ACC
13	32.87	32.88	153.31	153.78	200.73	40.03	202.38	ACC
14	32.85	32.88	154.11	154.17	200.66	40.17	202.56	ACC
15	32.84	32.81	153.65	153.72	200.68	39.96	202.38	ACC
16	32.38	32.48	153.81	153.82	200.60	40.08	202.61	ACC

17	32.49	32.74	153.85	154.00	200.72	40.08	202.75	ACC
18	32.34	32.49	153.84	153.94	200.48	39.97	202.66	ACC
19	32.36	32.39	153.80	153.79	200.70	40.00	202.78	ACC
20	32.44	32.34	153.84	153.75	200.76	40.21	202.70	ACC
21	32.64	32.60	154.10	154.00	200.40	40.22	202.79	ACC
22	32.72	32.77	153.89	154.16	200.67	40.13	202.57	ACC
23	32.75	32.72	153.65	153.71	200.70	39.91	202.43	ACC
24	32.28	32.22	153.77	153.62	200.88	40.07	202.66	ACC

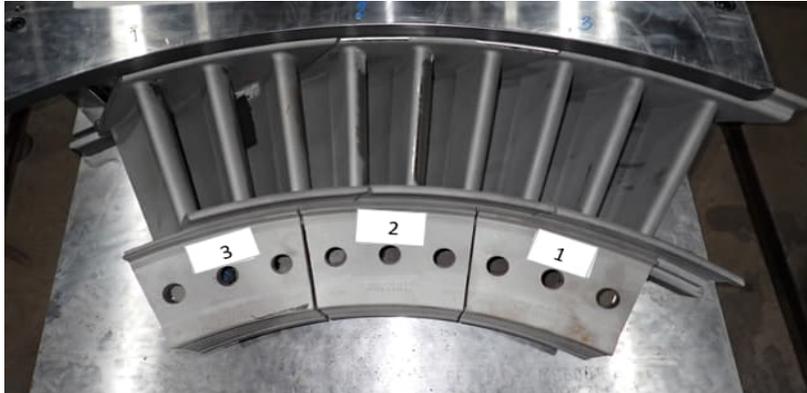
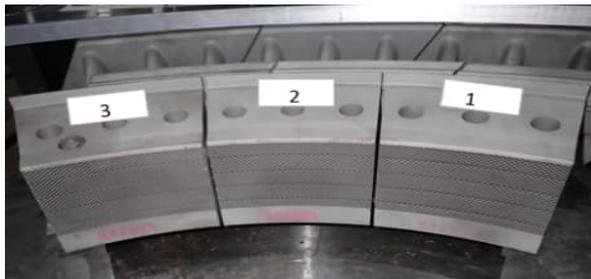
1. Segment position

Segments No.	1	2	3	4	5	6	7	8
Position (Acc / Rej)	Acc							
Segments No.	9	10	11	12	13	14	15	16
Position (Acc / Rej)	Acc							
Segments No.	17	18	19	20	21	22	23	24
Position (Acc / Rej)	Acc

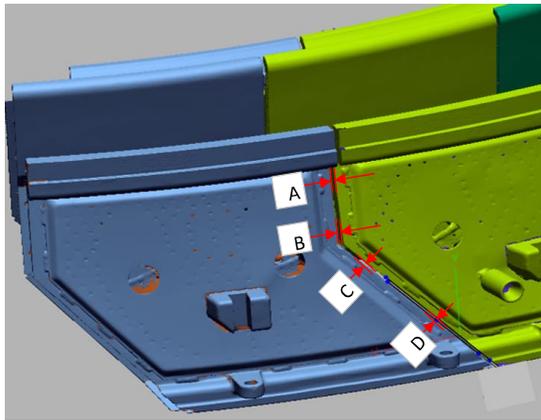
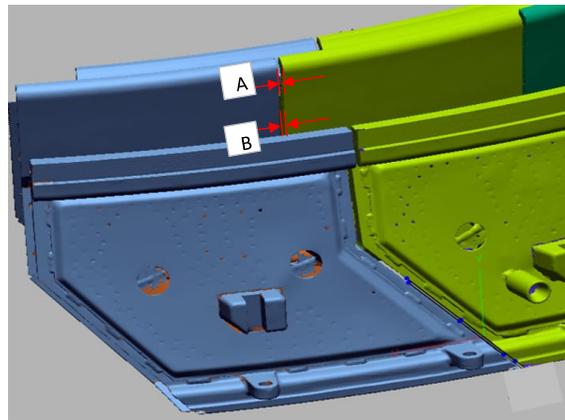
2. Outer wall/Inner wall abutment face gaps

Segment	A (Outer)	A (Inner)	B (Outer)	B (Inner)	C (Outer)	C (Inner)	D (Outer)	D (Inner)	Result
1-2	2.60	3.10	2.77	3.03	2.42	2.18	2.21	2.11	ACC
2-3	2.79	2.93	3.06	3.15	2.48	1.95	2.51	2.01	ACC
3-4	2.70	2.85	2.90	3.24	2.49	1.97	2.56	2.15	ACC
4-5	2.57	2.40	2.98	2.76	2.28	1.75	2.30	1.78	ACC
5-6	2.94	3.22	2.95	3.02	2.78	2.30	2.70	2.28	ACC
6-7	2.55	2.67	2.75	2.80	2.64	1.99	2.71	2.12	ACC
7-8	2.32	2.37	2.55	2.42	2.26	1.62	2.29	1.69	ACC
8-9	2.96	3.00	3.12	3.20	2.59	2.23	2.63	2.28	ACC
9-10	2.85	3.12	3.09	3.23	2.41	1.98	2.28	2.59	ACC
10-11	2.74	2.96	2.87	2.99	2.53	2.14	2.36	2.43	ACC
11-12	2.42	2.61	2.62	2.83	2.47	2.16	2.50	2.19	ACC
12-13	3.07	3.25	2.86	3.07	2.83	2.08	2.94	2.10	ACC
13-14	2.60	2.50	3.15	2.64	2.50	2.10	2.64	2.08	ACC
14-15	2.71	3.35	3.12	3.15	2.90	2.12	2.91	2.17	ACC
15-16	2.81	3.04	2.98	3.11	2.67	2.45	2.60	2.49	ACC
16-17	2.61	2.58	2.81	2.74	2.30	1.89	2.18	1.97	ACC
17-18	3.18	3.05	3.19	2.76	2.67	1.91	2.52	1.72	ACC

18-19	2.50	2.82	2.77	3.40	2.53	2.60	2.65	2.74	ACC
19-20	2.92	2.94	3.07	3.05	2.88	2.02	2.97	2.05	ACC
20-21	2.60	2.85	2.76	2.99	2.46	1.96	2.63	2.09	ACC
21-22	2.43	2.64	2.38	2.49	2.36	1.77	2.30	1.86	ACC
22-23	3.26	3.27	3.44	3.38	2.89	2.19	2.95	2.25	ACC
23-24	2.92	3.18	2.88	3.15	2.60	2.42	2.59	2.48	ACC
24-1	3.28	3.11	3.22	3.07	2.71	2.25	2.66	2.20	ACC

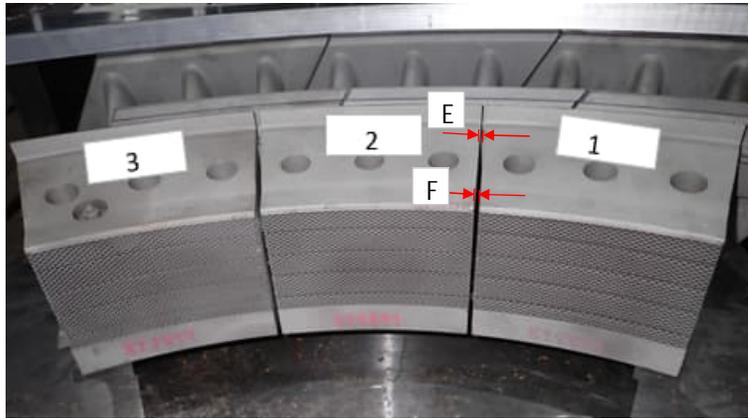
3. Diaphragm top face abutment face gaps

Segment	E	F	Result
1-2	3.61	3.68	ACC
2-3	3.53	3.65	ACC
3-4	2.79	3.07	ACC
4-5	2.96	3.05	ACC
5-6	3.28	3.17	ACC
6-7	2.98	3.19	ACC
7-8	2.86	2.89	ACC
8-9	3.32	3.31	ACC
9-10	2.86	2.97	ACC
10-11	3.22	3.38	ACC
11-12	3.24	3.49	ACC
12-13	3.15	3.14	ACC
13-14	3.20	3.18	ACC
14-15	3.44	3.30	ACC
15-16	3.31	3.36	ACC
16-17	2.84	3.18	ACC
17-18	3.32	2.86	ACC
18-19	3.02	3.59	ACC
19-20	2.88	2.93	ACC
20-21	3.35	3.42	ACC
21-22	3.12	3.16	ACC
22-23	3.18	3.07	ACC
23-24	3.51	3.63	ACC
24-1	3.05	2.86	ACC

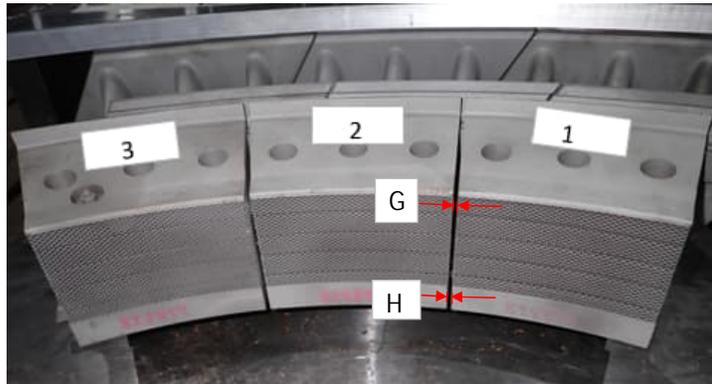
4. Diaphragm front face abutment face gaps

Segment	G	H	Result
1-2	3.64	3.71	ACC
2-3	3.45	3.76	ACC
3-4	3.04	3.58	ACC
4-5	2.90	3.72	ACC
5-6	3.13	2.90	ACC
6-7	3.26	3.30	ACC
7-8	2.95	3.06	ACC
8-9	3.49	3.45	ACC
9-10	3.18	3.25	ACC
10-11	3.31	3.44	ACC
11-12	3.50	3.64	ACC
12-13	3.11	3.30	ACC
13-14	2.99	2.94	ACC
14-15	3.11	3.35	ACC
15-16	3.40	3.41	ACC
16-17	3.19	3.31	ACC
17-18	2.87	2.26	ACC
18-19	3.39	3.65	ACC
19-20	2.90	3.01	ACC
20-21	3.36	3.44	ACC
21-22	3.11	3.40	ACC
22-23	3.06	2.79	ACC
23-24	3.74	3.67	ACC
24-1	2.73	2.65	ACC

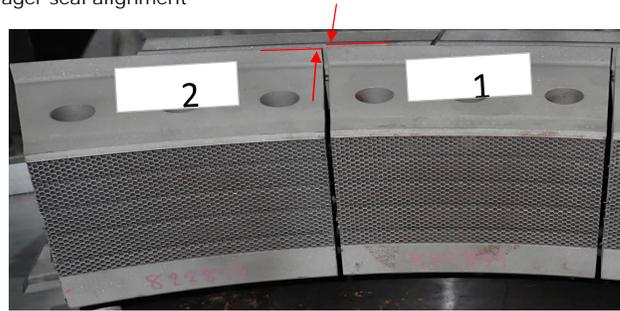
5. Diaphragm discourager seal alignment

Segment	Seal alignment	Result
1-2	0.13	ACC
2-3	0.09	ACC
3-4	0.10	ACC
4-5	0.28	ACC
5-6	0.12	ACC
6-7	0.17	ACC
7-8	0.19	ACC
8-9	0.23	ACC
9-10	0.22	ACC
10-11	0.18	ACC
11-12	0.13	ACC
12-13	0.15	ACC
13-14	0.08	ACC
14-15	0.19	ACC
15-16	0.08	ACC
16-17	0.10	ACC
17-18	0.23	ACC
18-19	0.28	ACC
19-20	0.14	ACC
20-21	0.25	ACC
21-22	0.16	ACC
22-23	0.07	ACC
23-24	0.15	ACC
24-1	0.21	ACC

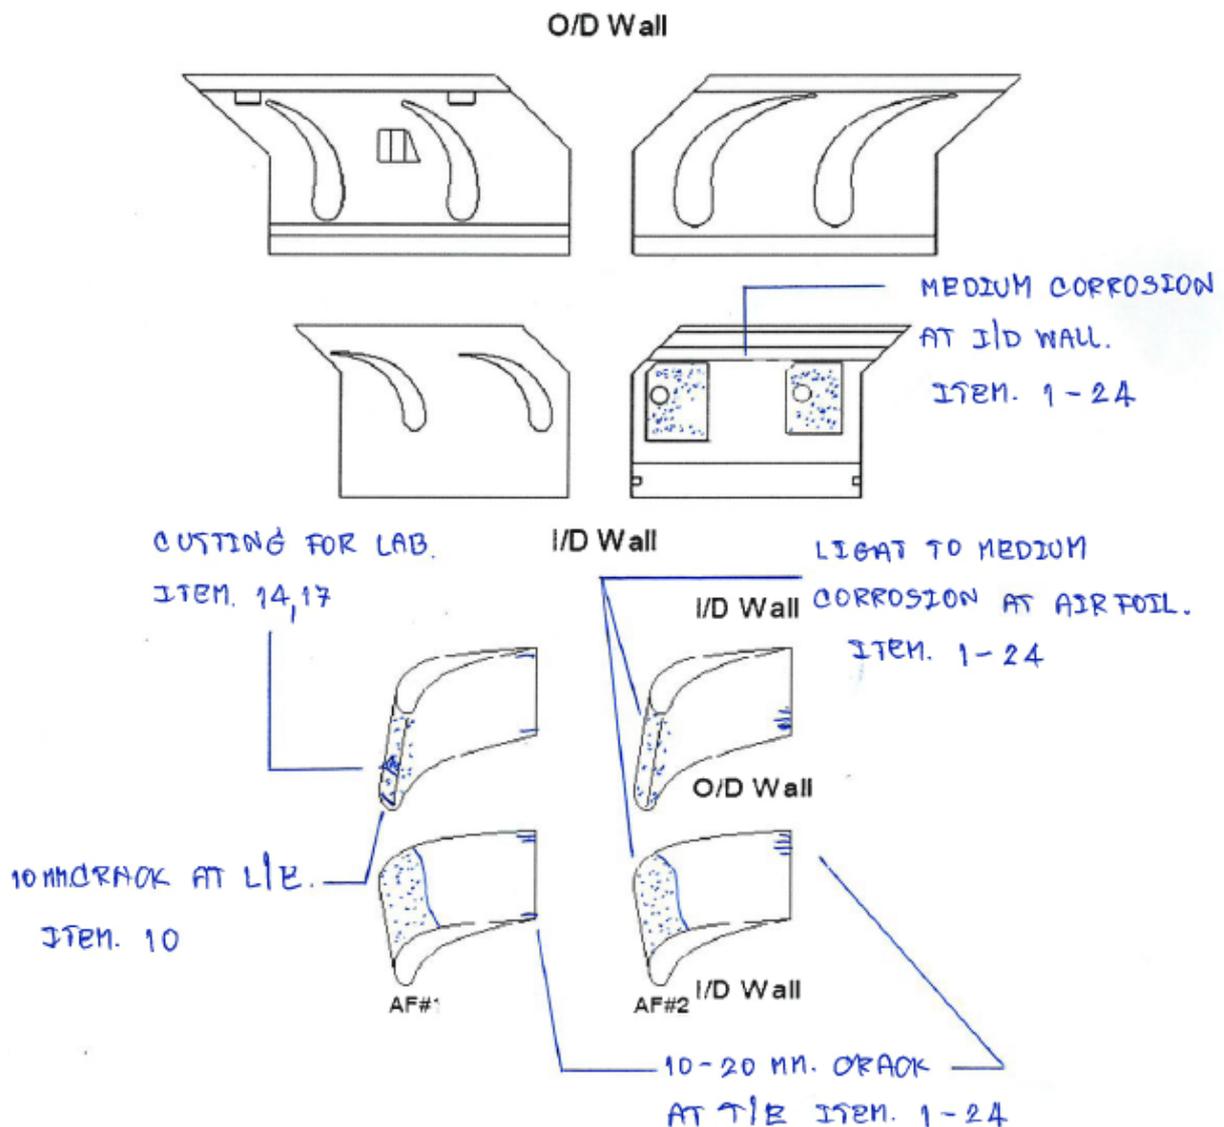
(Incoming condition)

INSPECTION AND PROCESS RECORD SHEET	MS6001FA 2nd STAGE NOZZLE		IPRS NO. 3063-70
	PART NUMBER : GENZ02M6FA		REV. 00
CUSTOMER :	Nghi Son Refinery &	CUSTOMER PO :	PO04102025-HGP
JOB NUMBER :	824029	OP.	0260
INSPECTED BY :		DATE :	07 JUL 2025

Crack (mm)
 Foreign Object Damage (L/M/H)
 Pitting (L/M/H)
 Deformation area(mm²)
 Corrosion (L/M/H)
 Missing Material (mm²)

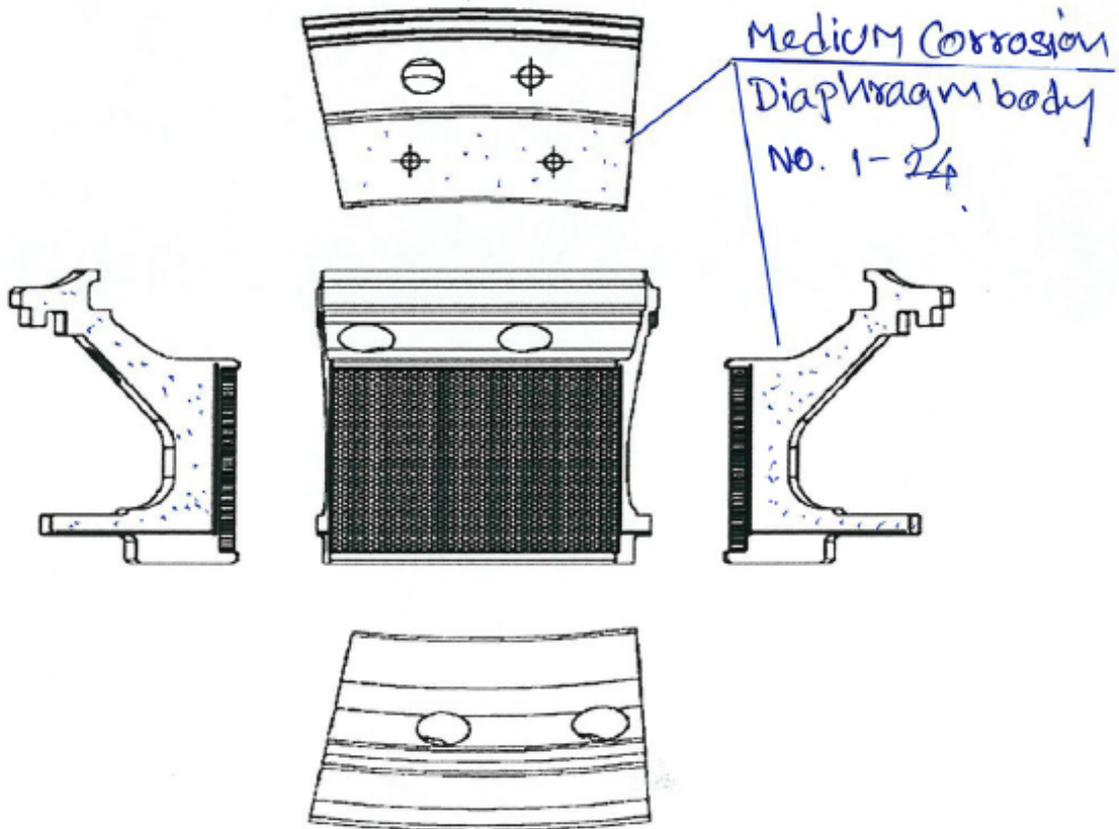
(Incoming condition)

INSPECTION AND PROCESS RECORD SHEET	MS6001FA 2nd STAGE NOZZLE		IPRS NO. 3063-70
	PART NUMBER : GENZ02M6FA		REV. 00
CUSTOMER :	Nghi Son Refinery &	CUSTOMER PO :	PO04102025-HGP
JOB NUMBER :	824029	OP.	0260
INSPECTED BY :
