## FINAL INSPECTION REPORT & CERTIFICATE OF CONFORMANCE

**Customer Name: Nghi Son Refinery & Petrochemical, LLC.**

**Component type: MS6001FA 3rd STAGE NOZZLE 824030**

**Date of Report: September 25, 2025**

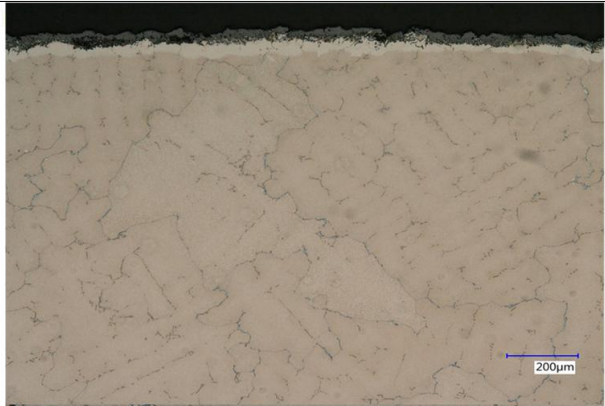
| <p>Fig.1 Showing the hot gas path surface condition.(Etched)</p> | | | | | | <p>Fig.2 Showing the typical microstructure at higher magnification.(Etched)</p> | | | | | |
| <p>The sample was mounted in L11054 to assess if the material would be acceptable for repair. The following was observed. Hot gas path was uncoated and exhibited a layer of oxidation-corrosion and associated substrate alloy depletion, refer to Fig.1. Base material was confirmed as GTD262 alloy, comprising of fine grain boundary carbide and a gamma matrix with fine gamma prime, primary carbide and dispersed secondary carbide, Fig.2.</p> | | | | | | | | | | | |

| <p>Based on the finding above, the base material was considered suitable for repair following surface cleaning by grit blast.</p> | | | | | | | | | | | |

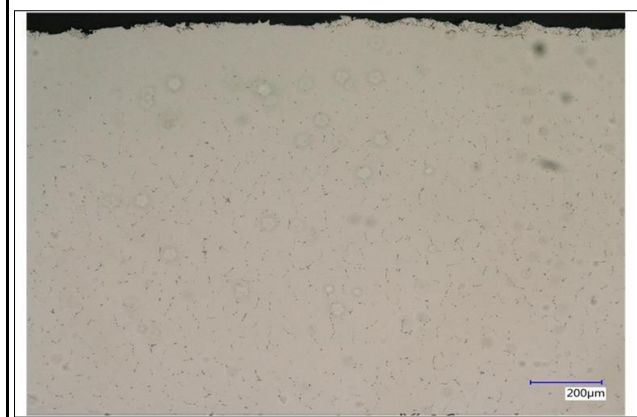
Fig.1 Showing heat treated material condition. (Etched)

The sample was mounted in L11054-1 to assess the material microstructure in pre-weld solution heat treated condition. Examination revealed that the base material has been significantly improved. The grain boundaries carbide and detrimental phase was satisfyingly refined (compare with the as-received microstructure in the report no.L11054). (Fig.1 and 2)

The base material was satisfyingly recovered by the used solution heat treatment program.

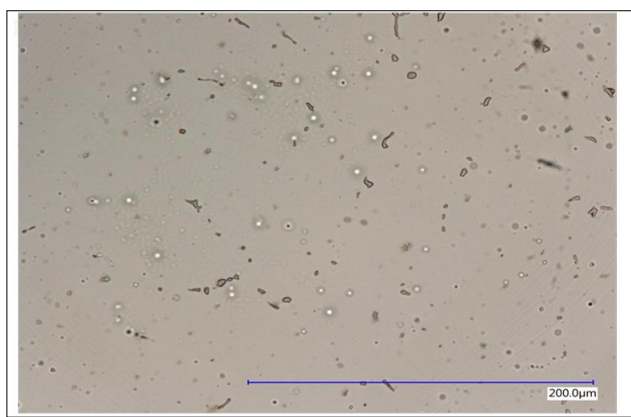
Fig.2 Showing the typical microstructure at higher magnification.(Etched)

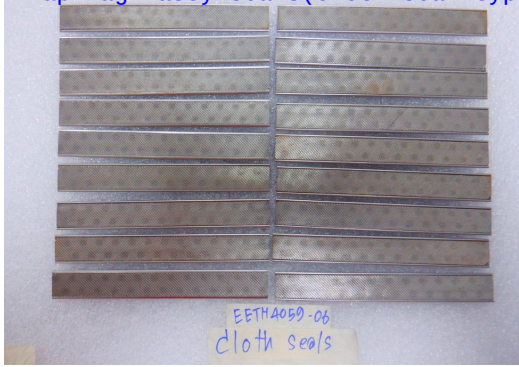
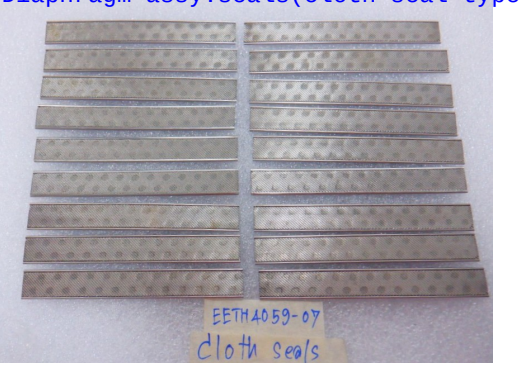
| <p>Fig.31 Final inspection.</p> | <p>Fig.32 Final inspection.</p> |

| <p>Diaphragm assy.seals(cloth seal type)</p> | <p>Diaphragm assy.seals(cloth seal type)</p> |

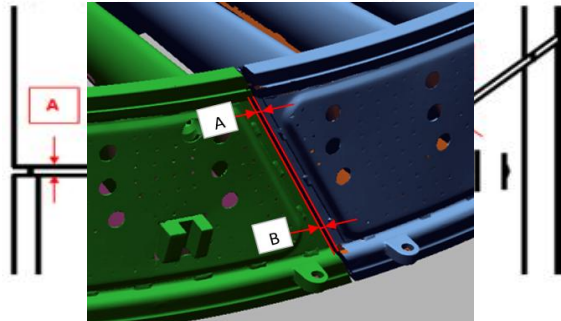
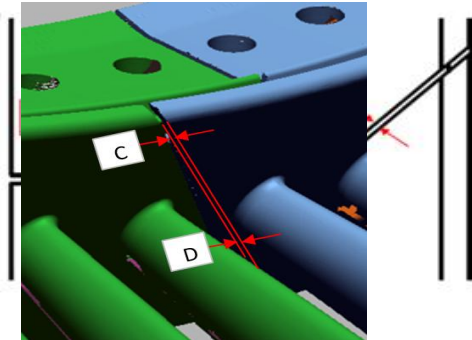
Outer wall/Inner wall abutment face gaps

Outer platform of Nozzle

Inner platform of Nozzle

| | A | B | C | D | Result |
|---|---|---|---|---|---|
| 1-2 | 3.09 | 3.15 | 2.98 | 3.10 | ACC |

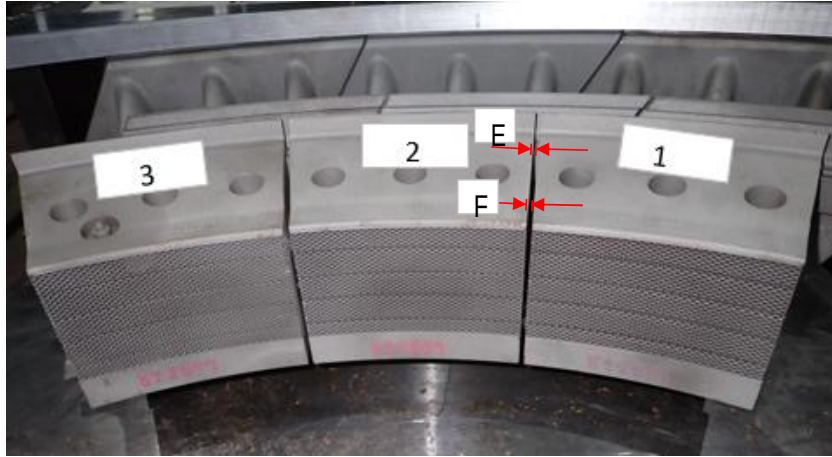
Diaphragm top face abutment face gaps

| | E | F | Result |
|---|---|---|---|
| 1-2 | 3.89 | 3.78 | ACC |

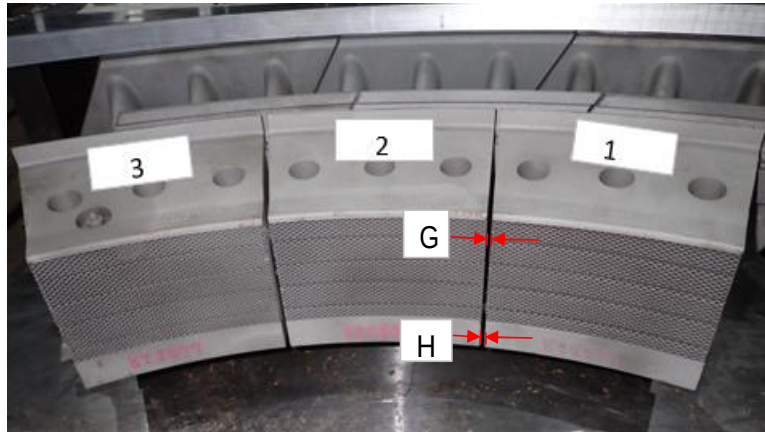
Diaphragm front face abutment face gaps

| | G | H | Result |
|---|---|---|---|
| 1-2 | 3.79 | 3.84 | ACC |

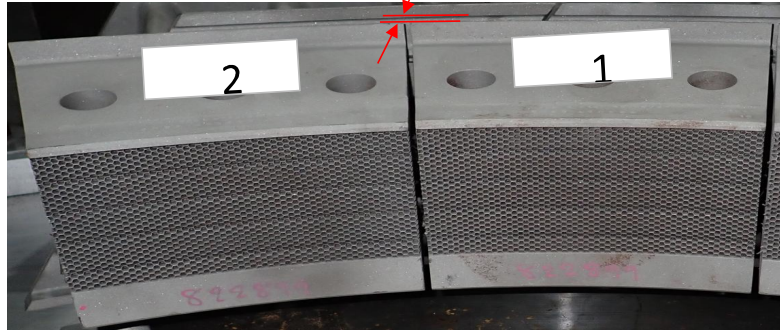
Diaphragm discourager seal alignment

| | Seal alignment | Result |
|---|---|---|
| 1-2 | 0.10 | ACC |
