FINAL INSPECTION REPORT & CERTIFICATE OF CONFORMANCE

Customer Name: Nghi Son Refinery & Petrochemical, LLC.

WORK ORDER #: PO04102025-HGP

Component type: MS6001FA 1st STAGE SHROUD

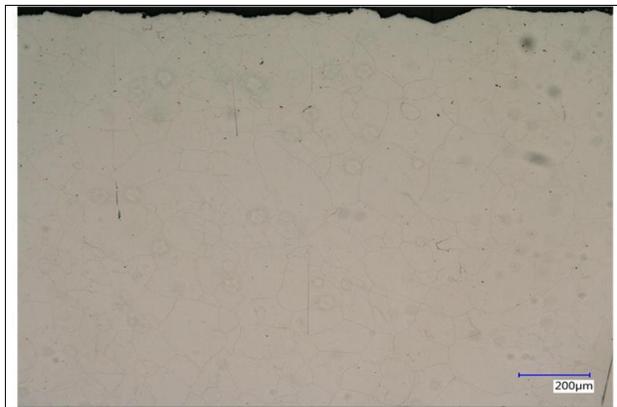
Fig.1 Showing the hot gas path surface condition.(Etched)

The entire hot gas path surface was uncoated, leaving the base alloy directly exposed to high-temperature gas flow and resulting in significant thermal degradation. This condition confirms that the component requires a heavy repair process rather than a standard refurbishment.

Fig. 1: Metallurgical analysis identifies the substrate as SS310 alloy, exhibiting a stable austenitic gamma matrix with grain-boundary and secondary carbides indicative of long-term high-temperature exposure.

Upon structural recovery, the component were received UNEW’s proprietary thermal barrier coating (TBC) abrasible system, a next-generation ceramic coating technology derived from aerospace turbine applications and specifically adapted to NSRP’s operating environment. This coating delivers superior oxidation resistance, thermal fatigue stability, and controlled abrasibility, providing protection and durability significantly beyond that of standard OEM coatings.

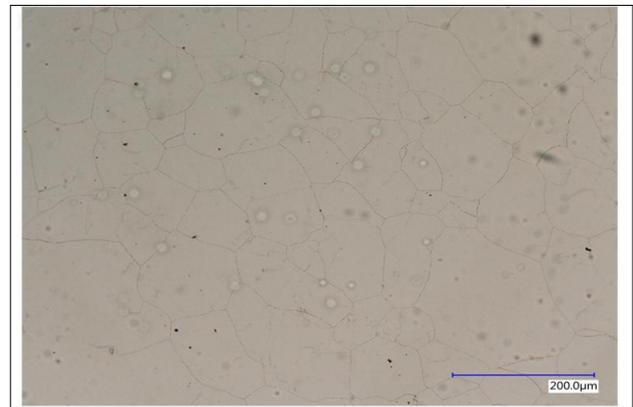
Fig.2 Showing the typical microstructure at higher magnification.(Etched)

Fig. 2: The microstructure remains structurally sound and fully suitable for UNEW’s advanced weld restoration and coating application processes, ensuring continued reliability in future turbine service.

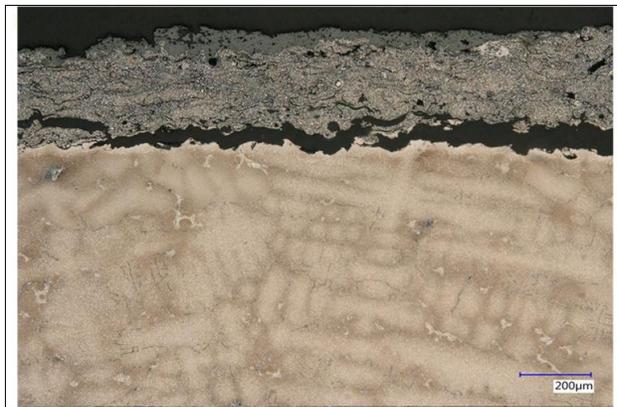
Fig.1 Showing the hot gas path coating and substrate condition.(Etched)

The sample was mounted in fixture L11061-1 to evaluate its suitability for heavy repair. Examination showed that the hot gas path surface was previously protected with a TBC-Abradable coating (see Fig. 1). The condition indicates significant thermal exposure and operational wear, confirming the need for an extensive restoration process.

After applying UNEW's proprietary aviation-grade TBC-Abradable ceramic coating, the component will gain thermal protection and dimensional integrity, with significantly improved durability and extended life compared to the generic coatings typically used by OEMs.

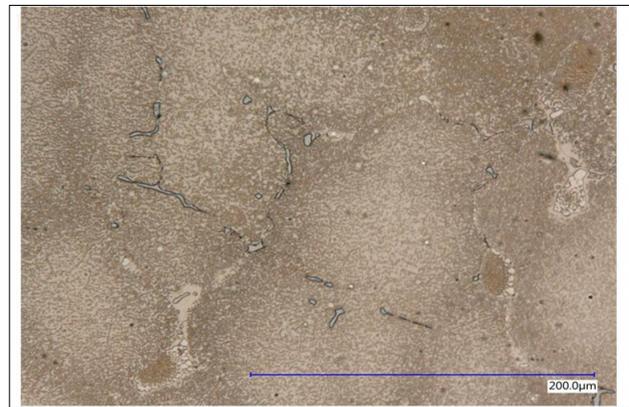
Fig.2 Showing the typical microstructure at higher magnification.(Etched)

The base material was identified as IN738 alloy, featuring a gamma matrix with fine gamma prime, grain boundary carbide, primary carbide, and dispersed secondary carbide (Fig. 2). This high-performance alloy remains structurally sound and is fully compatible with UNEW's advanced repair procedures.

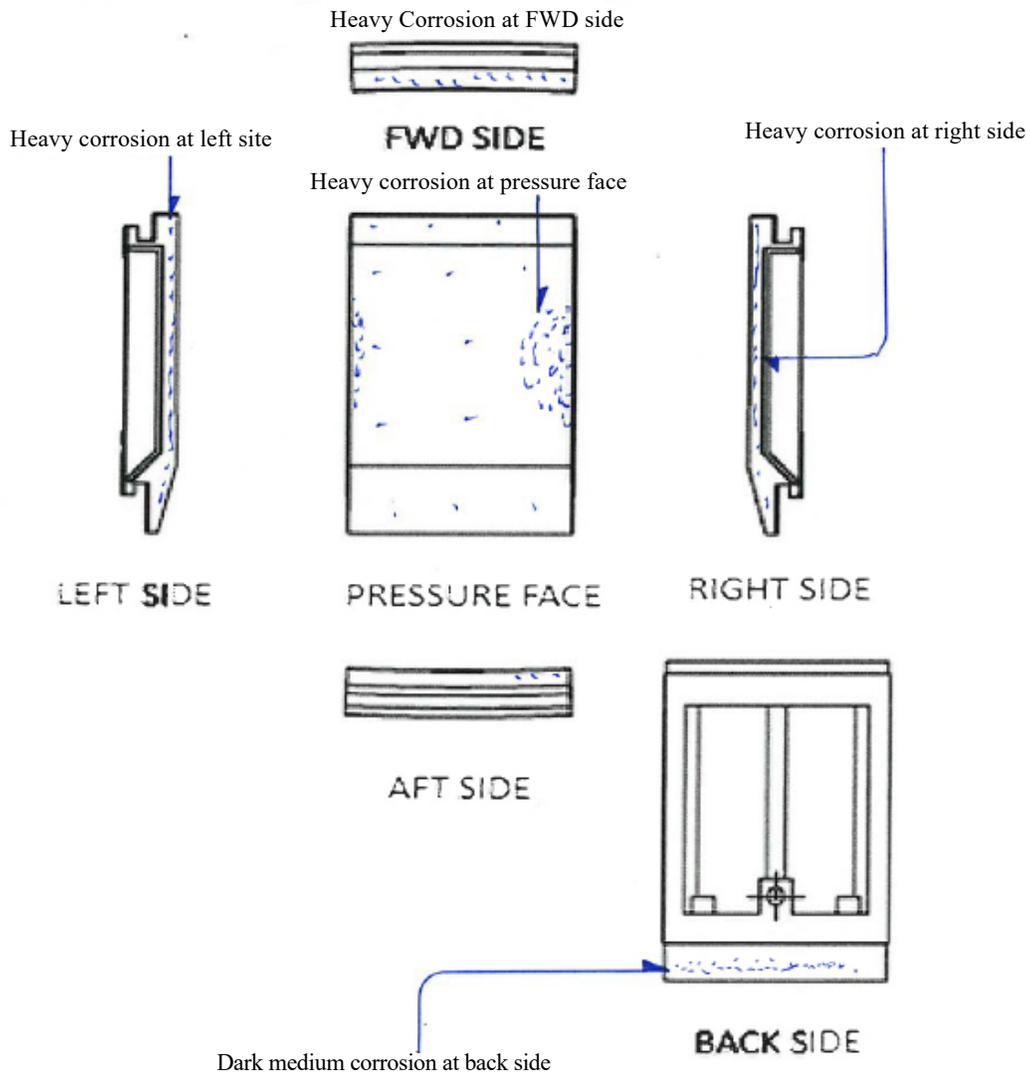
20x20 mm missing part on FWD side, No. 14,17

2-15mm crack at pressure face No. 11, 12, 17, 19

20x20mm missing materials at AFT side No. 14, 17
