FINAL INSPECTION REPORT & CERTIFICATE OF CONFORMANCE

Customer Name: Nghi Son Refinery & Petrochemical, LLC.

Component type: MS6001FA 3rd STAGE SHROUD BLOCK

Work Order: 824033	MS6001FA 3rd STAGE SHROUD BLOCK
---------------------------	--

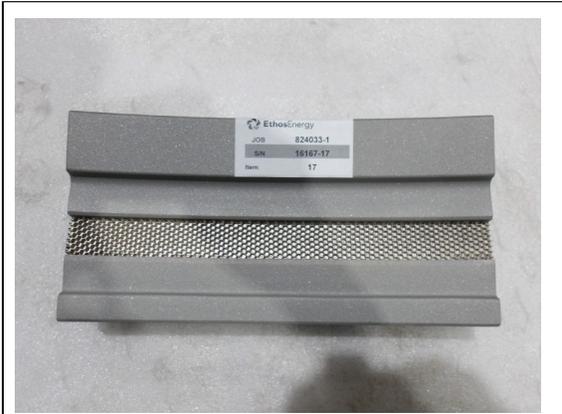
Fig.1 Final inspection.

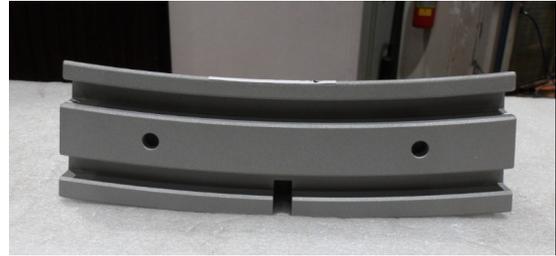
Fig.2 Final inspection.

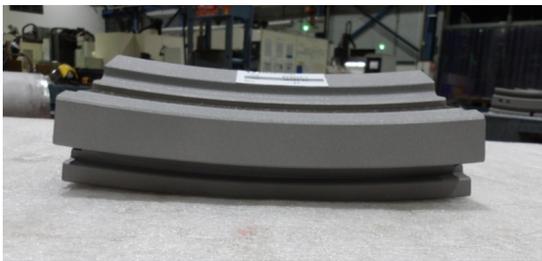
Fig.3 Final inspection.

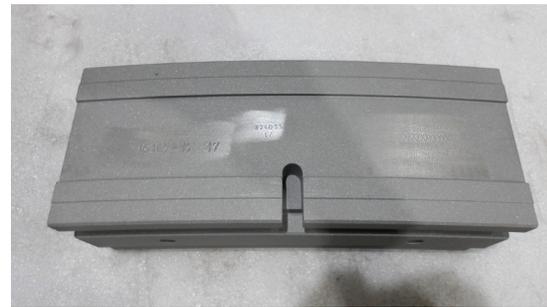
Fig.4 Final inspection.

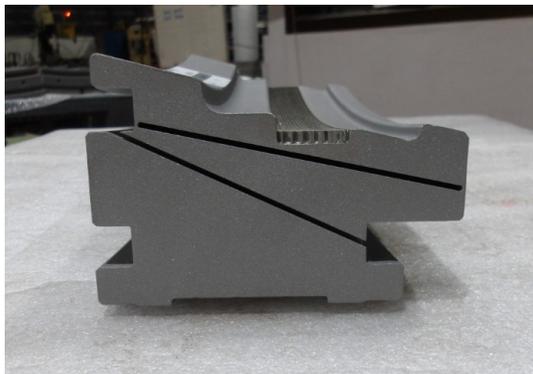
Fig.5 Final inspection. .

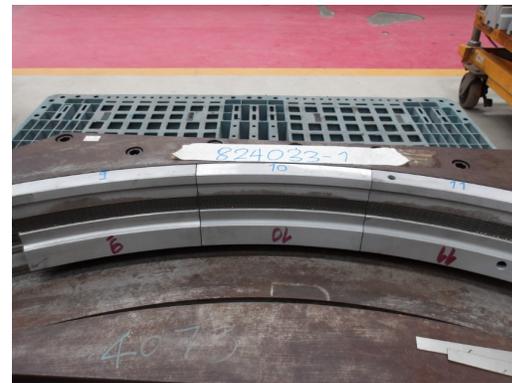
Fig.6 Fixture inspection.

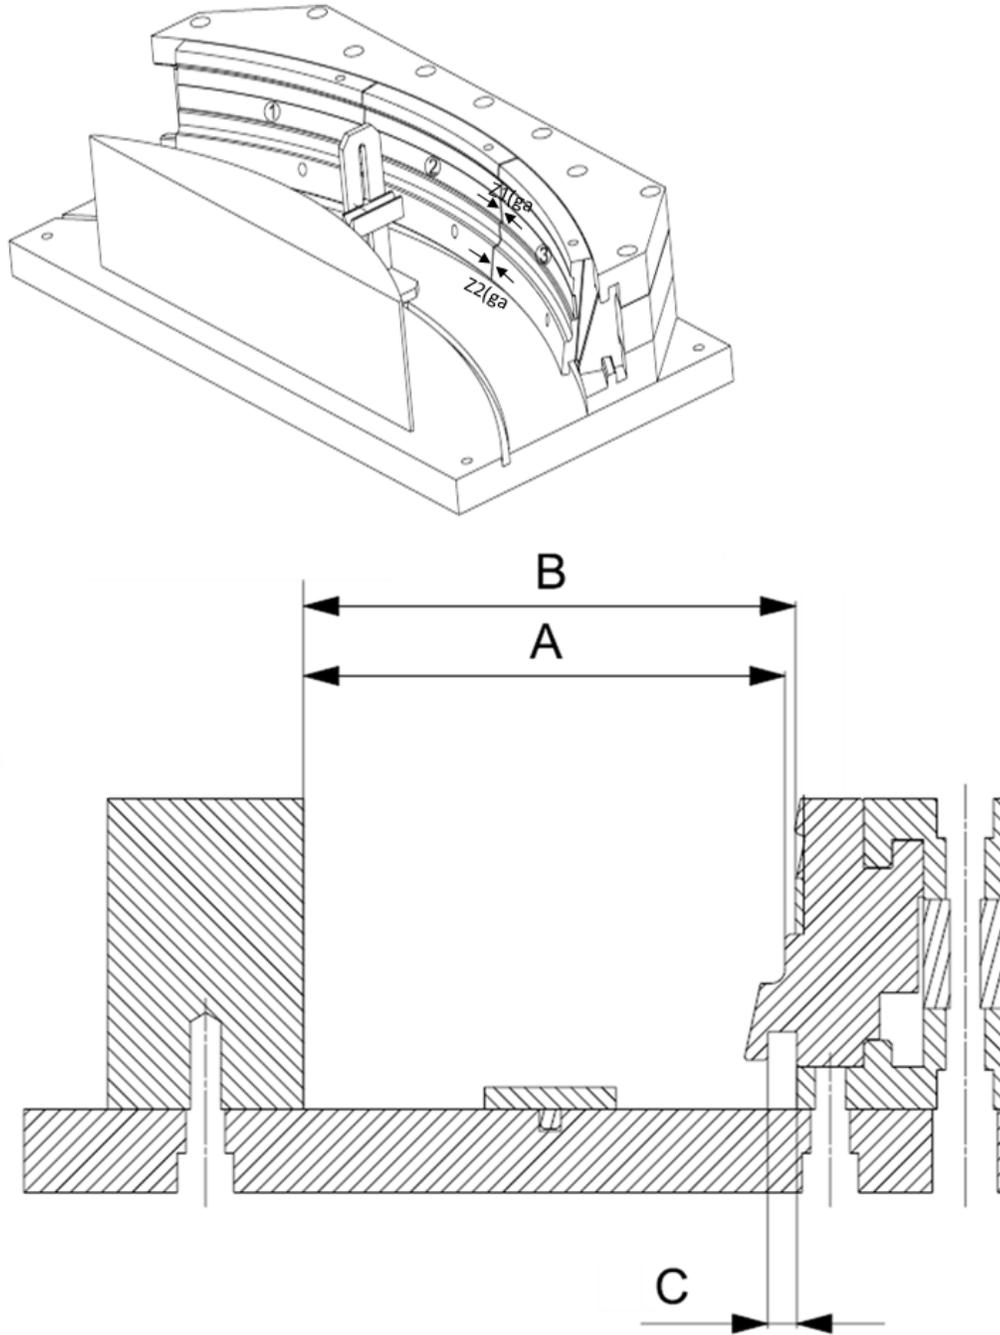
10. DIMENSION INSPECTION: (Fixture inspection)

Dimension Inspection							
ITEM	POSITION (Unit : mm.)						Result
	A	B	C	G1(gap)	G1(gap)	Bore scope hole ID	
1	221.35	226.92	13.06	ACC	ACC	13.03	ACC
2	221.37	226.91	13.00	ACC	ACC	-	ACC
3	221.32	226.92	13.04	ACC	ACC	-	ACC
4	221.39	226.91	13.03	ACC	ACC	-	ACC
5	221.36	226.80	12.99	ACC	ACC	-	ACC
6	221.33	226.79	13.04	ACC	ACC	-	ACC
7	221.35	226.82	13.02	ACC	ACC	12.97	ACC
8	221.41	226.95	13.08	ACC	ACC	-	ACC
9	221.39	226.77	13.07	ACC	ACC	-	ACC
10	221.39	226.92	12.99	ACC	ACC	-	ACC
11	221.34	226.84	13.01	ACC	ACC	12.88	ACC
12	221.33	226.87	13.08	ACC	ACC	-	ACC
13	221.37	226.94	13.04	ACC	ACC	-	ACC
14	221.35	226.87	13.04	ACC	ACC	-	ACC
15	221.34	226.78	12.98	ACC	ACC	-	ACC
16	221.42	226.90	13.02	ACC	ACC	-	ACC
17	221.40	226.97	13.02	ACC	ACC	-	ACC
18	221.34	226.87	13.09	ACC	ACC	-	ACC
19	221.43	226.77	13.04	ACC	ACC	-	ACC
20	221.41	226.80	13.07	ACC	ACC	-	ACC
21	221.39	226.85	13.03	ACC	ACC	-	ACC
22	221.33	226.87	13.05	ACC	ACC	-	ACC

23	221.32	226.87	13.06	ACC	ACC	-	ACC
24	221.35	226.94	13.05	ACC	ACC	-	ACC

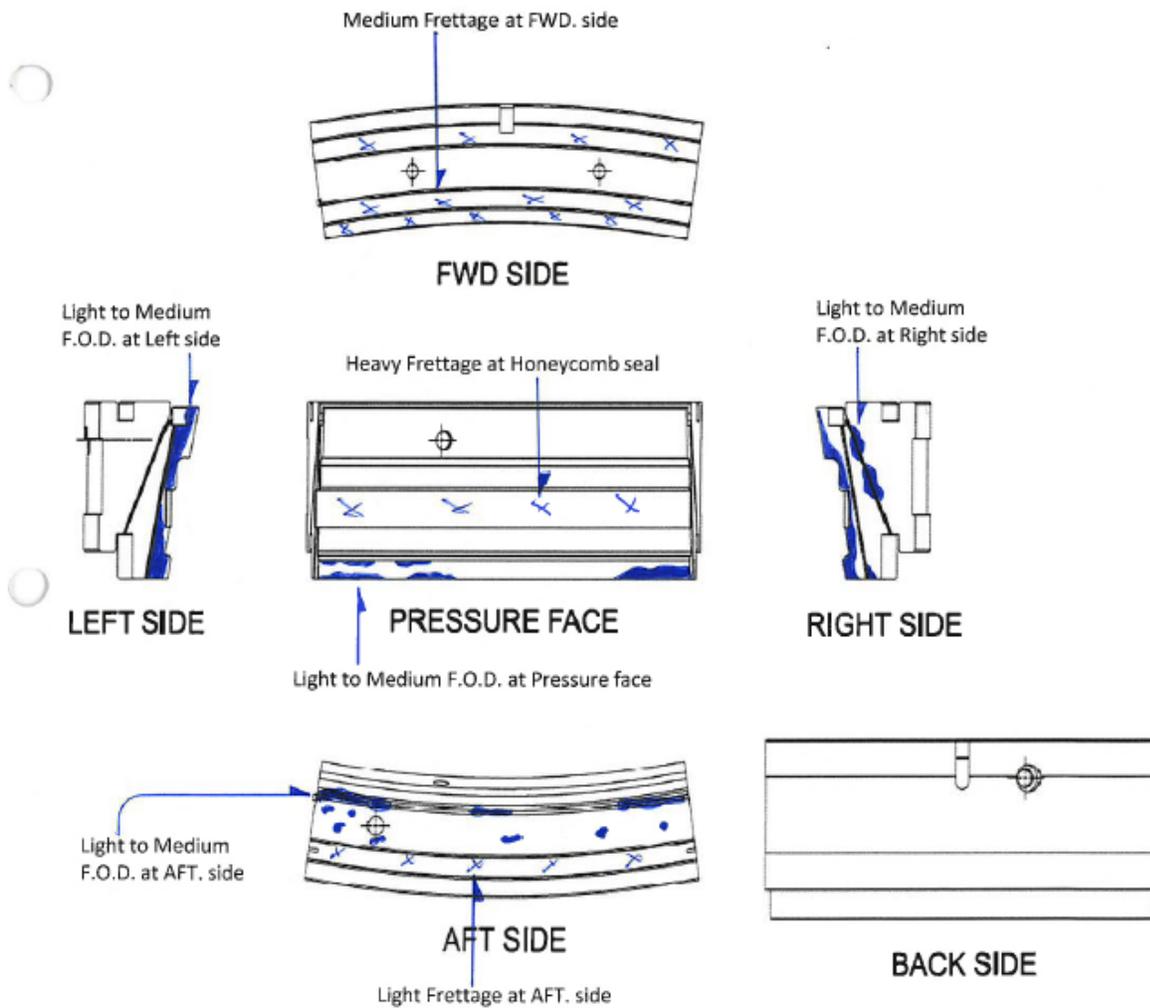
11. DEFECT MAP:

Mapping of FPI and Visual Inspection

(Incoming condition)

TYPICAL DEFECT
