GAS TURBINE INSPECTION REPORT

Combustion Inspection

Gas Turbine Model: GE 6FA.03, MNQC
Unit: GTG2 (Serial Number: 875123)
Plant: Nghi Son Refinery and Petrochemical, LLC

Report Date: July, 2025

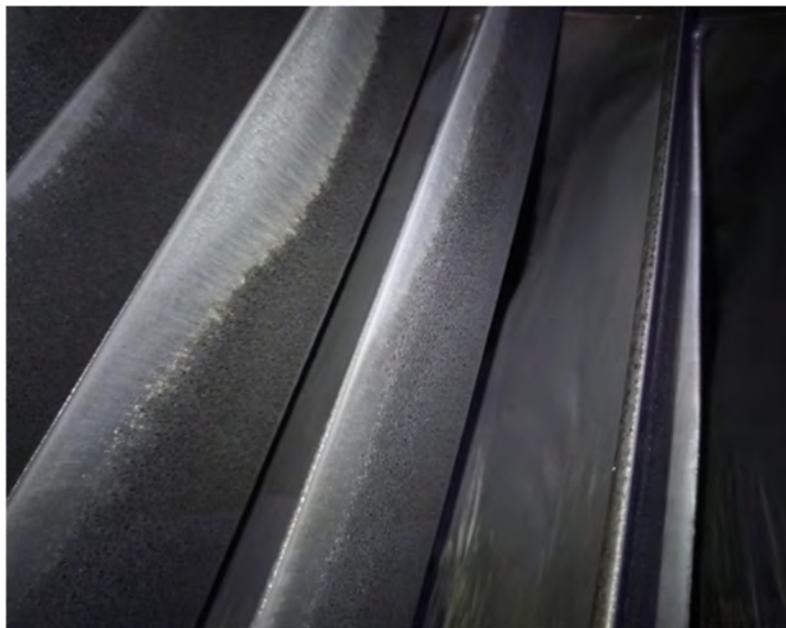
The inlet plenum area was accessed through a designated manhole. A light sooty deposit was visible on the plenum, bell mouth, as well as on IGV and compressor R1 blades. IGVs were cleaned, and no damages such as FOD or cracks were noticed on any vane. The whole plenum and VIGV was cleaned, and clearances of VIGV were recorded. It is advisable to keep the VIGV area clean. VIGVs were checked through the dye penetrant test, no abnormalities were revealed in the DP test. All clearances recorded and attached in jointly signed check sheets. During this opportunity condition of the water wash nozzles was also checked for integrity and any blockage, found to be in good condition. Compressor R1 and S1 blades were also inspected through the Bore scope for damage as corrosion, cracks, dents, bent, etc., no indication found except a light sooty deposit. BI images are available in the BI kit provided by NSRP.

Condition of IGV before Cleaning

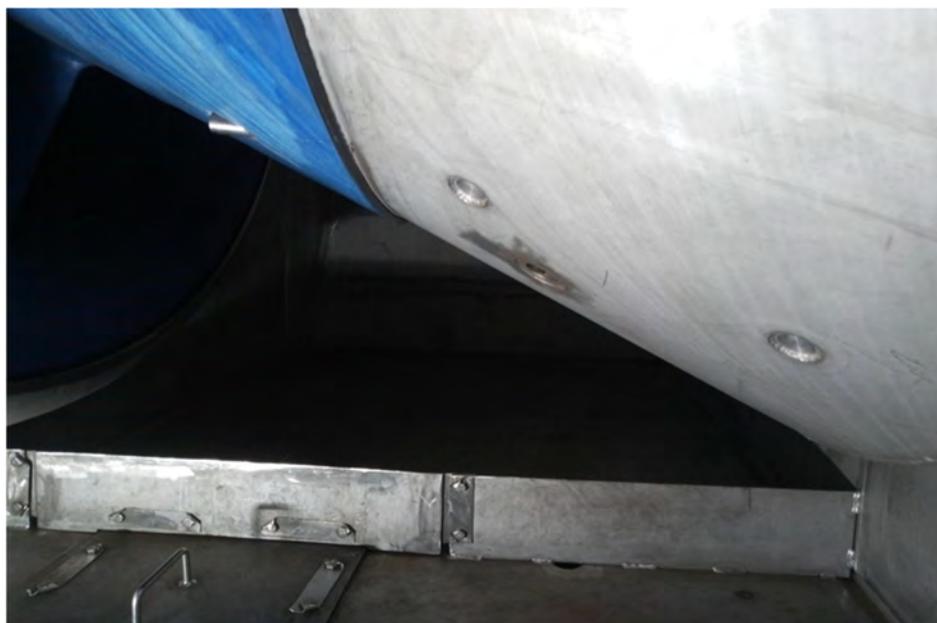
Condition of Plenum Bottom and Bell mouth

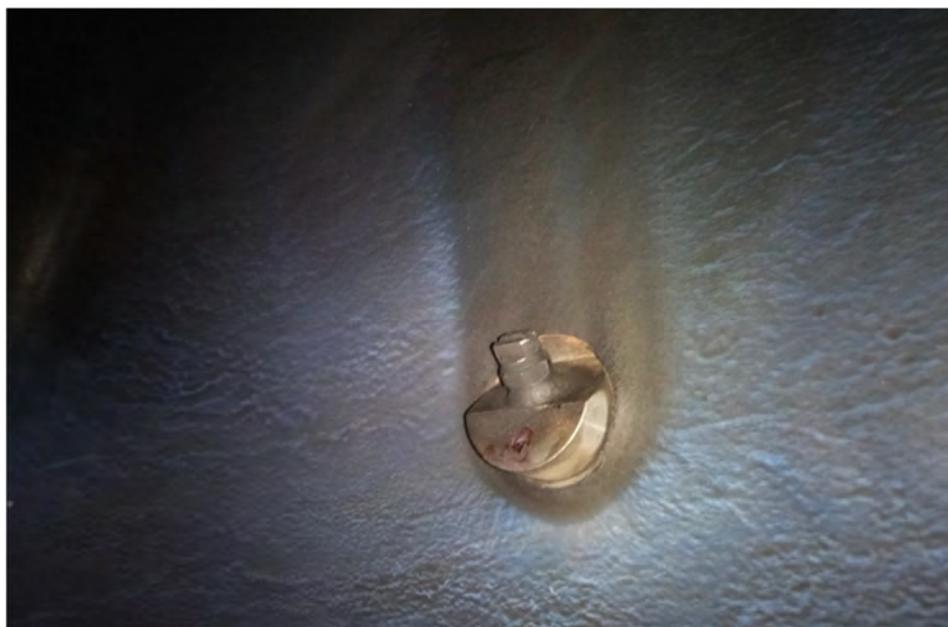
Condition of Water wash Nozzle

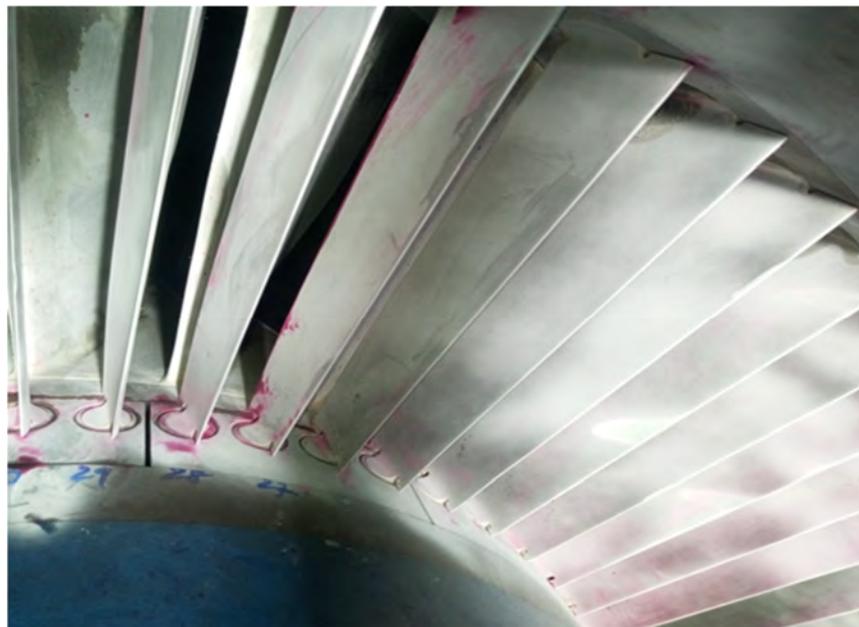
Dye Penetrant Test on VIGVs

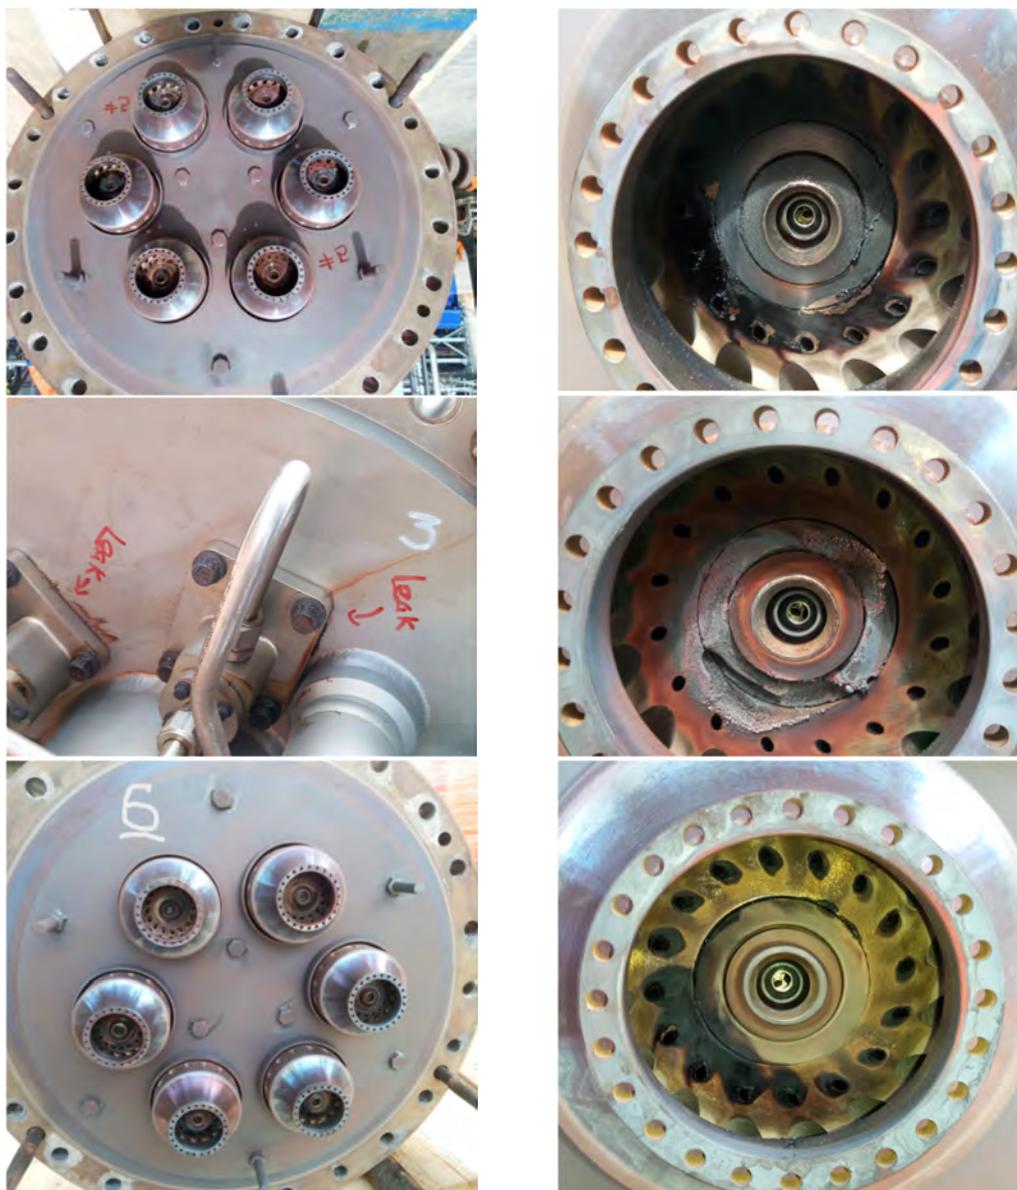
All fuel nozzles cum end covers of combustion cans were removed and inspected visually. Light to medium carbon deposits were observed on all the fuel nozzles. Minor to medium wear on a few of the AA cones, and fuel Gas tips were also observed. The Fuel Nozzle Set was installed during combustion inspection carried out in June 2024 at 51,277.7 fired hours (68,163.4 FFH), and so far, it has clocked 8556.8 FH (9239.3 FFH) since last installation. The set of Fuel nozzles was replaced with another refurbished set. Details of both removed and installed are recorded in jointly signed check sheets. The fuel nozzle cum end covers were installed with new gaskets, bolts tightened with the prescribed torque value, and recorded in respective jointly signed check sheets. Before installation of the refurbished fuel nozzles, the water injection distributor inlet connector was fitted from the old one and welded (due to non-availability of a suitable new connector and O-ring). NDT was also carried out on the weld joints; no indication was found. In addition, the connector for the Liquide fuel distributor drain line was also replaced from old nozzle set with new O-rings, tightness of bolts and tubing's also ensured before installation.

Figure 06: Removed Fuel Nozzles

The removed set can be considered for further refurbishment for future use, subject to the following OEM latest guideline mentioned in GER3620P. NSRP to provide the Total FFH and previous repair history of the removed fuel nozzle set to finalize refurbishment possibilities.

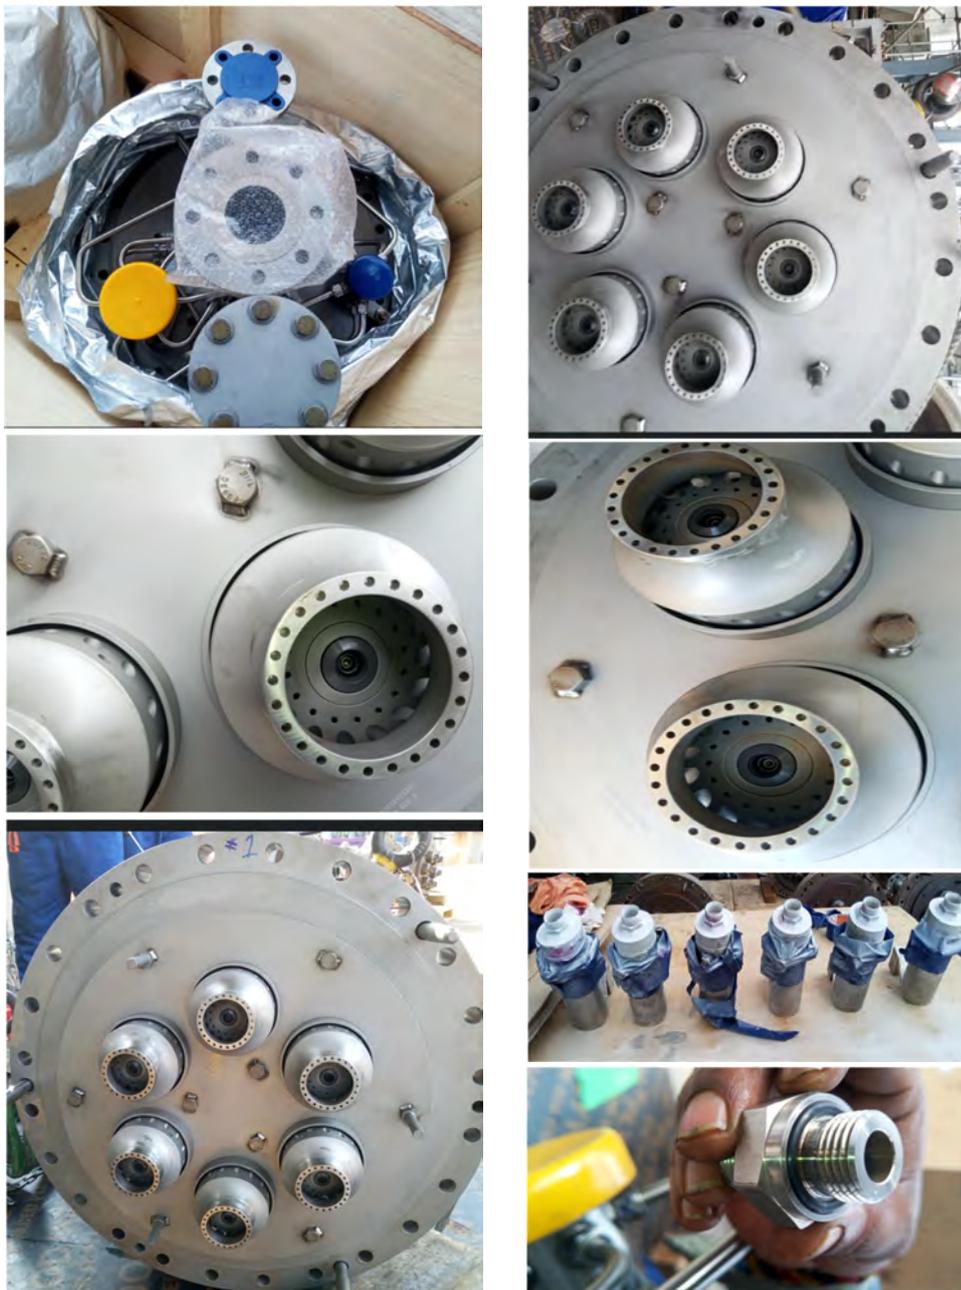
Figure 07: Installed Refurbished Fuel Nozzles

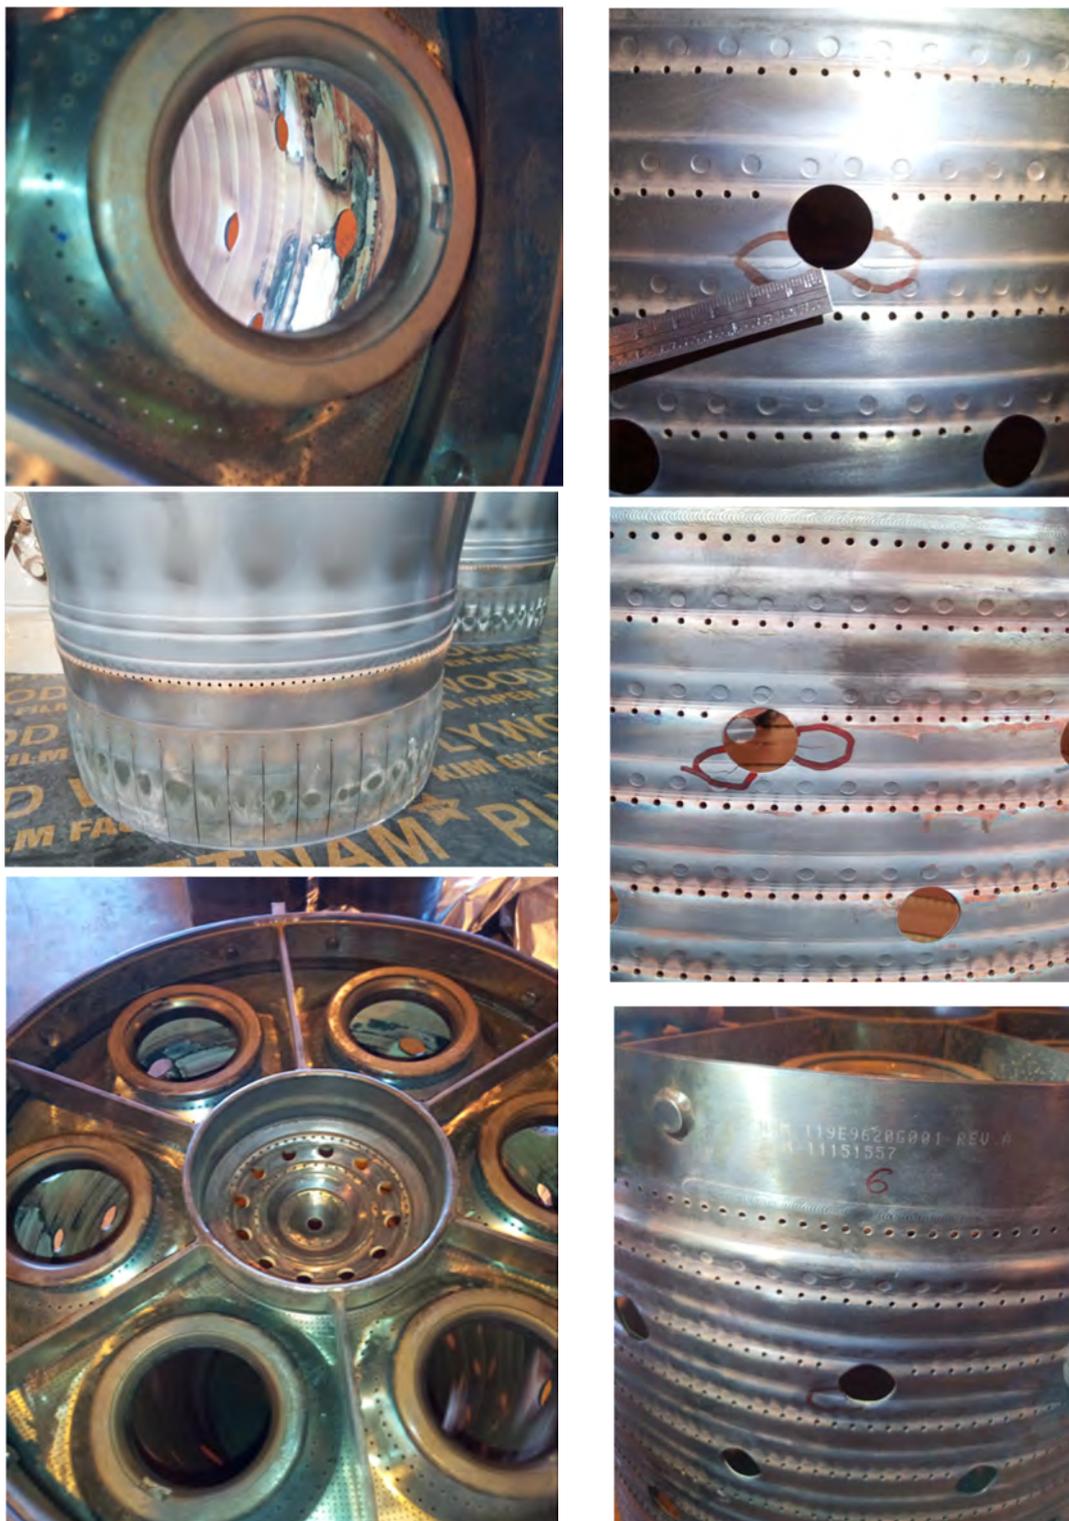
The combustion liners were removed from position and inspected. The combustion liners are found with TBC coating loss. Hot corrosion as well as radial and axial cracks of 5mm to 30mm length were also observed on the liner body; no noticeable damage noticed on the cap cowl. Normal wear and compression marks were noticed on the Hula seal. The removed liner set was in service since last CI executed during June 2024 and so far, clocked 8556.8 fired hours (FH)/ 9239.3 factored fired hours (FFH). The set replaced with a refurbished set provided by NSRP. The set total FFH and refurbishment history to be provided by NSRP for better parts management. Details recorded in jointly signed respective Check Sheet. The Removed set can be sent for refurbishment facility after assessing the total uses (FFH), previous repair history and expected residual designed life as per OEM latest guide line provided in GER3620P.

Figure 09: Removed Liners

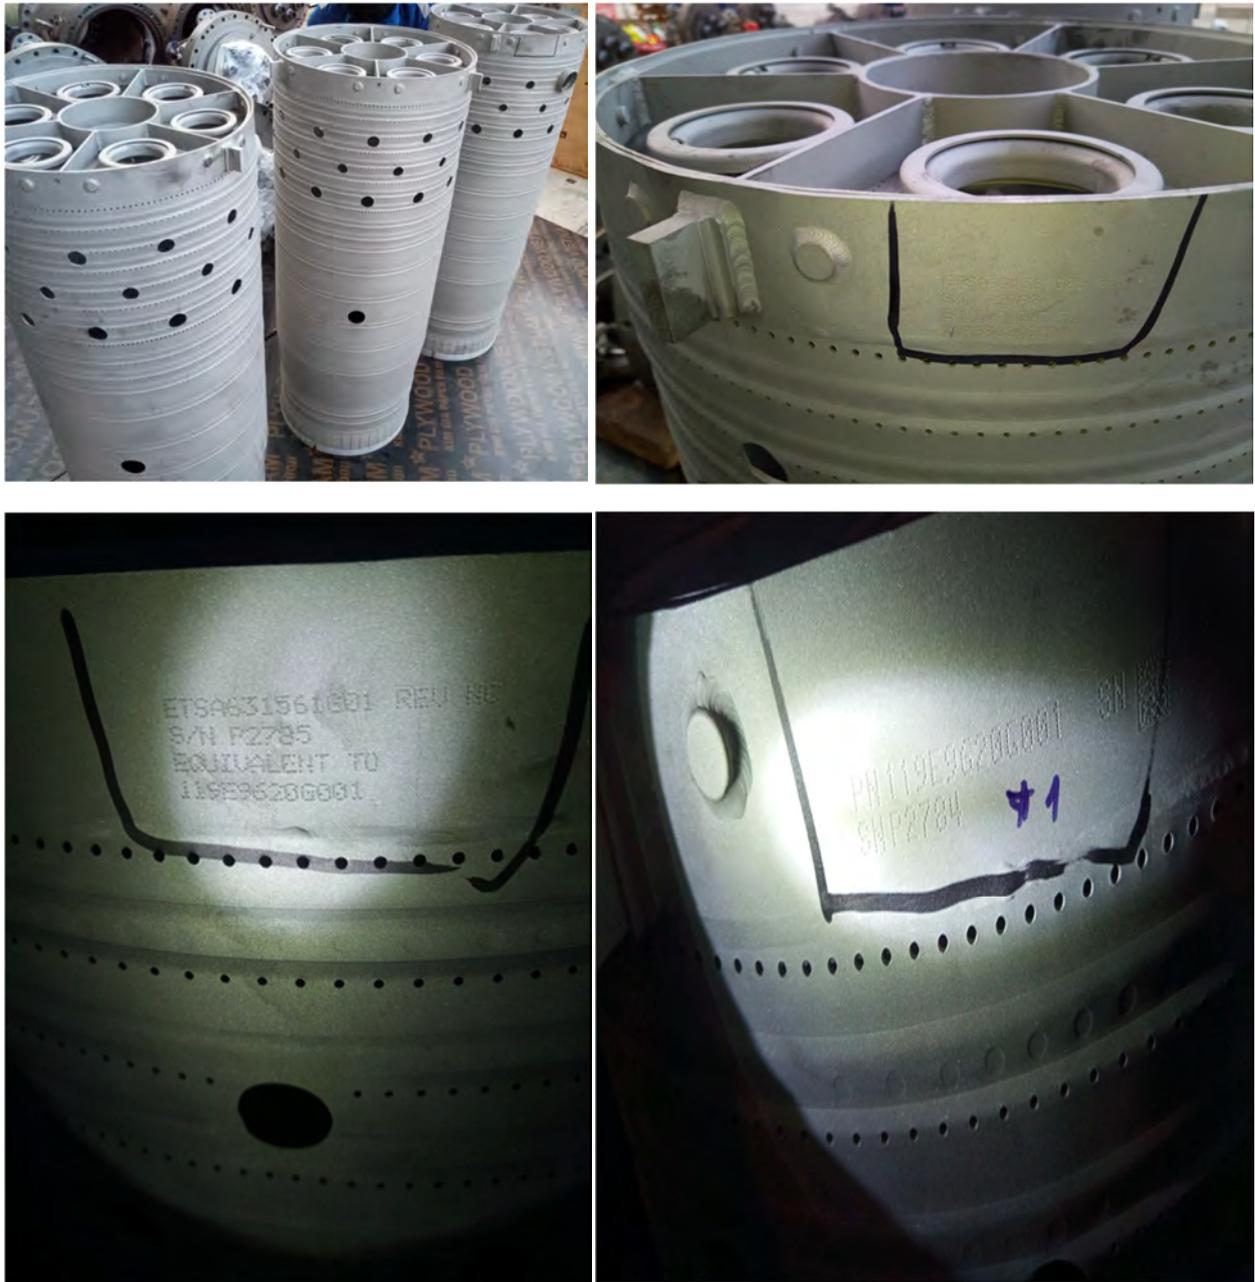
Figure 10: Installed Refurbished Liners

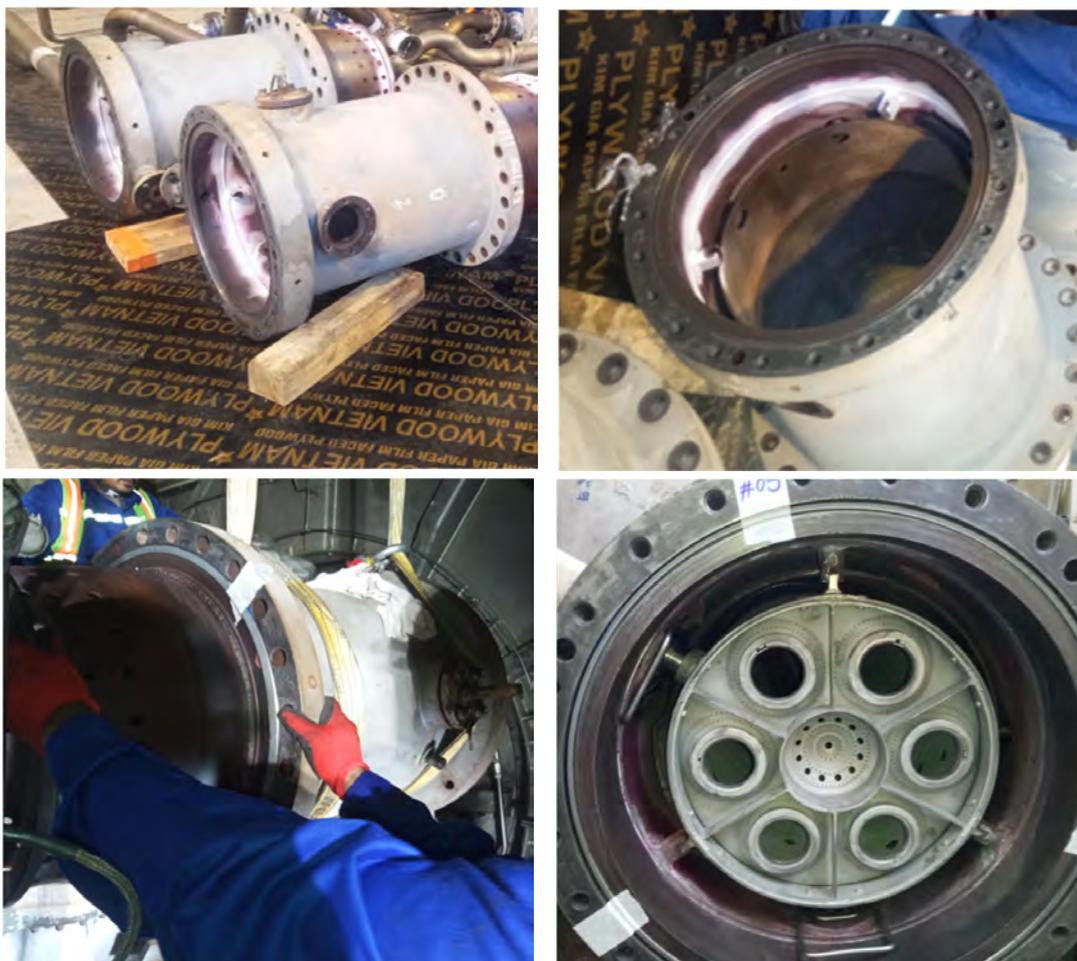
All the combustion cans were removed, cleaned and inspected. Mostly found in good condition except normal light hot corrosion. NDT carried out on weld joints of the Liner

stoppers except normal light hot corrosion. NDT carried out on weld joints of the Liner stoppers and retaining ring holders, no indication found. No cracks or other abnormalities noticed. The chambers installed back with new gaskets, bolts were tightened with prescribed torque value, details recorded in jointly signed respective check sheet. Drawing/ Part No. Out and In: 129E8465G003—1 no, G004—1 no, G011—2 no, G012—1 no And G013---1 no. The set is in use since commissioning of the unit and clocked 59834.4 FH/77402.5 FFH.

Figure 11: Removed and Installed Combustion chambers

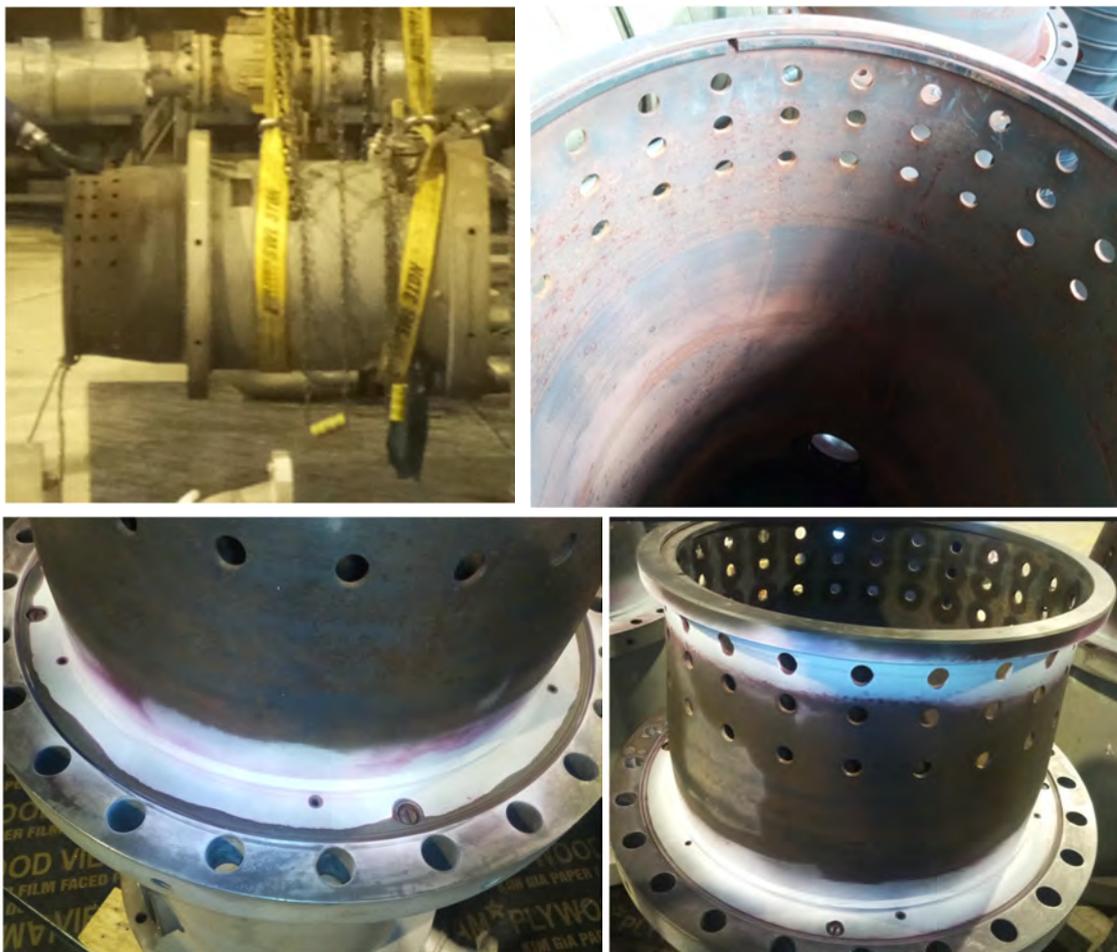
All the flow sleeves were cleaned and inspected visually. All weld joints were DP tested and found in good condition. The fixing screws were checked for tightness and integrity, Floating ring seal checked for freeness and integrity, both found in order. All were returned in service after proper cleaning. Details recorded in the jointly signed respective check sheet. The set of flow sleeve is in use since commissioning of the unit and clocked 59834.4 FH/ 77402.5 FFH. Drawing / Part No. Out and In: 110E1194G004

Figure 12: Removed and Installed Flow sleeves

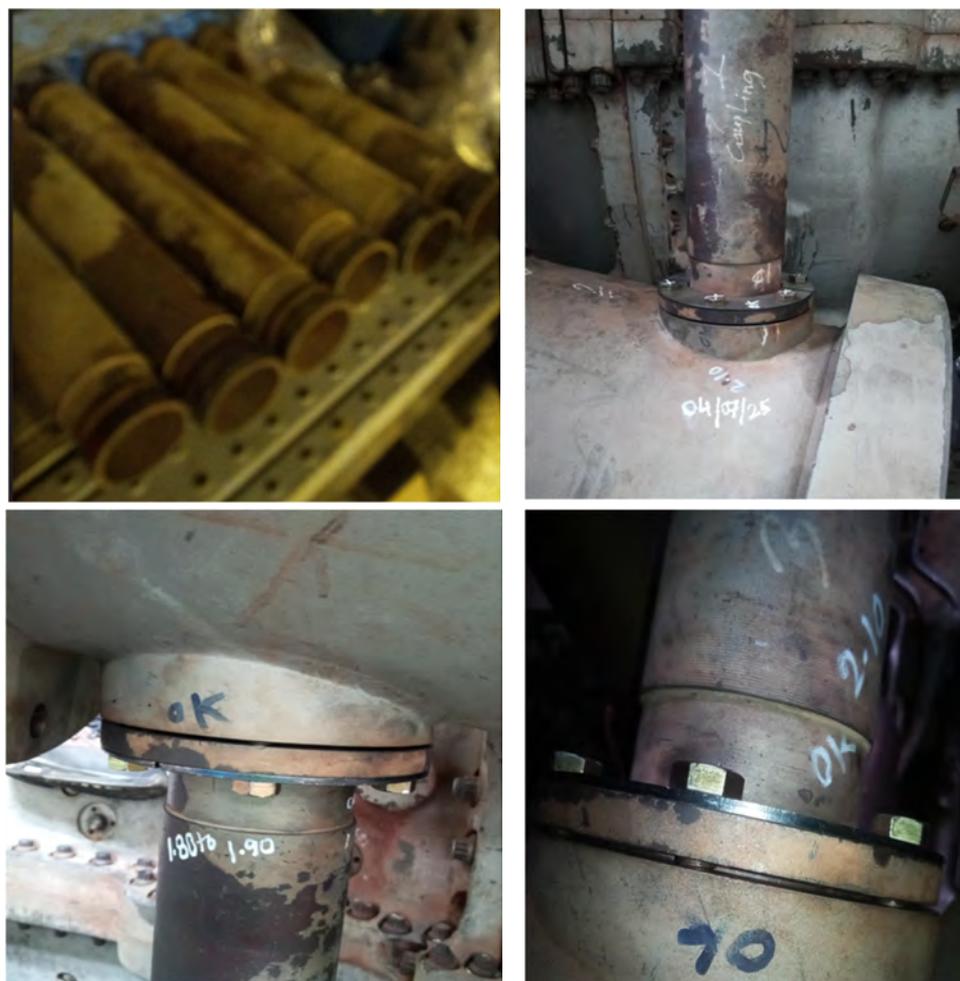
During combustion dis-assembly process, outer crossfire tubes were also removed. The outer tubes were cleaned and inspected, no mentionable damages noticed. Same were returned to service along with the fixing flanges with new packing rings (2 no at each side of the combustion chambers). Respective flange bolts were tightened such to maintain equal gap of 2.03 +/- 0.38 mm. Details recorded in jointly signed check sheets.

Figure 13: Removed and Installed Outer Cross-Fire Tubes

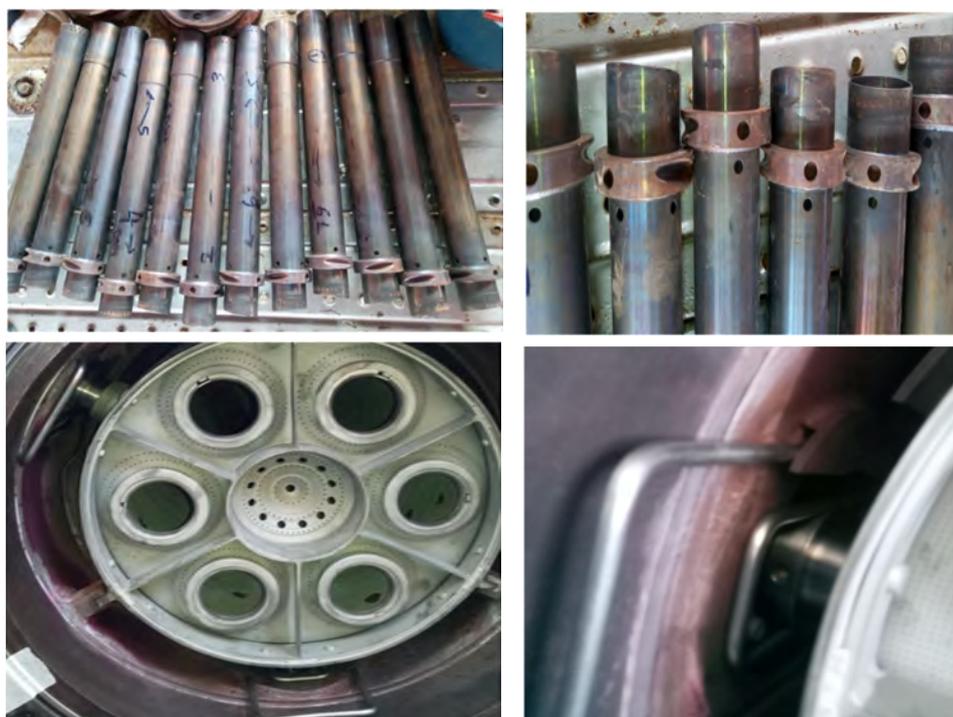
All the male and female cross-fire tubes were removed and inspected. All most all the cross- fire tubes (sets) were observed with minor wear and hot spot, hence replaced with new set for reliable service till next scheduled inspection. The removed set was in service since last installation during CI of June 2024 and clocked 8556.8 FH/ 9239.3 FFH and to be retired from service.

All the retainers were removed and inspected; no visual defects noticed except deterioration in spring action. The replaced with new set for reliable service till next scheduled inspection. The removed set was in service since last installation during CI of June 2024 and clocked 8556.8 FH/ 9239.3 FFH and to be retired from service. Drawing/ Part No. of Retainer Out: 230C3238P003

Figure 14: Removed and installed Cross-fire tubes and retainers

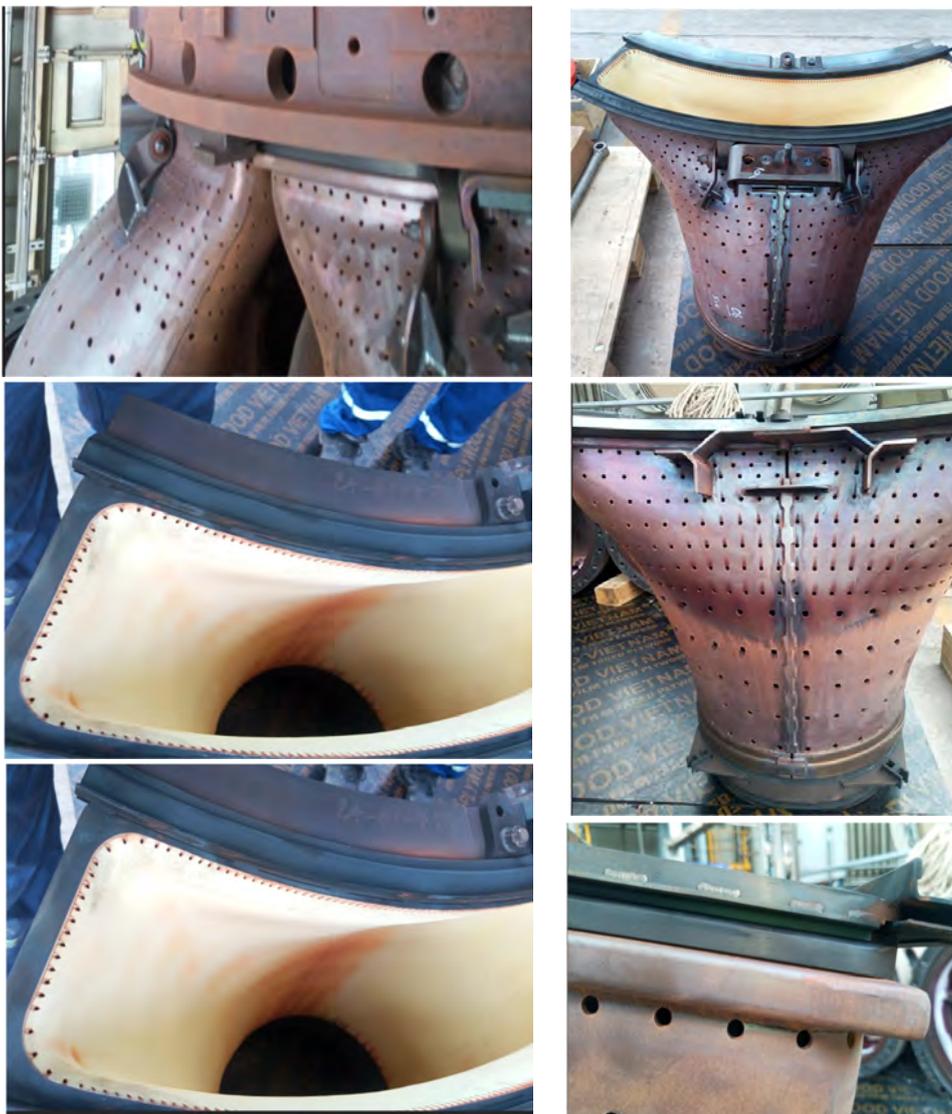
The transition pieces were removed and inspected. Minor wear was observed at picture frame and floating seal and slots. Light dis-coloration and hotspot on Cooling jacket and Inside TBC coating. No crack or major defects noticed. The TP set was replaced with refurbished set provided by NSRP. The total FFH and refurbishment history to be provided by NSRP for proper spares parts management. As per OEM lates guide line per GER3620P the TP repair interval is 1 CI and replacement interval is 3 CI. All fixing hardware was replaced with new.

The removed set of TPs was in service since last installation in June 2024 CI and so far, clocked 8556.8 FH/ 9239.3 FFH. No previous repair mark found on the body. The set can

Figure 15: Removed Transition Pieces

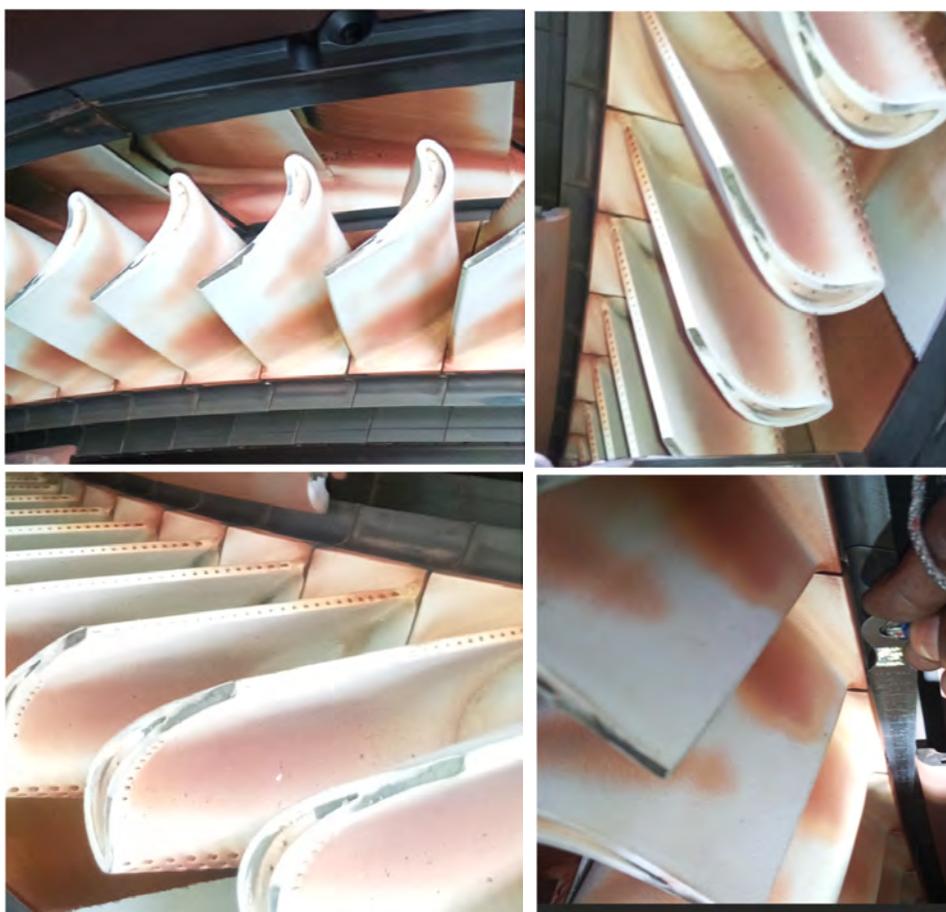
The Stage-1 buckets were inspected in situ. All buckets were found with minor tip rub, discoloration on both pressure and suction side. Cooling holes seems free from any blockage; no damages noticed on bucket platform and axial seals except normal hot corrosion. The coating found to be in good shape. Kept in service till next inspection. NSRP to provide total FFH and Repair history of the bucket kit for future parts management including repair prospect.

Figure 18: Stage-1 Bucket condition

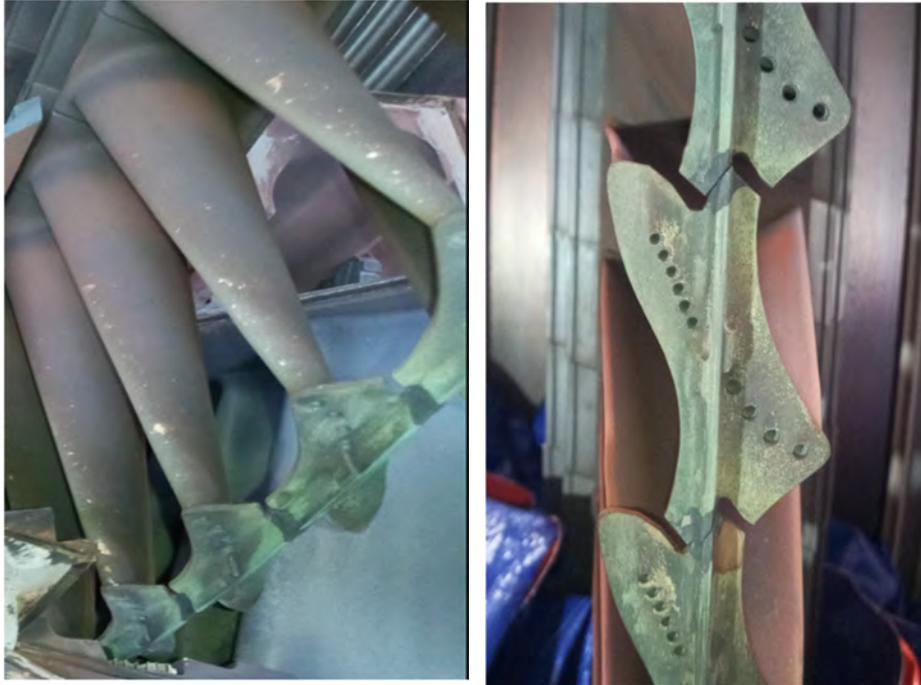
The Stage #2 buckets were visually inspected in situ. High to medium dis-coloration and corrosion noticed on both suction and pressure side of the bucket, same also noticed on platform and tip, light deposit also observed. No cracks, FOD, missing metal

visualized. Cooling holes found to be clear from any blockage. Bottom buckets also inspected through bore scope provided by NSR, images captured and kept on the instrument. Set kept in service till next scheduled inspection, HGPI due with in nex 8000 FFH. Recommended to replace.

Figure 19: Condition of Stage-2 Buckets

NSRP to keep 1 set ready for next HGPI outage. Regarding repair possibility, NSRP to provide total FFH of the set along with previous repair history.

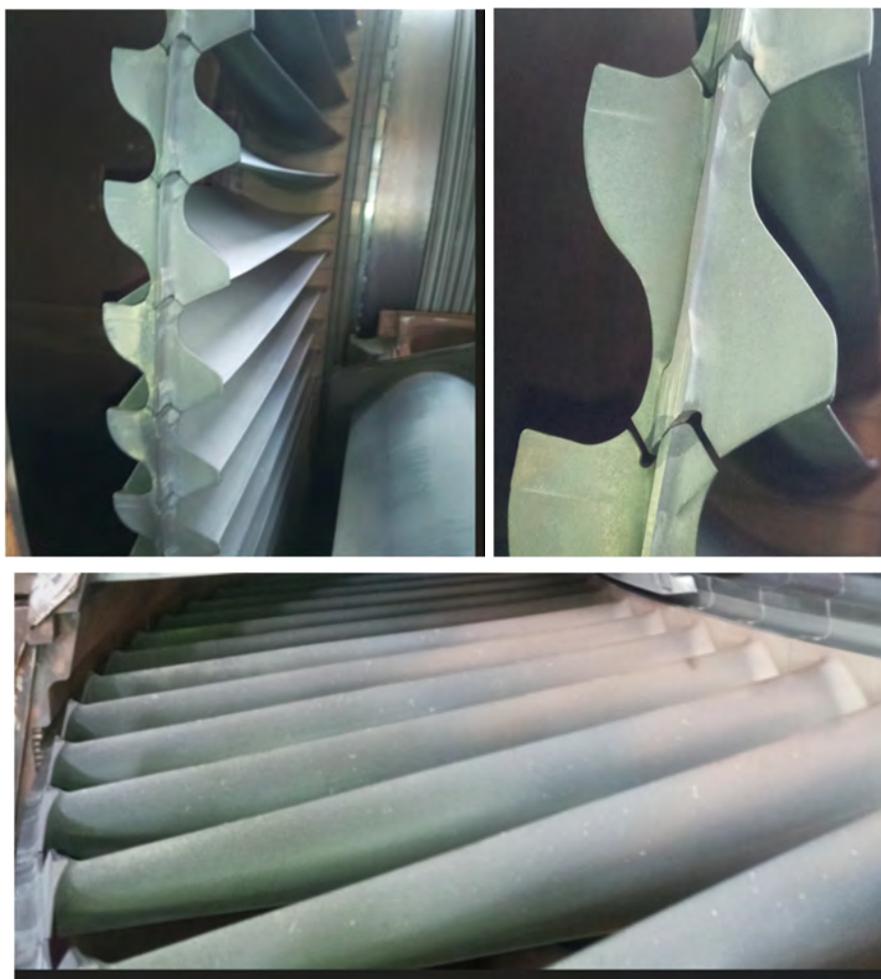
Stage #3 buckets were cleaned and inspected visually in situ. No remarkable defects noticed except minor and normal hot corrosion. Buckets were observed free from any nicks & dents. Shrouded tip seal and Z- lock observed in good condition. The set kep in service till next scheduled inspection.

Figure 20: Condition of Stage-3 Buckets

NSRP to keep I set ready for upcoming HGPI due within next 8000 FFH. Regarding repair possibility, NSRP to provide total FFH of the set along with previous repair history.

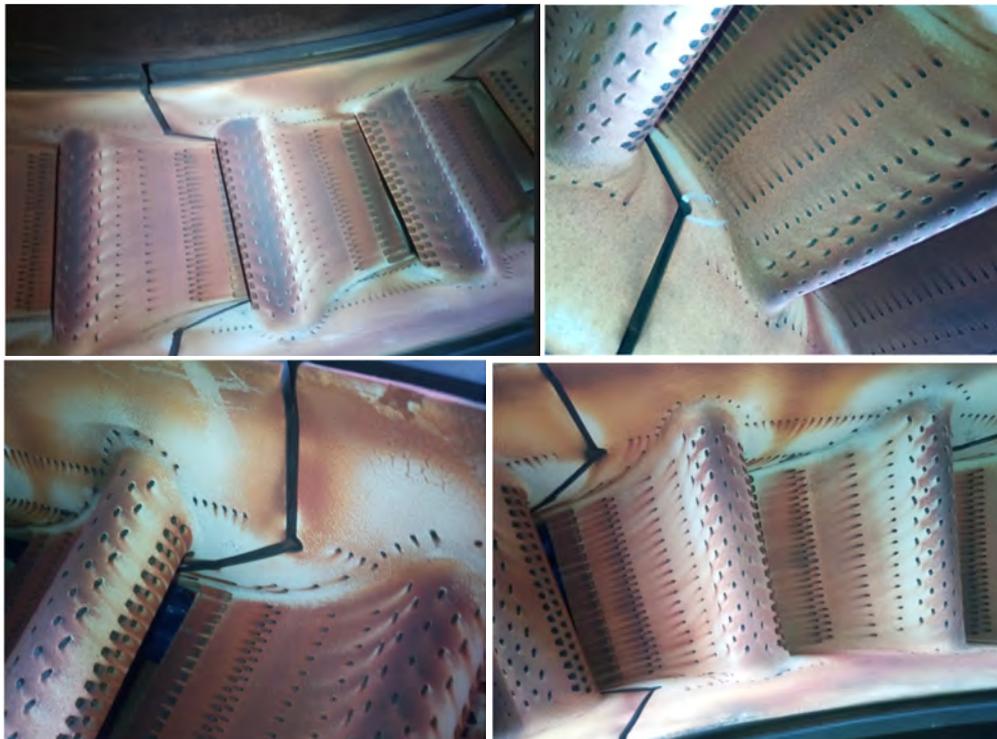
The first stage nozzle visually inspected in situ. In general; condition seems to be good. No cracks, FOD, missing metal observed. Black sooty deposit on the leading edge and suction side noticed in addition to normal hot corrosion, minor coating crack noticed on inner and outer walls of few segments. The cooling holes found to be clear from any blockage. The set is in operation since last replacement and kept in service till next scheduled outage, supposed to be HGPI. As per OEM latest guide line (GER3620P) the Stg-1 nozzle repair cycle is 1-HGPI and Replacement is 3 HGPI.

Figure 21: Stage-1 Nozzle Condition

NSRP to provide the total FFH of the nozzle set along with previous refurbishment history to finalize future repair possibilities and proper spare parts management.

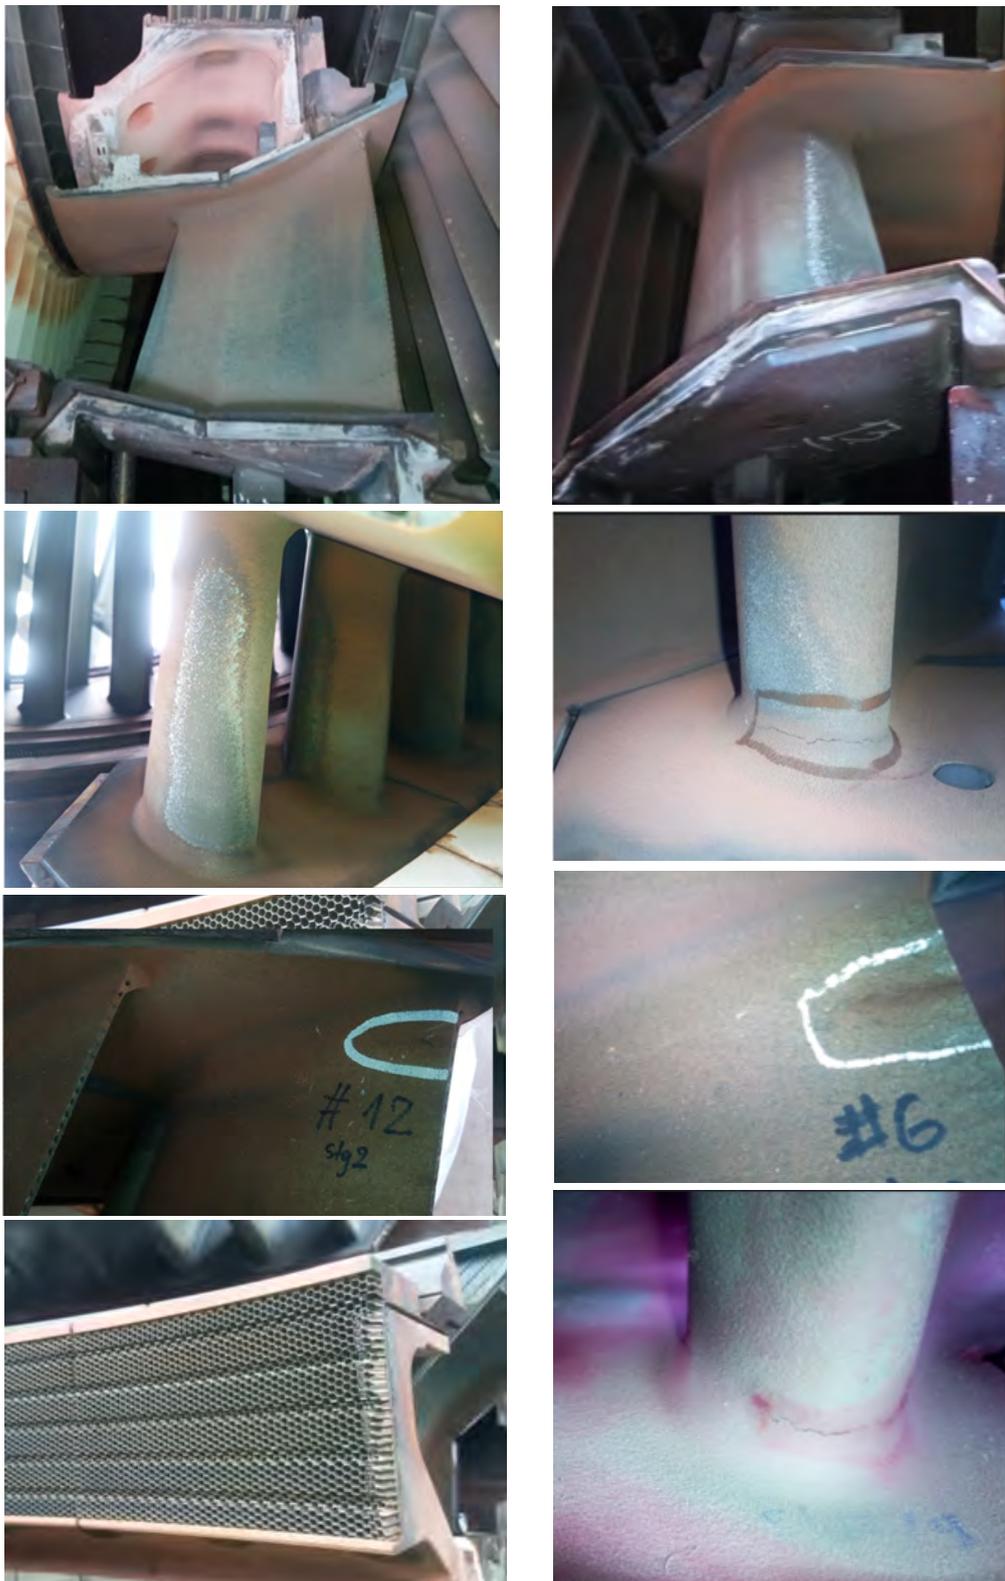
The second stage nozzle segments visual checked in situ on top casing and through bore scope on bottom casing. Medium to heavy corrosion and oxidation noticed on the nozzle leading and trailing edges including inner and outer walls. Single line hair crack noticed on almost all the vanes airfoil fillet area both leading and trailing edge. No open crack observed. After joint discussion it was decided keep the set in service till next scheduled inspection, HGPI will be due within next 8000 FFH. Considering the unit efficient and safe operation, it's advised to have a Bore scope inspection of the Stage-2 nozzle within next 4000 FFH to monitor the condition of the crack. If cracks open up, it will impact proper cooling of the nozzle as well as respective wheel space area. No damages noticed on Diaphragm, except hot corrosion.

Figure 22: Condition of Stage-2 Nozzle

NSRP to provide total FFH and refurbishment history of the nozzle set to finalize further repair and usability. NSRP to keep another set of Stage-2 nozzle along with fixing hardware for upcoming HGPI.

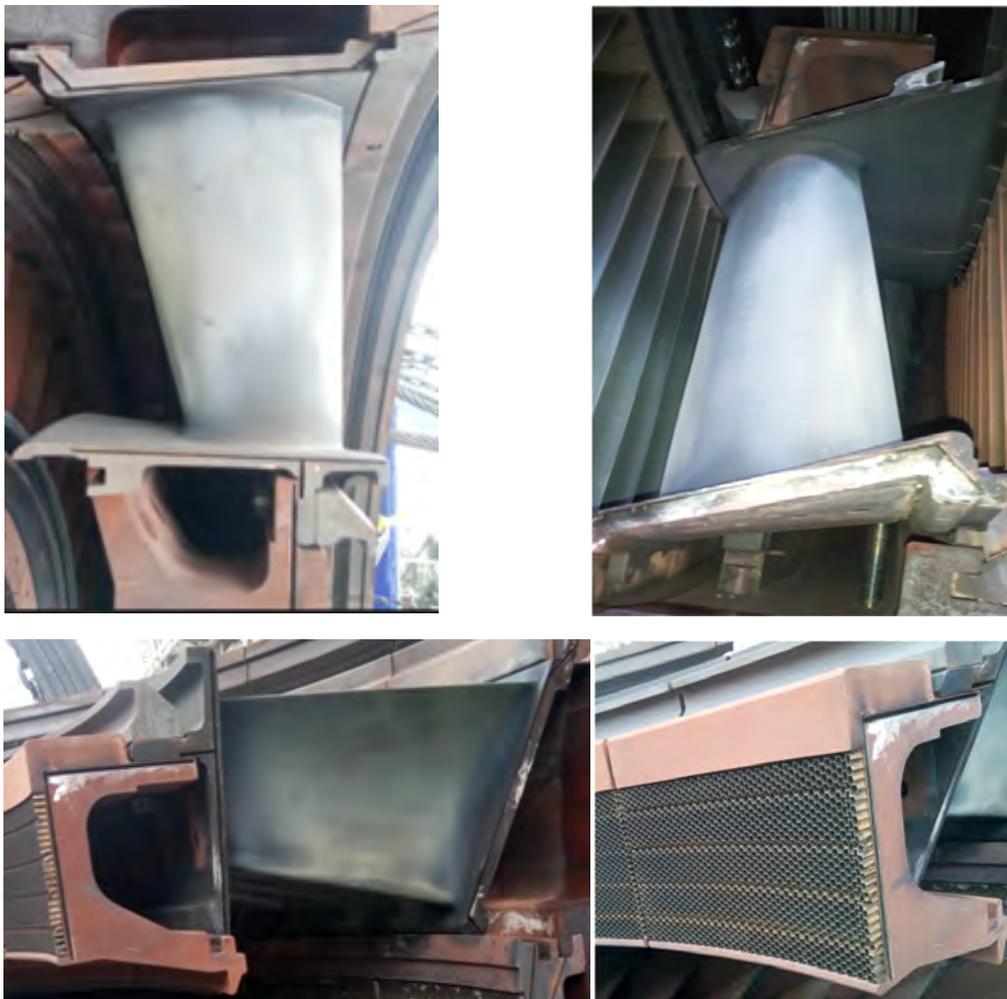
The third stage nozzles were visual checked in situ. No cracks, FOD or missing meta noticed. Light to medium hot corrosion and light oxidation noticed. The set kept in service till next scheduled outage, HGPI. As per OEM guide line repair interval is 1 HGPI and Replacement is 3 HGPI. NSRP to provide total FFH of the set along with refurbishment history to finalize further repairability and use.

Figure 23: Condition of Stage-3 Nozzle

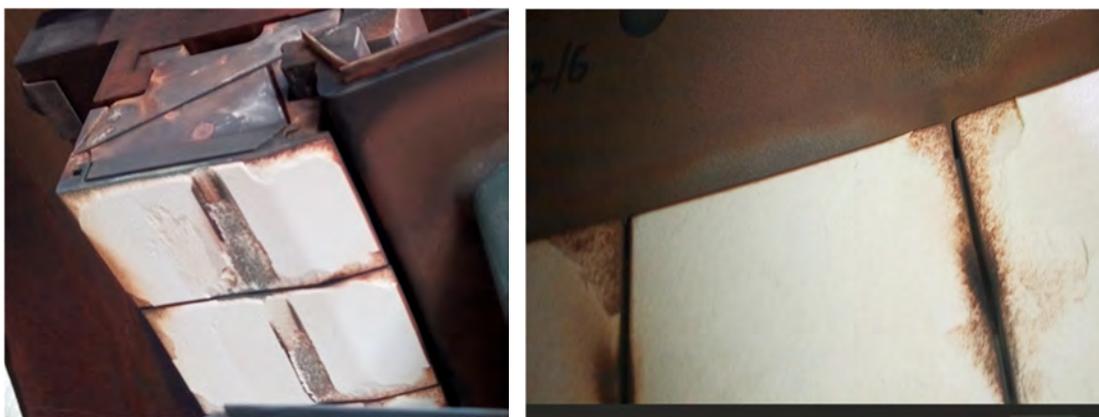
Stage - 1 shroud were visually inspected in situ. No remarkable damages visualized except minor discoloration and coating losses on few segments. Shroud segment 1 & 2 found with minor rub marks. The shroud set retained in service.

Figure 24: Condition of Stage-1 Shroud

As per OEM latest guide line Stage-1 shroud repair interval is 1 HGPI and replacement-3 HGPI. NSRP to keep 1 set Stage-1 shroud along with fixing hardware for upcoming HGPI. Also to provide total FFH and refurbishment history of the shroud set to finalize future repair and use accordingly.

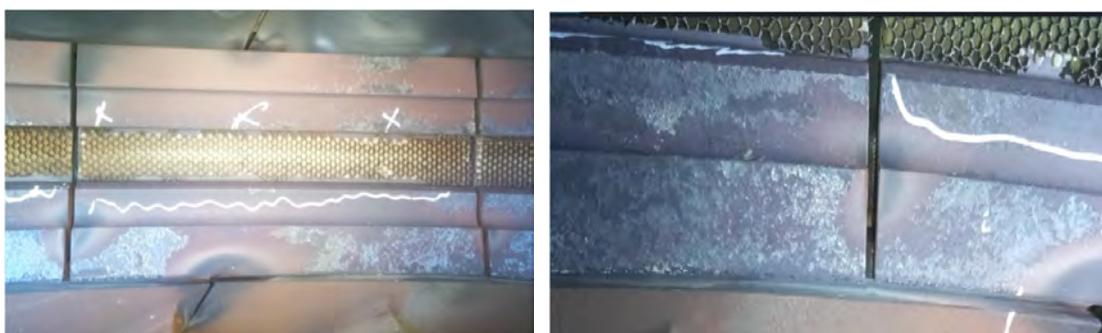
Stage #2 shrouds were inspected visually in situ. Medium to Heavy corrosion and oxidation noticed on all the segments. Loss of honey comb also found in few segments. The shroud set should be replaced in upcoming HGP inspection. NSRP to keep one set of stage-2 shroud in stock along with hard ware for upcoming HGP inspection. NSRP also to provide total FFH and refurbishment history of the existing set to finalize future repair and use possibilities. This will help better spare management.

Figure 25: Condition of Stage-2 Shroud
