GAS TURBINE INSPECTION REPORT

Combustion Inspection

Gas Turbine Model: GE 6FA.03, MNQC
Unit: GTG2 (Serial Number: 875123)
Plant: Nghi Son Refinery and Petrochemical, LLC

Report Date: July, 2025

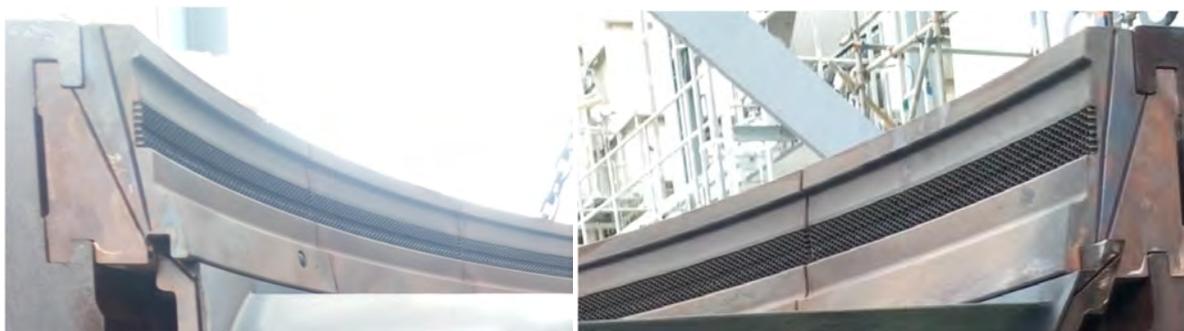
Stage #3 shrouds were inspected visually in situ. No remarkable defects noticed except normal hot corrosion and bucket rail groove on honeycomb face. The shroud set kept in service till upcoming HGP Inspection.

Figure 26: Condition of Stage-3 Shroud

NSRP to keep one set of Stage-3 shroud set in stock for upcoming HGPI along with fixing hardware. Also to provide total FFH and refurbishment history of the existing set to finalize repair prospect for future use accordingly.

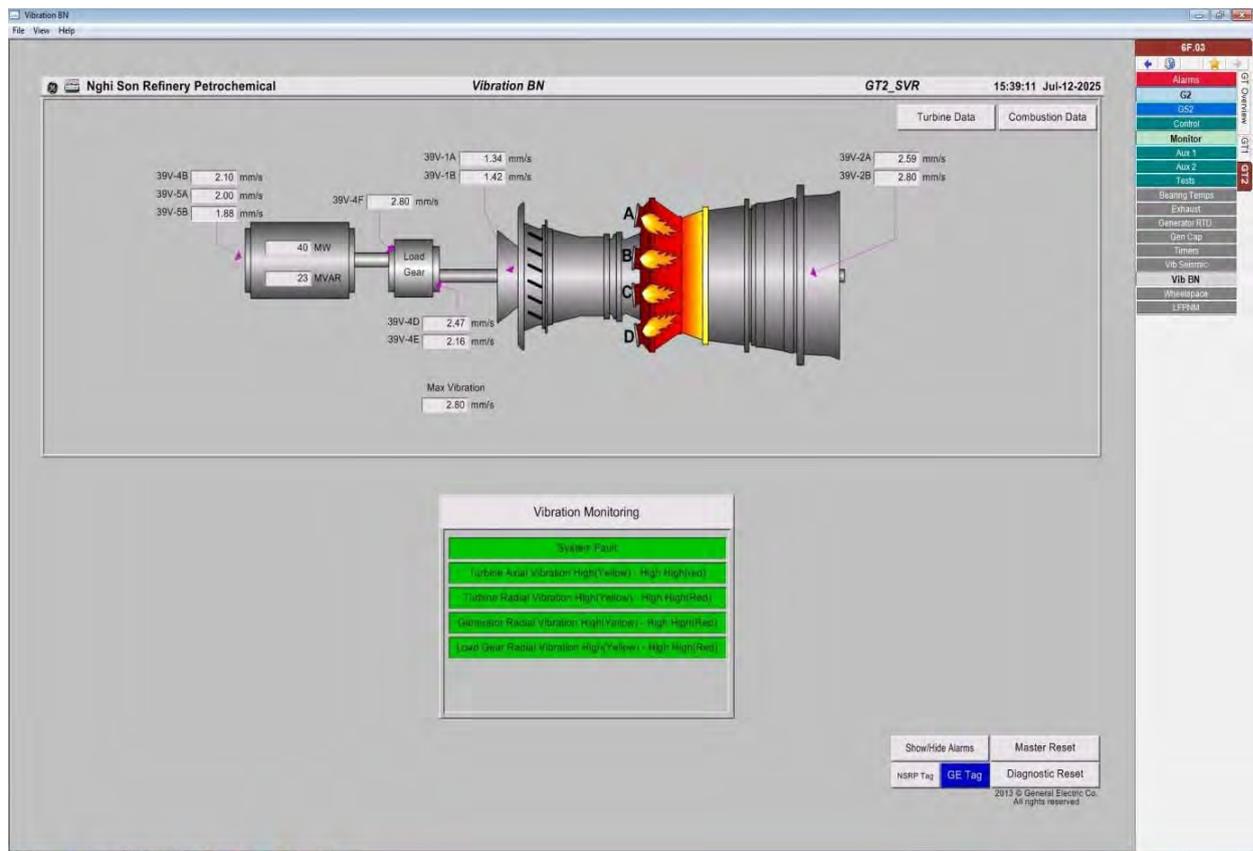
40 MW Screenshot

- Turbine axial (BN) vibration high during load transfer from 40 MW to 50 MW.
- Investigate root cause—check rotor balance, bearing clearances, shaft alignment, and damping system—and implement corrective actions during the next Major Overhaul.
