# INCOMING INSPECTION REPORT

| <b>Customer P.O. No.</b> | WO1003946086 | <b>Report Date</b> | April 30, 2026 |
| <b>Engine Type</b> | MS6001FA (GE Frame 6FA) | <b>Component</b> | MS6001FA Transition Piece |

| <b>Work Order:</b> WO1003946086 | <b>MS6001FA TRANSITION PIECE</b> |

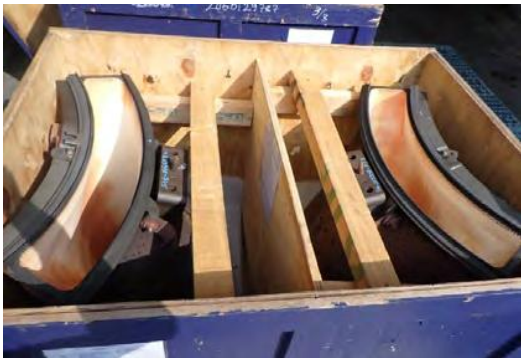
Fig.1 As-received condition.

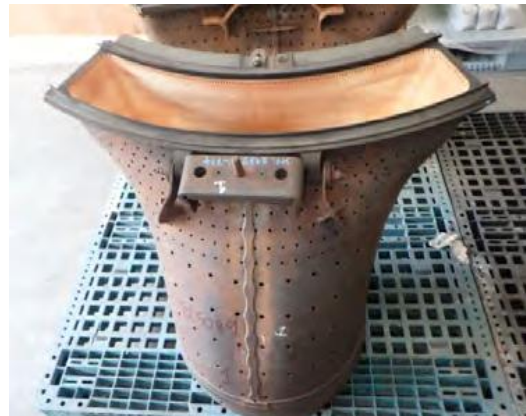
Fig.2 As-received condition.

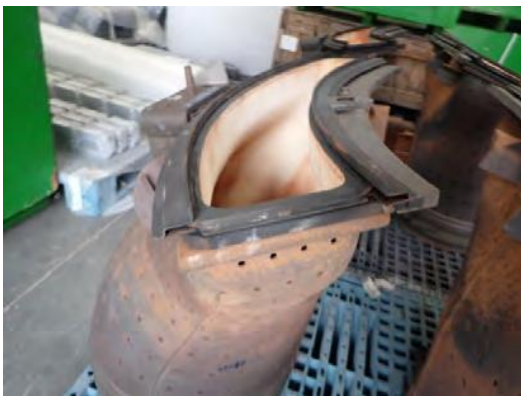
Fig.3 As-received condition.

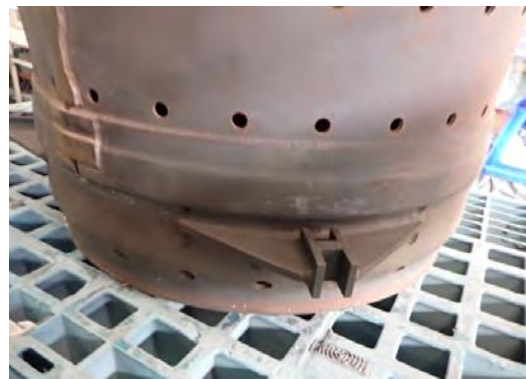
Fig.4 As-received condition.

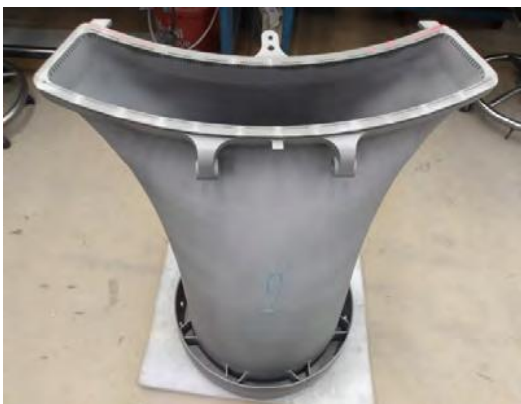
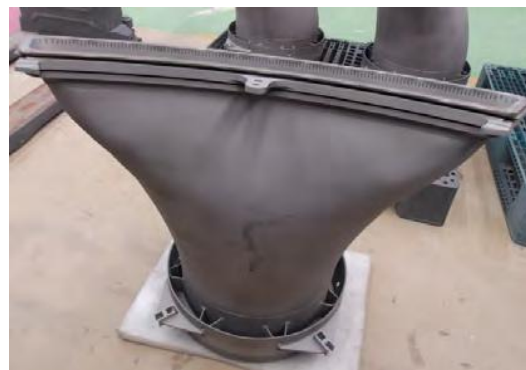
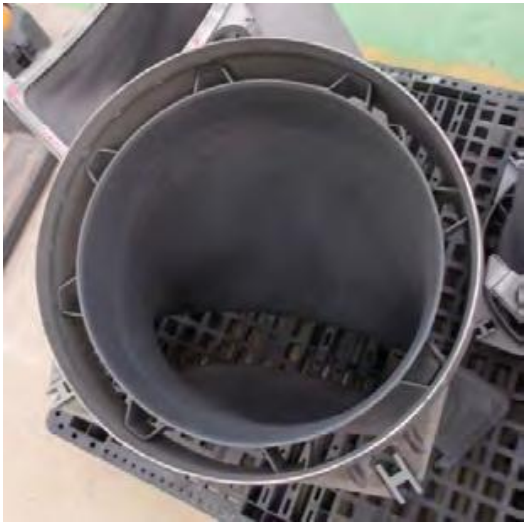
Visual inspection and fluorescent penetrant inspection confirmed that the transition piece bodies show no structural cracking, heavy corrosion, or base metal loss across all six units. The internal and external body surfaces exhibit normal oxidation consistent with the operational history, which will be removed by blending during repair. Wall thickness measurements are within acceptable limits across the complete set, confirming that no weld build-up to the main body is required. The base material was confirmed as Nimonic 263 by metallurgical evaluation, with a stable microstructure suitable for weld repair and heat treatment. This structural soundness of the primary pressure-containing body is the

Fig.5 Typical condition of body.

Fig.6 Typical condition of body.

Fig.7 Typical condition of body.

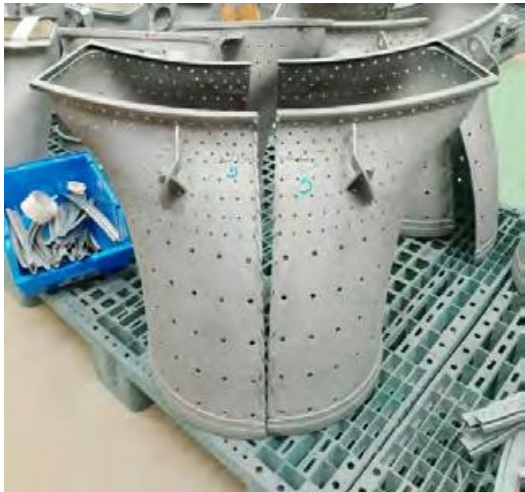
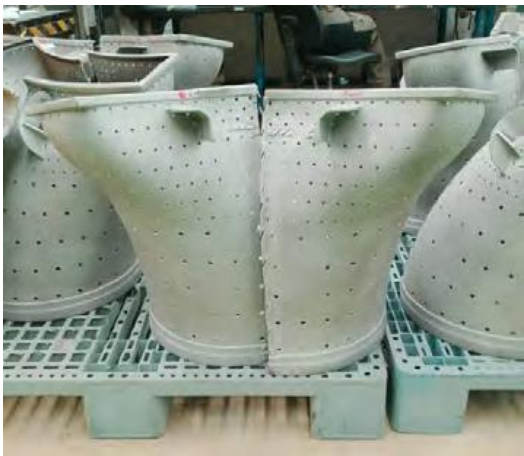
Fig.8 Typical condition of impingement sleeve.

Fig.9 Typical condition of impingement sleeve.

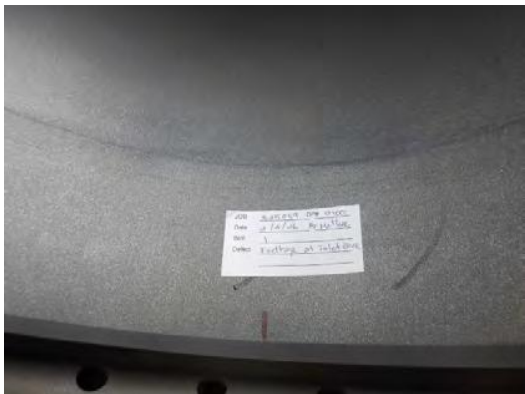
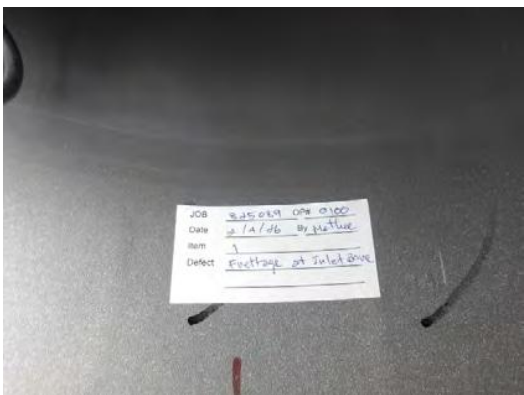
| Damage Category | Finding (As Inspected) | Disposition |
|---|---|---|
| <b>Frettage at Inlet Bore</b> | Light frettage confirmed on all inlet bores across all 6 units. Inlet bore ID and roundness recorded as REJECT on units 1, 4, and 6, with out-of-roundness up to 4.12 mm. | <b>Blend Repair</b> |

Fig.10 Fretting on inlet bore.

Fig.11 Fretting on inlet bore.

| No. | Defect / Condition | Location / Affected Items | Repair Method | Action |
|---|---|---|---|---|
| 1 | Frettage at inlet bore | Light frettage confirmed on all 6 inlet bores. Inlet bore ID and roundness REJECT on units 1, 4, | Blend Repair | REQUIRED |

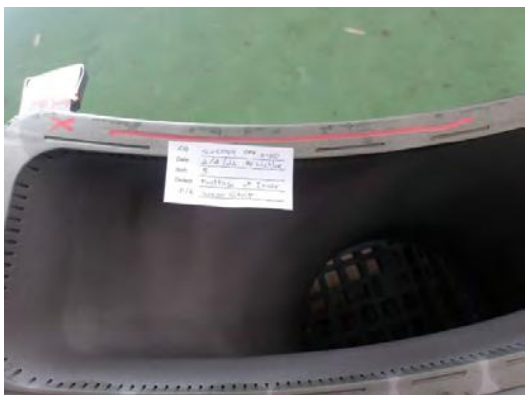
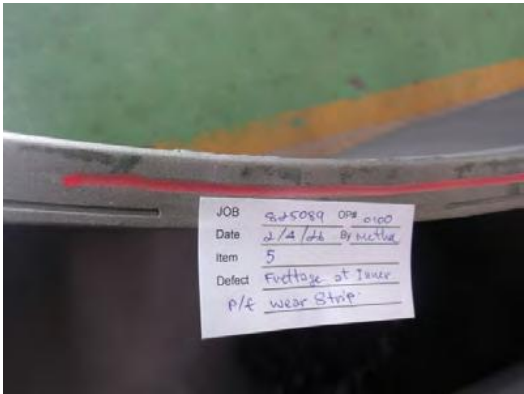
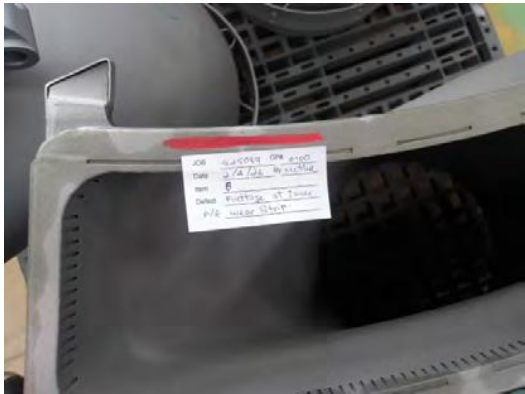
| Damage Category | Finding (As Inspected) | Disposition |
|---|---|---|
| <b>Frettage and Cracking at Inner Picture Frame Wear Strip</b> | Medium frettage confirmed on all inner picture frame wear strips across all 6 units. A 10 mm crack confirmed on unit 6. All inner wear strips require replacement. | <b>Replace / Weld and Blend</b> |

Fig.12 Fretting on inner picture frame wear strip.

Fig.13 Fretage on inner picture frame wear strip.

Fig.14 Fretage on inner picture frame wear strip.

| 3 | <b>Cracking at inner picture frame wear strip</b> | 10 mm crack confirmed on inner picture frame wear strip of unit 6. Medium frettage on all 6 units — all inner wear strips to be replaced. | <b>Replace / Weld and Blend</b> | <b>REQUIRED</b> |

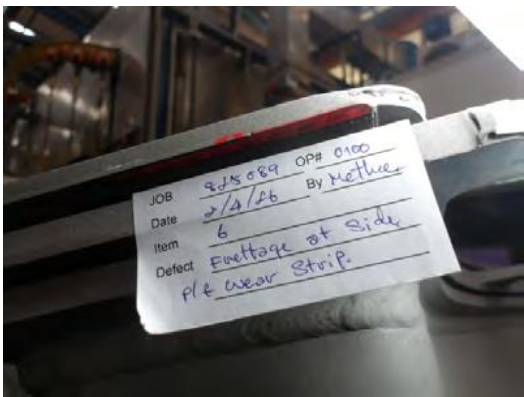
| Damage Category | Finding (As Inspected) | Disposition |
|---|---|---|
| <b>Frettage at Side Picture Frame Wear Strip</b> | Light to medium frettage confirmed on all side picture frame wear strips (2 per unit) across all 6 units. All side wear strips require replacement. | <b>Replace</b> |

Fig.15 Fretage on side picture frame wear strip.

| 5 | <b>Frettage at side picture frame wear strip</b> | Light to medium frettage confirmed on all side picture frame wear strips (2 per unit) across all 6 units. All to be replaced. | <b>Replace</b> | <b>REQUIRED</b> |

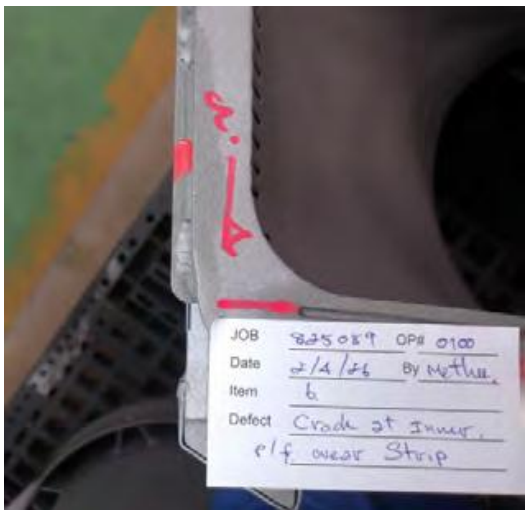
Fig.16 Crack on inner picture frame wear strip.

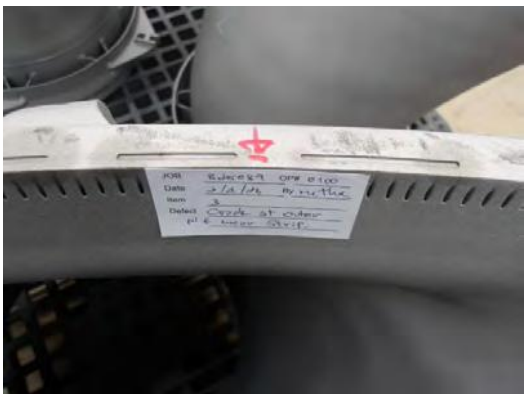
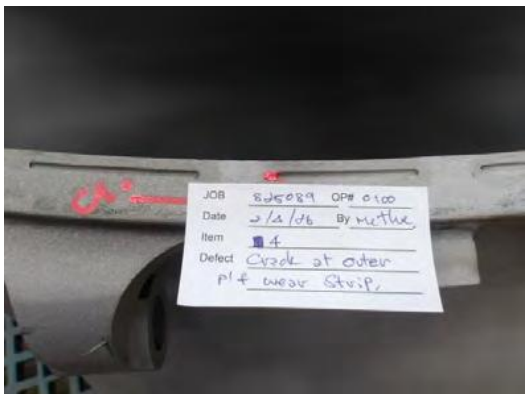
| Damage Category | Finding (As Inspected) | Disposition |
|---|---|---|
| <b>Cracking at Outer Picture Frame Wear Strip</b> | Cracks of 5 to 10 mm confirmed on outer picture frame wear strips of units 1, 3, 4, and 5. Weld and blend repair required at all affected locations. | <b>Weld and Blend</b> |

Fig.17 Crack on outer picture frame wear strip.

Fig.18 Crack on outer picture frame wear strip.

| 4 | <b>Cracking at outer picture frame wear strip</b> | Cracks of 5 to 10 mm confirmed on outer picture frame wear strips of units 1, 3, 4, and 5. | <b>Weld and Blend</b> | <b>REQUIRED</b> |

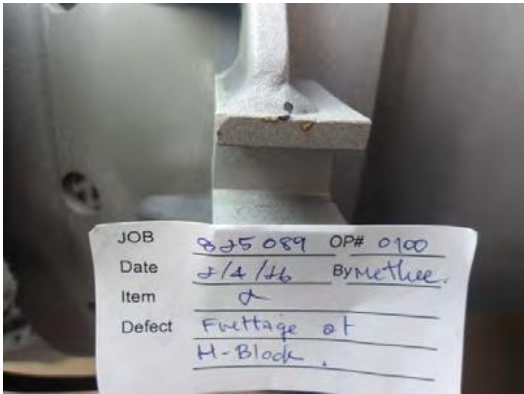
| Damage Category | Finding (As Inspected) | Disposition |
|---|---|---|
| <b>Frettage and Wear at H-Blocks</b> | Light frettage confirmed on all H-blocks (2 per unit) across all 6 units. H-block dimensions remain within acceptable limits. Blend repair sufficient to restore contact surfaces. | <b>Blend Repair</b> |

Fig.19 Fretting on H-Block.

| 6 | <b>Frettage and wear at H-blocks</b> | Light frettage confirmed on all H-blocks (2 per unit) across all 6 units. H-block dimensions within acceptable limits. | <b>Blend Repair</b> | <b>REQUIRED</b> |

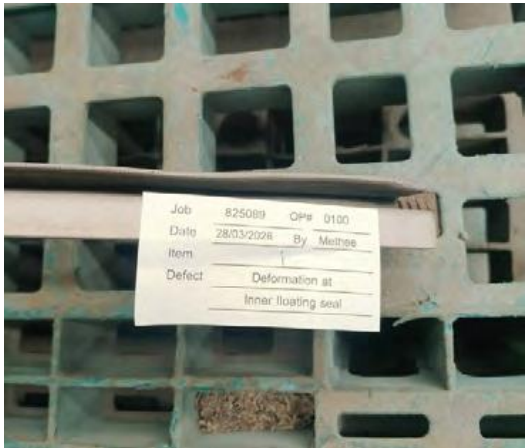
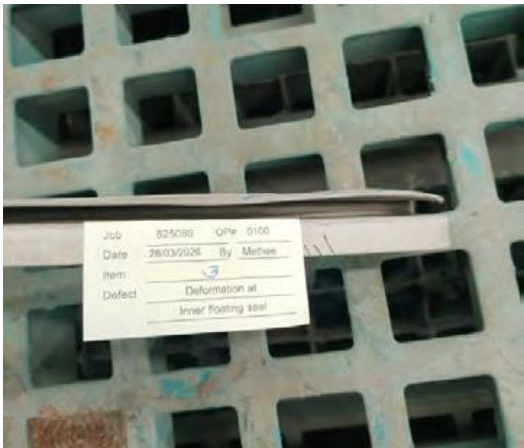
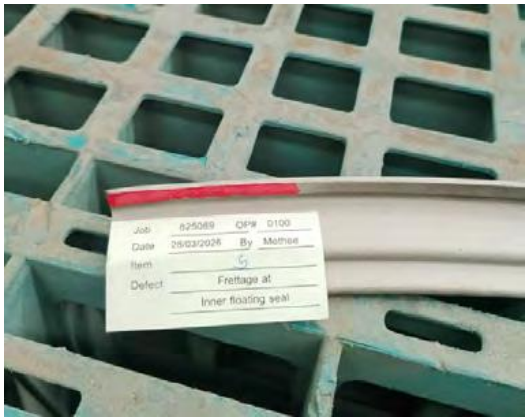
| Damage Category | Finding (As Inspected) | Disposition |
|---|---|---|
| <b>Deformation and Wear at Inner Floating Seals</b> | Deformation and wear confirmed on all inner floating seals across all 6 units. All inner floating seals require replacement. | <b>Replace</b> |

Fig.20 Deformation on inner floating seal.

Fig.21 Deformation on inner floating seal.

Fig.22 Fretting on inner floating seal.

| 7 | <b>Deformation and wear at inner floating seals</b> | Deformation and wear confirmed on all inner floating seals across all 6 units. All to be replaced. | <b>Replace</b> | <b>REQUIRED</b> |

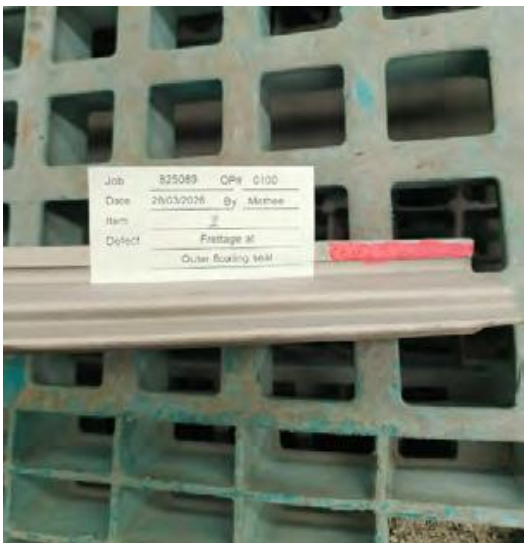
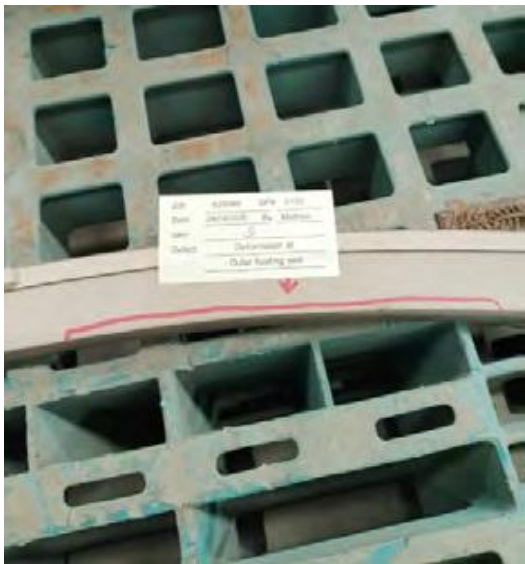
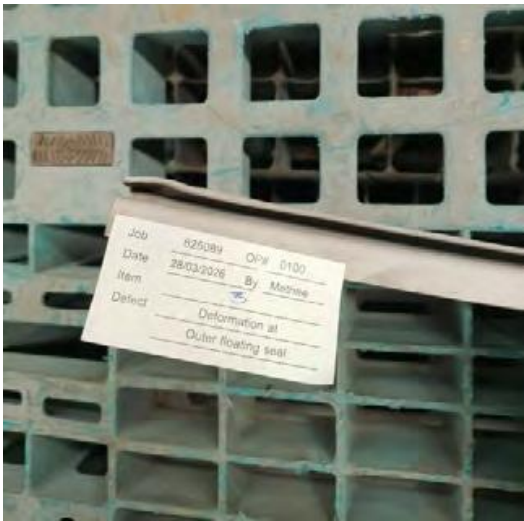
| Damage Category | Finding (As Inspected) | Disposition |
|---|---|---|
| <b>Deformation and Wear at Outer Floating Seals</b> | Deformation and wear confirmed on all outer floating seals across all 6 units. All outer floating seals require replacement. | <b>Replace</b> |

Fig.23 Fretting on outer floating seal.

Fig.24 Deformation on outer floating seal.

Fig.25 Deformation on outer floating seal.

| 8 | <b>Deformation and wear at outer floating seals</b> | Deformation and wear confirmed on all outer floating seals across all 6 units. All to be replaced. | <b>Replace</b> | <b>REQUIRED</b> |

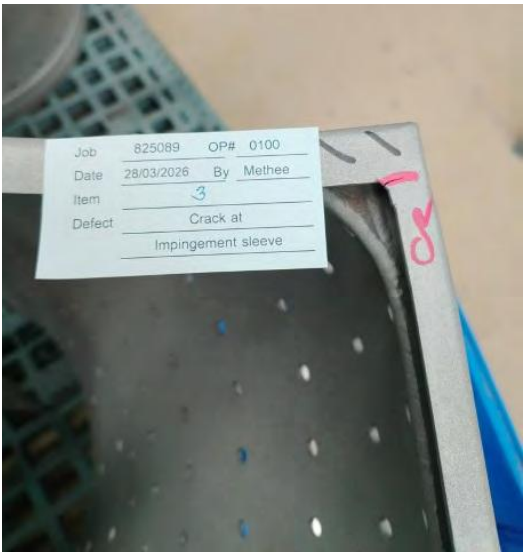
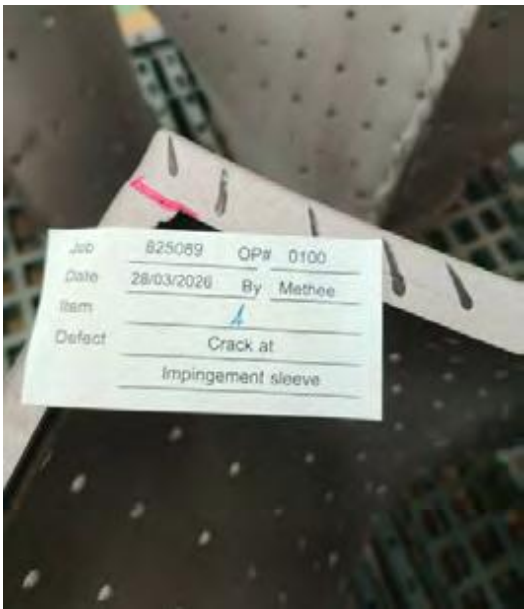
| Damage Category | Finding (As Inspected) | Disposition |
|---|---|---|
| <b>Wear and Cracking at Impingement Sleeve</b> | Light to medium frettage confirmed across all 12 impingement sleeve halves. Cracks of 2 to 5 mm confirmed by FPI across the full set. Weld and blend repair required to restore sleeve profile. | <b>Weld and Blend</b> |

Fig.26 Crack on impingement sleeve.

Fig.27 Crack on impingement sleeve.

| 2 | <b>Wear and cracking at impingement sleeve</b> | Light to medium frettage and cracks of 2 to 5 mm confirmed across all 12 impingement sleeve halves on all 6 units. | <b>Weld and Blend</b> | <b>REQUIRED</b> |

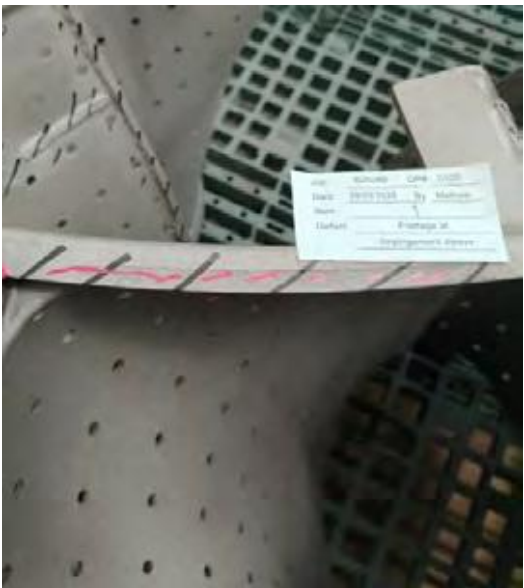
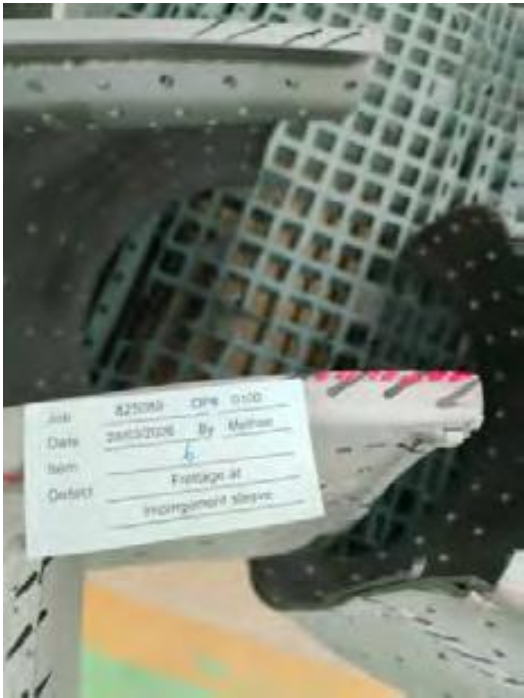
Fig.28 Fretting on impingement sleeve.

Fig.29 Fretting on impingement sleeve.

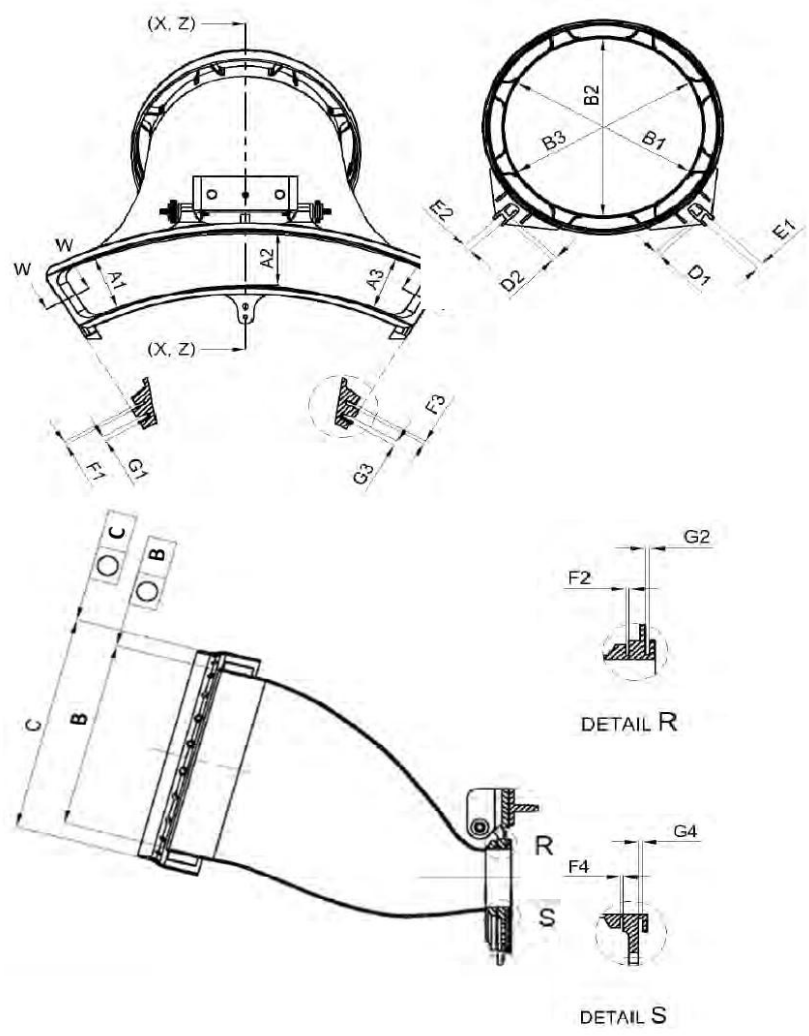
12. DIMENSION INSPECTION

Roundness values shown in red exceed acceptable limits: exit end (C) roundness on all six units, inlet bore (B) roundness on units 1, 4, and 6. These recorded deviations drive the full-set cold press and dimensional restoration requirement supporting the Level 7 classification.
