# INCOMING INSPECTION REPORT

## MS6001FA (GE Frame 6FA) Combustion Liner MNQC — Complete Set

| Engine Type | MS6001FA (GE Frame 6FA) | Component | Combustion Liner MNQC |
| Component Part No. | 119E9620G001 | Qty. Received | 6 units (1 complete set) |

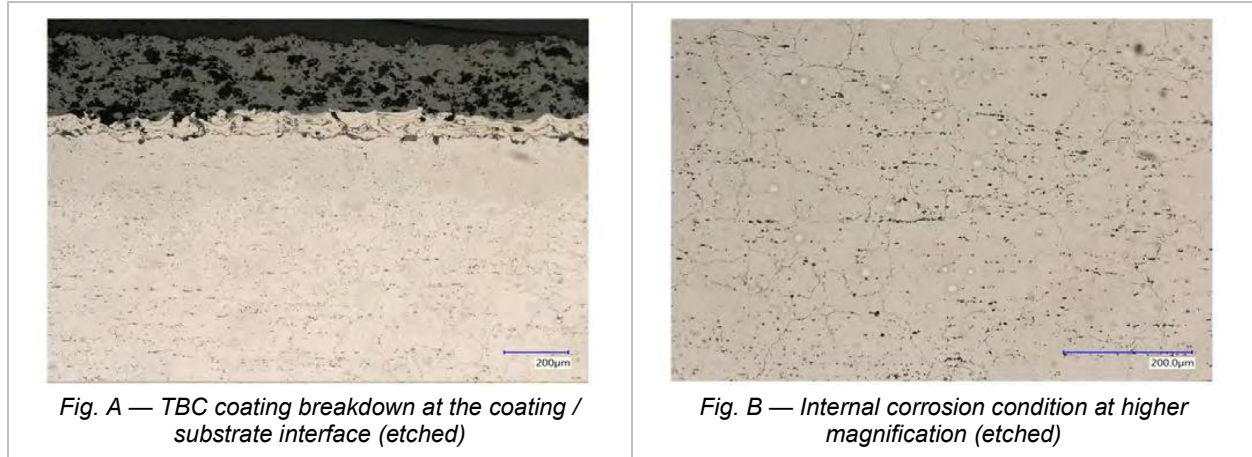
Specimen UNEW-ME-825088-01 was prepared from material sectioned from the liner body of Item 2, one of the most affected areas in the set, and examined metallographically. The base material was confirmed as Hastelloy-X, with composition consistent with the nominal specification. The examined internal surface shows coating breakdown at the coating and substrate interface (Fig. A) and internal corrosion and oxidation (Fig. B). The base metal microstructure shows a stable gamma matrix with normal carbide distribution.

Material conclusion: the alloy identity and microstructure support weld repair after controlled removal of affected surface material, approved weld procedures, post-weld heat treatment, NDT verification, dimensional acceptance, and coating restoration. The material evaluation therefore supports repair rather than scrap. It does not support a Standard or Medium classification, because the surface condition, the coating-interface damage, the welding scope, and the full-set dimensional rejections recorded in Sections 2, 6, and 7 remain in force regardless of the acceptable base microstructure.

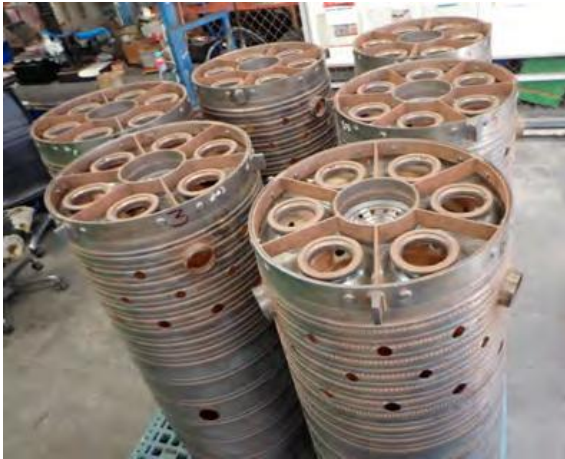
*Fig. 1 — As-received liner set condition*

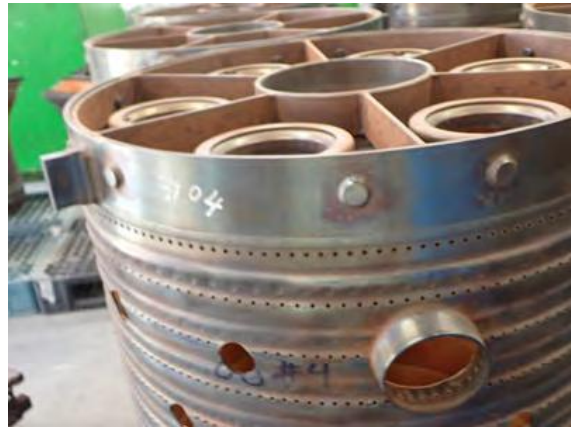
*Fig. 2 — As-received body and cowl cap condition*

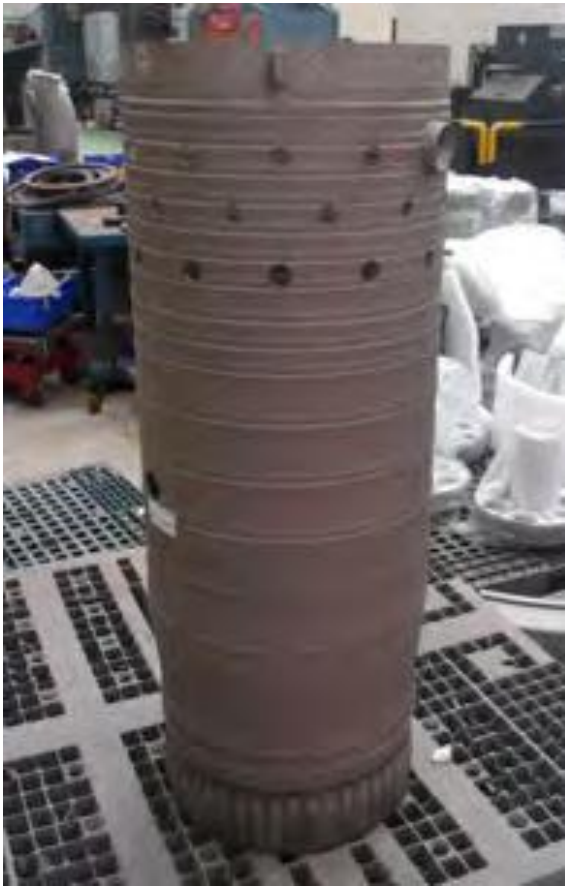
*Fig. 3 — Typical liner body condition*

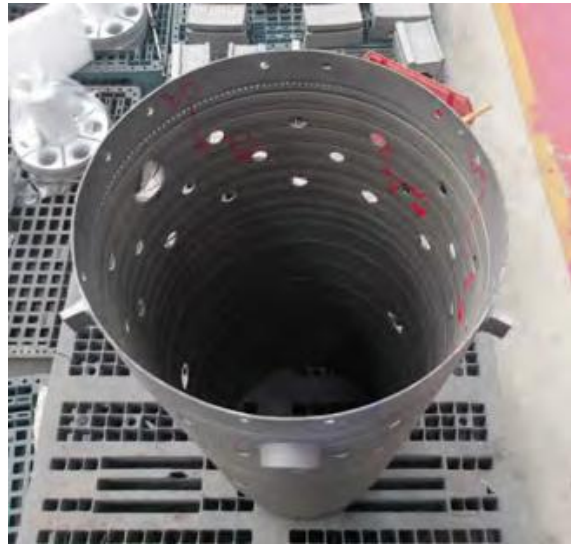
*Fig. 4 — Internal body surface condition*

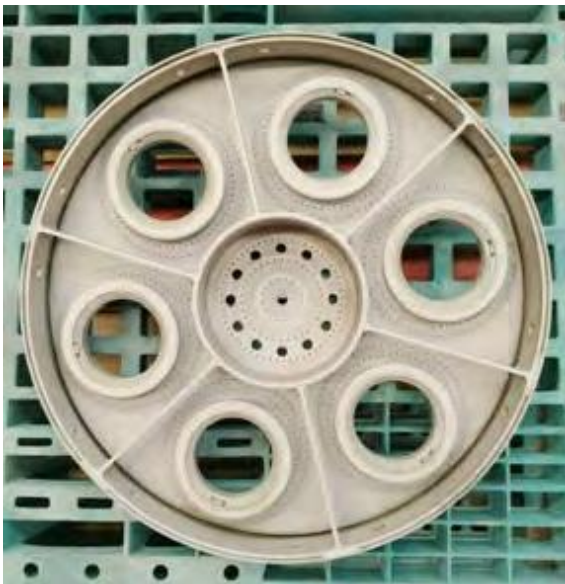
*Fig. 5 — Degraded cowl cap condition*

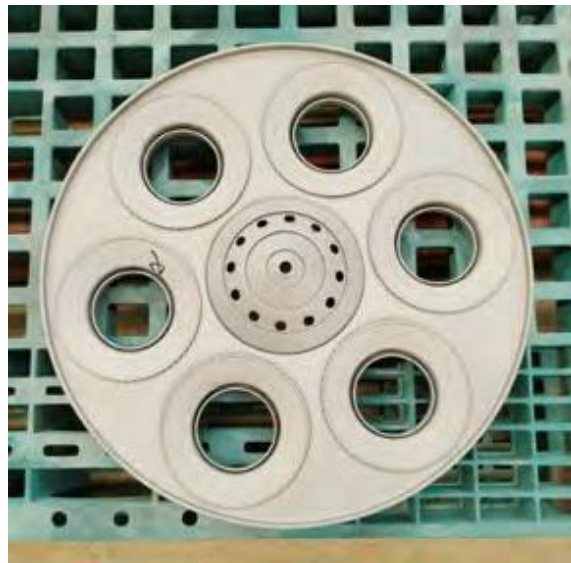
*Fig. 6 — Degraded cowl cap condition*

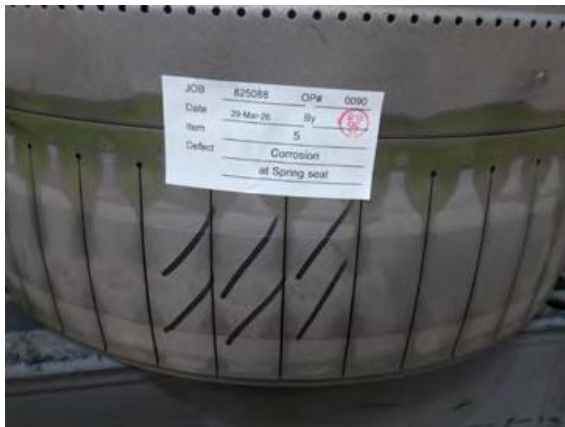
Fretting and wear are recorded at the sealing and fit-up interfaces. The per-item record (Section 7) shows: spring seal wear on 6 of 6 liners; collar retainer wear on 6 of 6 liners; floating collar wear on 6 of 6 liners (six collars per liner); crossfire collar fretting recorded across the set (two collars per liner); and liner stop wear on 4 of 6 liners (Items 1, 3, 5, 6). These locations are sealing, location, and fit-up features; damage at these features carries a higher severity weight than the same damage at a non-critical area.

Fig. 7 — Fretting on spring seal

The repair route at these interfaces is: replacement of the wear hardware itself with new parts (Section 8), blend repair of the liner-side mating surfaces to the location blend limits, weld repair where blend limits would be exceeded, and dimensional fit-up verification. The Heavy Repair

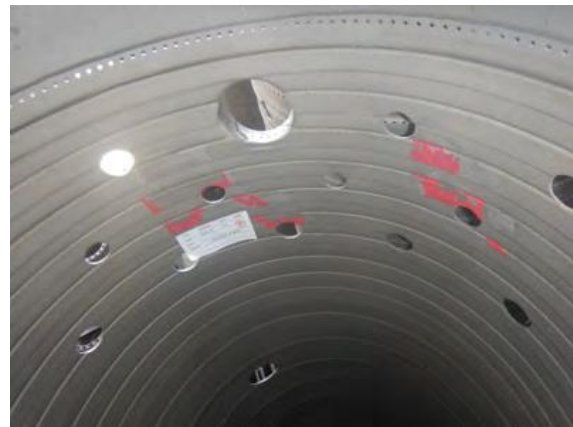
Corrosion and coating-interface degradation are recorded on the internal combustion surfaces across the set (disposition B/WB on 6 of 6 liners). General wall-thickness readings were recorded as ACCEPTABLE at the incoming stage. These two records are consistent and both stand: the acceptable wall-thickness result means the liners are not classified as scrap; it does not remove the Heavy Repair requirement, because the surface condition, the cracking record, the coating breakdown, and the full-set dimensional rejections control the repair level independently of wall thickness. Localized areas of corrosion-affected material require controlled removal and local weld build-up before coating, with ultrasonic wall-thickness verification repeated after repair.

Fig. 8 — Corrosion on internal body

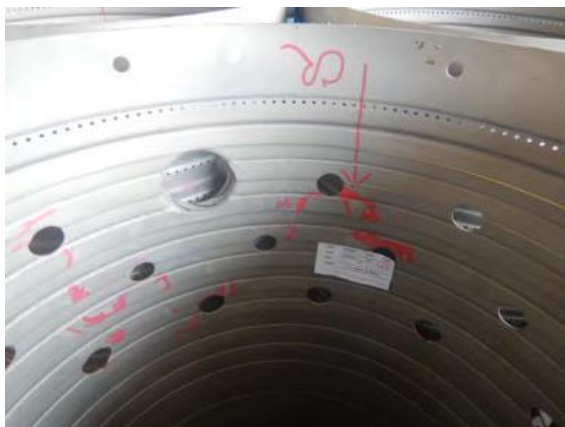
Fig. 9 — Multiple corrosion areas on internal body

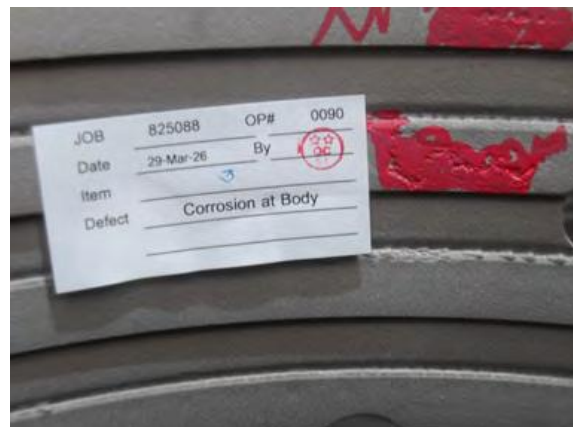
Fig. 10 — Corrosion across liner body

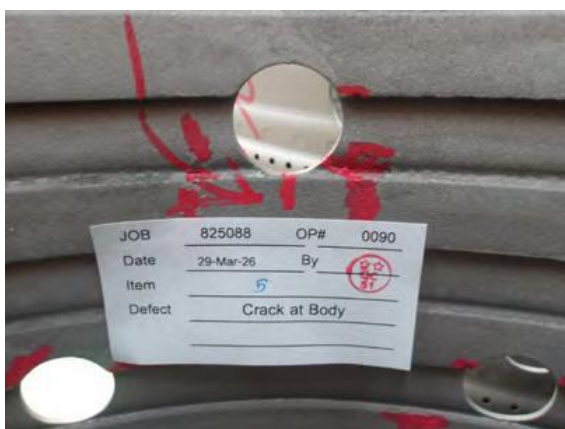
Visual inspection and fluorescent penetrant inspection (FPI) recorded body cracking on all six liners. Cracks of 2 to 4 mm are located in high-temperature combustion zones and extend beyond surface level. The recorded disposition is Weld and Blend (WB) on 6 of 6 liners: cracked material must be fully excavated and reconstructed by GTAW weld repair. A 2 mm cowl cap crack is recorded on Item 5, and one floating collar crack is recorded on Item 5. These findings cannot be corrected by local blending.

Fig. 11 — Crack across liner body

| Step | Process — Applies to All 6 Liners |
|---|---|
| 13 | GTAW weld repair to liner body: all cracked and missing material areas. |

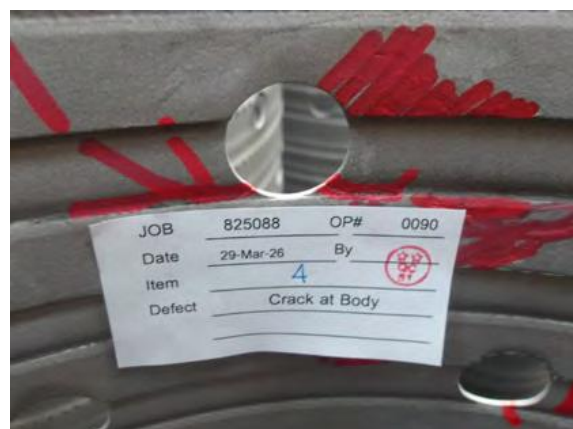
Fig. 12 — Crack across liner body

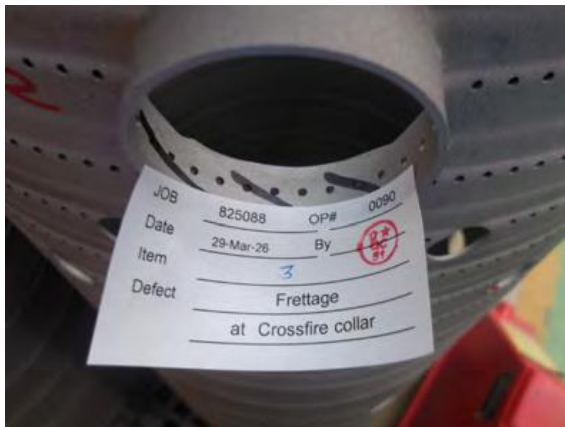
*Fig. 13 — Fretage at crossfire collar*

| Step | Process — Applies to All 6 Liners |
|---|---|
| 14 | GTAW weld repair to crossfire collar locations. |

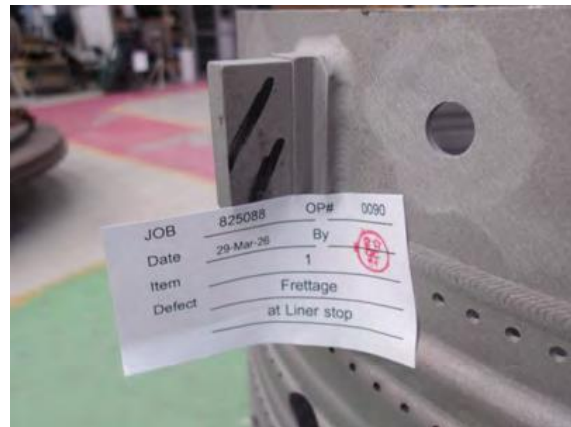
*Fig. 14 — Fretage at liner stop*

| Step | Process — Applies to All 6 Liners |
|---|---|
| 15 | GTAW weld repair to liner stops. |

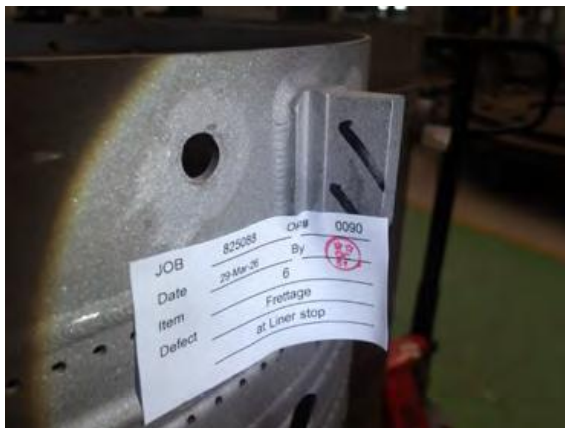
*Fig. 15 — Fretage at liner stop*

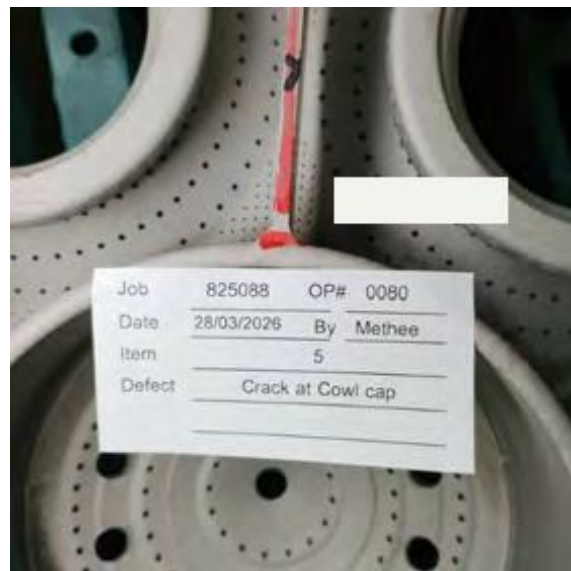
| Inspection Feature | Item 1 | Item 2 | Item 3 | Item 4 | Item 5 | Item 6 |
|---|---|---|---|---|---|---|
| Cowl cap cracking | | | | | WB | |

*Fig. 16 — Cowl cap crack (Item 5)*

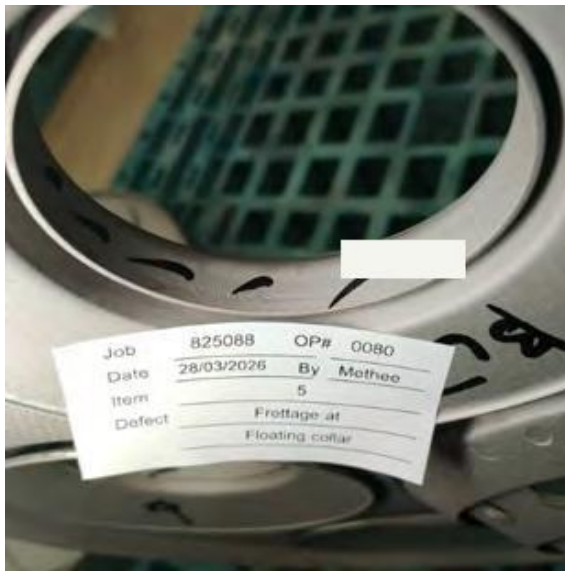
| Inspection Feature | Item 1 | Item 2 | Item 3 | Item 4 | Item 5 | Item 6 |
|---|---|---|---|---|---|---|
| Floating collar wear (qty 6 per liner) | B | B | B | B | B | B |

*Fig. 17 — Floating collar fretage*

| Item | Part Description | Required Quantity | Condition | Remark |
|---|---|---|---|---|
| 5 | Floating collar | 36/36 | Replace | Additional |

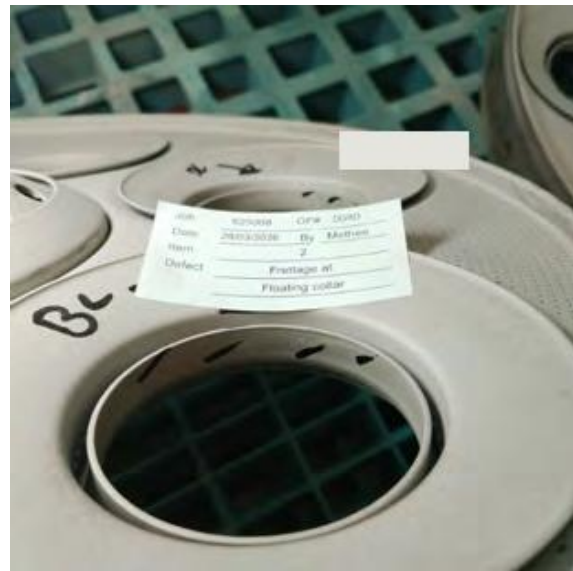
*Fig. 18 — Floating collar fretage*
