## INCOMING INSPECTION REPORT

| Customer | Nghi Son Refinery & Petrochemical, LLC. | Report Date | 27 April 2026 |
| Customer P.O. No. | WO1003986864 | Component | 1st Stage Nozzle |
| Engine Type | MS6001FA (GE Frame 6FA) | Part Number (Ring) | 143E5711G02 |

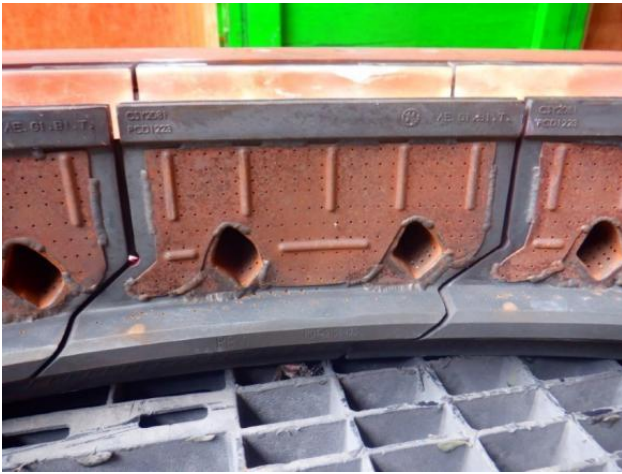
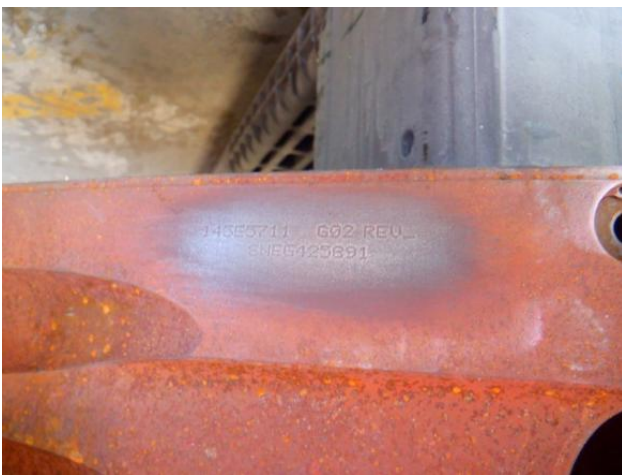
Fig.1 Received as heavy damage condition

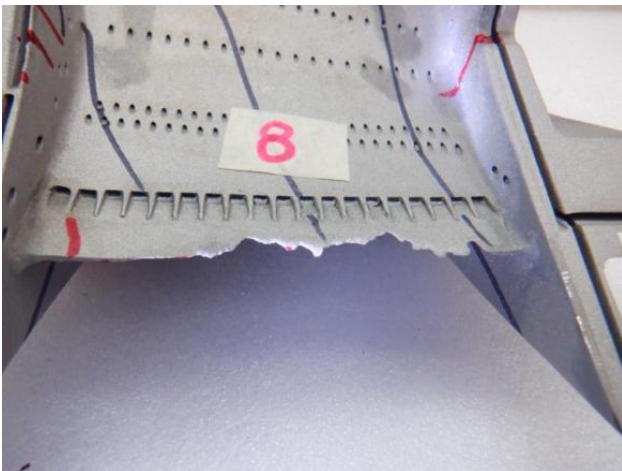
- Trailing edge (T/E): Extensive cracks ranging 5 to 75 mm at the O/D wall and 5 to 25 mm at the I/D wall across all segments (Items 1 to 24). Photographs (Figs. 11 to 13) show severe crack networks with associated heavy corrosion at the trailing edge.

Fig.11 Extensive crack and heavy corrosion on trailing edge

The extent and distribution of cracking present on every single segment of the set require full structural weld repair (GTAW), Transient Phase Restoration (TPR), and subsequent vacuum solution heat treatment.

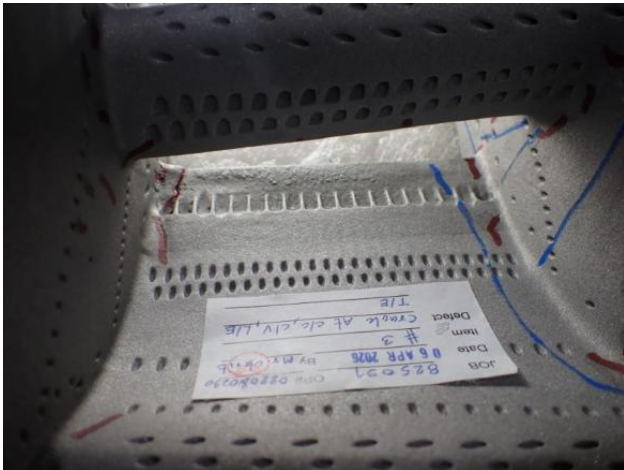
Fig.13 Extensive crack and heavy corrosion on trailing edge

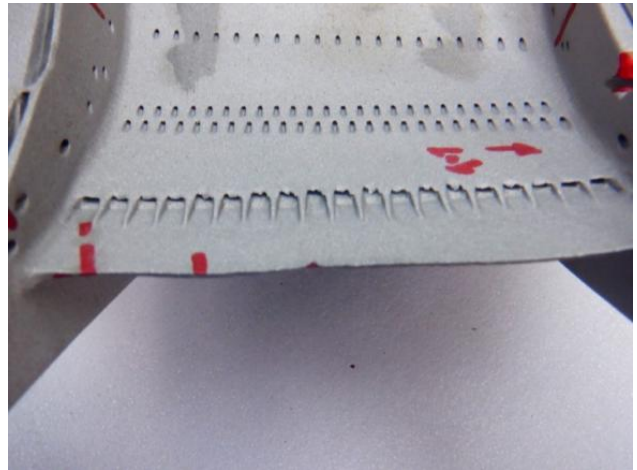
- Heavy corrosion on the concave airfoil face and trailing edge, resulting in critical metal loss and surface pitting (Items 1 to 24).
- Heavy oxidation on the outer shroud (O/D) wall. This is structurally significant as it affects load bearing and sealing surfaces.
- Light to medium corrosion on the I/D wall and non-gas-path surfaces across all 24 segments requiring blending and restoration.

The severity of corrosive attack, combined with trailing edge thinning, is consistent in morphology with Type I or Type II high temperature hot corrosion under severe service exposure. Fuel chemistry and operating history should be reviewed separately if root cause confirmation is required. The resulting material loss is addressed through the Heavy Repair work scope.

Fig.14 Heavy corrosion on concave airfoil and trailing edge

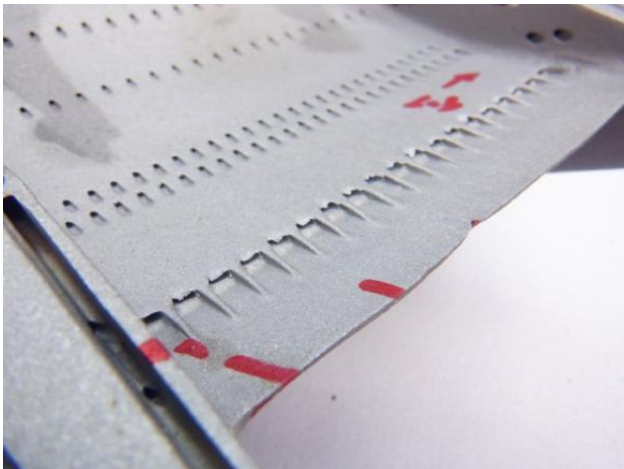
Fig.15 Heavy corrosion on concave airfoil and trailing edge

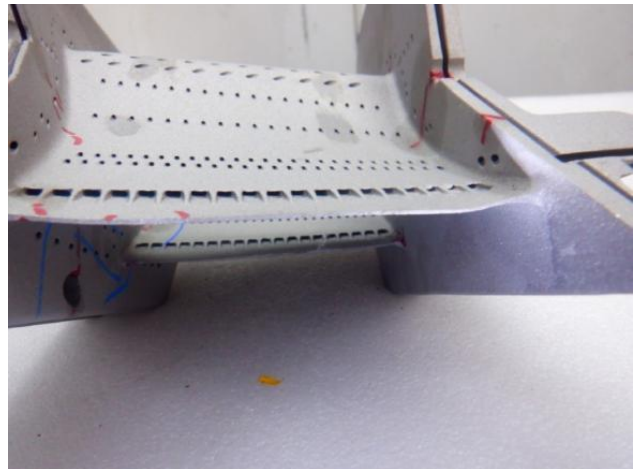
Visible bowing and permanent deformation of the trailing edge walls were documented in Fig. 16, with accompanying annotation confirming the thin wall condition requiring PSP. Cold straightening and planishing will be performed on all affected trailing edge and airfoil sections prior to weld repair.

Fig.16 Critical bowing and thin wall on trailing edge
