# INCOMING INSPECTION REPORT

| <b>Customer P.O. No.</b> | WO1003986864 | <b>Component</b> | MS6001FA 1st Stage Shroud Block |
| <b>Engine Type</b> | MS6001FA (GE Frame 6FA) | <b>Qty. Received</b> | 24 Units (1 Complete Set) |

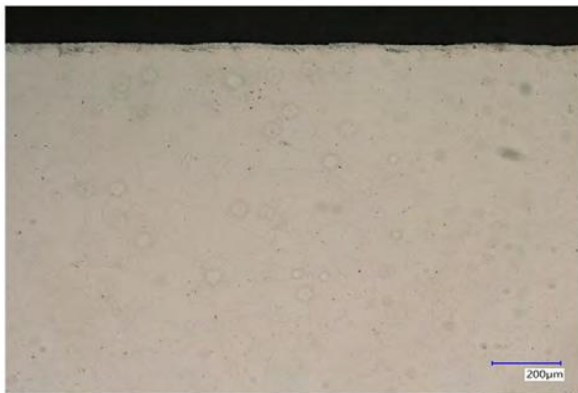
Fig. 1: Hot gas path surface condition (Etched)

The component was evaluated to determine the condition of the base material for repair. The internal combustion surface is uncoated and exhibits surface degradation from service exposure, including localized oxidation, wear, and material loss in high temperature regions. The base material was confirmed as SS310 alloy, consisting of a gamma matrix with primary and secondary carbide distribution along grain boundaries. Abnormal metallurgical transformation is observed in the base material, characterized by coarsened grain boundary carbide networks, secondary phase precipitation, an oxidation-affected surface layer, and localized base metal loss in high temperature regions, indicating degradation of microstructural stability under service conditions (Figs. 1 and 2). The metallurgical findings support the requirement for removal of degraded material, controlled weld repair, and post-weld heat treatment; the material evaluation is not used alone as the repair classification basis and supports the dimensional and structural findings of Sections 3 and 12.

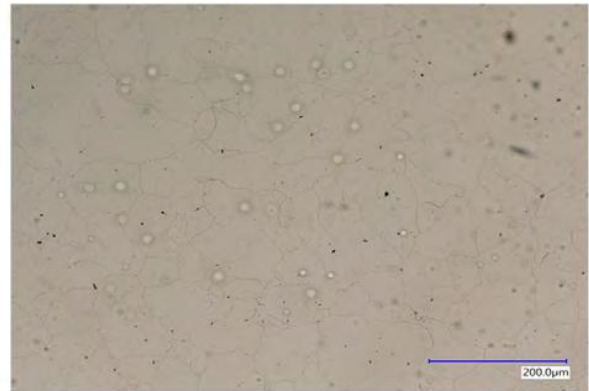
Fig. 2: Typical microstructure at higher magnification (Etched)

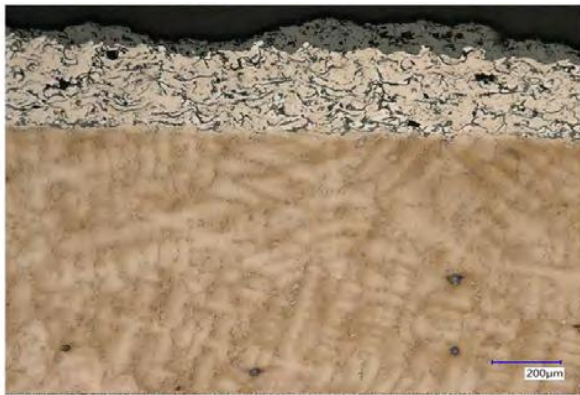
Fig. 1: Hot gas path coating and substrate condition (Etched)

The component was evaluated to determine the condition and suitability of the base material for repair. The internal combustion surface is protected by TBC Abradable coating; inspection confirms coating degradation and localized damage associated with service exposure, including wear and material loss in critical areas. The base material was confirmed as Inconel 738 alloy, consisting of a gamma matrix with fine gamma prime, primary carbide, and dispersed secondary carbide along grain boundaries. Abnormal metallurgical transformation is observed, characterized by coating and substrate interface degradation, gamma prime coarsening consistent with extended high temperature exposure, and localized base metal loss at critical areas, indicating degradation of microstructural stability under high temperature service conditions (Figs. 1 and 2). The metallurgical findings support the requirement for removal of degraded material, controlled weld repair, and post-weld heat treatment; the material evaluation is not used alone as the repair classification basis and supports the dimensional and structural findings of Sections 3 and 12.

surface, or material-loss region shall be completely removed before repair. Damaged areas on the Inconel 738 inner plates shall be restored by controlled weld build-up using compatible high temperature filler material; repaired surfaces shall be machined and contoured to restore original profile, clearance control, and assembly fit-up. Post-weld heat treatment shall be performed to relieve residual stress and stabilize the repaired material. After dimensional verification and FPI confirmation, the repaired surfaces shall be recoated with TBC Abradable coating to restore thermal protection and operating clearance performance. Based on the coating degradation, material loss, and abnormal metallurgical transformation observed, these components require Heavy Repair rather than standard repair.

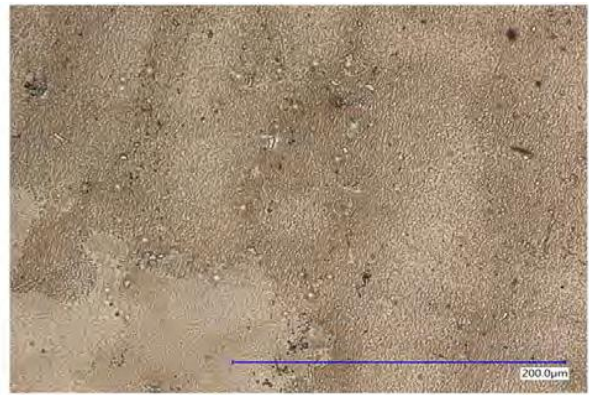
Fig. 2: Typical microstructure at higher magnification (Etched)

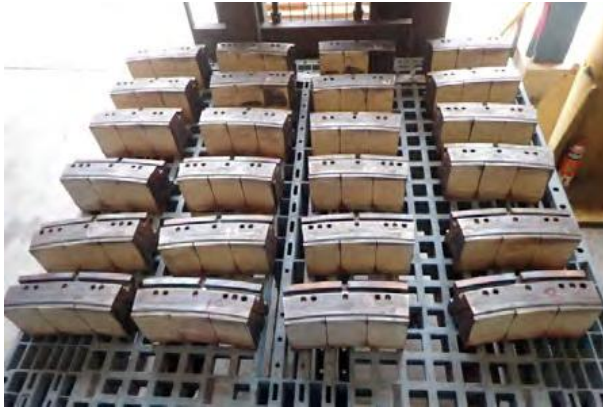
Fig. 1: As-received condition

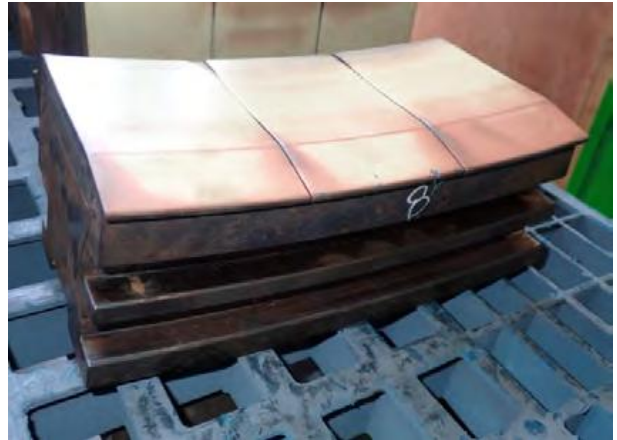
Fig. 2: As-received condition

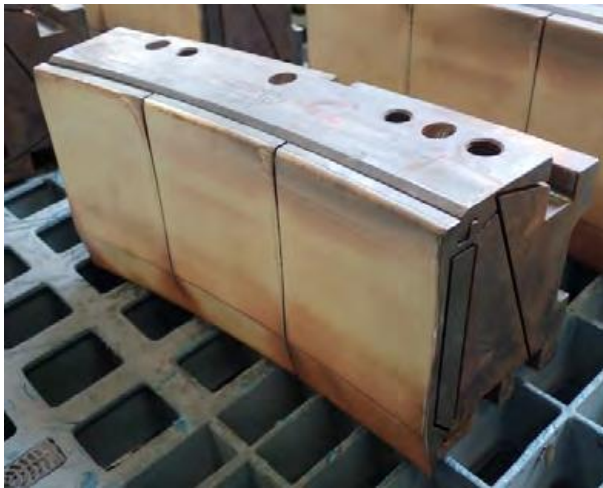
Fig. 3: Heavy damage, as-received condition

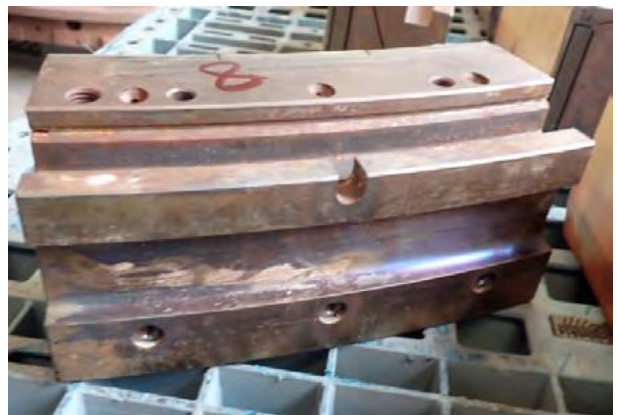
Fig. 4: Heavy damage, as-received condition

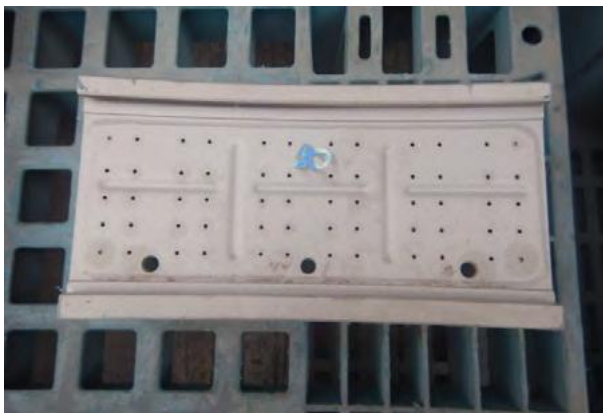
Fig. 5: Tear and wear, shroud block body

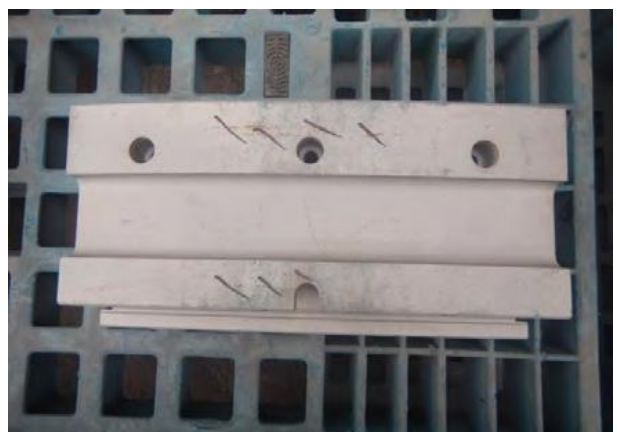
Fig. 6: Tear and wear, shroud block body

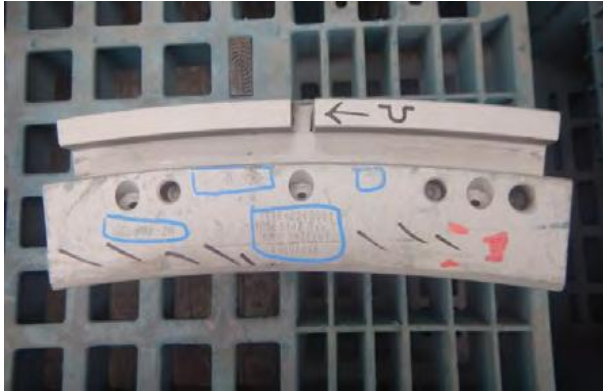
Fig. 7: Heavy wear and surface degradation

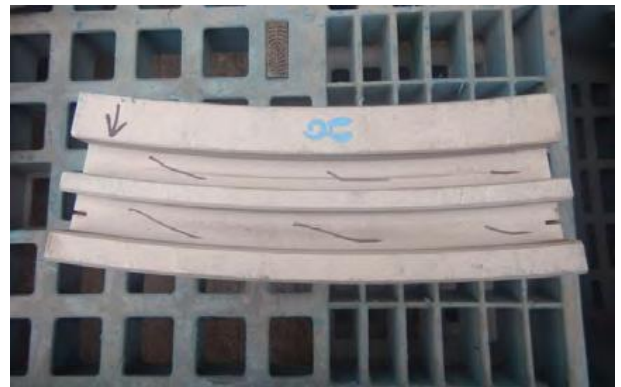
Fig. 8: Heavy wear and surface degradation

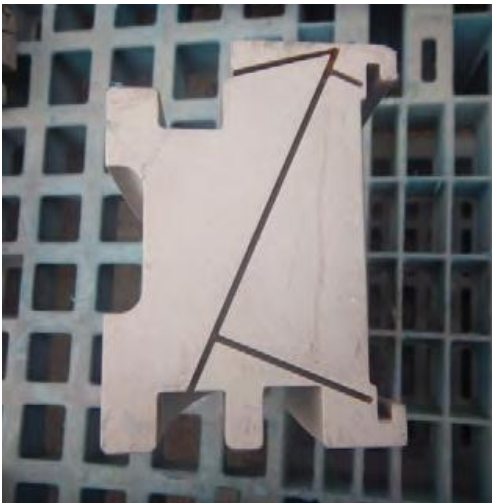
Fig. 9: Heavy tear and wear of shroud block body

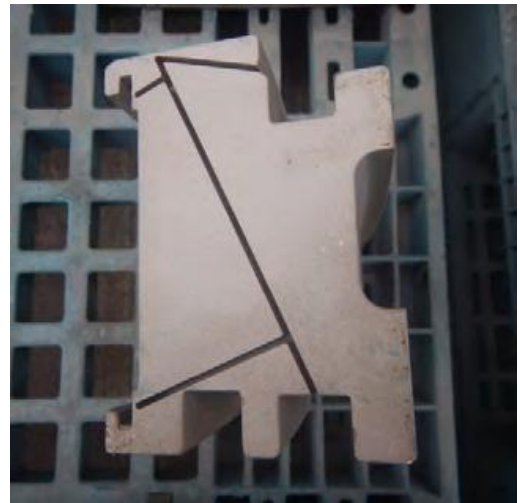
Fig. 10: Heavy tear and wear of shroud block body

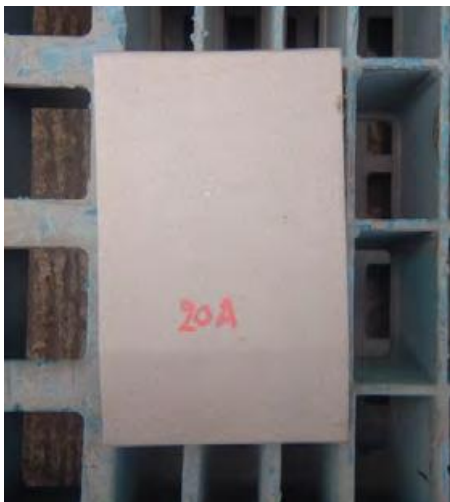
Fig. 11: Severe degradation on tip shoe (inner plate)

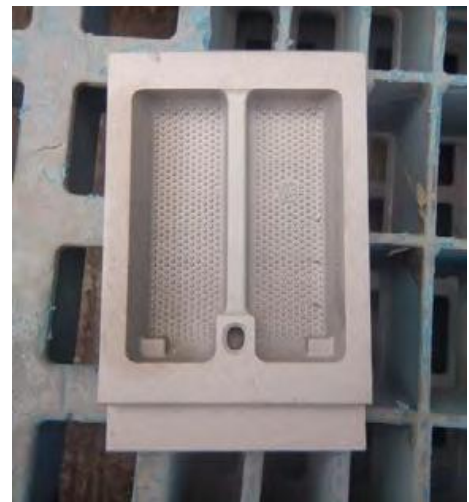
Fig. 12: Severe degradation on tip shoe (inner plate)

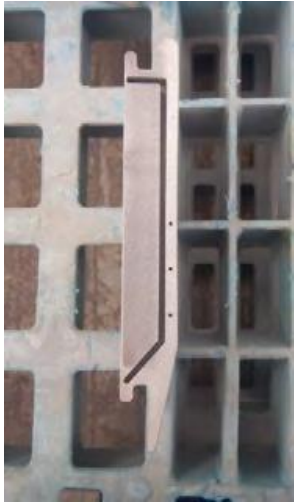
Fig. 13: Severe degradation on tip shoe (inner plate)

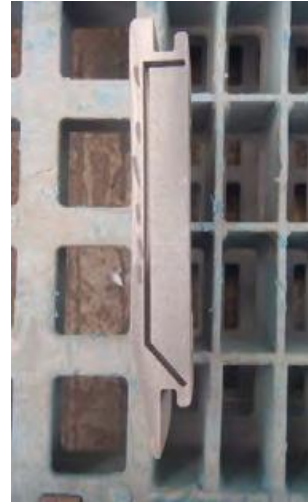
Fig. 14: Severe degradation on tip shoe (inner plate)

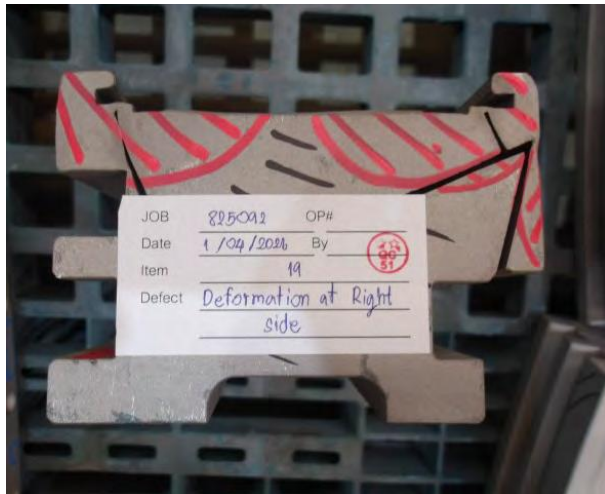
Fig. 15: Heavy deformation on right side, body

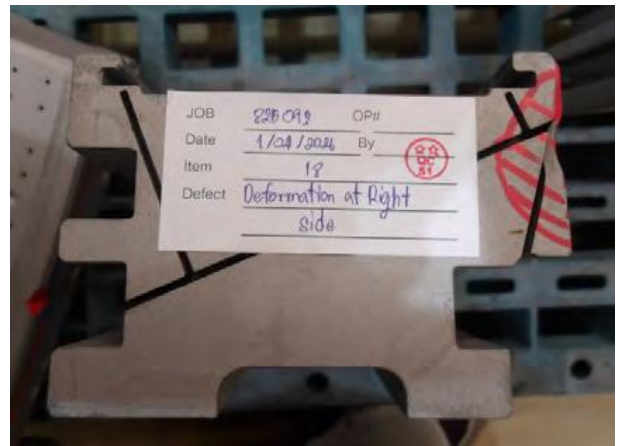
Fig. 16: Heavy deformation on right side, body

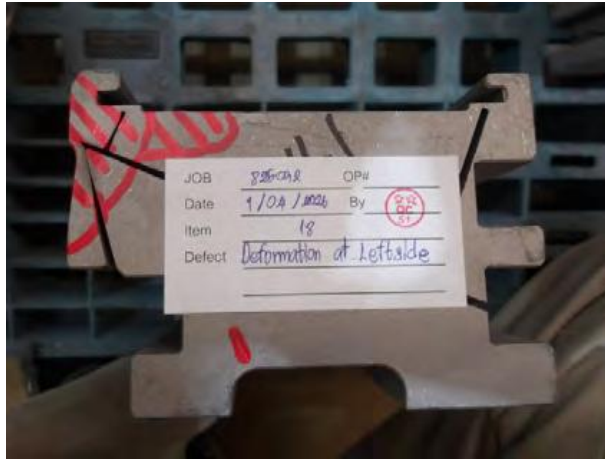
Fig. 17: Heavy deformation on left side, body

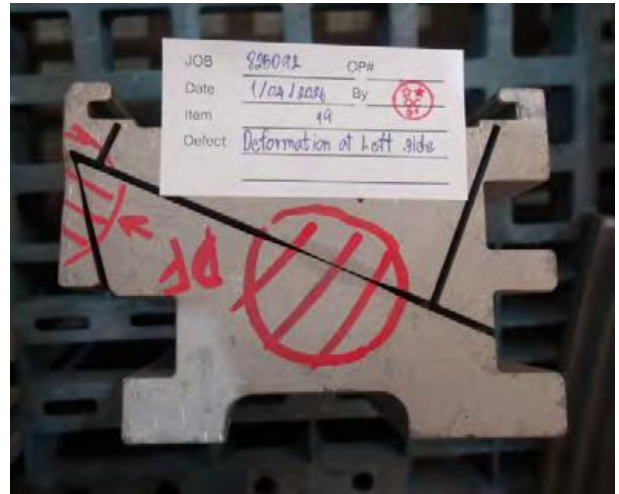
Fig. 18: Heavy deformation on left side, body

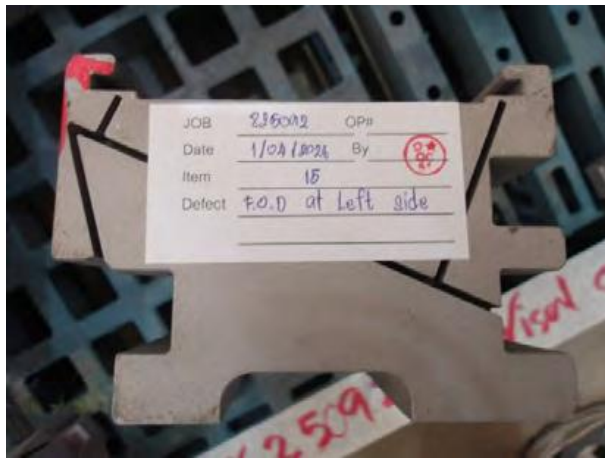
| Damage Category | Finding (As Inspected) | Disposition |
|---|---|---|
| <b>Foreign Object Damage (FOD), Body</b> | FOD confirmed on exposed surfaces of multiple shroud body units, creating localized surface damage and stress concentration points. Combined with fretting, FOD significantly increases the risk of crack initiation during operation. | <b>Blend + Weld Repair</b> |

Fig. 19: Heavy FOD damage on left side, body

| 5 | Foreign object damage (FOD) | Exposed body surfaces; Items 3, 9, 13 to 19, 21 to 24 (Section 11) | Blend and weld repair | REQUIRED |

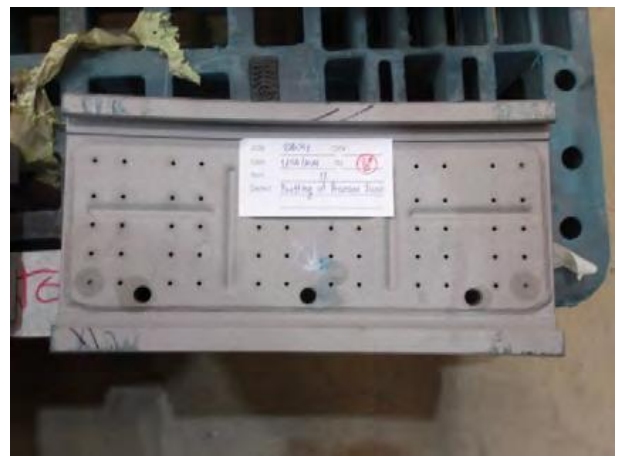
| Damage Category | Finding (As Inspected) | Disposition |
|---|---|---|
| <b>Fretting at Pressure Face, Body</b> | Heavy fretting confirmed on the pressure face across multiple units. Material loss at this surface directly affects load distribution and sealing condition during high temperature operation. | <b>Weld Build-up + Blend</b> |

Fig. 20: Heavy frettage on pressure face, body

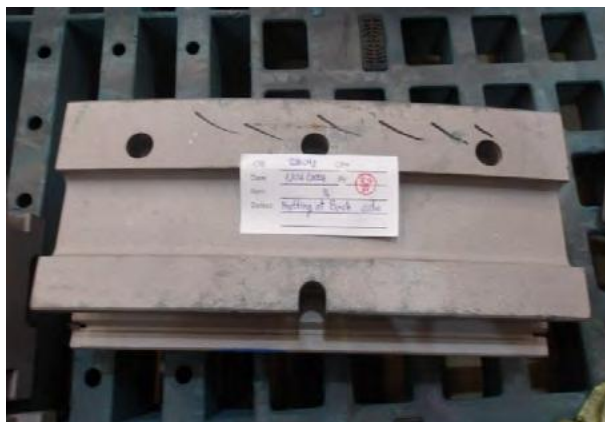
Fig. 21: Heavy frettage on back side, body

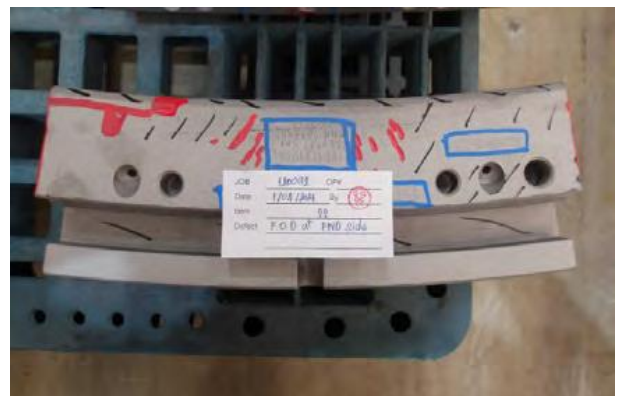
Fig. 22: Heavy FOD damage on FWD side, body

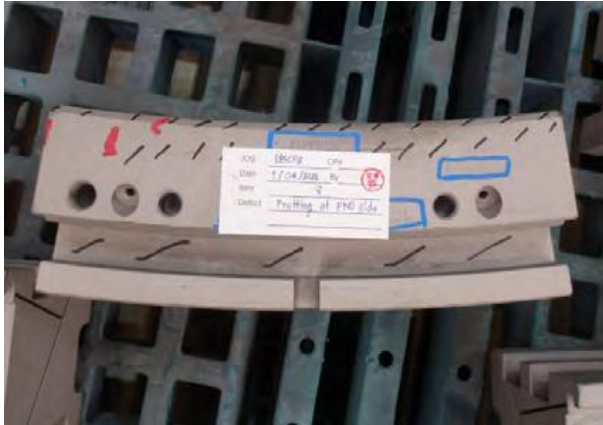
| Damage Category | Finding (As Inspected) | Disposition |
|---|---|---|
| <b>Fretting at FWD and AFT Contact Surfaces, Body</b> | Widespread fretting confirmed on FWD and AFT sides across all 24 shroud bodies. Progressive material loss and deterioration of contact interface geometry at all load-bearing rails. Fretting depth and area exceed the limits of blend repair. | <b>Weld Build-up + Blend</b> |

Fig. 23: Heavy fretage on FWD side, body

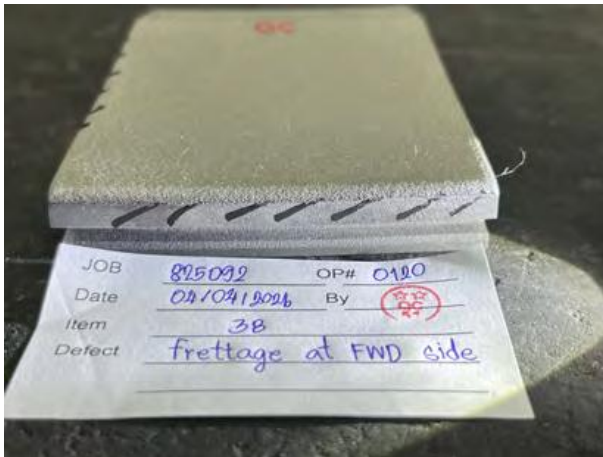
Fig. 25: Heavy fretage on FWD side, tip shoe

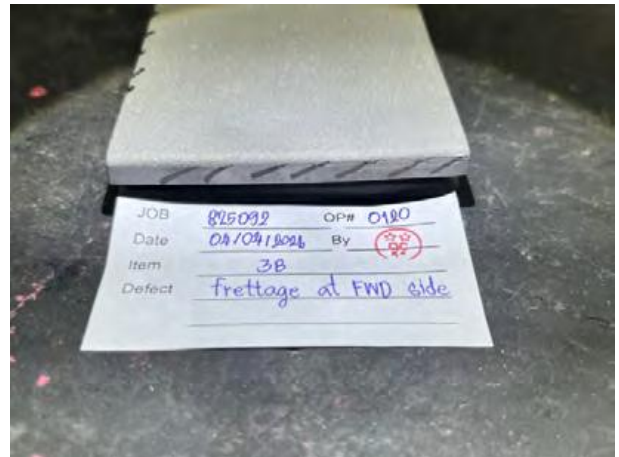
Fig. 26: Heavy fretage on FWD side, tip shoe

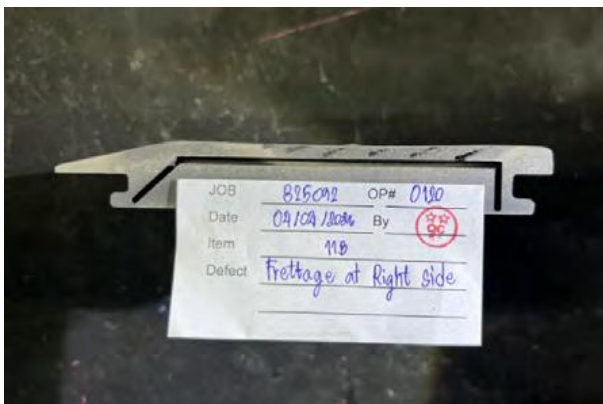
Fig. 27: Heavy fretage on right side, tip shoe

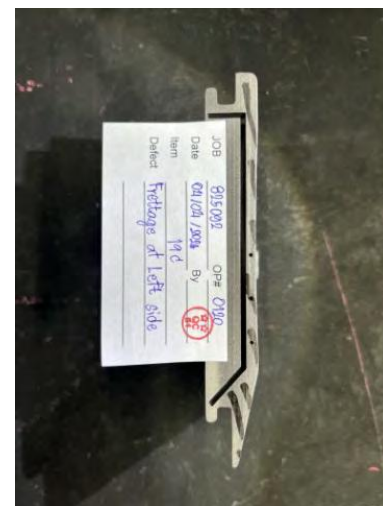
Fig. 28: Heavy fretage on left side, tip shoe

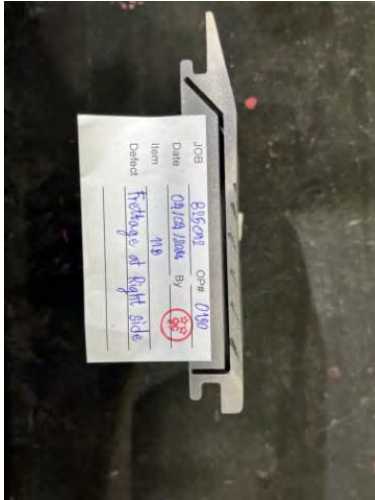
Fig. 29: Heavy fretage on right side, tip shoe

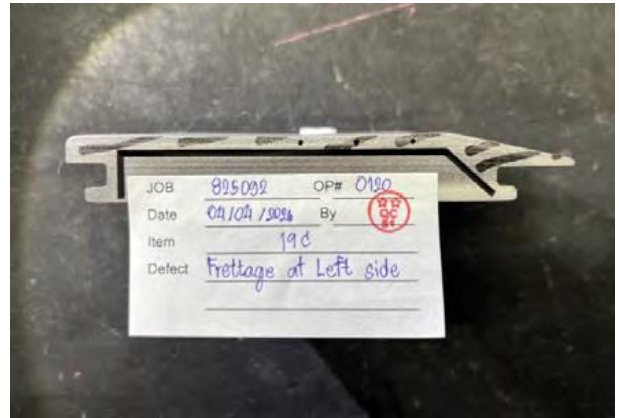
Fig. 30: Heavy fretage on left side, tip shoe

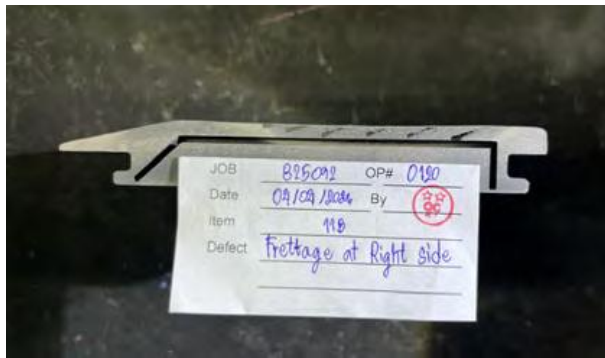
Fig. 31: Heavy fretage on right side, tip shoe

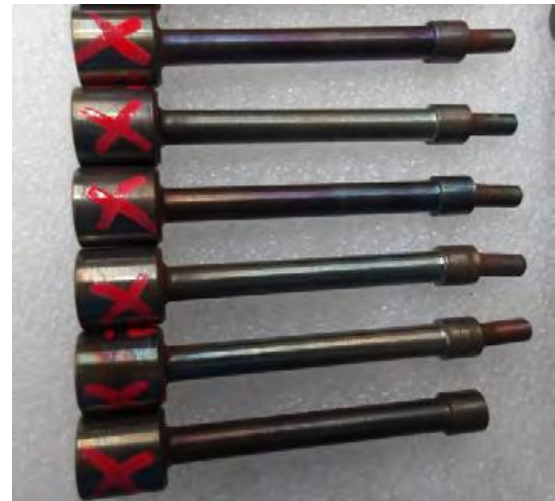
| <b>Tile Retention Pins Deformed</b> | All tile retention pins received in deformed condition, confirmed visually across the complete set. Pins cannot be reused and require full replacement. | <b>Replace with New</b> |

Fig. 32: Deformation on tile retention pins requiring replacement with new

| 11 | Tile retention pins deformed | Complete set, 72 pins | Replace with new | ADDITIONAL ITEM |

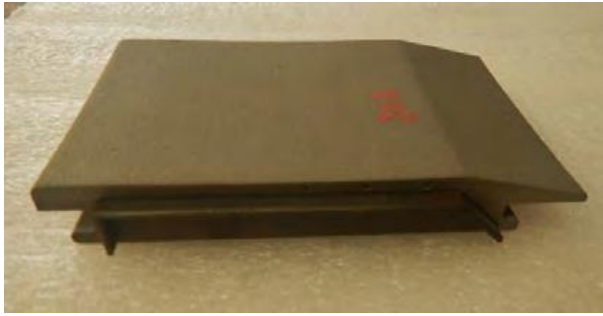
All shroud blocks were received with inner plate side seals (cloth seal type) in damaged and non-serviceable condition, with loss of sealing function. Replacement with new inner plate side seals (L605 flat and bone type) is required for Heavy Repair and is not included in the standard repair scope.

Fig. 33: As-received cloth-type side seals, damaged and non-serviceable

| 10 | Side seals non-serviceable | All 24 assemblies, cloth type seals with complete loss of sealing function | Replace with new L605 flat and bone type seals | ADDITIONAL ITEM |

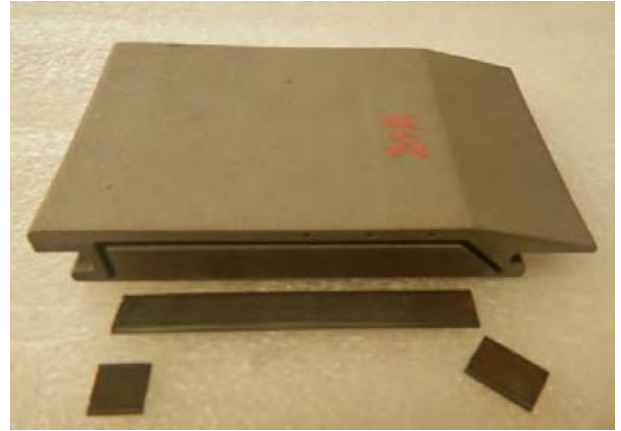
Fig. 34: Seal replacement with new L605 flat and bone type required

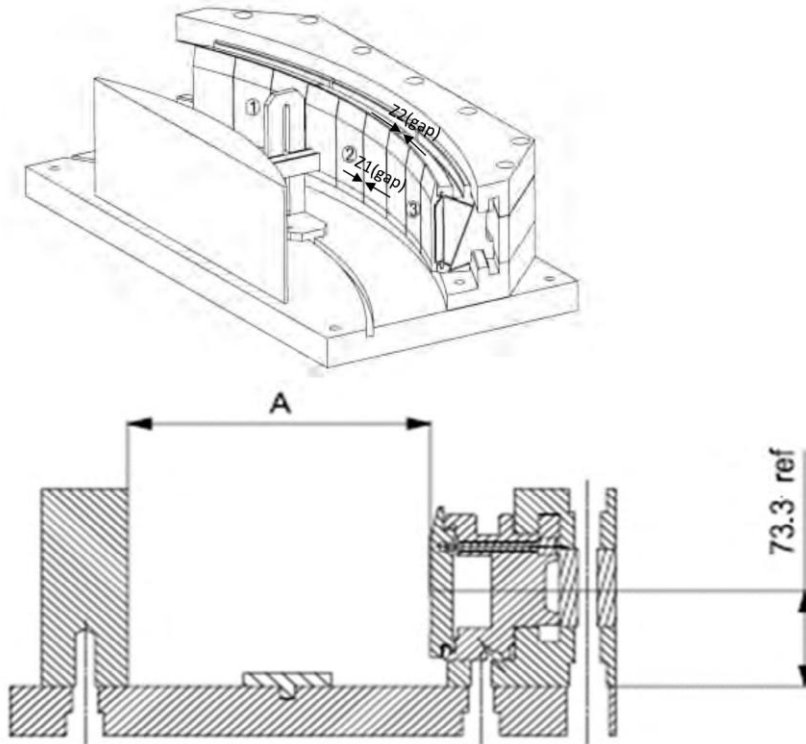
## 12.4 FIXTURE CHECK RESULTS, ALL 24 ASSEMBLIES

| Fixture Check Method and Acceptance Basis | |
|---|---|
| <b>Result</b> | 24 of 24 assemblies REJECT at Z2; tip shoe position C REJECT at Z1 on 24 of 24; Item 18 rejected on failure to achieve full fixture seating |
