## INCOMING INSPECTION REPORT

### MS6001FA (GE Frame 6FA) 3rd Stage Bucket Set

Work Order WO-1004061634 / WO-1004061642

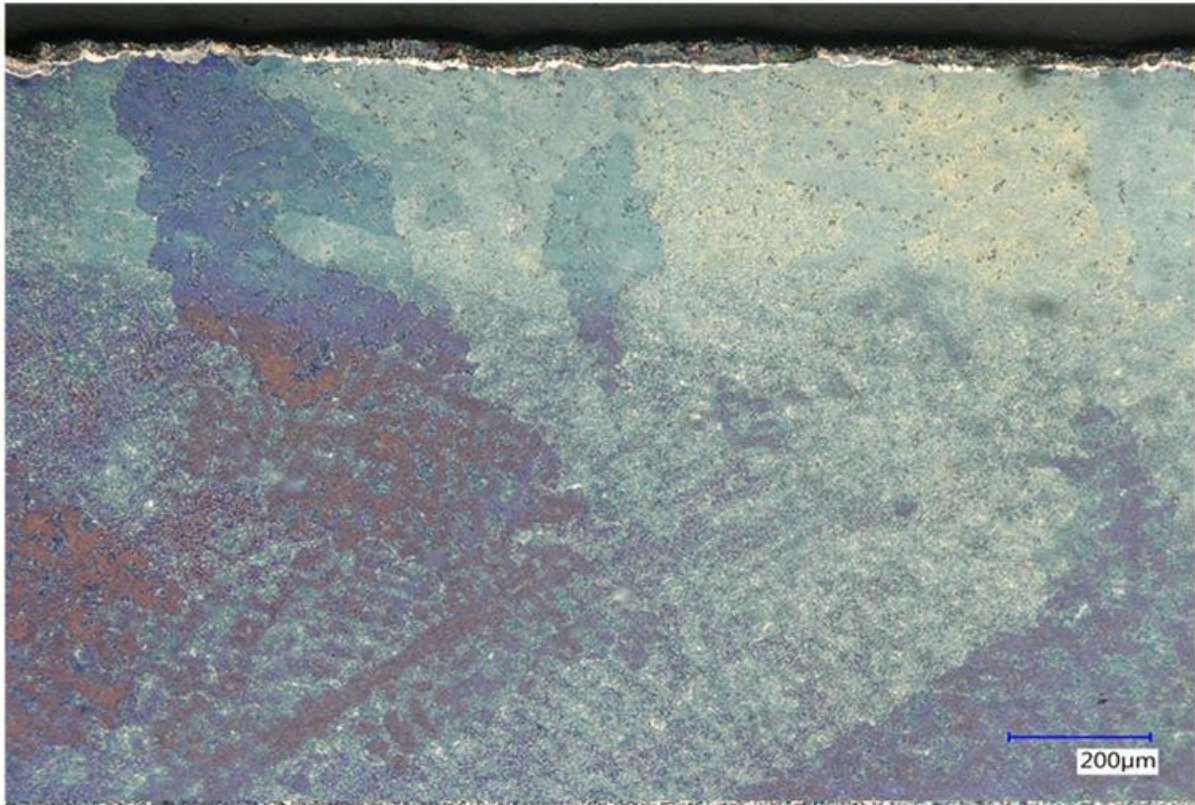
Fig.1 Showing the hot gas path surface condition. (Etched)

A cut section taken from NSRP bucket Item 42 (Serial E1SH018093), shroud cutting location, was mounted under Report No. L11447 to confirm whether the serviced material remains acceptable for repair. The hot gas path surface was uncoated and showed oxidation corrosion with associated substrate alloy depletion. The base material was confirmed as GTD 111 alloy, with fine grain boundary carbide and a gamma matrix with fine gamma prime, primary carbide, and dispersed secondary carbide.

measured depth of the oxidation corrosion layer with associated substrate alloy depletion is approximately 60 to 90 micrometres below the hot gas path surface, within the range recoverable by controlled surface removal. Hardness of the sectioned coupon was recorded at 40.2 HRC, within the UNEW acceptance range for serviced GTD 111 and consistent with weld repair eligibility after solution heat treatment. The sectioned coupons are representative of the full population: airfoil corrosion was verified on 92 of 92 buckets by visual and fluorescent penetrant inspection, and both coupons were taken from the feature region with the highest surface exposure.

The base material is repairable after removal of the oxidation corrosion products and the affected surface material by controlled cleaning and grit blasting. However, the combined surface degradation, the weld build-up, the EDM and machining, the repeated inspection, and the heat treatment scope support the Level 9 classification. Final acceptance is subject to dimensional restoration, heat treatment, FPI and NDT verification, and final acceptance inspection.

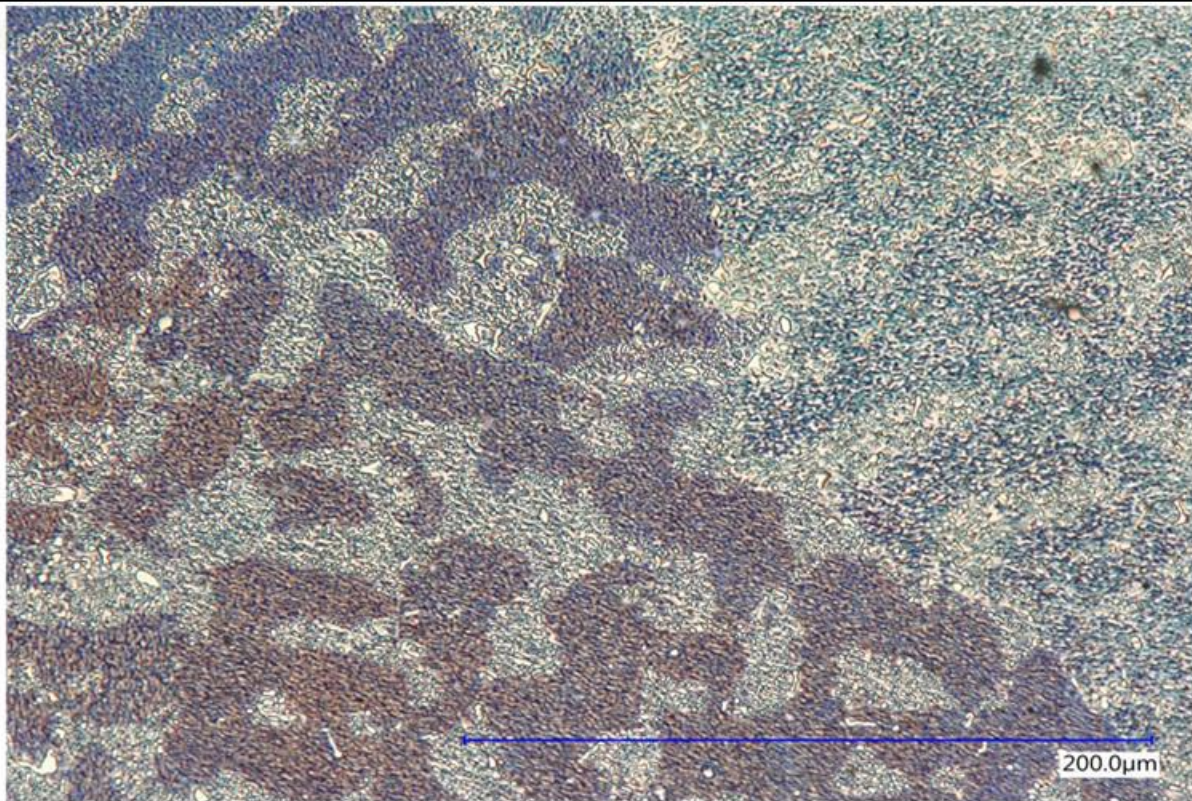
Fig.2 Showing the typical microstructure at higher magnification. (Etched)

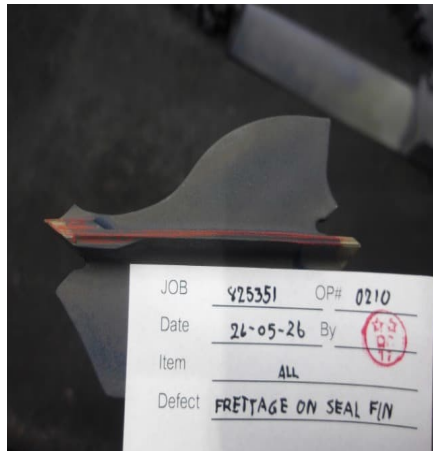
| Feature | Incoming Finding | Required Restoration |
|---|---|---|
| <b>Seal fin and cutter teeth</b> | Fretage on 92 of 92 buckets. Seal fin height recorded as REJ (dimension unacceptable, repair required) across the set. | Critical sealing feature. Requires weld build-up and machining or EDM to restore the seal fin and cutter tooth. |

Figure 13. Fretage on seal fin.

| Damage Category | Finding (As Inspected) | Disposition |
|---|---|---|
| <b>Seal fin and cutter teeth frettage and wear</b> | Frettage on the seal fin and cutter teeth on 92 of 92 buckets. Seal fin height recorded as REJ across the set. | Weld build-up, machining and EDM restoration, FPI, and dimensional verification. |

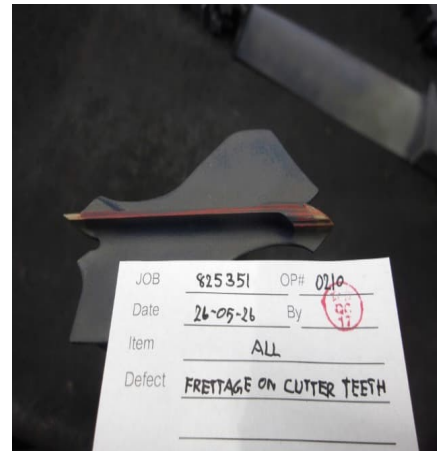
| No. | Defect Basis | Numeric Finding | Required Restoration | Restoration Basis |
|---|---|---|---|---|
| 3 | <b>Seal fin and cutter tooth condition</b> | Frettage on the seal fin and cutter teeth on 92 of 92 buckets. | Weld build-up of the tip seal fin, restoration of cutter tooth areas, and machining and EDM to restore the seal fin and cutter tooth configuration. | Critical sealing features need material restoration and precision geometry recovery across the full set. |

Figure 14. Fretage on cutter teeth.

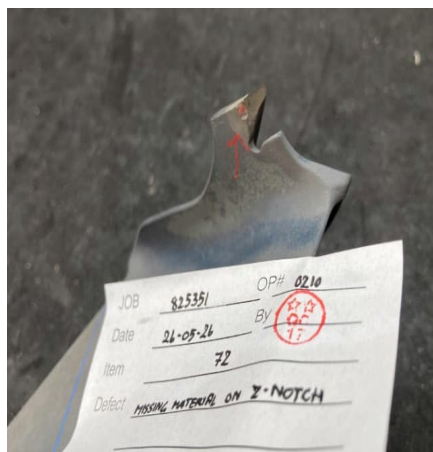
| Feature | Incoming Finding | Required Restoration |
|---|---|---|
| <b>Z-notch</b> | Fretage on 92 of 92 buckets. Item 72 shows 2 mm x 3 mm (approximately 6 mm <sup>2</sup> ) missing material at the Z-notch. | Critical engagement and load transfer feature. Requires weld build-up and EDM to recreate the Z-notch and shroud profiles. |

| Feature | Affected Qty | Typical / Max Size | Max Depth | Blend Limit at Location | Required Repair |
|---|---|---|---|---|---|
| Z-notch missing material (Item 72) | 1 of 92 | 2 mm x 3 mm (approx. 6 mm <sup>2</sup> ) | 1.5 mm | 0.5 mm | Weld build-up + EDM geometry recreation |

Figure 15. Dent or missing mat. on Z-notch.

| Damage Category | Finding (As Inspected) | Disposition |
|---|---|---|
| <b>Z-notch wear and missing material</b> | Z-notch frettage on 92 of 92 buckets, on a critical engagement feature. Item 72 shows 2 mm x 3 mm (approximately 6 mm <sup>2</sup> ) missing material at the Z-notch. | Weld build-up, EDM and machining to recreate the Z-notch and shroud profiles, and repeated FPI and NDT. |

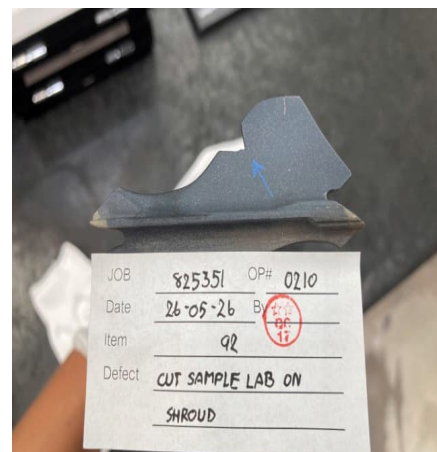
**Sectioning representativeness and quantified results.** A second confirmation section was taken at the same shroud cutting location from Item 92 (Serial E1SH017520) and showed equivalent microstructure and surface condition; the result is held on file under Report No. L11447. The

Figure 16. Cut sample on shroud.

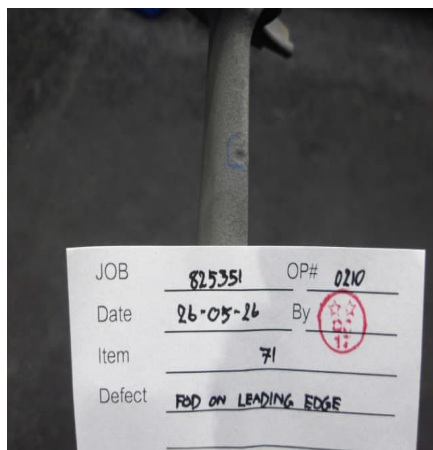
| Feature | Incoming Finding | Required Restoration |
|---|---|---|
| <b>Leading edge</b> | Foreign object damage on 7 of 92 buckets (7.6%): Items 1, 2, 25, 53, 67, 71, 72. | Airfoil aerodynamic surface. Requires blend and weld repair and FPI verification. Affects crack initiation risk. |

| Leading edge FOD | 7 of 92 | Typical 1 x 1 mm; max 3 x 2 mm | 0.6 mm | 0.3 mm | Blend / weld repair + FPI |

Figure 17. FOD on leading edge.

| 8 | <b>Leading edge FOD</b> | Leading edge FOD on 7 of 92 buckets (7.6%): Items 1, 2, 25, 53, 67, 71, 72. | Blend and weld repair review of the leading edge, removal of stress concentration, and FPI after repair. | Airfoil leading edge damage affects the aerodynamic profile and the crack initiation risk. |

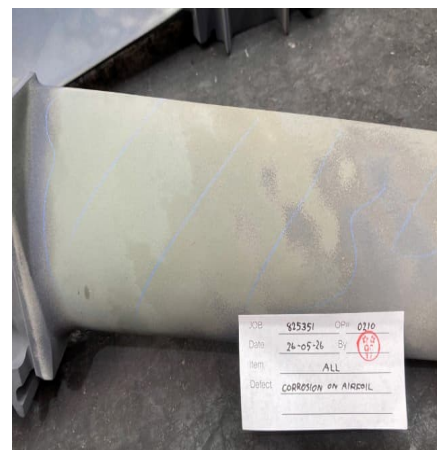
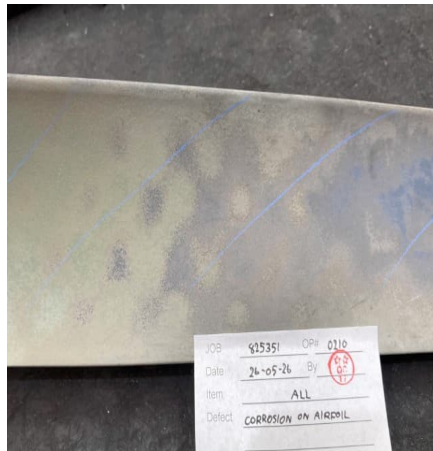
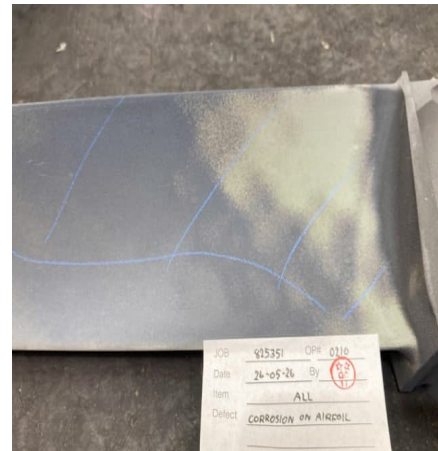
| Feature | Incoming Finding | Required Restoration |
|---|---|---|
| <b>Airfoil (hot gas path)</b> | Corrosion on 92 of 92 airfoils. Metallurgical sectioning shows oxidation corrosion with substrate alloy depletion. | Base metal attack across the full set. Requires grit blast, controlled material removal, metallurgical acceptance, and heat treatment. |

Figure 18. Corrosion on airfoil.

Figure 19. Corrosion on airfoil.

Figure 20. Corrosion on airfoil.

| Damage Category | Finding (As Inspected) | Disposition |
|---|---|---|
| <b>Airfoil corrosion and surface degradation</b> | Corrosion on 92 of 92 airfoils. Metallurgical sectioning shows oxidation corrosion and substrate alloy depletion. | Controlled cleaning, defect removal, blending, and FPI verification. |

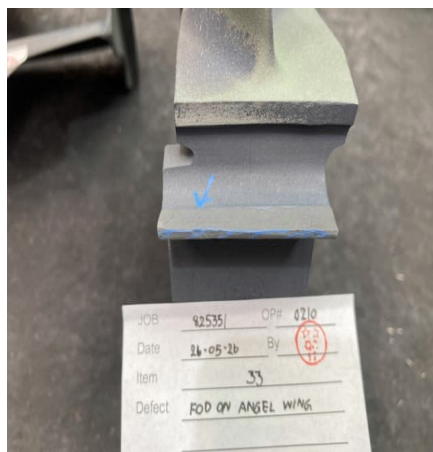
| Feature | Incoming Finding | Required Restoration |
|---|---|---|
| <b>Angel wing</b> | Fretage on 92 of 92 buckets. Foreign object damage on 36 of 92 buckets (39.1%). | Critical interface and sealing feature. Requires restoration on 92 of 92 buckets, with weld build-up where defect depth exceeds the blend limit, and machining to recreate the angel wing dimensions. |

Figure 21. FOD on angel wing.

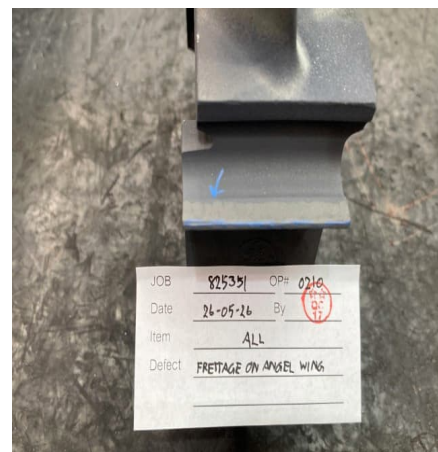
Figure 22. Fretage on angel wing.

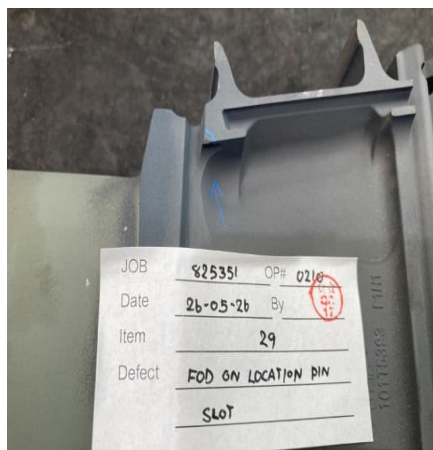
| Feature | Incoming Finding | Required Restoration |
|---|---|---|
| <b>Location pin slot</b> | Fretage on 92 of 92 buckets. Foreign object damage on 40 of 92 buckets (43.5%). | Locating and fit-up feature. Requires blend and weld repair and recovery of contact and fit-up across nearly half the set. |

Figure 23. FOD on location pin slot.

| Damage Category | Finding (As Inspected) | Disposition |
|---|---|---|
| <b>Leading edge and location pin slot FOD</b> | Leading edge FOD on 7 of 92 buckets. Location pin slot FOD on 40 of 92 buckets. | Blend repair, weld repair where required, and dimensional and visual verification. |

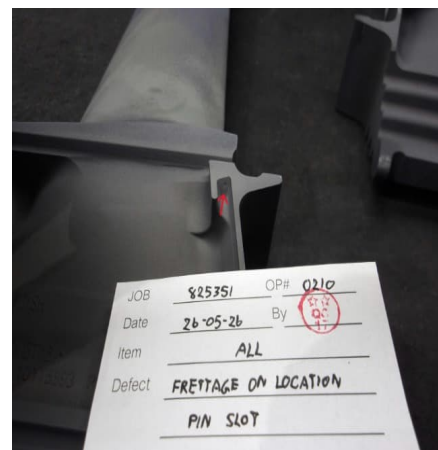
Figure 24. Fretage on location pin slot.
