## INCOMING INSPECTION REPORT

| <b>Report No.</b> | UNEW-NSRP-825355-SB2-IIR-Rev01 | <b>UNEW Job No.</b> | 825355 |
| <b>Customer P.O. No.</b> | WO-1004061634-100406 | <b>Component</b> | MS6001FA 2nd Stage Shroud Block |

### 1. EXECUTIVE SUMMARY

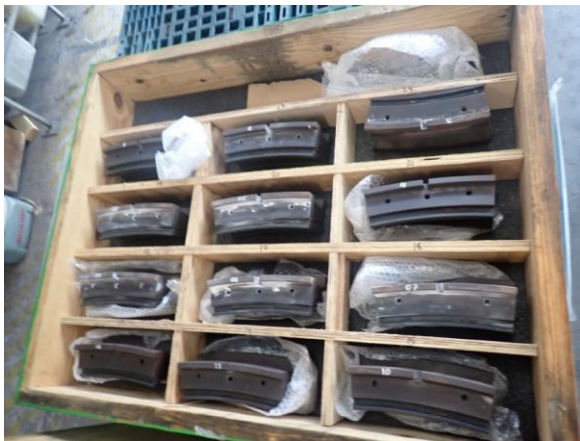
Fig.1 As-received condition.

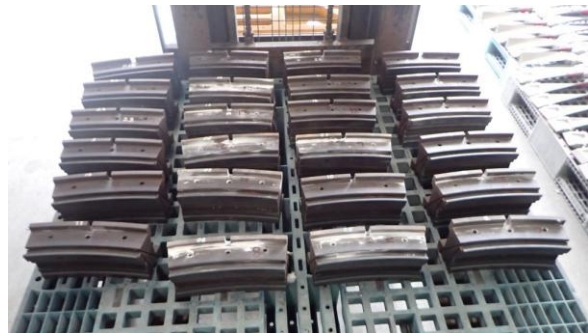
Fig.2 As-received condition.

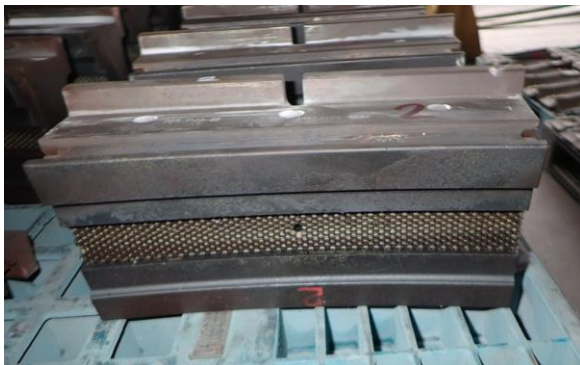
Fig.3 As-received condition.

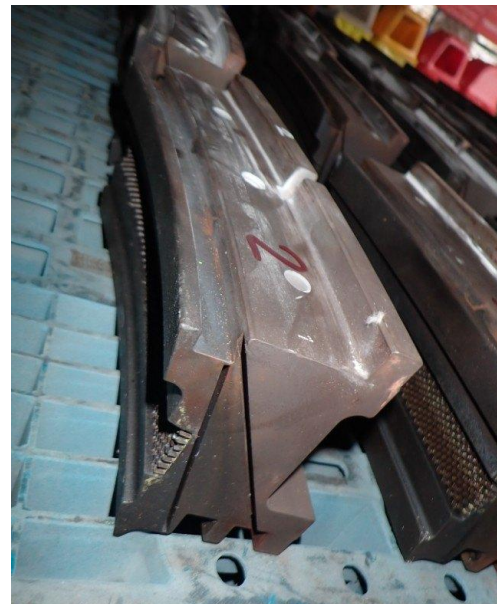
Fig.4 As-received condition.

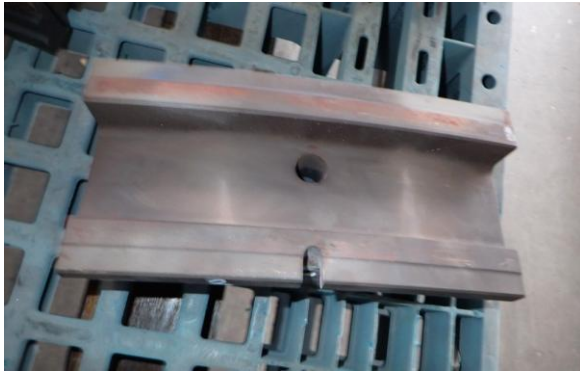
Fig.5 As-received condition.

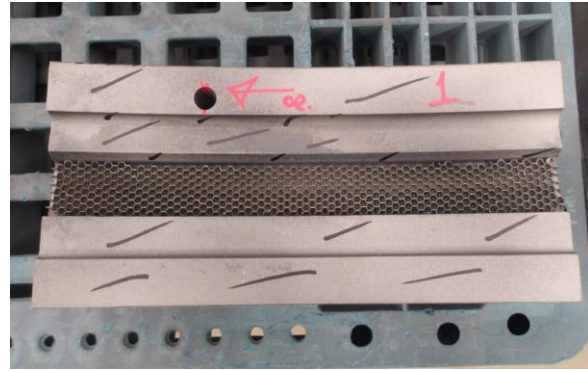
Fig.6 Typical condition.

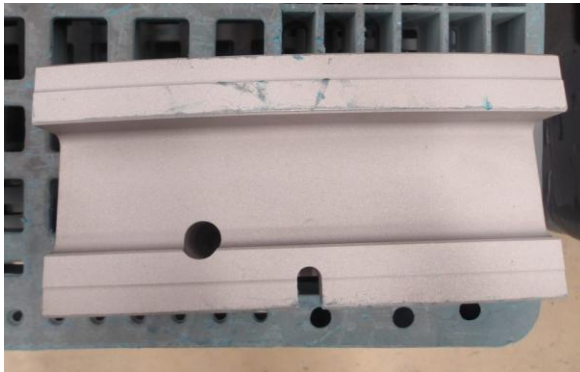
Fig.7 Typical condition.

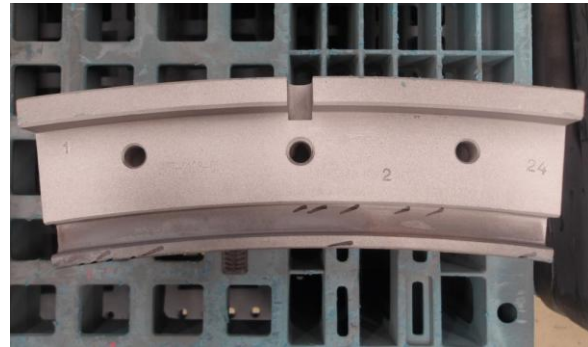
Fig.8 Typical condition.

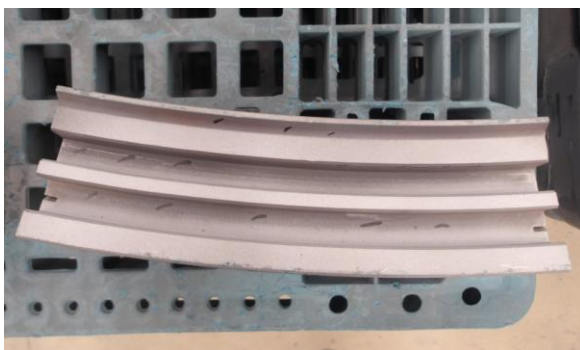
Fig.9 Typical condition.

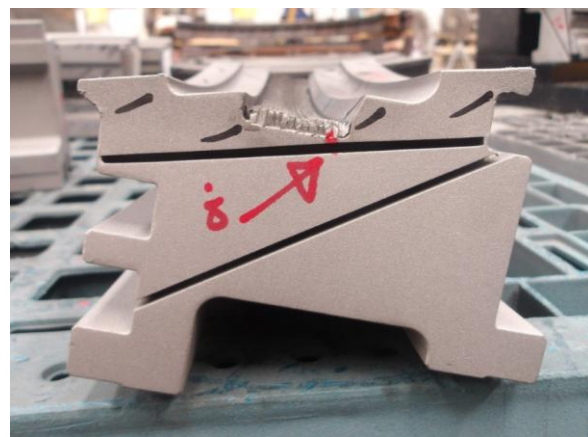
Fig.10 Typical condition.

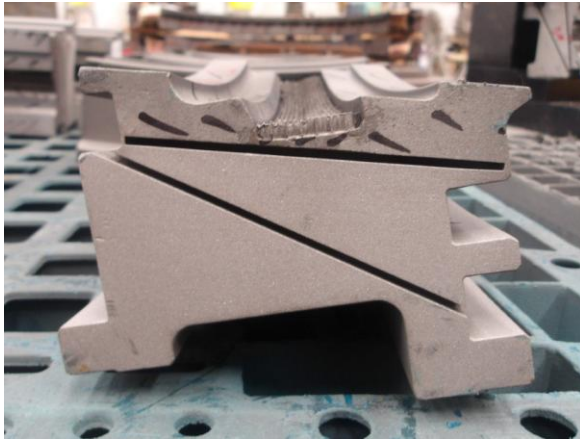
Fig.11 Typical condition.

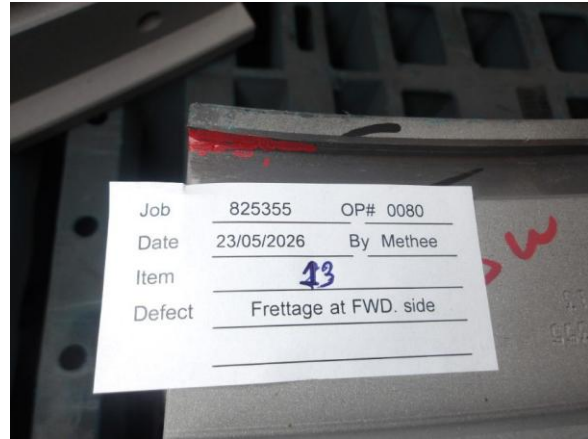
| Damage Category | Finding (As Inspected) | Disposition / Required Restoration |
|---|---|---|
| Forward side corrosion/fretage | Light corrosion at forward side and light-to-medium fretage at forward side. | Controlled blend, clean and verify surface condition and fit-up. |

Fig.12 Fretage on forward side.

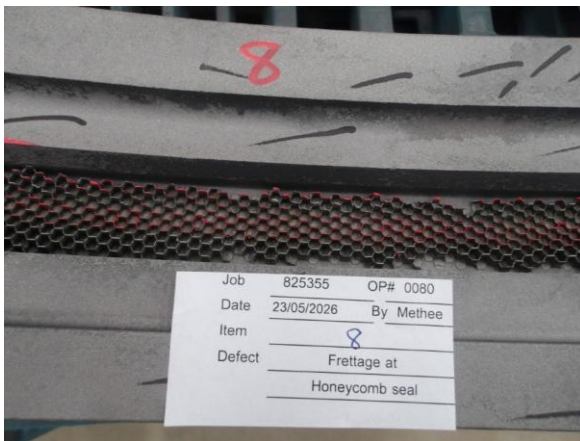
| Damage Category | Finding (As Inspected) | Disposition / Required Restoration |
|---|---|---|
| Honeycomb seal / seal ID | 24/24 honeycomb seals require replacement; honeycomb seal ID rejected for 24/24 components. | Remove existing honeycomb, prepare surfaces, fit replacement honeycombs, braze heat treatment, blend excess honeycomb flush with shroud block side walls, inspect. |

Fig.13 Fretage on honeycomb seal.

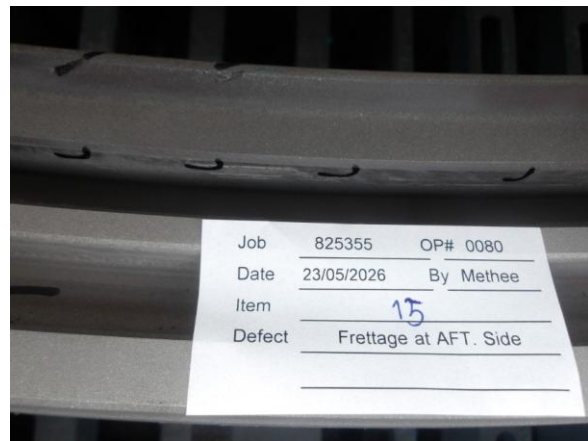
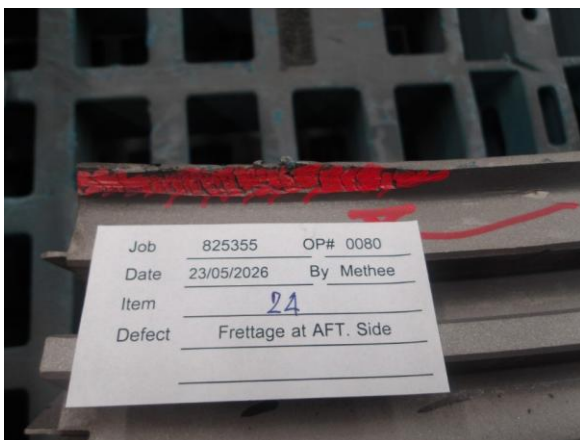
| Aft side corrosion/fretage/wear | Light corrosion at aft side and light-to-heavy fretage at aft side; local weld-and-blend at No. 24 wear position. | Blend and local weld-and-blend as required; verify profile and final fit-up. |

Fig.14 Fretage on aft side.

Fig.15 Fretage on aft side.

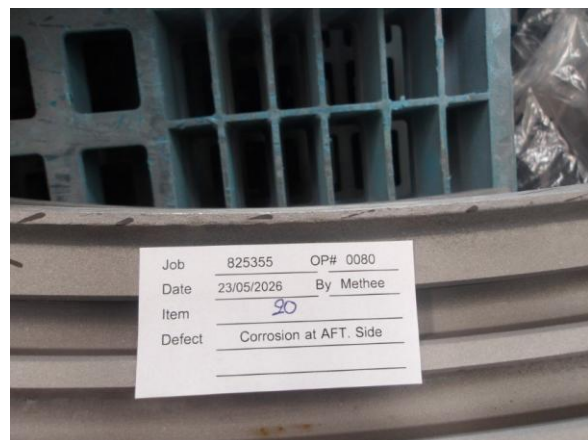
Fig.16 Corrosion on aft side.

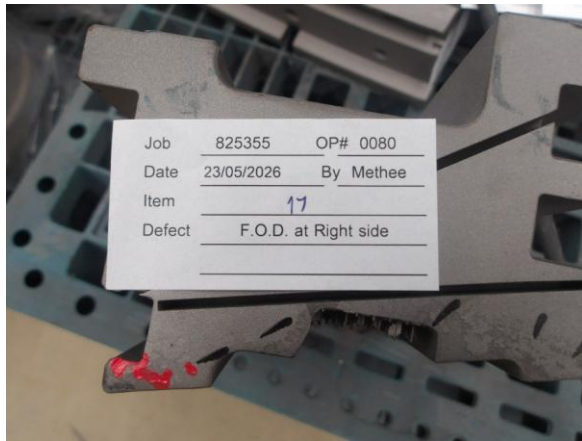
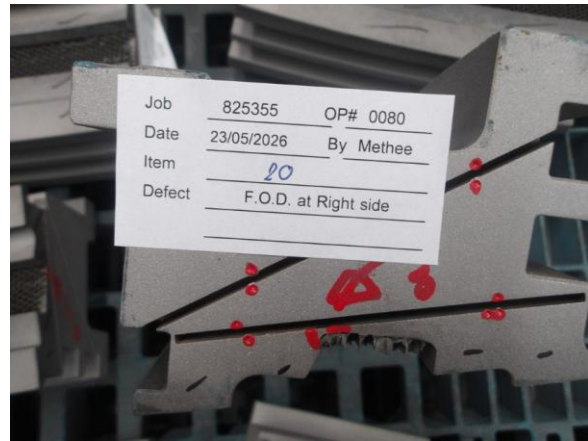
| Damage Category | Finding (As Inspected) | Disposition / Required Restoration |
|---|---|---|
| FOD | Medium FOD at left side No. 13, 20, 24 and right side No. 17, 20. | Blend damaged areas and perform weld-and-blend where defect removal exceeds blend limits; FPI after repair. |

Fig.17 FOD on right side.

Fig.18 FOD on right side.

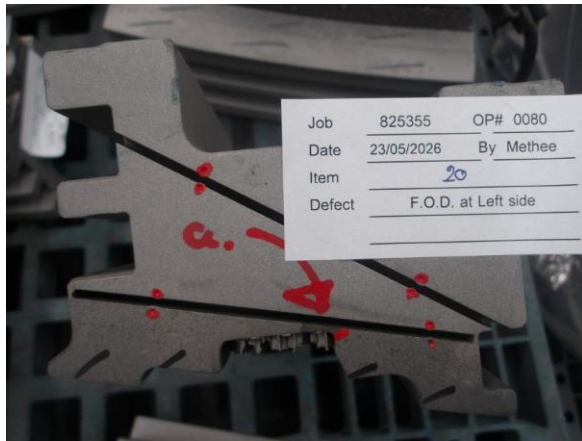
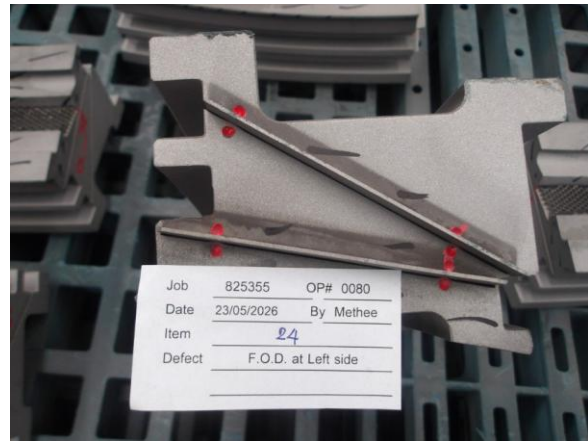
Fig.19 FOD on left side.

Fig.20 FOD on left side.

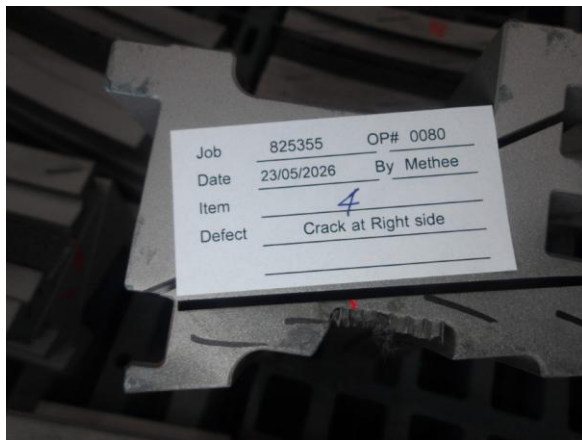
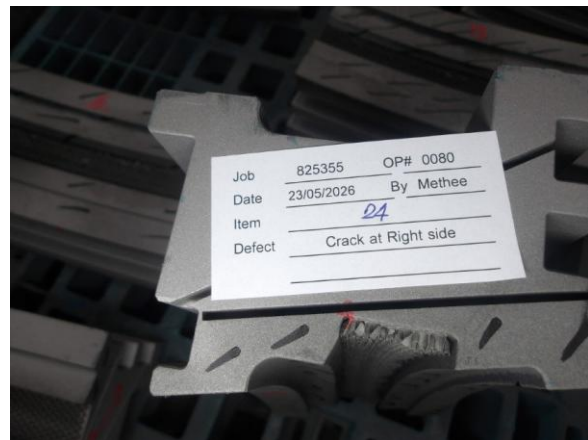
| Damage Category | Finding (As Inspected) | Disposition / Required Restoration |
|---|---|---|
| Left/right side cracks | 2-5 mm cracks recorded at left and right sides; defect table routes left/right side cracking as weld-and-blend for 24/24 pieces. | Prepare local crack areas, weld-and-blend repair, restore profile, FPI and dimensional verification. |

Fig.21 Crack on right side.

Fig.22 Crack on right side.

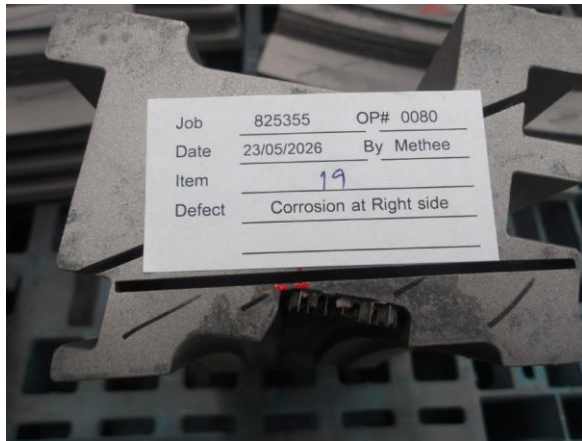
Fig.23 Corrosion on right side.

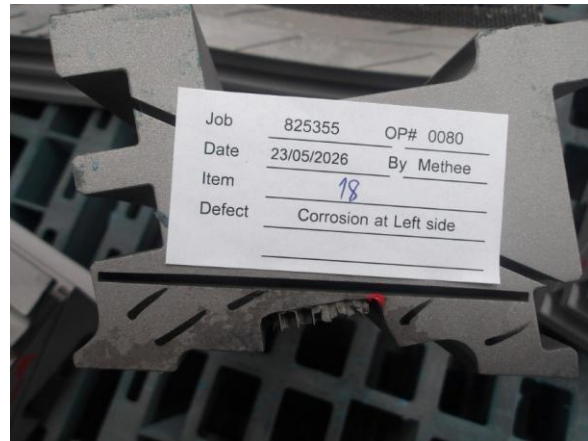
Fig.24 Corrosion on left side.

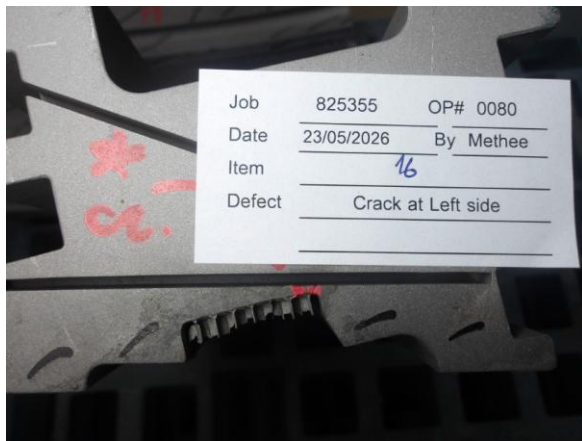
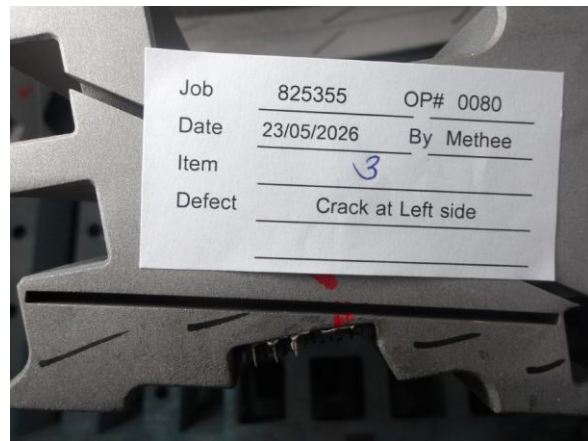
Fig.25 Crack on left side.

Fig.26 Crack on left side.

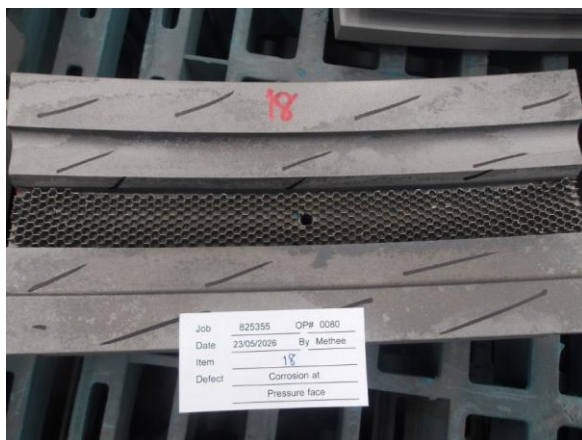
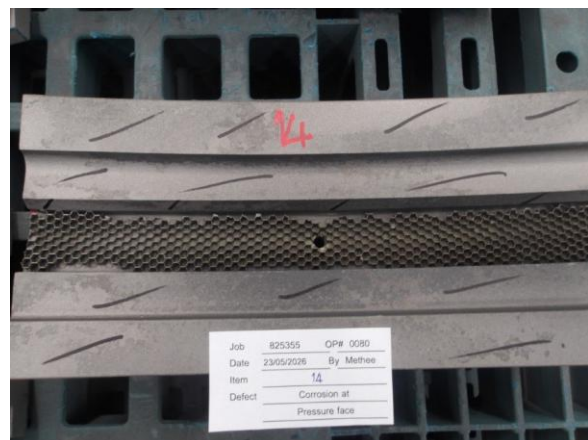
| Damage Category | Finding (As Inspected) | Disposition / Required Restoration |
|---|---|---|
| Pressure face corrosion | Corrosion recorded on pressure face; typical map indicates light corrosion at pressure face. | Abrasive blast, controlled blend to remove corrosion/oxidation products, visual inspection and FPI as required. |

Fig.27 Corrosion on pressure face.

Fig.28 Corrosion on pressure face.

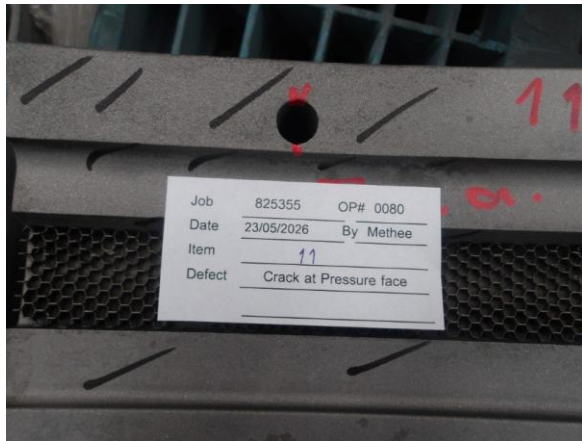
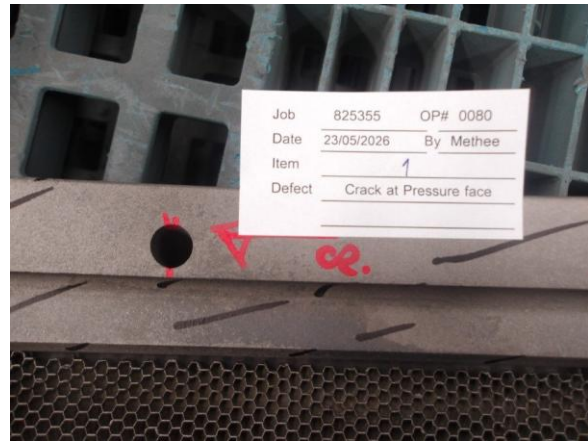
| Damage Category | Finding (As Inspected) | Disposition / Required Restoration |
|---|---|---|
| Pressure face cracks | 2-5 mm cracks recorded at pressure face on shroud blocks No. 1, 7 and 11. | Excavate/scallop crack, weld repair, blend to profile, FPI confirmation and heat treatment. |

Fig.29 Crack on pressure face.

Fig.30 Crack on pressure face.

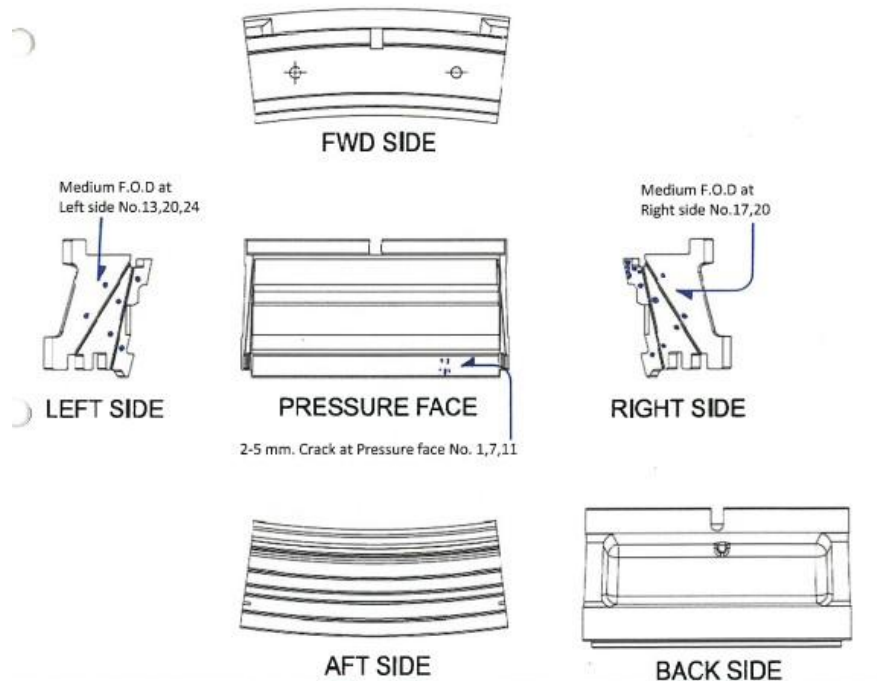
Defect Map 2 – Non-typical defect locations (cracks at pressure face No. 1, 7, 11; FOD at left side No. 13, 20, 24 and right side No. 17, 20).
