## INCOMING INSPECTION REPORT

### MS6001FA (GE Frame 6FA) 1st Stage Shroud Block Set

Work Order WO-1004061634 / WO-1004061642

| Customer | Nghi Son Refinery and Petrochemical LLC | Report Date | 19 June 2026 |

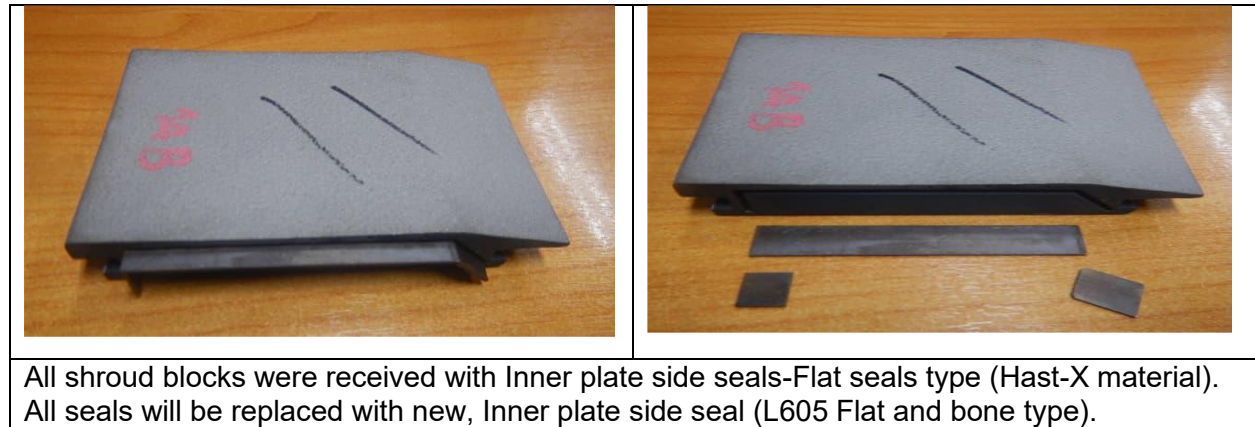
All shroud blocks were received with Inner plate side seals-Flat seals type (Hast-X material). All seals will be replaced with new, Inner plate side seal (L605 Flat and bone type).

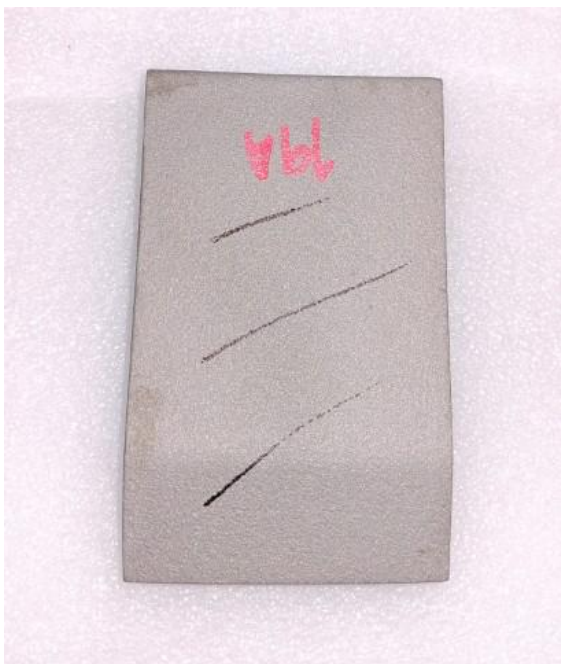
**Cracking.** Cracking of 2 to 5 mm is present on the inner plate side faces of 16 blocks and on the block top face of 2 blocks. The cracked areas are removed by weld and blend, followed by full vacuum heat treatment and re inspection.

Fig. 17 Cracking on inner plate.

Cracking on inner plate side faces and pressure face, removed by weld and blend.

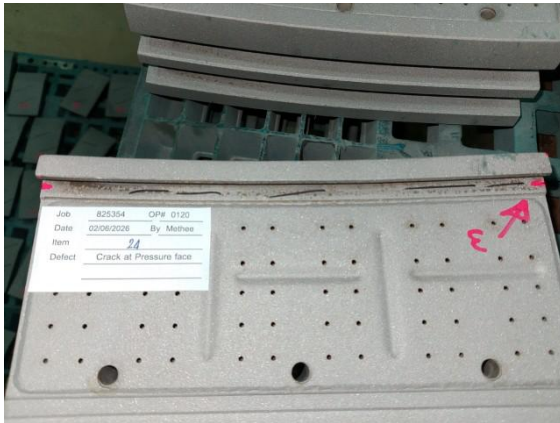
Fig. 19 Crack on pressure face.

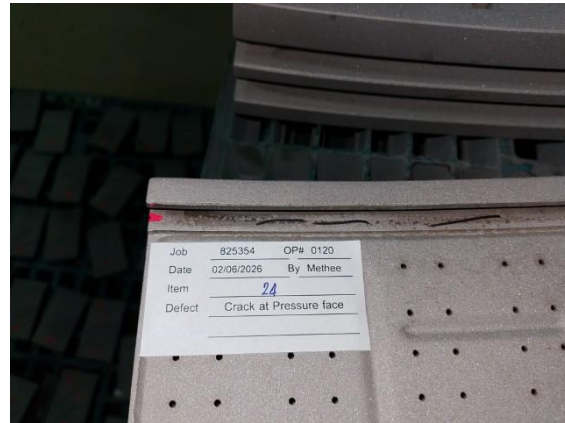
Fig. 20 Crack on pressure face.

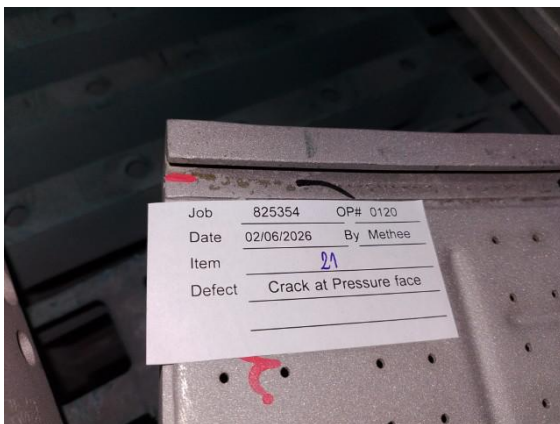
Fig. 21 Crack on pressure face.

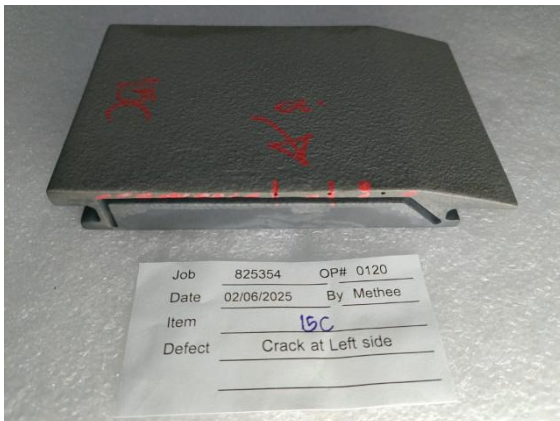
Fig. 23 Crack on left side.

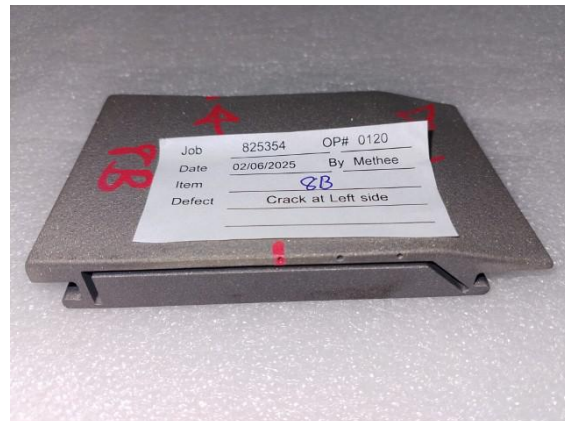
Fig. 24 Crack on left side.

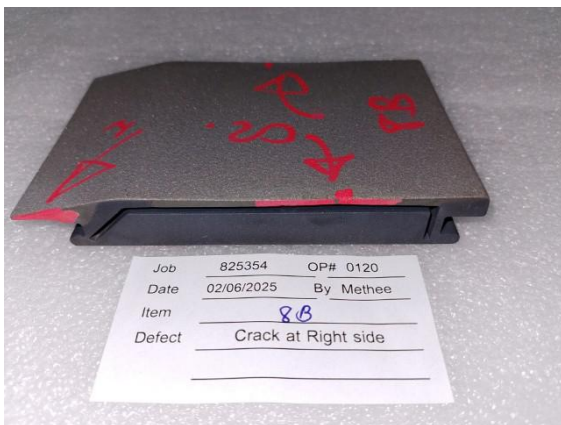
Fig. 25 Crack on right side.

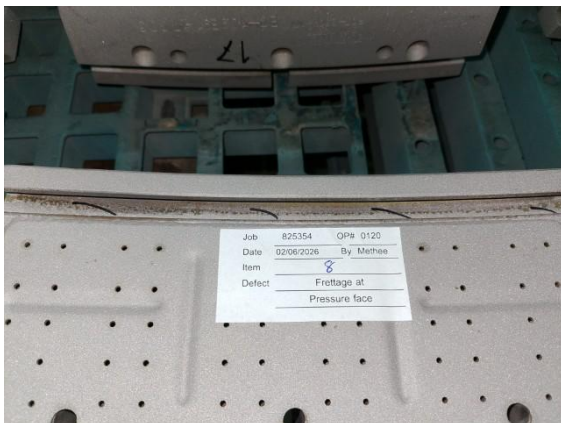
Fig. 26 Fretage on pressure face.

Foreign object damage and fretage on block faces and side rails, removed by blend or weld and blend.

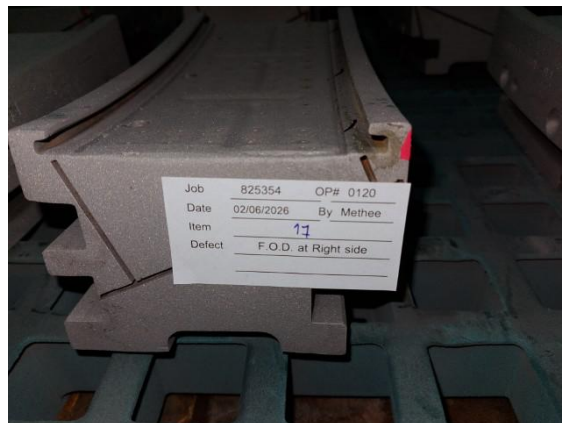
Fig. 27 FOD on right side.

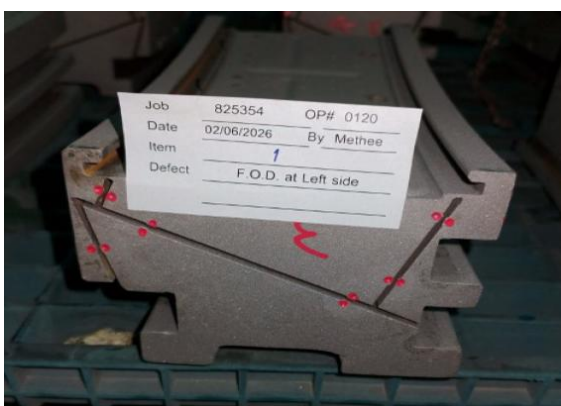
Fig. 28 FOD on left side.

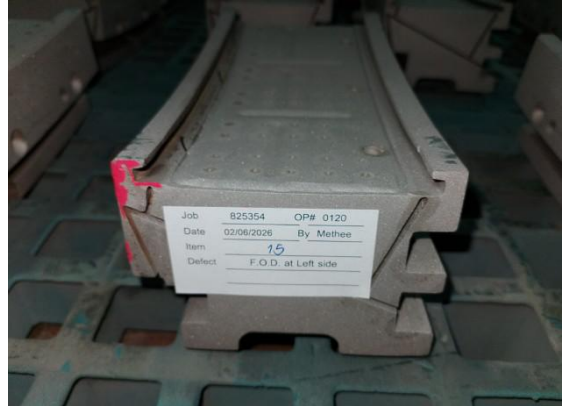
Fig. 29 FOD on left side.

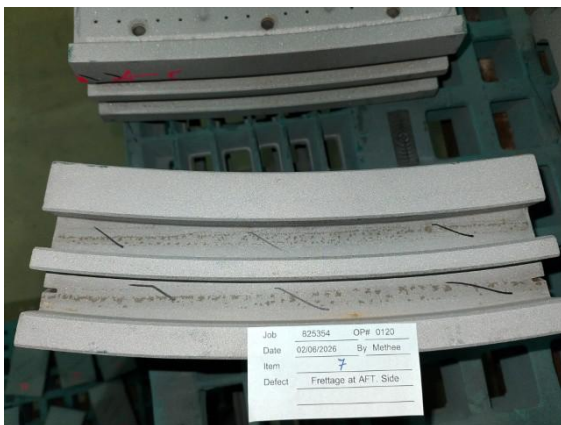
Fig. 30 Fretage on aft side.

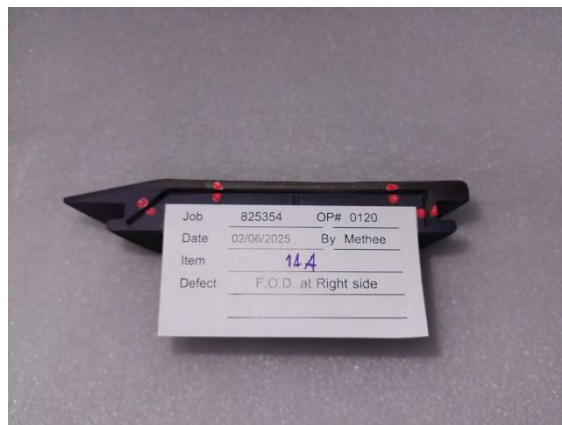
Fig. 31 FOD on right side.

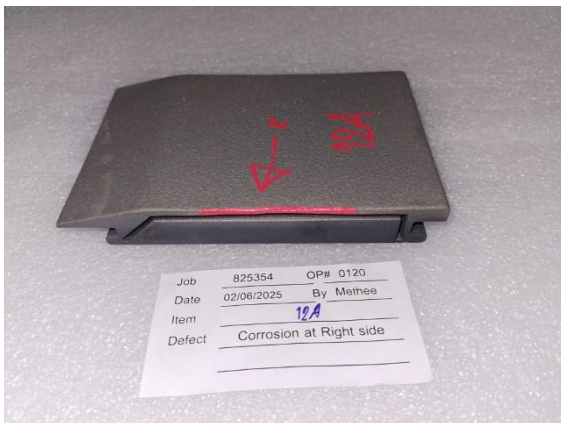
Fig. 32 Corrosion on right side.

Surface corrosion on inner plate pressure, side and back faces, removed by blast and blend and recoated.

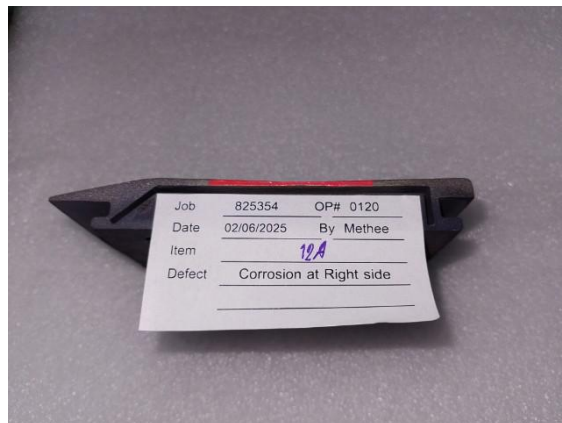
Fig. 33 Corrosion on right side.

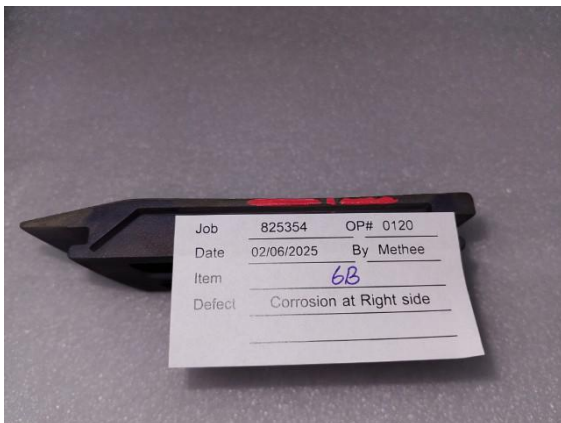
Fig. 34 Corrosion on right side.

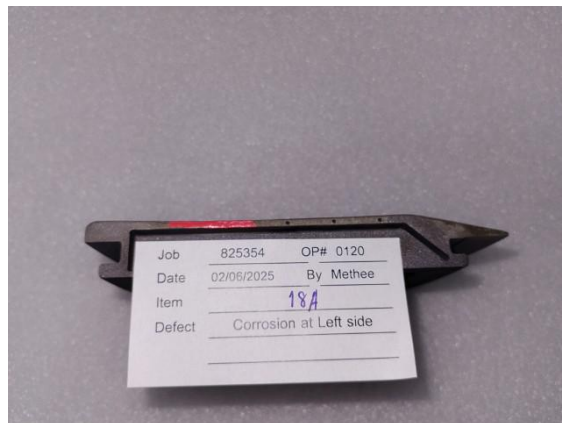
Fig. 35 Corrosion on side face.

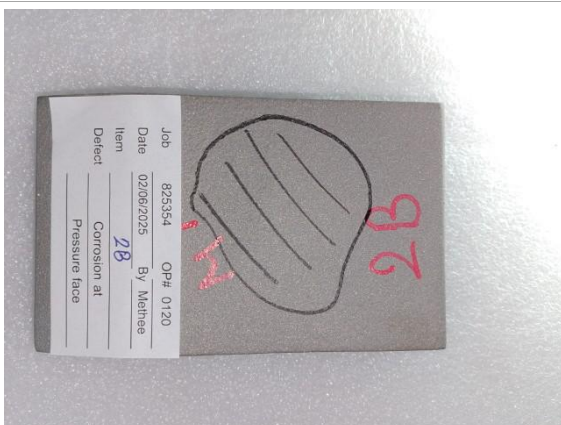
Fig. 36 Corrosion on pressure face.

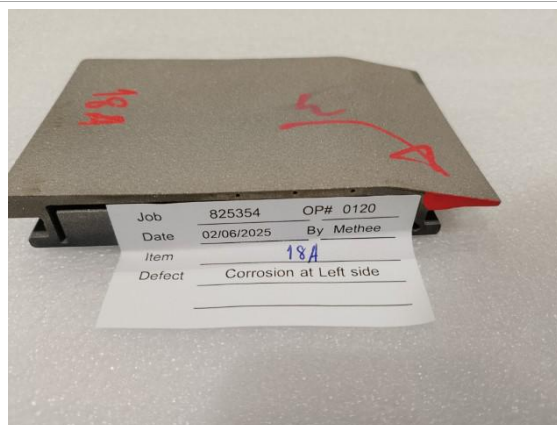
Fig. 37 Corrosion on left side.

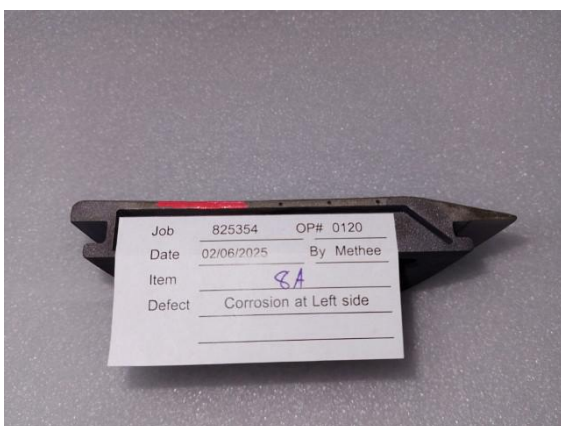
Fig. 38 Corrosion on left side.

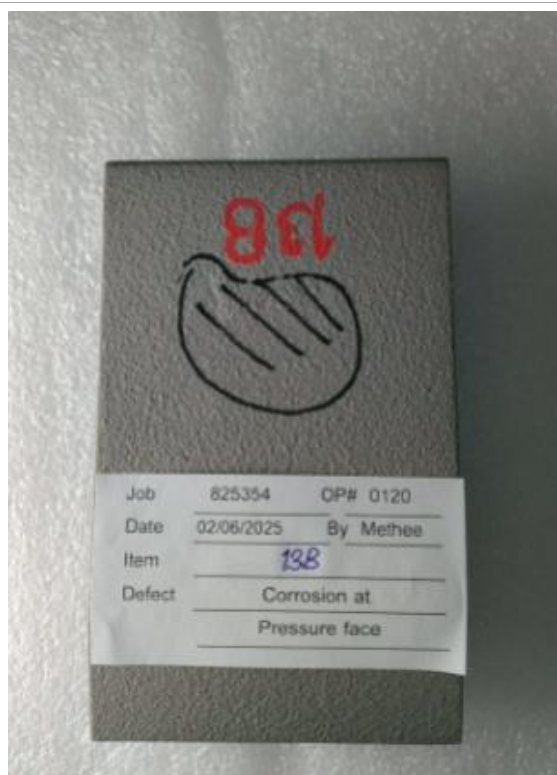
Fig. 39 Corrosion on pressure face.

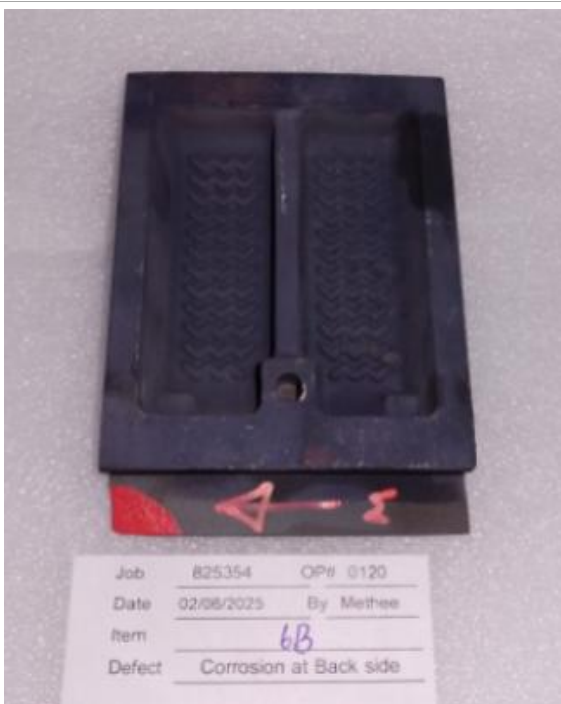
Fig. 40 Corrosion on back side.

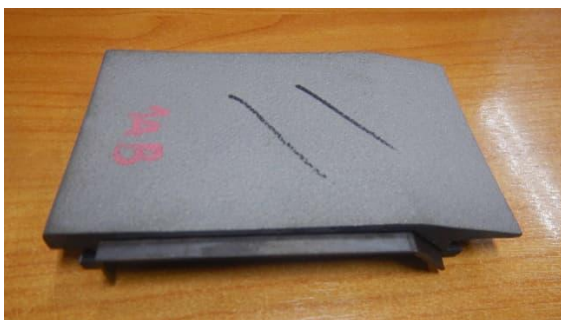
Fig. 41 Inner plate side seals as received, to be replaced with new.

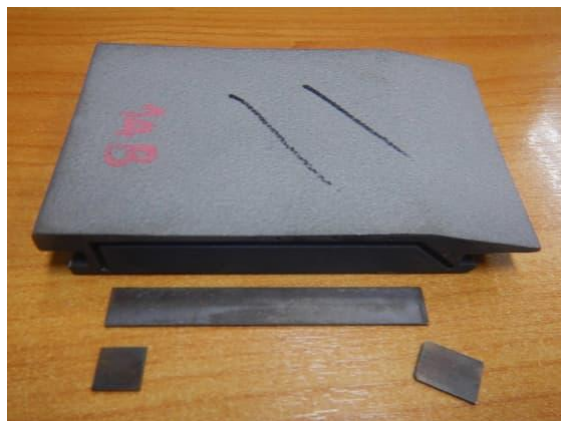
Fig. 42 Inner plate side seals as received, to be replaced with new.

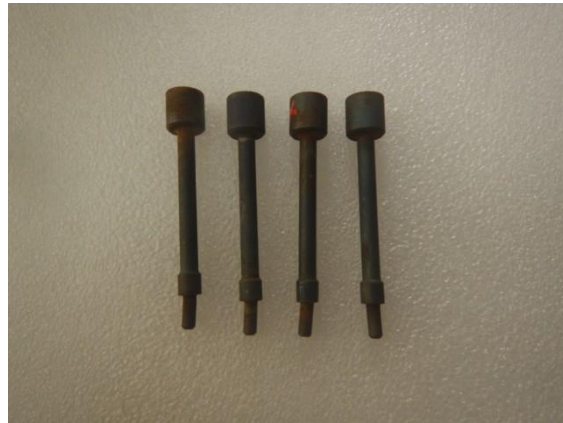
*Fig. 44 Tile retention pins, to be replaced with new where required.*

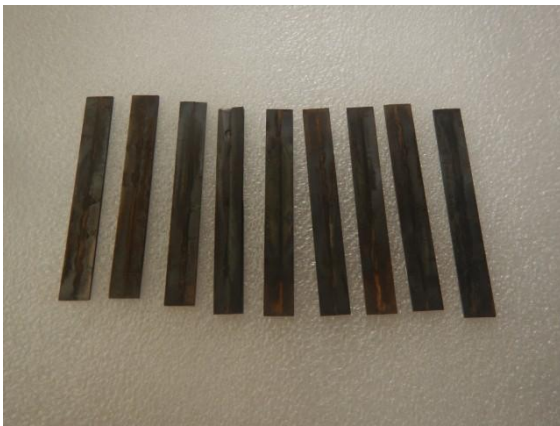
*Fig. 45 Inner plate side seals, to be replaced with new.*

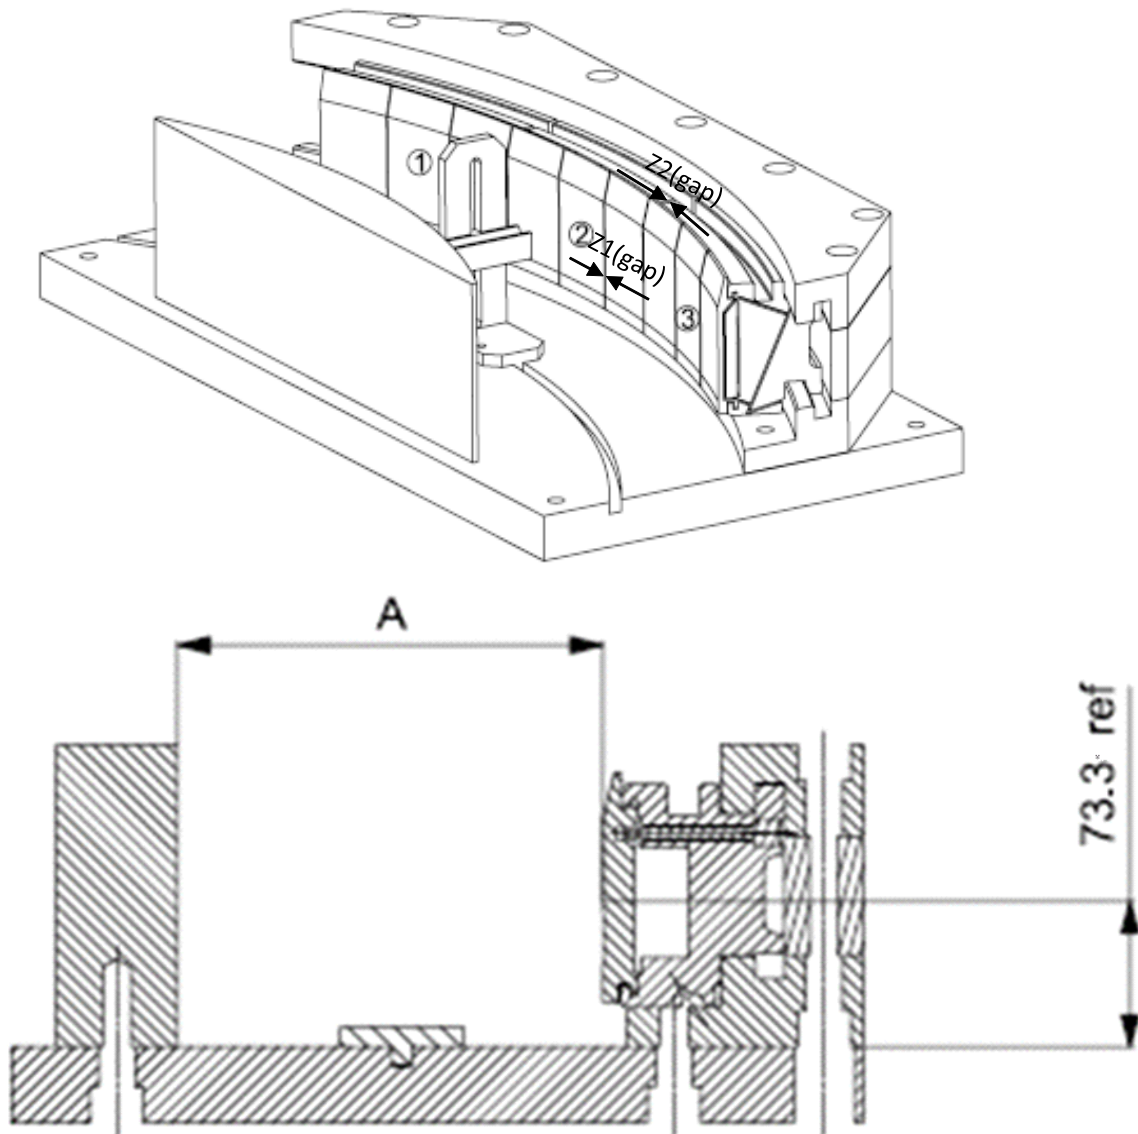
## Fixture inspection:

**Inner plate seating.** The inner plate seating is outside the fixture gap limit on all 24 assemblies, on both Z1 and Z2. The seating on every assembly is restored to the design by dimensional restoration and is re checked in the fixture.

The inner plate assembly was mounted in the fixture and the controlled gap dimensions Z1 and Z2 were checked against the acceptance limit. The A reading is recorded in millimetres. The Z1 and Z2 result is pass or fail. On this set all 24 inner plate assemblies are outside the gap limit on both Z1 and Z2. The seating on every assembly is restored to the design by dimensional restoration and is then re checked in the fixture, which is a standard repair for this feature.
