## INCOMING INSPECTION REPORT

### MS6001FA (GE Frame 6FA) 3rd Stage Nozzle Set

Report No. UNEW-NSRP-825353-NZ3-IIR-Rev01 | Work Order WO-1004061642

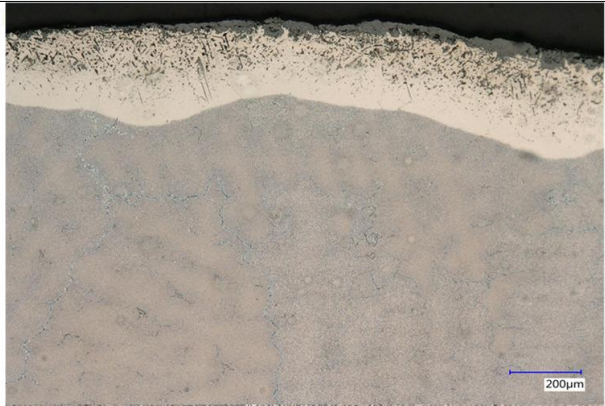
| <p><b>Fig.1</b> Showing the hot gas path surface condition.(Etched)</p> | | | | | | <p><b>Fig.2</b> Showing the typical microstructure at higher magnification.(Etched)</p> | | | | | |
| <p>The sample was mounted in L11464 to assess if the material would be acceptable for repair. The following was observed. Hot gas path was uncoated and exhibited a layer of oxidation-corrosion and associated substrate alloy depletion, refer to Fig.1. Base material was confirmed as GTD262 alloy, comprising of fine grain boundary carbide and a gamma matrix with fine gamma prime, primary carbide and dispersed secondary carbide, Fig.2.</p> | | | | | | | | | | | |

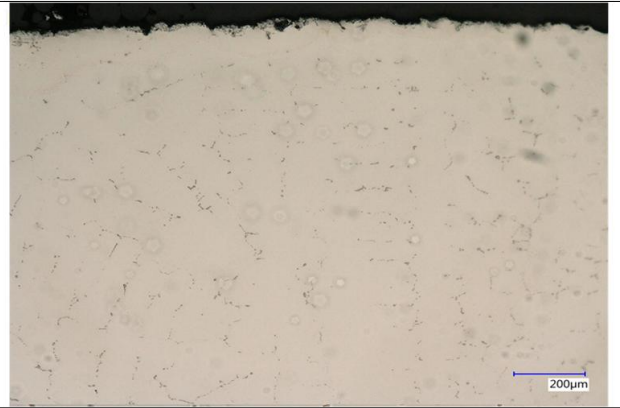
| Fig.1 | | Fig.2 | |
| Showing heat treated material condition. (Etched) | | Showing the typical microstructure at higher magnification.(Etched) | |

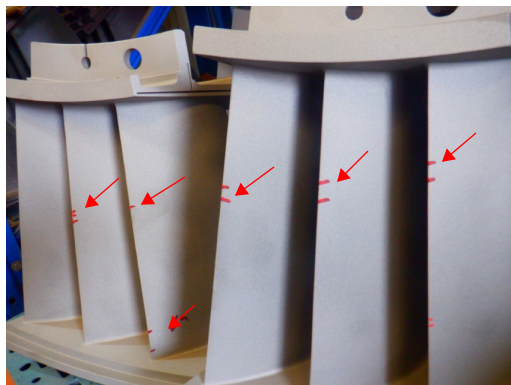
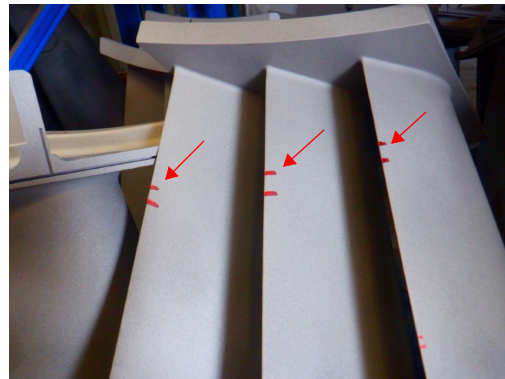
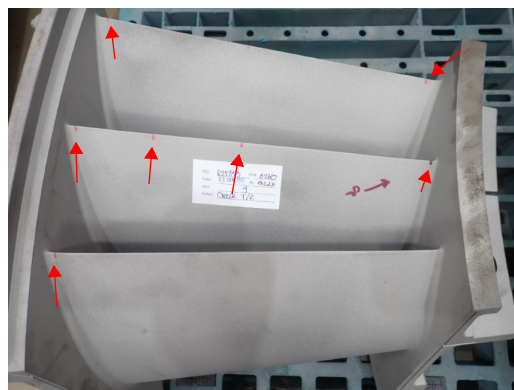
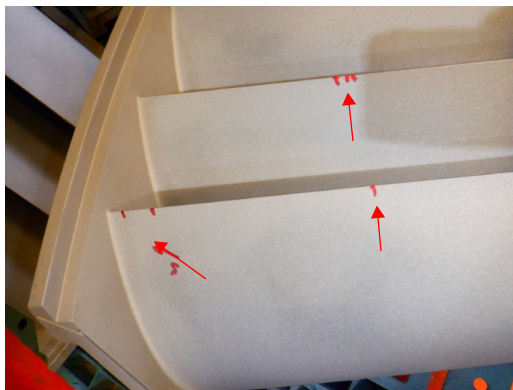
| No. | Defect Basis | Finding | Required Restoration / Repair Process | Technical Significance / Repair Control |
|---|---|---|---|---|
| 3 | Trailing-edge crack indications | Inspection photographs identify trailing-edge cracks (5–10 mm, typical) on multiple nozzle airfoils. The defect record routes all 20 nozzle segments with weld-and-blend requirements. | Scallop/excavate defect, weld repair, blend to restore profile, FPI after weld and after heat treatment. | Trailing-edge/local crack indications are at designated weld-repairable locations and require localized excavation, weld repair and profile blending. FPI after weld and after heat treatment is required before release. |

| Damage Category | Finding (As Inspected) | Disposition |
|---|---|---|
| <b>Trailing Edge Cracks</b> | Crack indications identified on trailing edge in inspection photos; defect map routes nozzle segments for weld-and-blend. | Excavate / scallop defect, weld repair, blend to profile, FPI confirmation and heat treatment. |

Fig.13 Crack on trailing edge.

Fig.14 Crack on trailing edge.

Fig.15 Crack on trailing edge.

Fig.16 Crack on trailing edge.

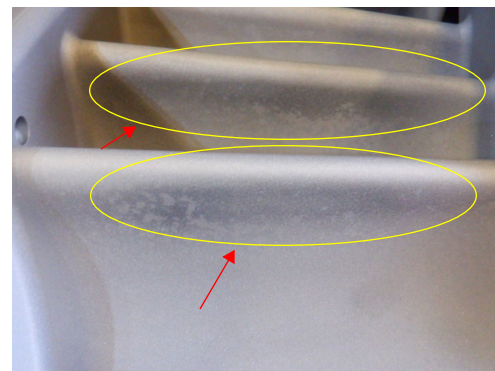
| Damage Category | Finding (As Inspected) | Disposition |
|---|---|---|
| <b>Leading Edge / Airfoil Corrosion</b> | Corrosion identified on leading edge and concave airfoil; material evaluation identifies surface oxidation-corrosion, removable by controlled cleaning. | Grit blast, controlled blend, surface cleaning, metallurgical acceptance, FPI, and diffused aluminide coating. |

Fig.17 Corrosion on leading edge.

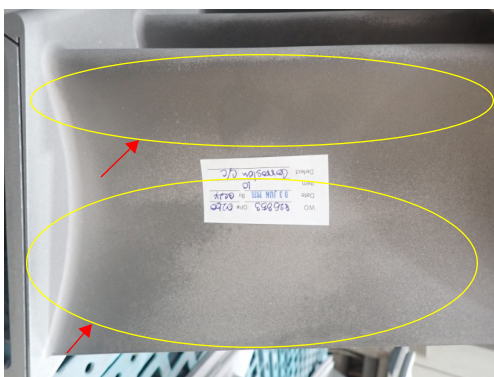
Fig.18 Corrosion on leading edge and concave airfoil.

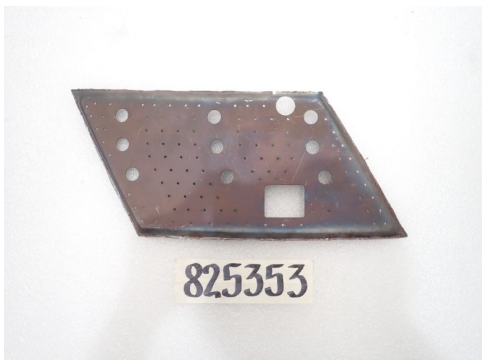
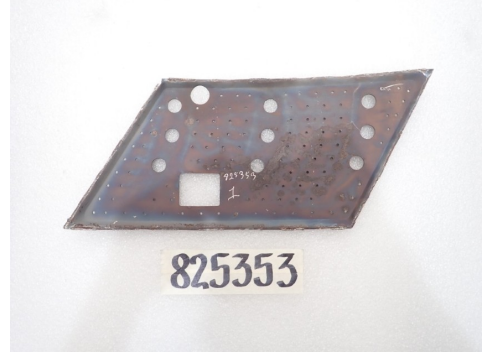
| <p>Fig.19 As received condition of Cover plate, (repairable).</p> | <p>Fig.20 As received condition of Cover plate, (repairable).</p> |

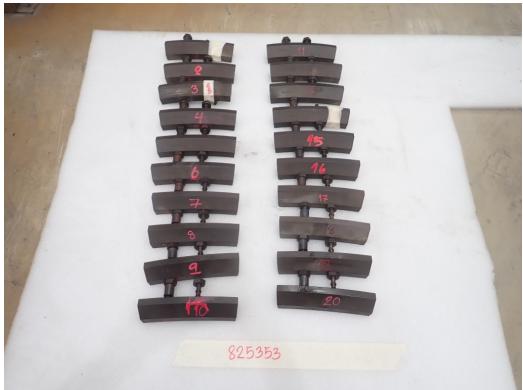
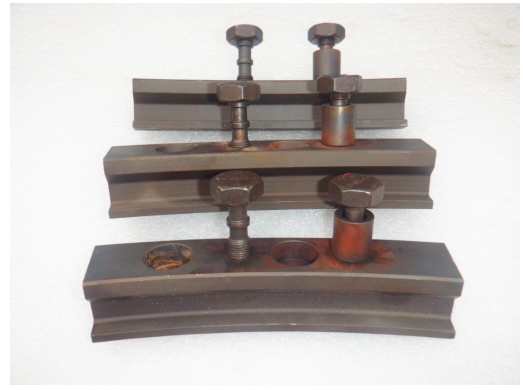
| <p>Fig.21 Impingement plate, Bush, Diaphragm RET. screw pin- Hex. Head Bolt, (repairable).</p> | <p>Fig.22 Impingement plate, Bush, Diaphragm RET. screw pin- Hex. Head Bolt, (repairable).</p> |

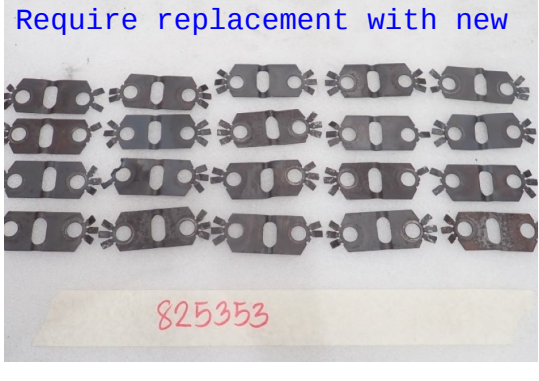
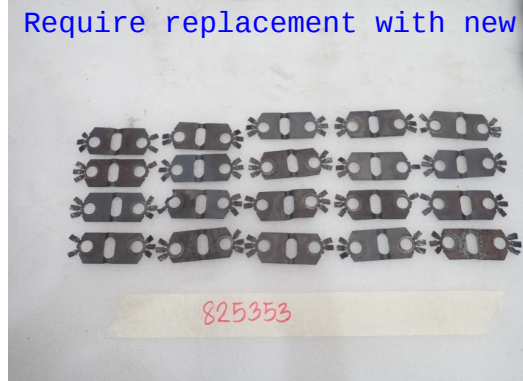
| Damage Category | Finding (As Inspected) | Disposition |
|---|---|---|
| <b>Locking Plates</b> | 20/20 locking plates show deformation and require replacement. | Replace locking plates; inspect fastening and post-repair assembly fit-up. |

| <p>Fig.23 Deformation of locking plate which requires replacement with new.</p> | <p>Fig.24 Deformation of locking plate which requires replacement with new.</p> |

| <p>Require replacement with new</p> <p>825353</p> | <p>Require replacement with new</p> <p>825353</p> |

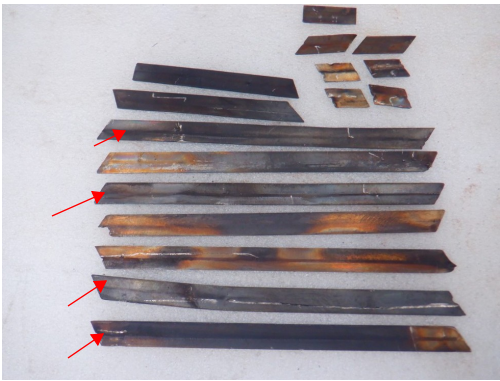
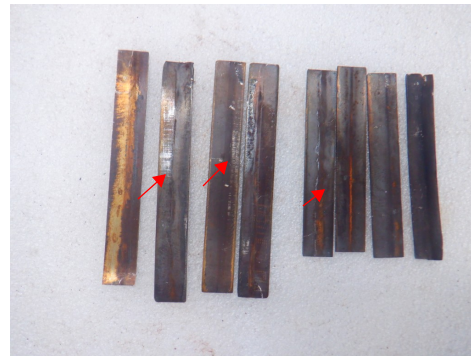
| Damage Category | Finding (As Inspected) | Disposition |
|---|---|---|
| <b>Cloth Seals and Joint Seals</b> | 90/90 segment assembly cloth seals, 36/36 diaphragm cloth seals, 10/10 segment joint seals, and 4/4 diaphragm joint seals require replacement. | Replace all listed seals and verify final assembly fit-up and seal alignment. |

Fig.25 Fretting,deformation and corrosion on seals which require replacement with new.

Fig.26 Fretting,deformation and corrosion on seals which require replacement with new.

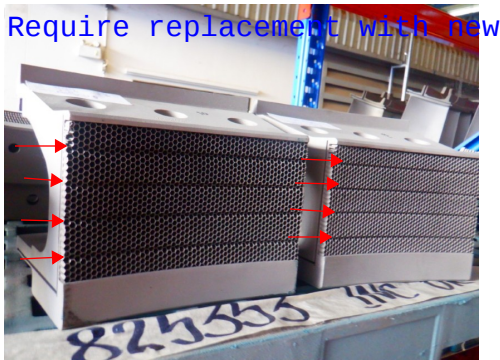
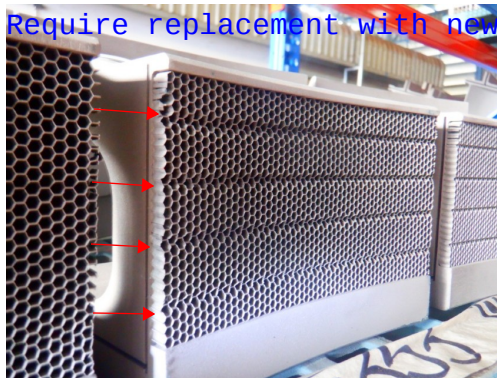
| Damage Category | Finding (As Inspected) | Disposition |
|---|---|---|
| <b>Honeycomb Seals</b> | 20/20 honeycomb seals require replacement. | Prepare and fit replacement honeycombs to diaphragm faces; braze heat treatment; blend excess honeycomb and inspect. |

Fig.27 Fretting on Honeycomb seals which require replacement with new.

Fig.28 Fretting on Honeycomb seals which require replacement with new.

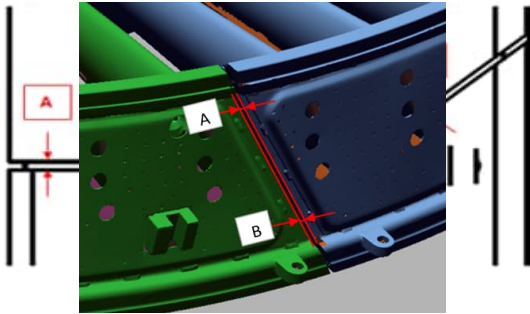
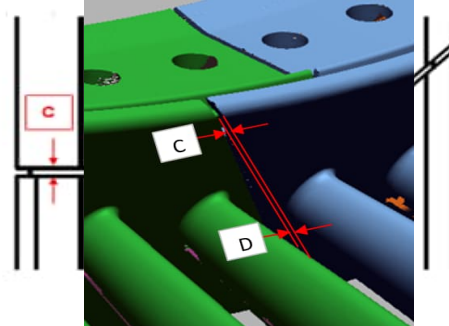
Outer wall/Inner wall abutment face gaps

| 9 | Gap and alignment measurements | Outer/inner abutment face gaps A–D range 2.07–4.73 mm; diaphragm top face gaps E–F range 2.32–5.04 mm; front face gaps G–H range 2.42–5.60 mm; discourager seal alignment 0.17–0.25 mm. | Final seal alignment and assembly verification after diaphragm repair, seal/honeycomb replacement, and coating. | Gap/alignment values provide the baseline for seal alignment. Final alignment must be verified after diaphragm repair, honeycomb replacement and coating. |
