# INCOMING INSPECTION REPORT

## MS6001FA (GE Frame 6FA) 2nd Stage Bucket Set

| Customer | Nghi Son Refinery & Petrochemical LLC |
| Component | MS6001FA 2nd Stage Bucket |

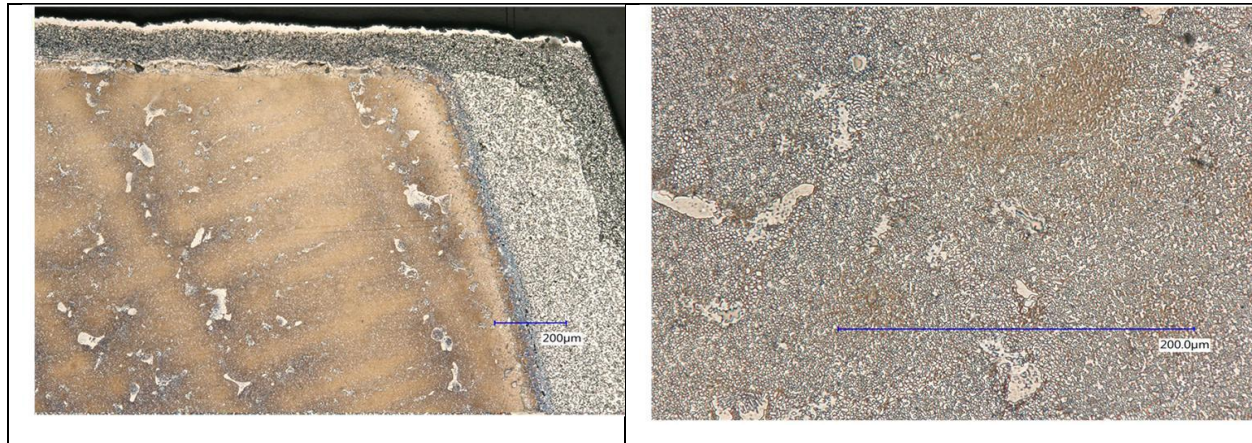
The cut section taken from bucket item 92 was mounted and evaluated to confirm whether the serviced component material remains acceptable for repair. The hot gas path surface was protected by MCrAlY (HVOF) coating. The base material was confirmed as GTD 111 alloy. Based on the evaluation, the base material remains acceptable for repair after removal of the coating by controlled acid stripping. The component is therefore repairable, subject to completion of the required Level 9 heavy repair scope, dimensional restoration, heat treatment, FPI/NDT verification, and final acceptance inspection. Microstructure micrographs are retained in the inspection file.

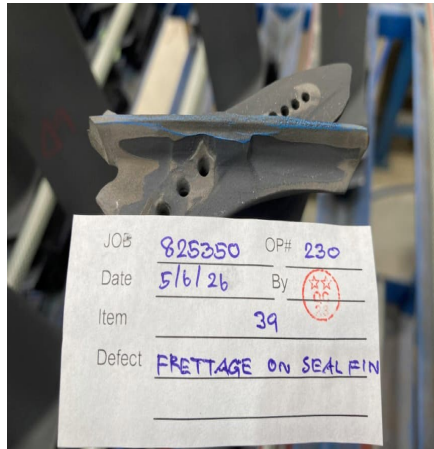
- **Seal fin.** The seal fin sits at the bucket tip and controls the gap between the tip and the shroud. When the seal fin is worn down, more hot gas leaks over the bucket tip. This lowers stage sealing, reduces output, and raises tip temperature. Seal fin height is rejected on all 92 buckets.

Figure 13. Fretage on seal fin.

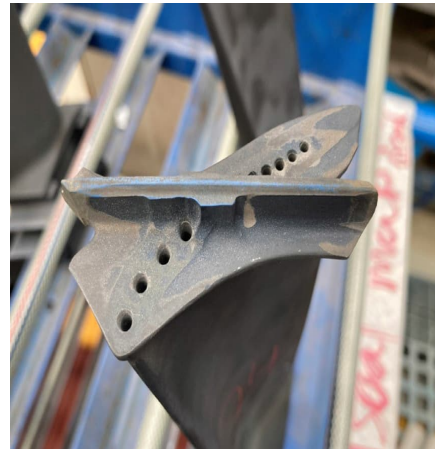
Figure 14. Fretage on seal fin.

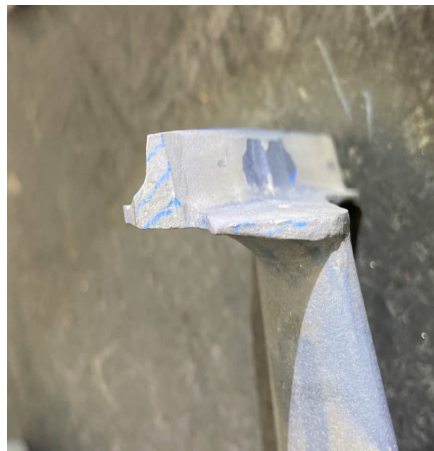
- **Z-notch and shroud interlock.** The Z-notch and shroud on each bucket lock to the next bucket. Together they form one continuous ring at the bucket tips. This ring stiffens the tips and controls bucket vibration and tip sealing. When the engagement is low, the ring is loose, the tip is less stiff, the bucket vibrates more, and the airfoil sees higher stress. On item 75 the engagement is below zero, which means the interlock contact is gone and that bucket no longer locks to its neighbor. The Z-notch is rejected on all 92 buckets, and engagement is below the 50% limit on 23 buckets.

Figure 15. Fretage on Z-notch.

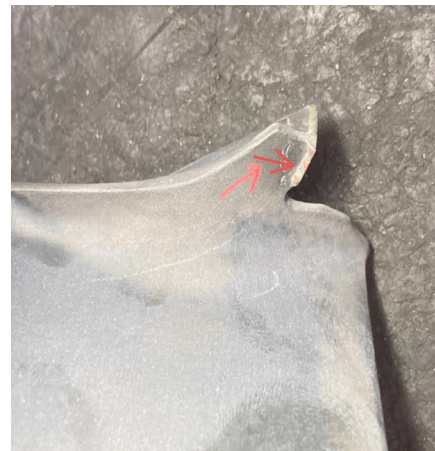
Figure 16. Weldment on Z-notch.

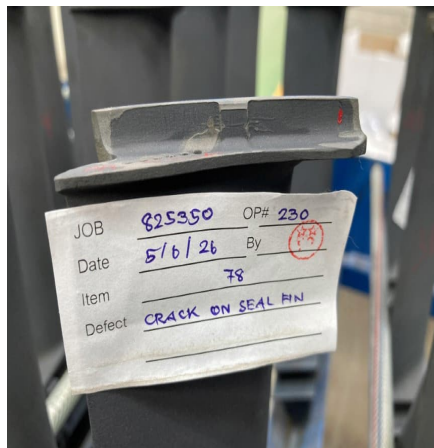
| No. | Measurement / Defect Basis | Numeric Finding | Required Restoration / Repair Process | Level 9 Justification |
|---|---|---|---|---|
| 8 | Seal fin crack | <b>Discrete crack indication on item 78 seal fin.</b> Recorded during fluorescent penetrant inspection. | Excavate the crack, weld repair the affected area, and verify by FPI. | A crack at a sealing feature requires controlled excavation and weld repair, not blending. |

| Damage Category | Finding (As Inspected) | Disposition |
|---|---|---|
| <b>Seal Fin Crack</b> | Discrete crack indication on item 78 seal fin. | Excavate, weld repair, and FPI verification. |

Figure 17. Crack on seal fin.

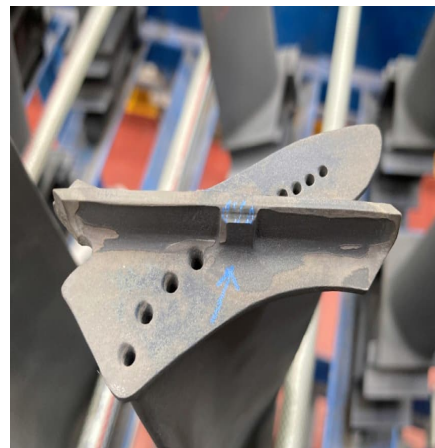
- **Cutter teeth.** The cutter teeth cut a clean track in the shroud during running and set the tip clearance. Worn cutter teeth cannot hold the clearance, so tip leakage goes up. The cutter teeth are worn on all 92 buckets.

Figure 18. Fretage on cutter teeth.

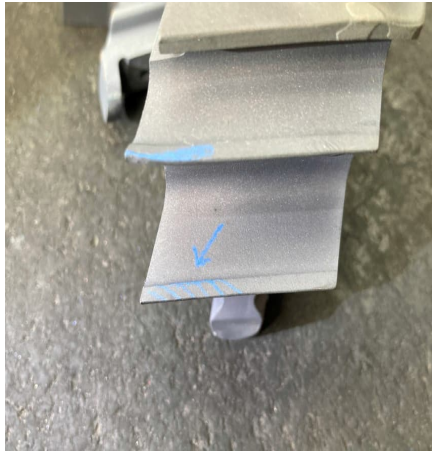
- **Angel wings.** The angel wings seal the wheelspace below the airfoil and keep hot gas out of the rotor wheelspace. When the angel wing height is low, this seal is weak and hot gas can reach the wheelspace and the rotor. This raises rotor metal temperature. Angel wing height is rejected on all 92 buckets, and 4 buckets have cracks in this area.

Figure 19. Deformation and fretage on angel wing.

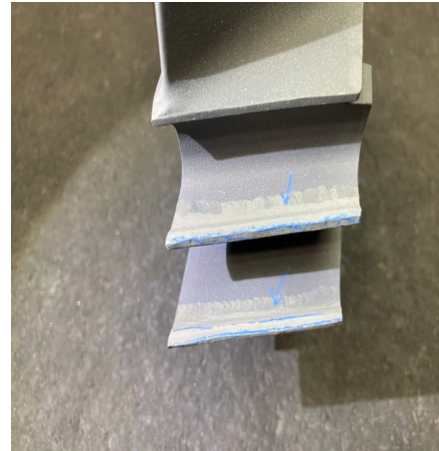
Figure 20. FOD on angel wing.

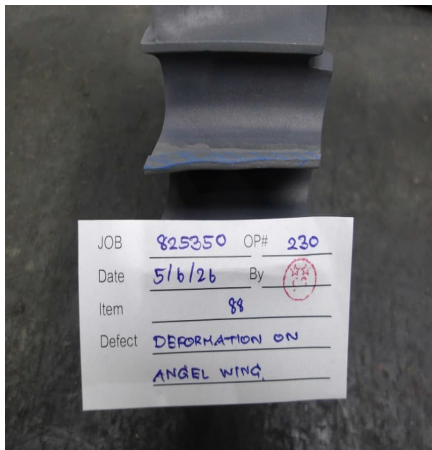
Figure 21. Deformation on angel wing.

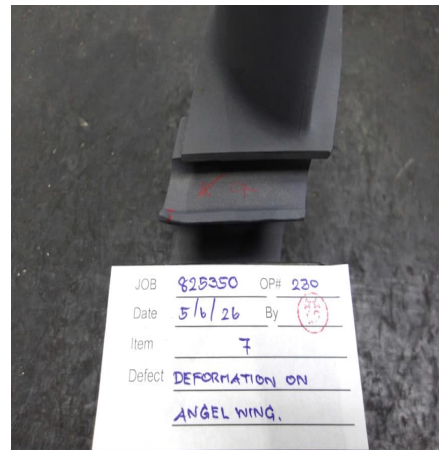
| Damage Category | Finding (As Inspected) | Disposition |
|---|---|---|
| <b>Angel Wing</b> | Angel wing fretting and deformation on 92 of 92 buckets. Angel wing height dimensionally rejected on 92 of 92 buckets. Discrete cracks on items 7, 28, 29, and 33. | Weld build up, machine to recreate angel wing dimensions, crack excavation and weld repair, and profile restoration. |

Figure 22. Deformation and crack on angel wing.

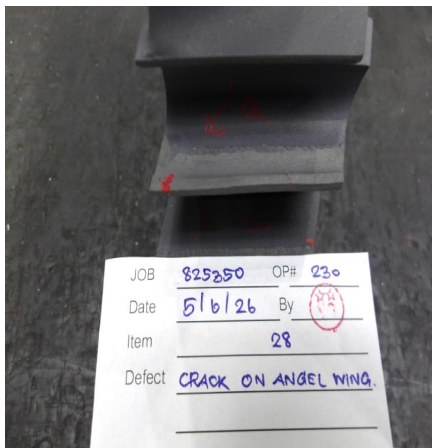
Figure 23. Crack on angel wing.

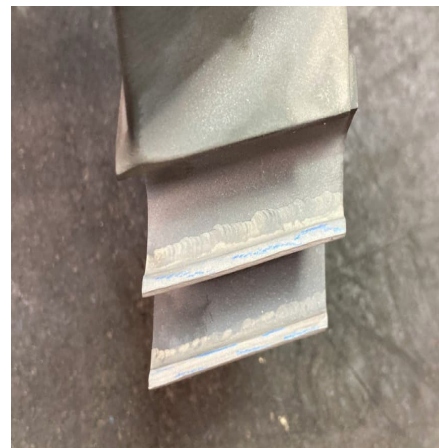
Figure 24. Weldment on angel wing.
