INCOMING INSPECTION REPORT

Customer	Nghi Son Refinery and Petrochemical, LLC.
Customer PO Number	770682
Part Description	Frame 6FA MNQC Syngas Dual Fuel Nozzles
Report No	AB9015557 – 250919 Rev 0
Report Date	October 1, 2025
Author	Liam Watson

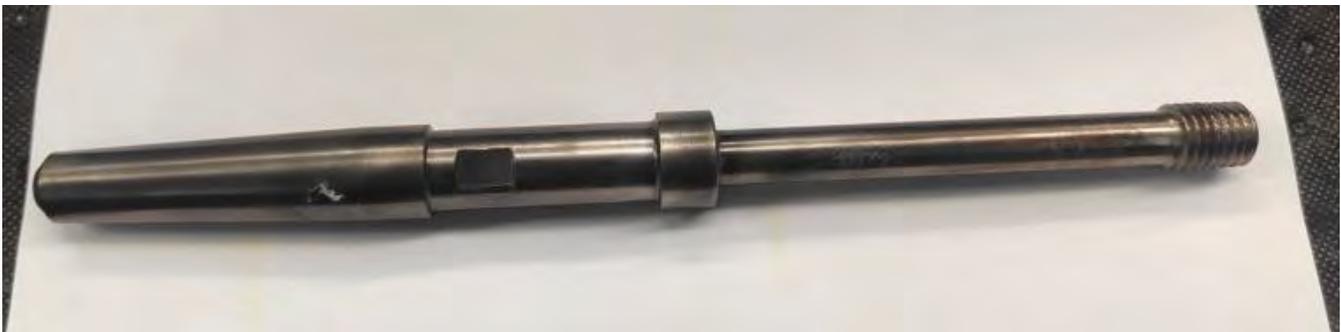
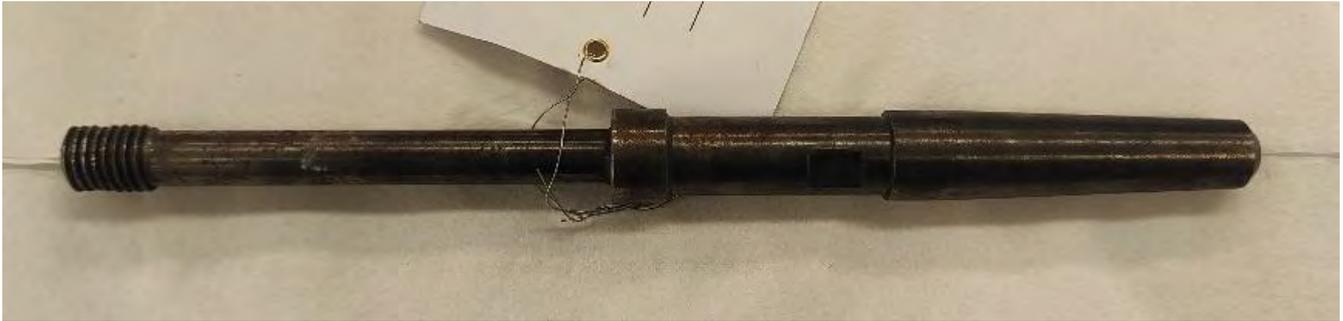
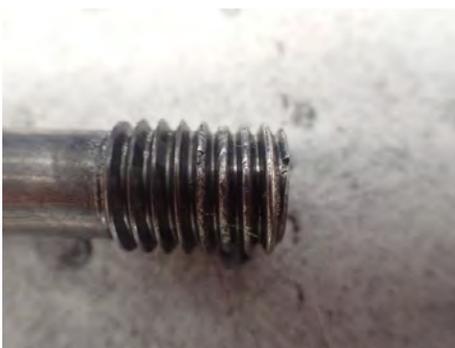
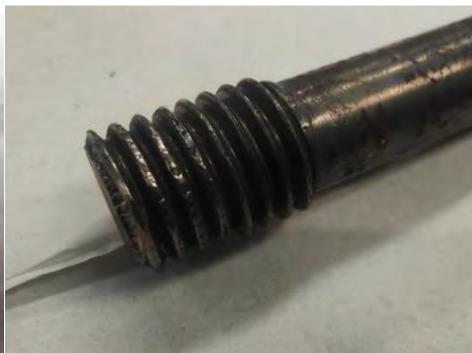
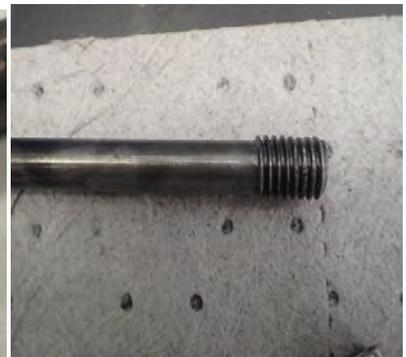
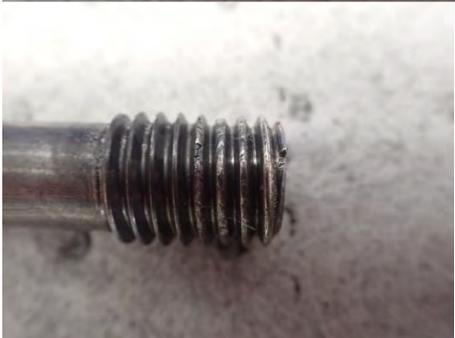
a. 4 x End Cover Liner Pins were found to have stripped threads

- **Repeated thermal cycling and mechanical vibration** over extended operating hours caused gradual loosening between the liner and end cover interface. The cyclic expansion and contraction resulted in micro-movement that led to thread wear and material galling.
- **High installation torque during previous maintenance** may have over-stressed the thread roots, weakening the material and making it prone to stripping during removal.
- **Carbon and oxide buildup** around the threaded sections also contributed to thread seizure, requiring additional torque during disassembly and leading to partial stripping.
- **Localized heat exposure** near the combustor end increased metal hardness differentials between the pin and the female threads, accelerating wear when subjected to vibration.

The thread damage is attributed to combined effects of thermal fatigue, vibration-induced fretting, and excessive tightening during prior installation. Replacement of all affected liner pins with new components was carried out as part of the heavy repair scope to restore full mechanical integrity and secure alignment between the end cover and liner assembly.

- **End Cover Liner Pins** – replaced to restore the secure mechanical connection between the liner and end cover; the original pins were found worn and elongated from repeated thermal cycling.

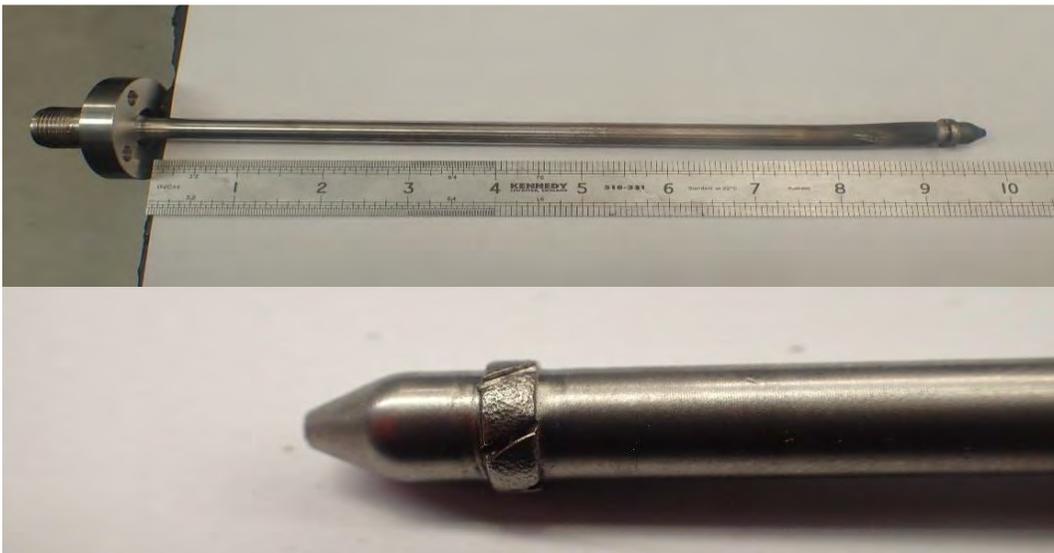
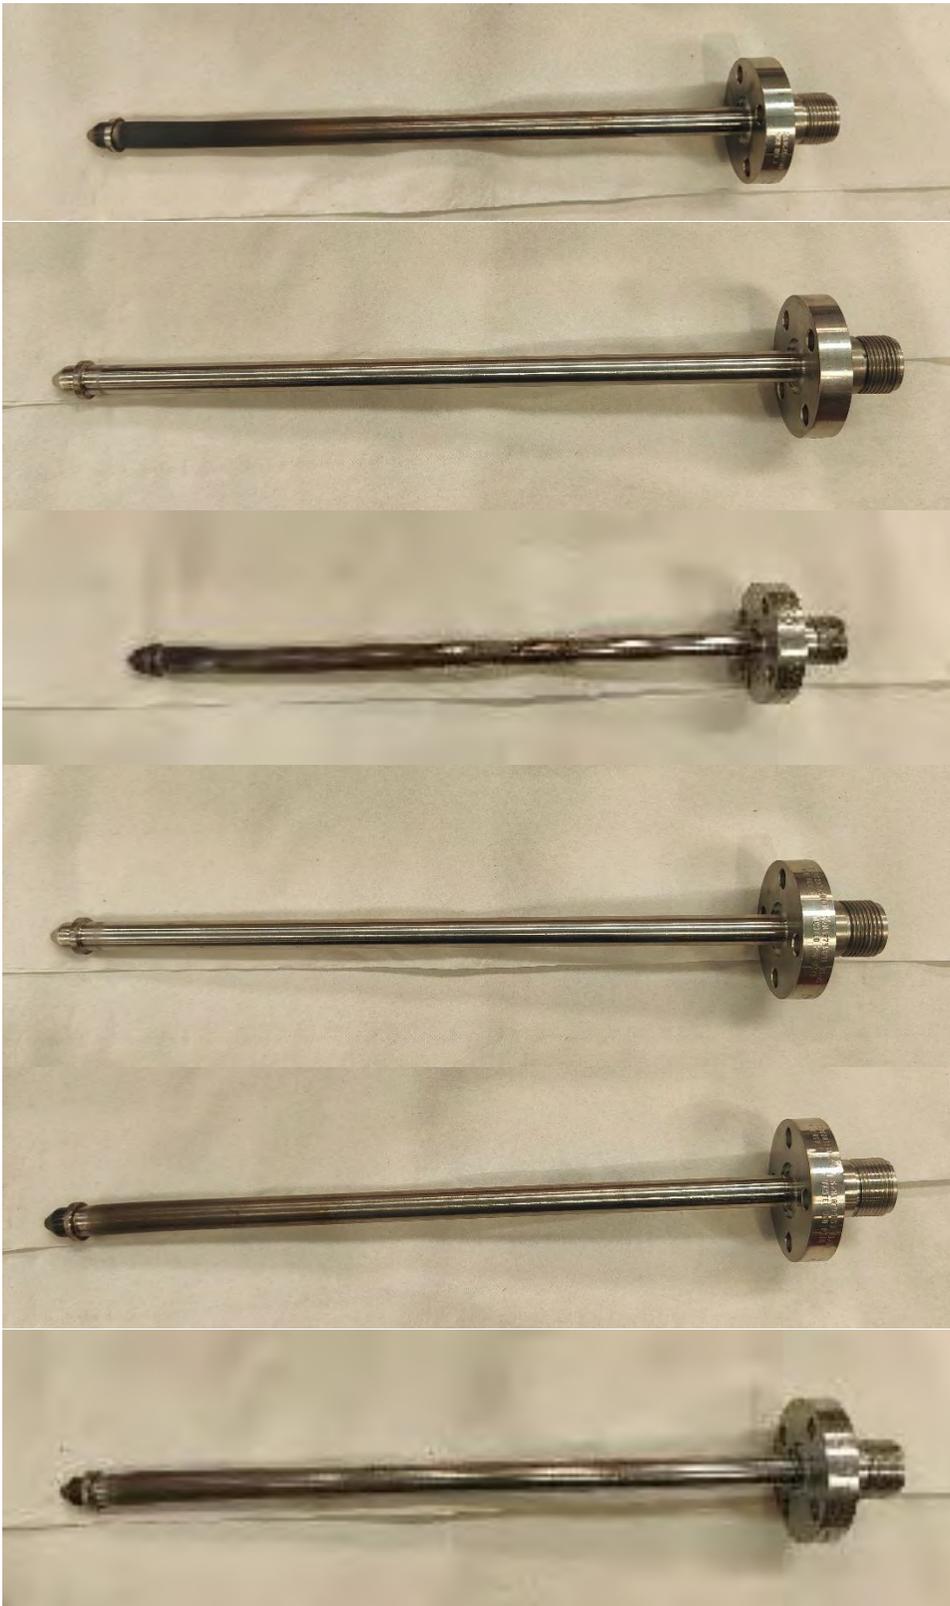
b. 12 x Liquid Cartridge Assemblies were found to be burnt out

During detailed inspection, twelve (12) Liquid Cartridge Assemblies were found to be beyond refurbishable condition, exhibiting severe erosion, pitting, and deformation of the internal fuel passages.

- Prolonged high-temperature exposure was identified as the primary factor contributing to material degradation. Continuous operation under elevated combustion temperatures caused thermal fatigue, oxidation, and loss of coating adhesion, especially near the liquid cartridge tip area.

- Erosion and cavitation within the internal fuel passages occurred due to high-velocity liquid fuel injection, especially during transient load changes. This led to surface roughening and enlargement of metering orifices, reducing fuel flow accuracy.

- Thermal fatigue cracking propagated along cartridge walls and tip zones due to cyclic heating and cooling, particularly during frequent start-up and shutdown sequences.

- Chemical corrosion and carbon deposition from fuel impurities and incomplete combustion accelerated metal surface deterioration and internal coating breakdown.

- Misalignment and wear at sealing interfaces between the cartridge and end cover resulted in uneven load transfer and localized stress, further promoting cracking and deformation.

The damage to the 12 Liquid Cartridge Assemblies is attributed to combined high-temperature exposure, thermal fatigue, and erosion accumulated over extended service time. These factors caused irreversible distortion and internal flow path degradation, making refurbishment impractical. Replacement of all twelve assemblies under the heavy repair scope was therefore carried out to restore proper flow geometry, spray pattern accuracy, and combustion stability in accordance with OEM-equivalent performance standards.

- **Liquid Cartridge Assembly** – replaced due to internal erosion, distortion, and passage deformation that could not be corrected by standard refurbishment processes.

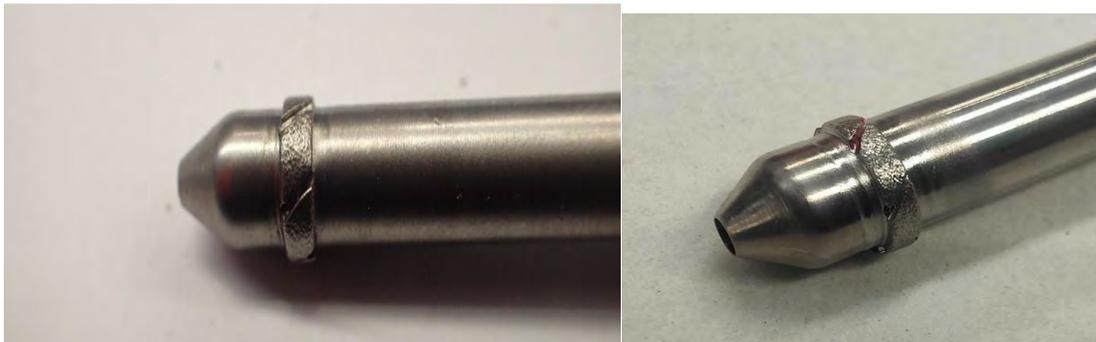
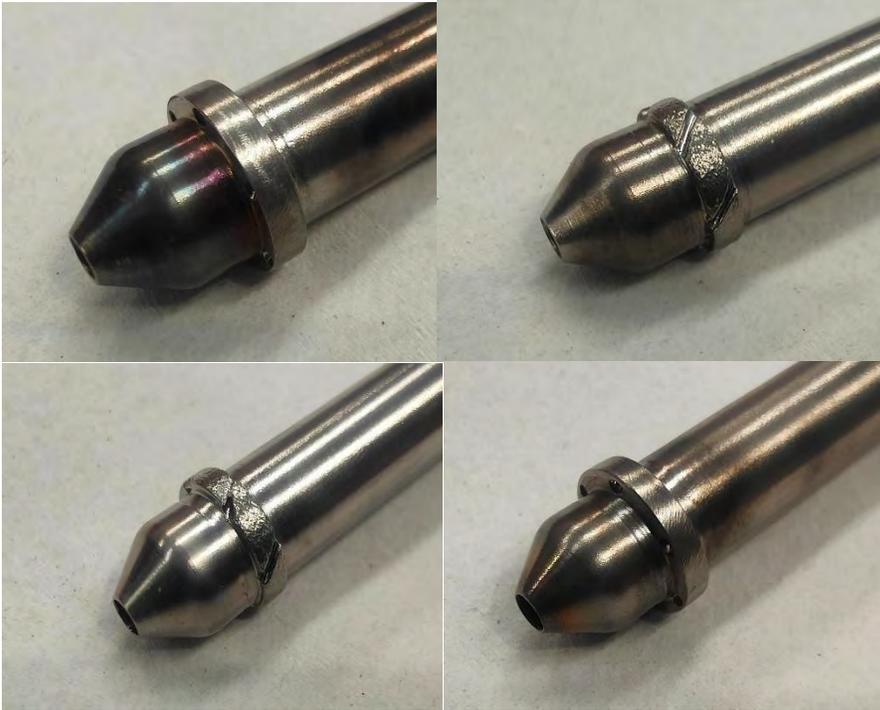
c. 10 x Liquid Cartridge Tips were found to have eroded water swirl vanes.

During inspection, ten (10) Liquid Cartridge Tips were found to be severely damaged and beyond repairable condition. The affected tips exhibited significant signs of surface cracking, tip deformation, and internal erosion in the fuel discharge ports.

- High-temperature exposure during extended operation was the primary cause of degradation. Continuous exposure to extreme flame temperatures led to oxidation, metal fatigue, and loss of surface integrity at the tip ends.

- Localized overheating occurred due to uneven fuel flow and combustion dynamics, causing melting and rounding of the tip edges. These effects were most pronounced in tips located near zones of high thermal flux.

- Thermal fatigue resulting from repeated start-up and shutdown cycles caused fine cracks to form along the outer surface and internal bore areas. Over time, these cracks propagated and led to structural weakening.

- Erosive wear was also evident at the metering holes, resulting from high-velocity liquid fuel streams impinging on the nozzle surfaces. This contributed to distortion of the orifice shape and inconsistent spray angles.

- Carbon deposition and coating loss were observed in several tips, indicating breakdown of the protective layer due to prolonged exposure to high heat and fuel impurities.

The 10 Liquid Cartridge Tips were determined to be unfit for refurbishment due to thermal fatigue cracking, orifice distortion, and coating failure caused by high-temperature exposure and erosive operating conditions. Replacement with new components under the heavy repair scope was therefore required to restore proper atomization characteristics, fuel distribution uniformity, and overall combustion performance of the MNQC fuel nozzle assemblies.

- **Liquid Cartridge Tip** – replaced to restore the correct spray pattern and combustion stability; previous tips exhibited surface fatigue and carbon deposition.

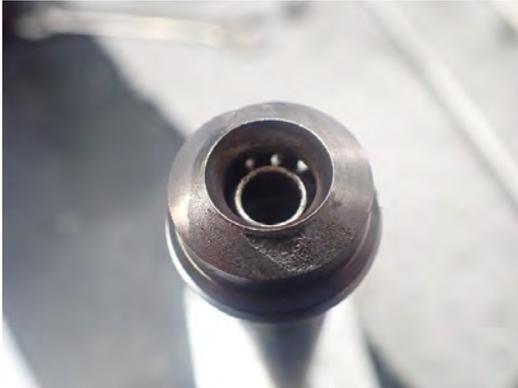
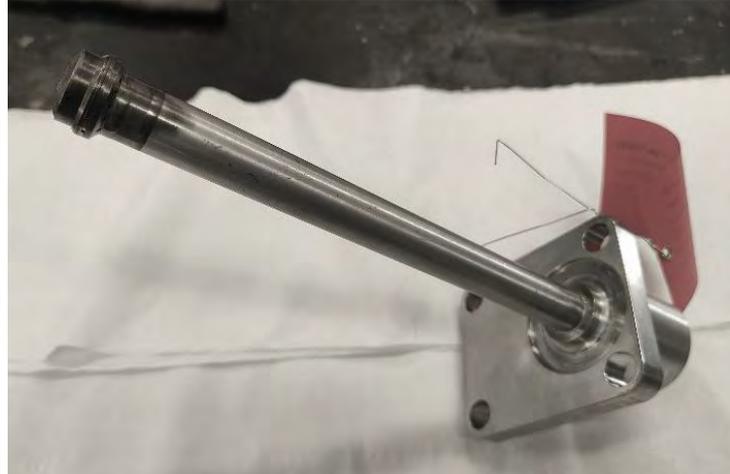
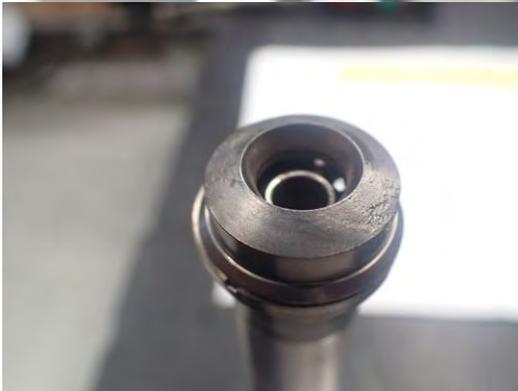
d. 2 x Water Cartridge Tip was found to be eroded

During detailed inspection, two (2) Water Cartridge Tips were found to be eroded and worn beyond acceptable service limits. The erosion was concentrated around the discharge ports and tip faces, with evident surface thinning and loss of geometric profile.

High-velocity water injection during operation caused continuous impingement and abrasive wear at the tip outlets. Over time, this eroded the metal surfaces and enlarged the injection orifices, resulting in degraded spray patterns and reduced atomization efficiency.

- **High-temperature exposure** in the combustion environment accelerated surface oxidation and coating breakdown, further weakening the material and exposing the base metal to direct erosion.
- **Thermal cycling and quenching** effects during frequent startup and shutdown operations induced surface fatigue, which promoted micro-crack formation and progressive surface loss.
- **Chemical reaction** between injected water and combustion byproducts also contributed to localized corrosion, particularly in areas where the protective coating had deteriorated.

The 2 Water Cartridge Tips were found to be irreparable due to severe erosion, oxidation, and loss of dimensional integrity. The damage compromised water injection uniformity and posed a risk of imbalance in combustion cooling effectiveness. Replacement with new Water Cartridge Tips under the heavy repair scope was therefore carried out to restore proper flow geometry, cooling efficiency, and stable combustion performance in accordance with OEM-equivalent standards.

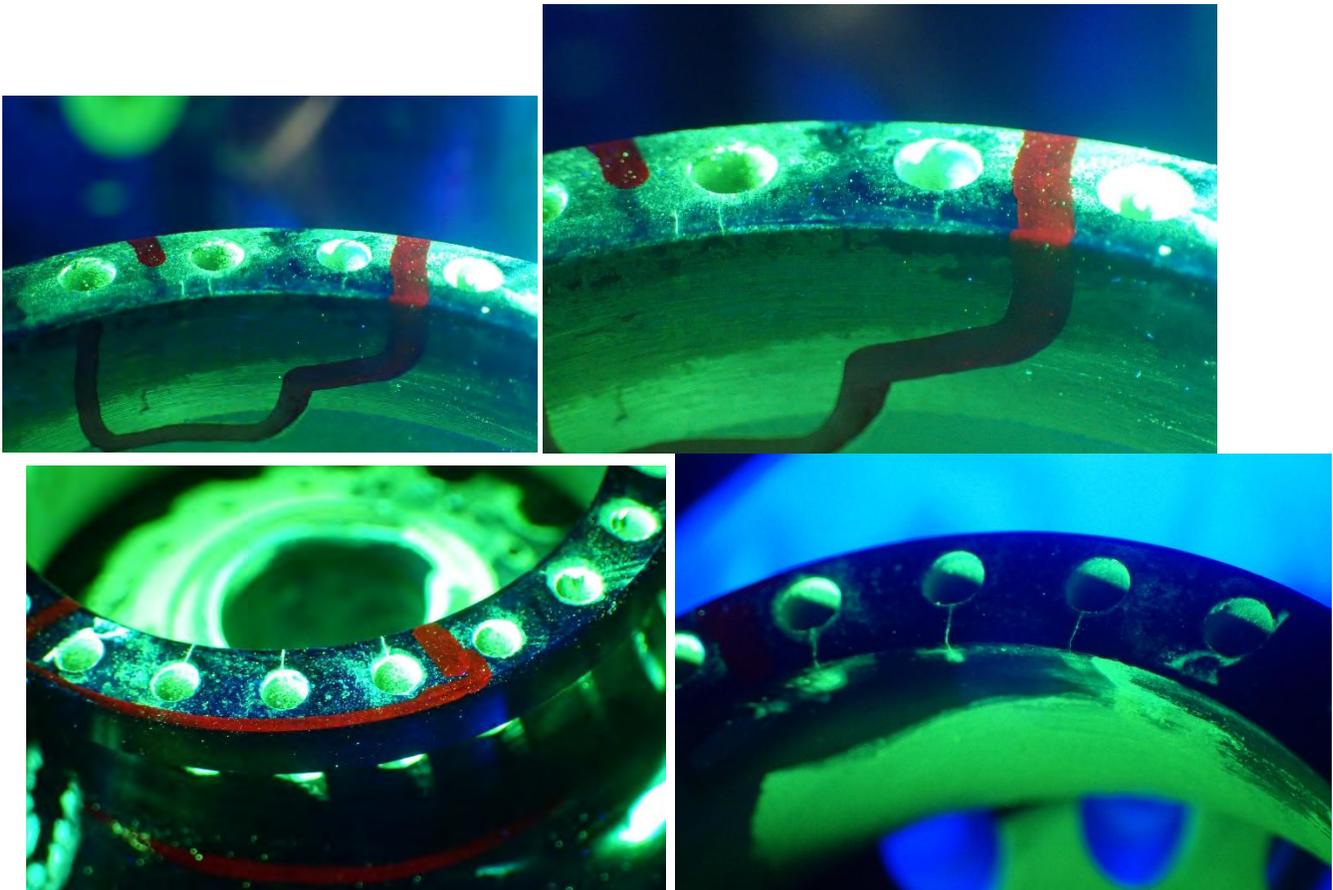
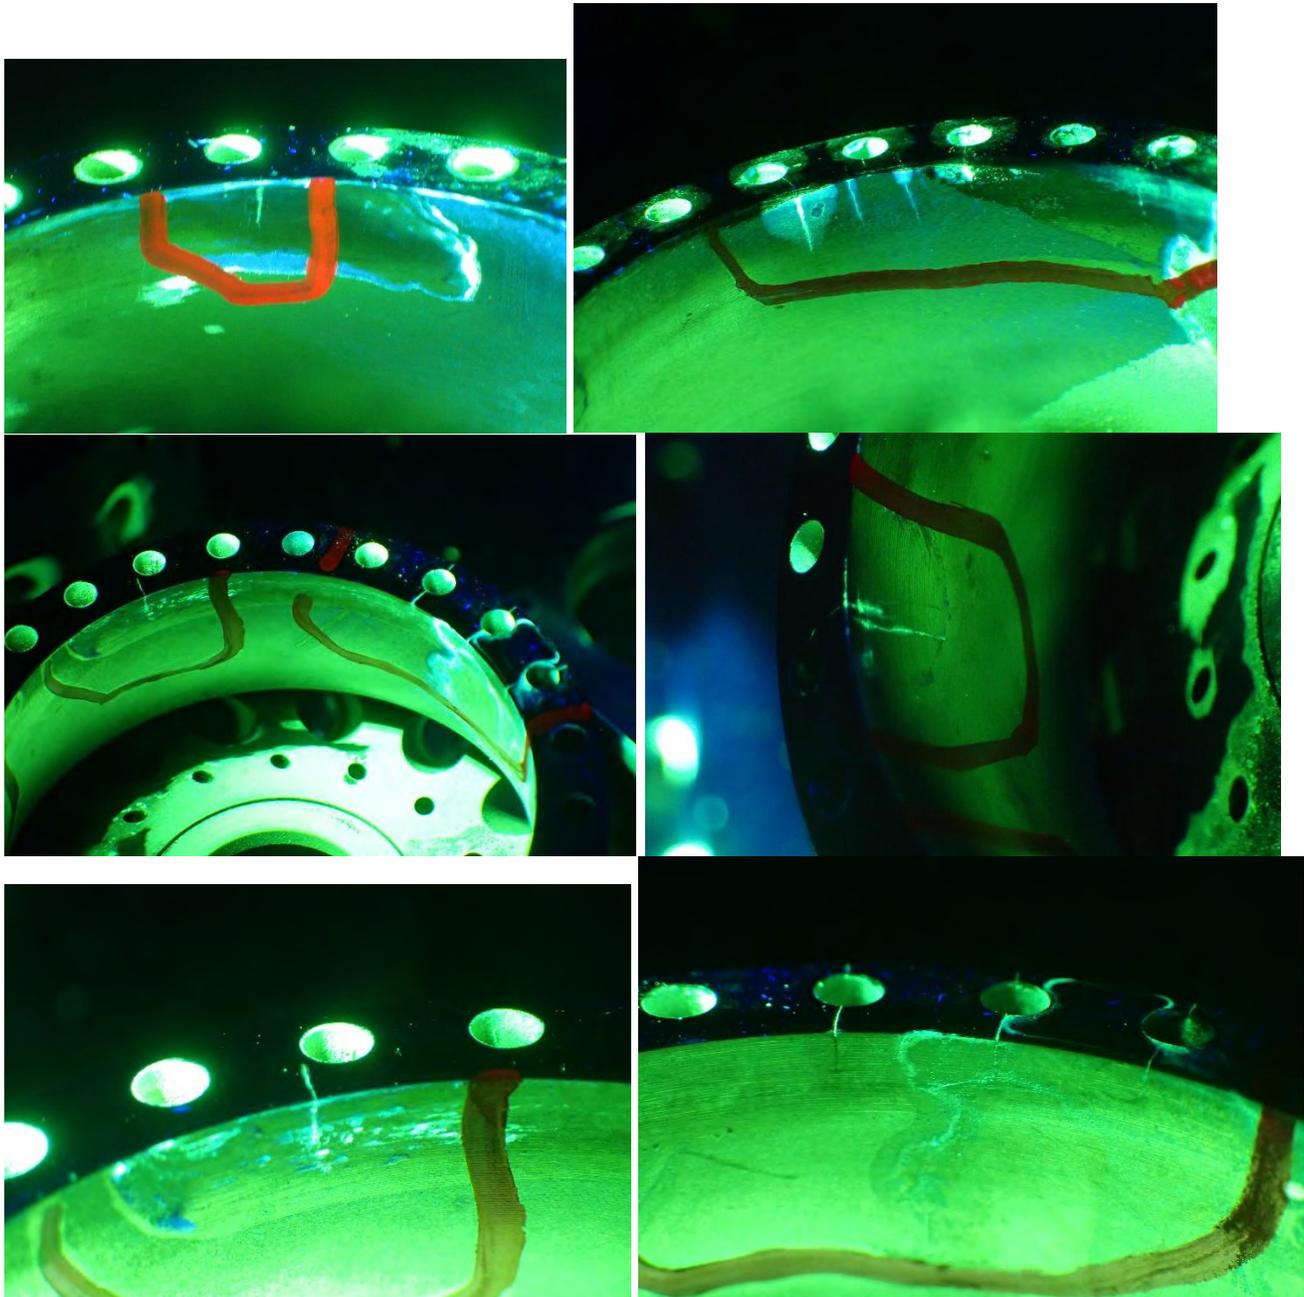
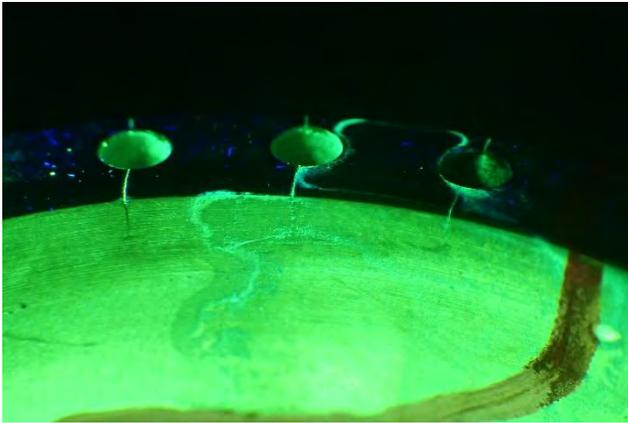
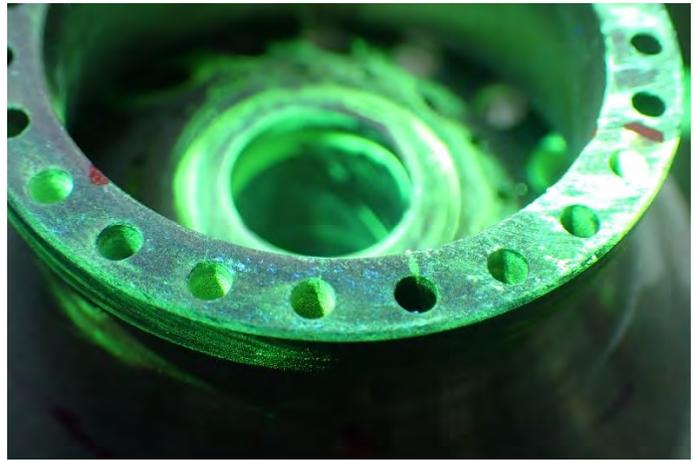
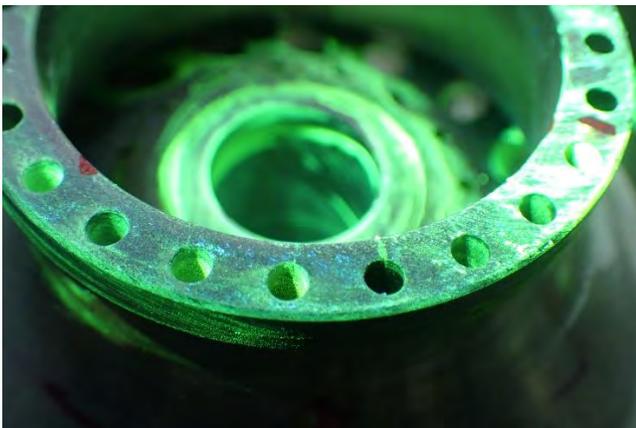
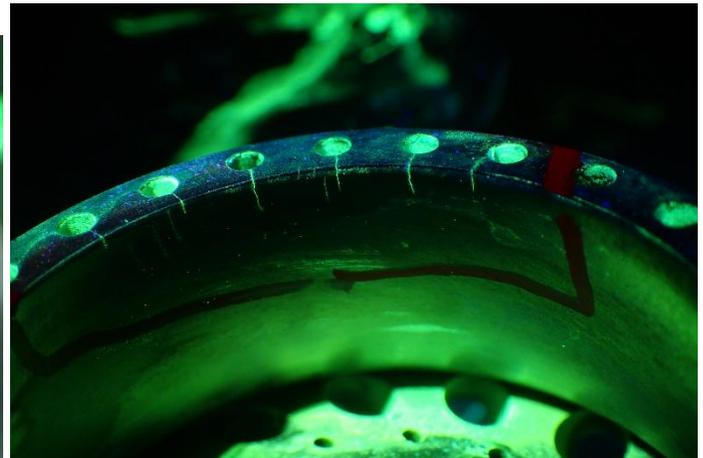
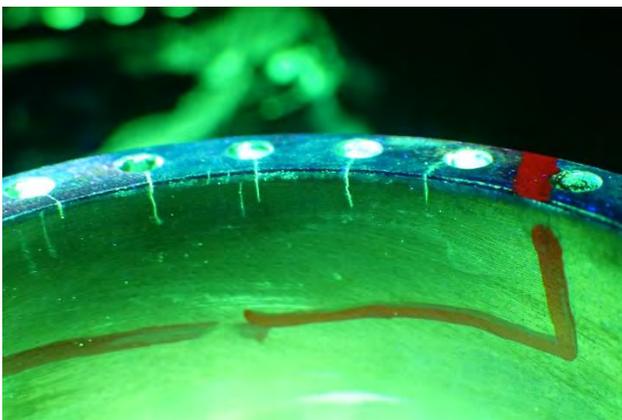
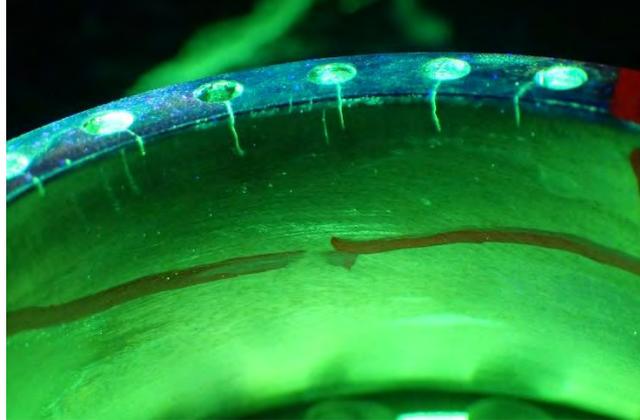
e. 24 x End Cover Gas Swirlers were found to have cracking around the air outlet holes.

- **Thermal fatigue** was identified as the principal cause of cracking. Continuous exposure to high combustion temperatures, combined with repeated heating and cooling cycles, induced material fatigue stresses in the thin sections surrounding the outlet holes.
- **High-velocity air and fuel mixture flow** generated localized vibration and pressure pulsation at the outlet edges, which further propagated existing fatigue cracks.

- **Metal oxidation and coating degradation** weakened the protective layer, exposing the base material to thermal stress and oxidation-assisted crack growth.
- **Structural stress concentration** at the outlet hole perimeters — a known weak point in the swirler geometry — contributed to the initiation and propagation of circumferential cracks under cyclic loading.

The 24 End Cover Gas Swirlers were assessed to be beyond refurbishable condition due to the presence of multiple thermal fatigue cracks and oxidation damage in critical flow zones. Continued operation in this condition would risk loss of mixing uniformity and potential combustion instability. All affected swirlers were therefore replaced under the heavy repair scope to restore the original flow distribution, mechanical integrity, and reliable mixing performance consistent with OEM standards.

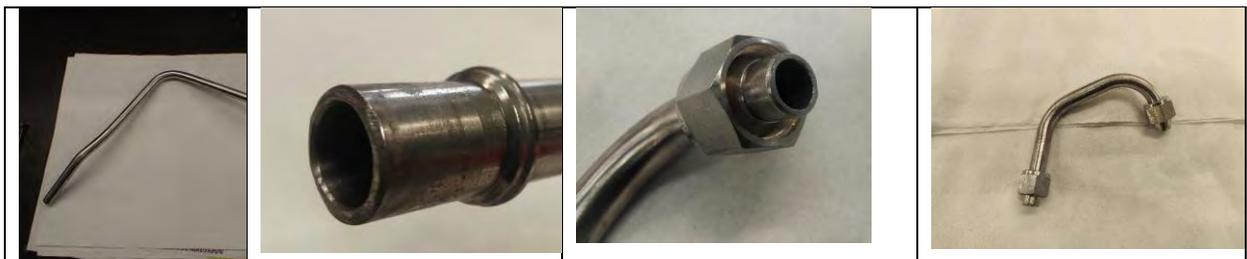
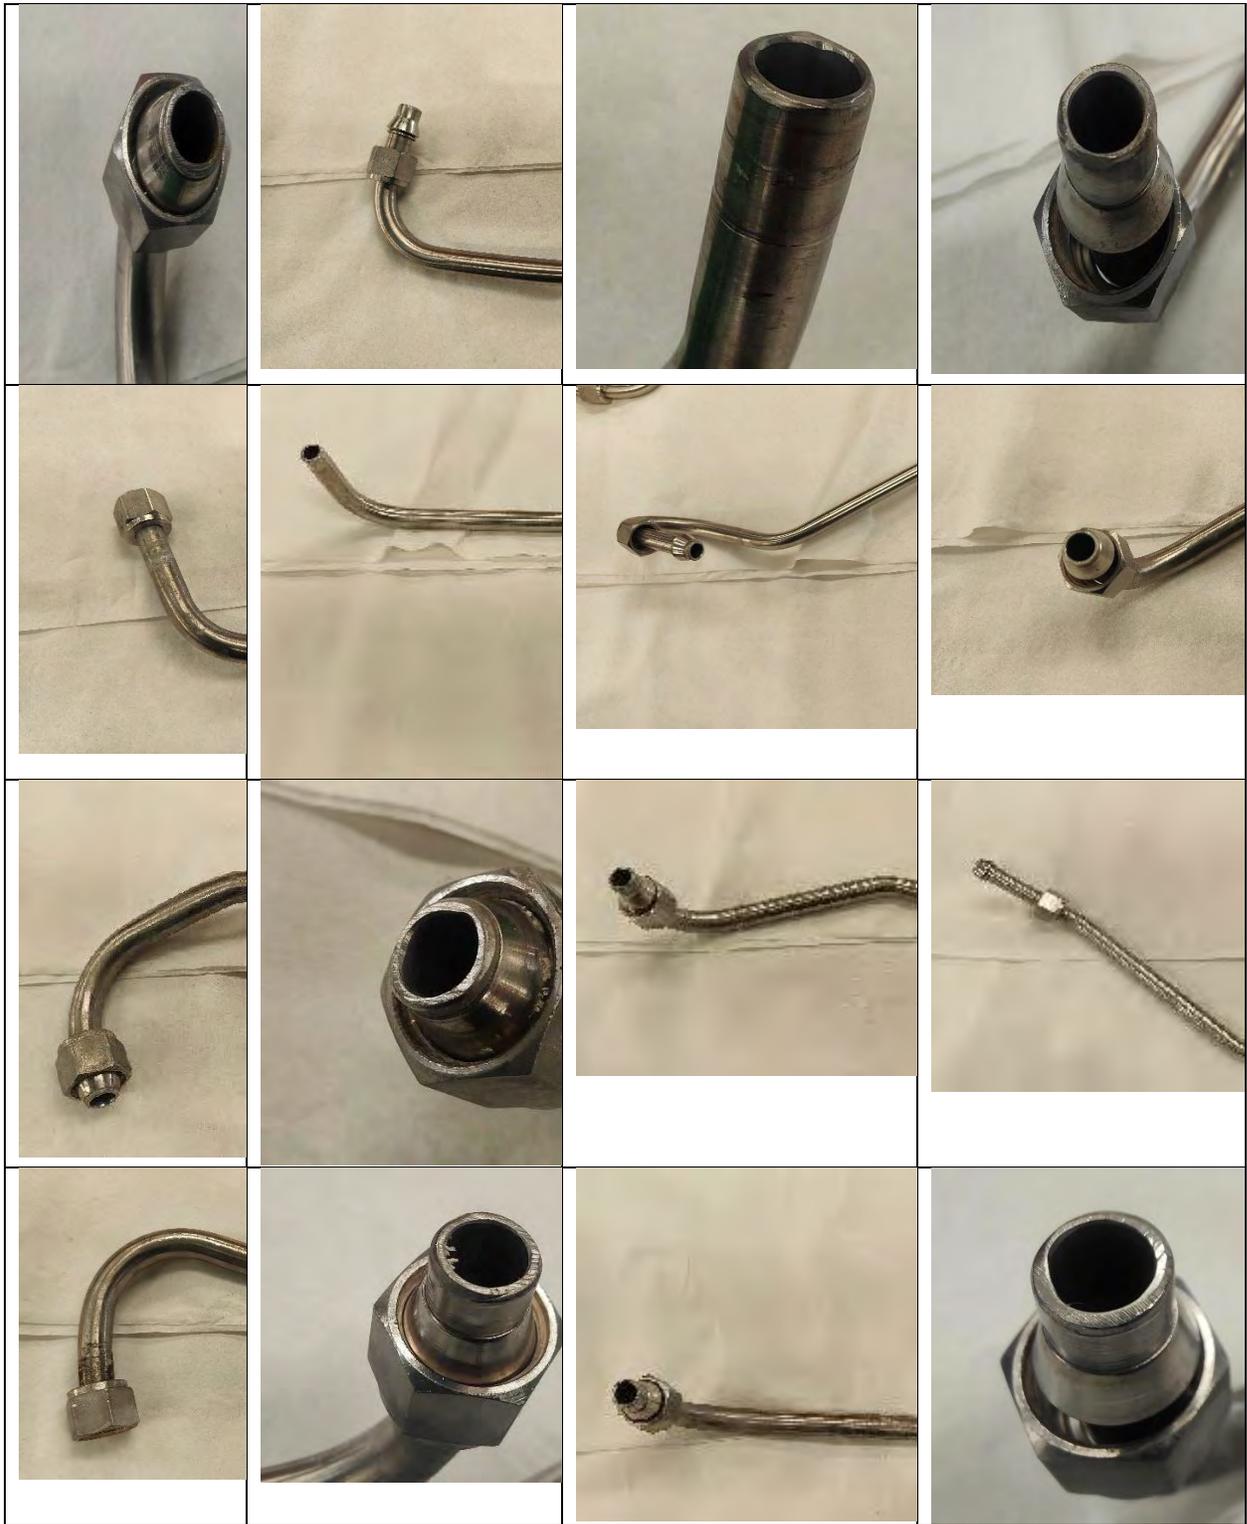
f. 16 x Water Pipes were found to be deformed

During inspection, **sixteen (16) Water Pipes** were found to be **deformed and out of dimensional tolerance**. The deformation was primarily observed along the curved sections and connection ends, resulting in misalignment and restricted flow passages.

- **Prolonged exposure to high operating temperatures** led to gradual softening of the pipe material and thermal distortion, particularly in sections located near the combustion zone.
- **Thermal expansion and contraction cycles** during frequent start-up and shutdown operations induced mechanical stresses, causing gradual bending and ovalization of the pipe walls.
- **Vibration and pulsation from high-velocity water flow** contributed to material fatigue and structural displacement at unsupported segments.
- **Assembly stress during previous installations**—including over-tightened fittings and forced alignment—may have introduced residual strain, which amplified deformation over subsequent operation cycles.
- **Surface oxidation and scaling** reduced wall strength, making the pipes more susceptible to deformation under high thermal and pressure conditions.

The 16 Water Pipes were determined to be beyond acceptable service limits due to deformation, wall thinning, and loss of alignment caused by thermal distortion, vibration, and material fatigue. The deformed geometry adversely affected water flow uniformity and cooling effectiveness. All affected Water Pipes were replaced under the heavy repair scope to restore correct alignment, flow capacity, and cooling performance in accordance with OEM-equivalent specifications.

- **Water Pipework** – replaced to restore full flow integrity and eliminate thinning and corrosion observed in the previous assemblies.

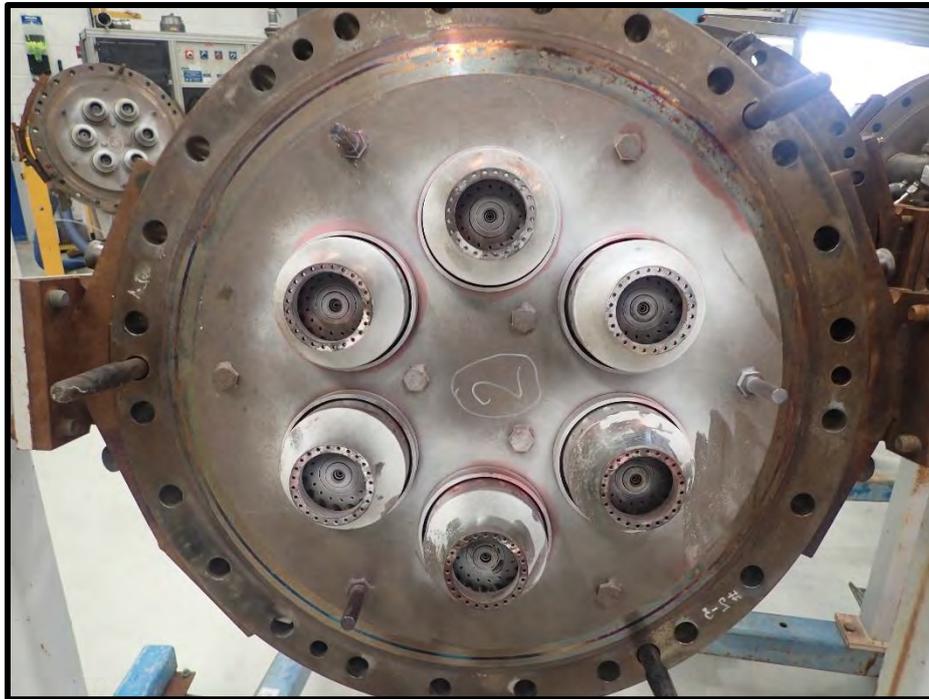
Nozzle Received (Hot side) with Evidence of DPI
