## GAS TURBINE INSPECTION REPORT

### Hot Gas Path Inspection at 33,000 Equivalent Operating Hours

Prepared for  
**DUBAI ELECTRICITY & WATER AUTHORITY (DEWA)**  
**JEBEL ALI G55 POWER PLANT**  
Jebel Ali, Dubai, United Arab Emirates

| Document Number | UNEW-DEWA-G55-HGPI-2018-G51-001 |

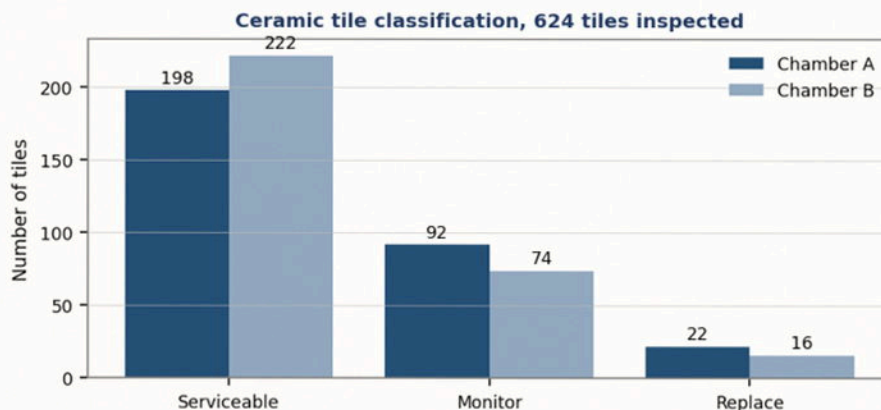
Figure 2. Ceramic tile classification result, chambers A and B

Both chambers were entered under confined space entry permit after atmosphere testing. One hundred percent of the ceramic tiles in both chambers were inspected against the tile inspection template and classified as serviceable, monitor or replace. The classification result is summarized below. All tiles classified as replace were removed and new tiles were installed in the identified positions. Every replacement was photographed and recorded by position number. Tile retaining hardware was inspected at each position and renewed where distortion was found.

| Chamber | Tiles Inspected | Serviceable | Monitor | Replace | Principal Defect Modes |
| Chamber A | 312 | 198 | 92 | 22 | Edge chipping, surface spalling, hot face cracking near the burner belt |
| Chamber B | 312 | 222 | 74 | 16 | Edge chipping, surface spalling, localized hot spotting |
| Total | 624 | 420 | 166 | 38 | |

Note: the monitor classification total of 166 includes tiles in secondary and tertiary zones. Of these, 61 tiles in the burner belt and flame zone are recorded by position as priority monitor items for the next Combustion Inspection.

- Sixty one ceramic tiles are classified as monitor and are recorded by position in the check sheets. These positions should be inspected at the next Combustion Inspection and replaced if the classification has moved to replace. It is recommended that a full replacement tile set be held at site before the next Combustion Inspection.

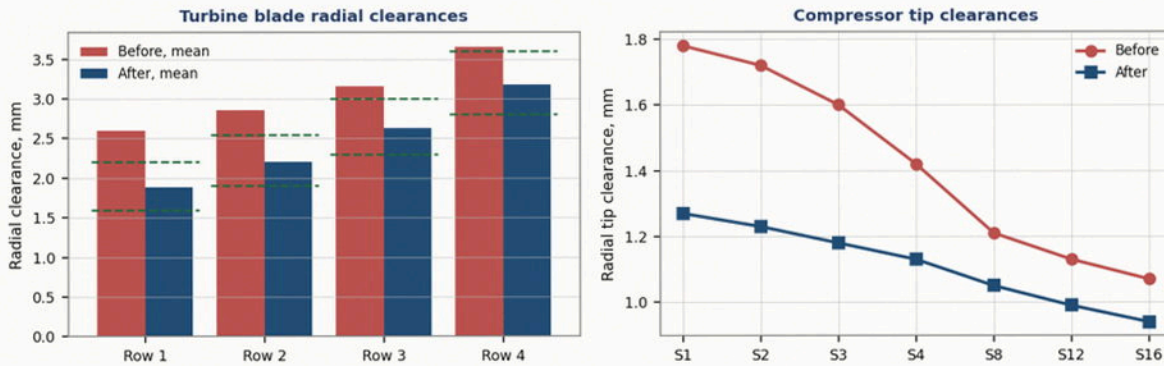
Figure 3. Radial clearance restoration, turbine blade rows 1 to 4 and compressor stages, before and after parts renewal

| Row | Radial Design Band (mm) | Radial Before, Range (mm) | Radial After, Range (mm) | Axial After, Range (mm) | Assessment |
|---|---|---|---|---|---|
| Vane Row 1 inner seal | 1.20 to 1.70 | 1.82 to 2.14 | 1.30 to 1.56 | Not applicable | Within band |
| Vane Row 2 inner seal | 1.35 to 1.85 | 1.90 to 2.22 | 1.44 to 1.70 | Not applicable | Within band |

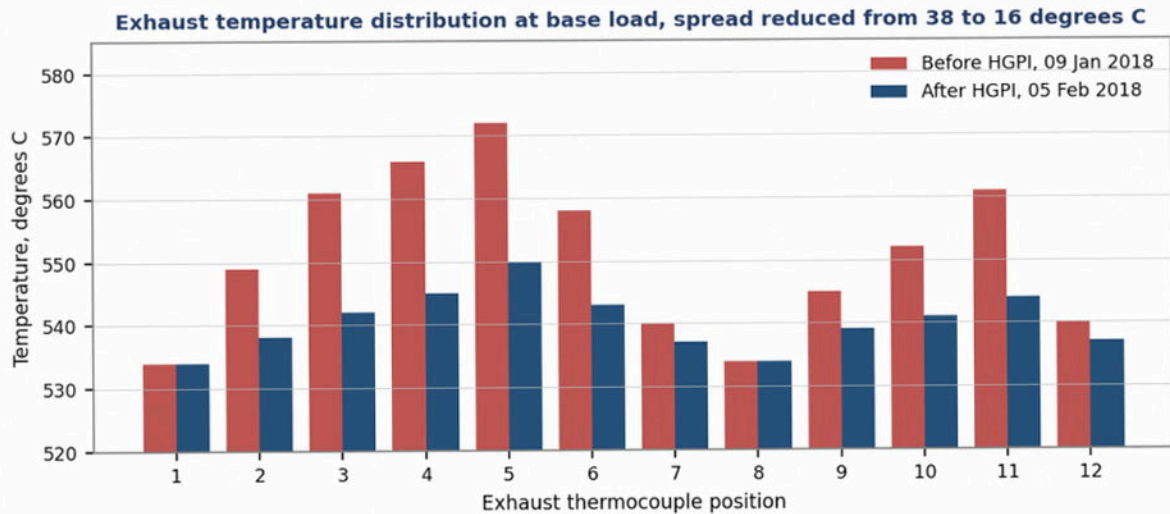
Figure 4. Exhaust temperature distribution at base load recorded on the SPPA-T3000 operator station, before and after the outage

The recovery in output, heat rate and exhaust temperature spread is consistent with the renewal of the complete hot gas path and the compressor blading and with the restoration of design clearances.

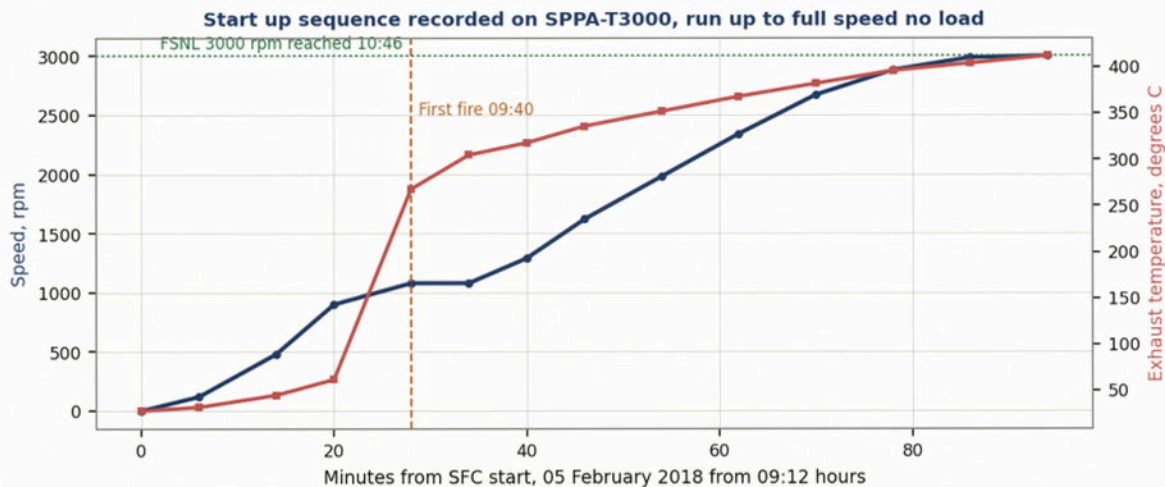
Figure 5. Start up sequence recorded on the SPPA-T3000 fast trend, run up to full speed no load

The Unit was started on 05 February 2018. The static frequency converter start command was accepted at 09:12 hours. The purge sequence completed at 09:26 hours. Ignition of both combustion chambers occurred at 09:40 hours with flame established in chamber A and chamber B within the permitted window. The warm up period completed at 09:52 hours and acceleration was released. Full speed no load at 3000 rpm was reached at 10:46 hours. The speed and exhaust temperature record taken from the SPPA-T3000 fast trend is shown below.

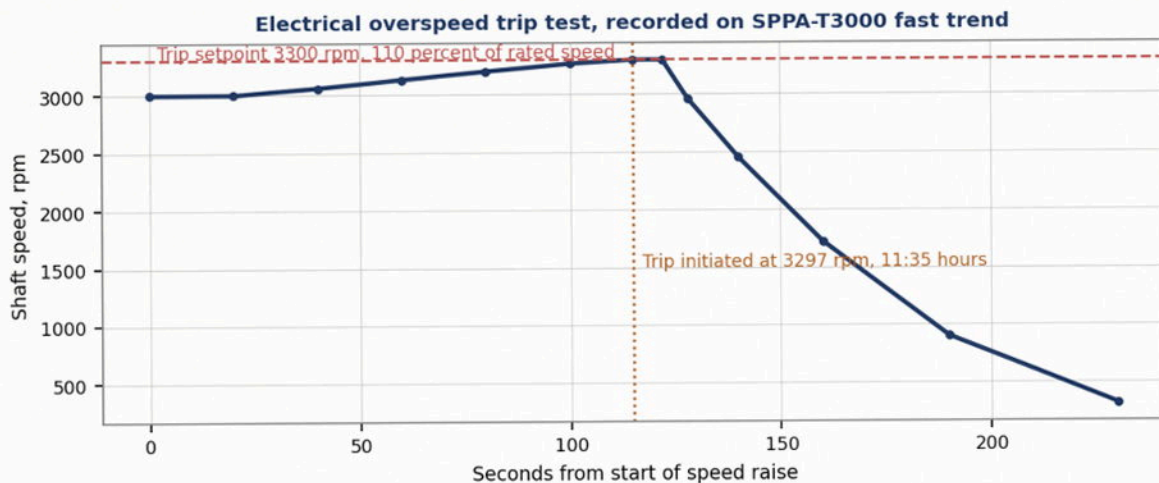
Figure 6. Electrical overspeed trip test, speed trace recorded on the SPPA-T3000 fast trend

An electrical overspeed trip test was carried out at full speed no load on 05 February 2018 at 11:35 hours in the presence of the DEWA controls engineer and the shift charge engineer, in order to verify the integrity of the overspeed protection function after the outage. The Unit was accelerated under controlled conditions from 3000 rpm. The overspeed trip operated at 3297 rpm against a setpoint of 3300 rpm, which is 110 percent of rated speed and within the acceptance band of plus or minus 0.5 percent. All protective devices responded within the required time, all fuel stop valves closed and the shutdown sequence completed without anomaly. The Unit was then restarted and synchronized.

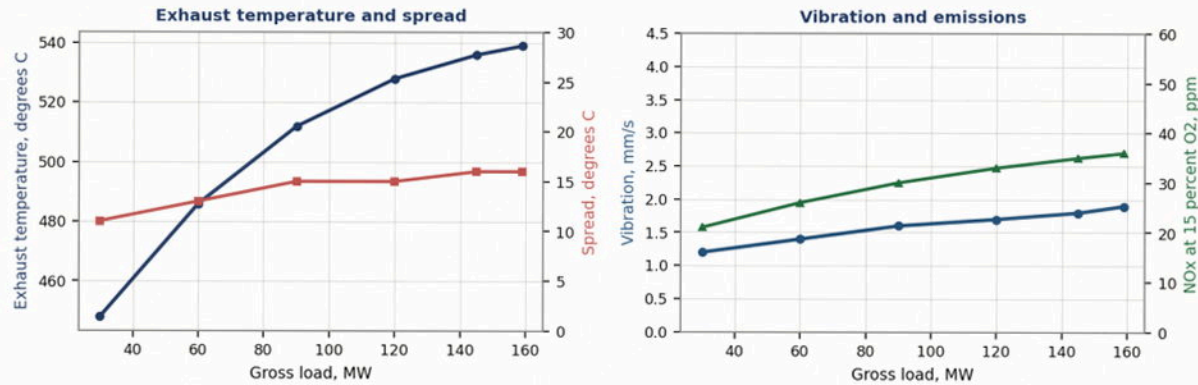
Figure 7. Loading test results recorded on the SPPA-T3000 operator station, exhaust temperature, spread, vibration and emissions

| Load, MW | Speed, rpm | IGV, percent | Exhaust Temp Mean, deg C | Exhaust Spread, deg C | CDP, bar | Fuel Gas Flow, kg/s | Vib Max, mm/s | NOx, ppm | Remarks |
|---|---|---|---|---|---|---|---|---|---|
| 158.9 | 3000 | 86 | 539 | 16 | 11.06 | 9.4 | 1.9 | 36 | Base load, stable operation |
