# INCOMING INSPECTION REPORT

## MS6001FA (GE Frame 6FA) Combustion Liner MNQC — Complete Set

| Customer P.O. No. | WO1003946086 | UNEW Work Order | 825088 |
| Engine Type | MS6001FA (GE Frame 6FA) | Component | Combustion Liner MNQC |

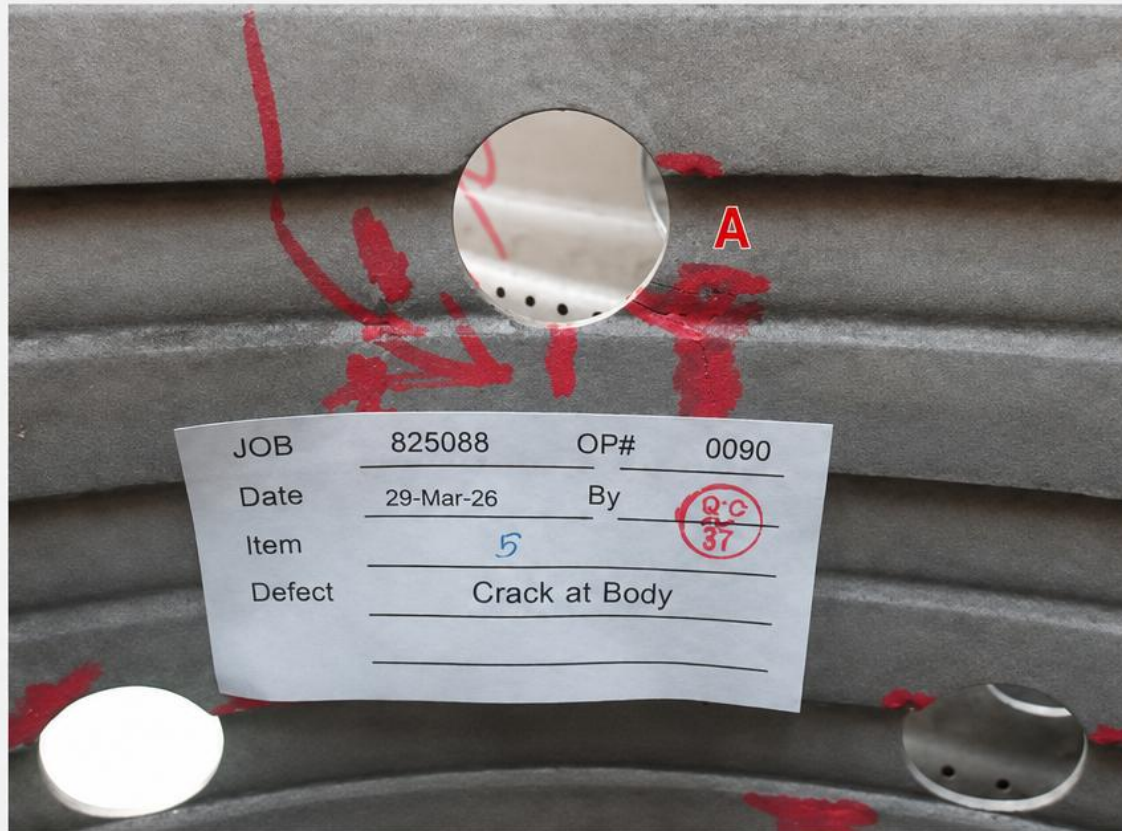
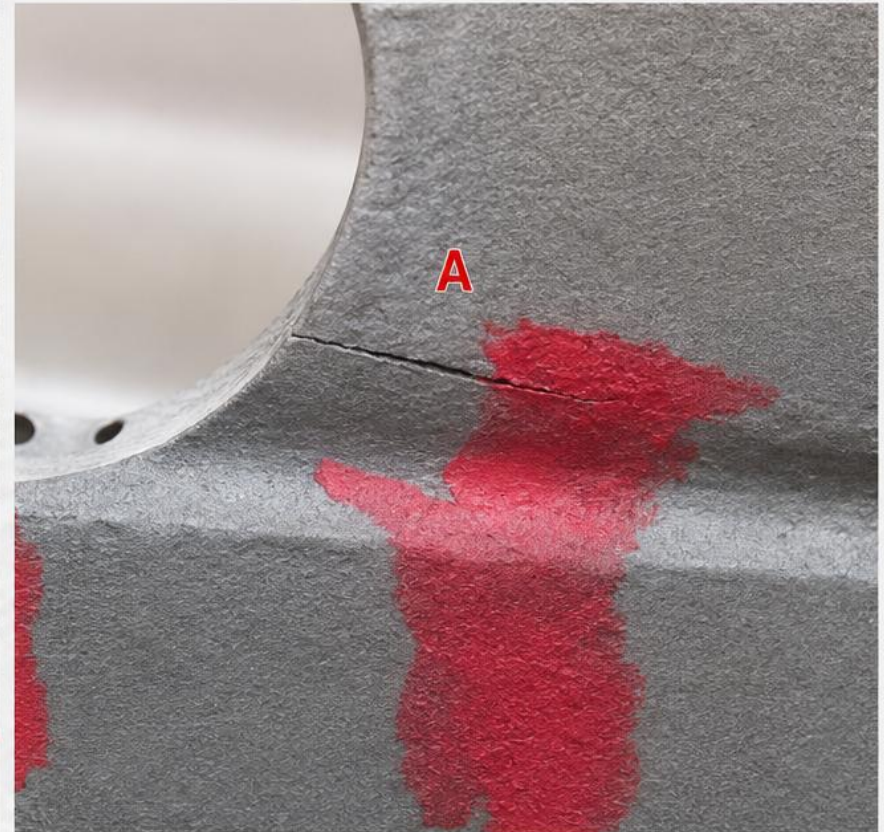
**FIG. 11 — LINER BODY CRACK (ITEM 5)**

**MAGNIFIED VIEW A**

**DOCUMENTED CRACK SIZE: 2–4 mm**

Crack is located in a high-temperature combustion zone and extends beyond surface level.  
Complete excavation and GTAW weld reconstruction are required; local blending is not acceptable.  
Repair severity is determined by defect location and required restoration scope, not crack length alone.

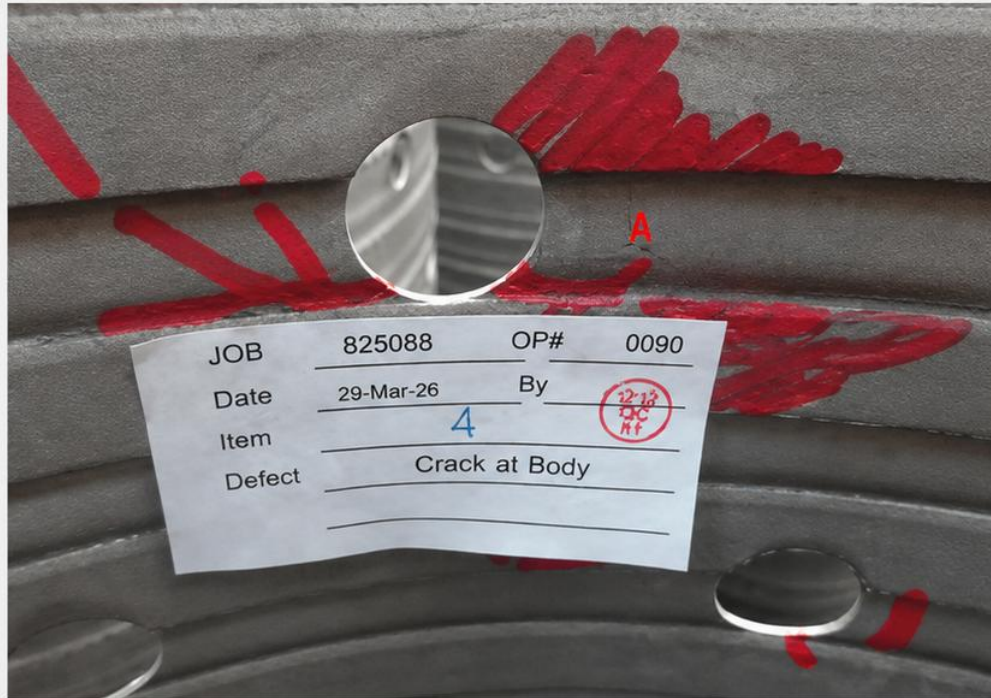
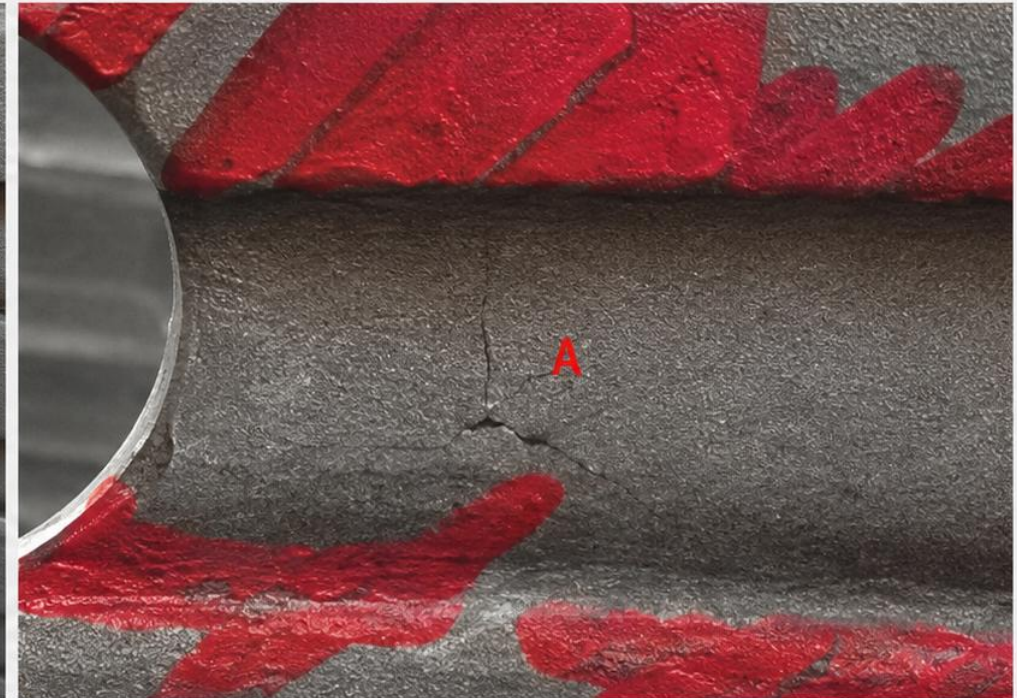
**FIG. 12 — LINER BODY CRACK (ITEM 4)**

DOCUMENTED CRACK SIZE: 2–4 mm  
HEAVY REPAIR BASIS

Crack is located in a high-temperature combustion zone and extends beyond surface level. Complete excavation and GTAW weld reconstruction are required; local blending is not acceptable. Repair severity is determined by defect location and required restoration scope, not crack length alone.

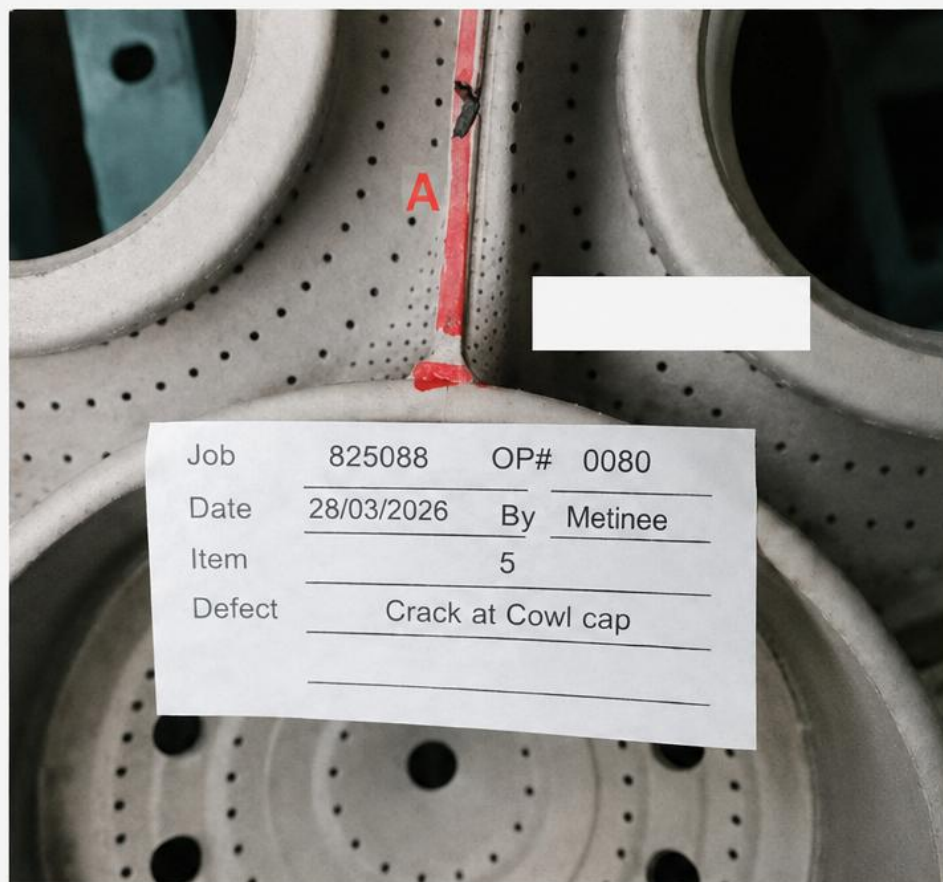
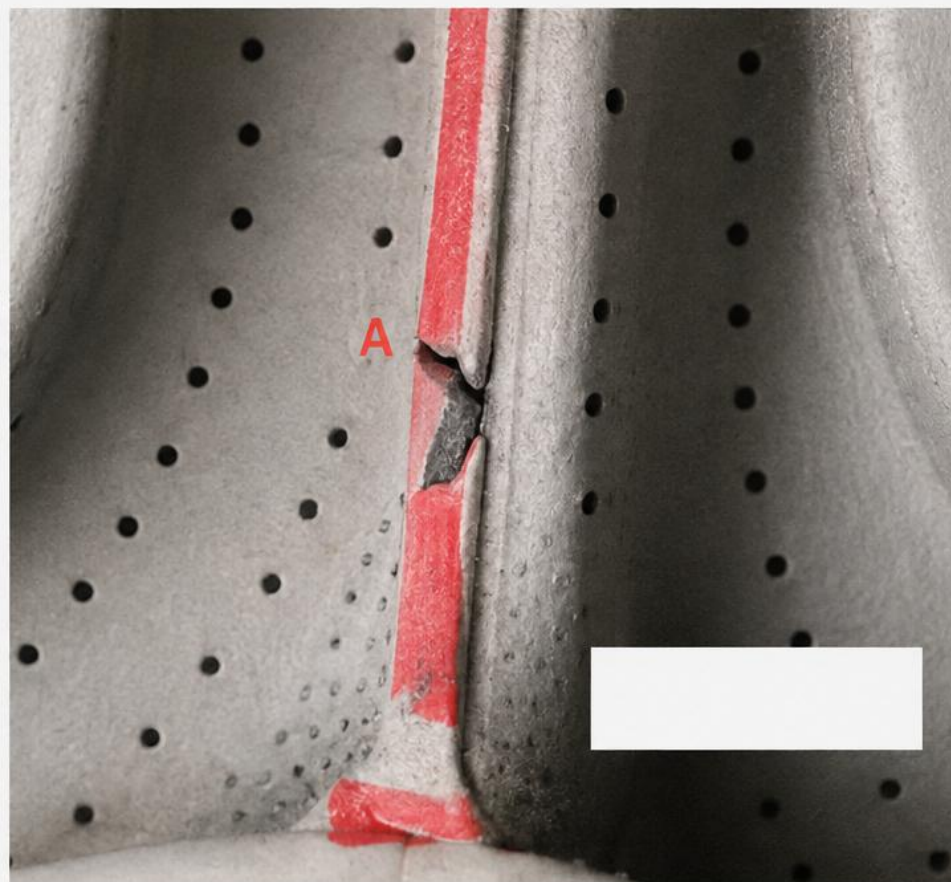
**FIG. 16 — COWL CAP CRACK (ITEM 5)**

**DOCUMENTED CRACK SIZE: 2 mm**

Although limited in length, the crack is located on the cowl cap in the combustion zone.

Repair severity is determined by defect location and required restoration scope, not crack length alone.

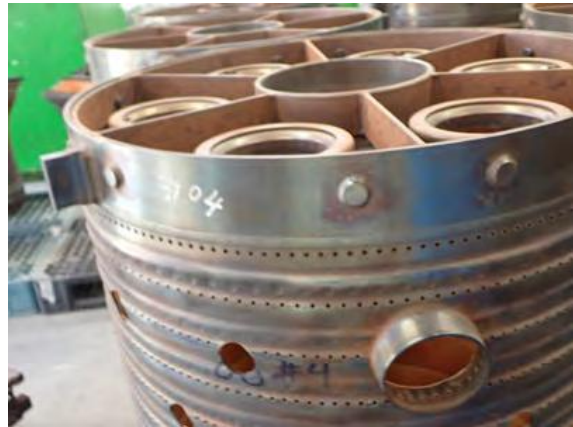
*Fig. 2 — As-received body and cowl cap condition*

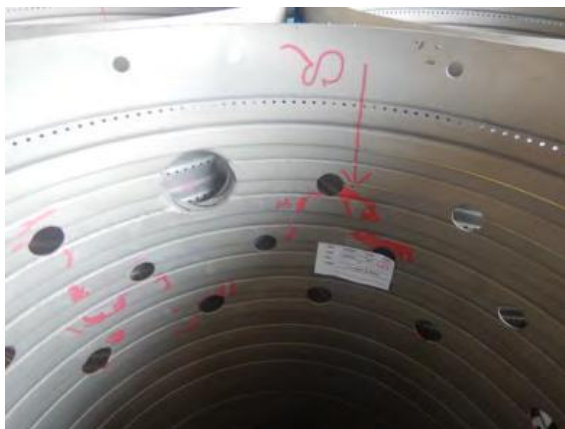
Fig. 9 — Multiple corrosion areas on internal body

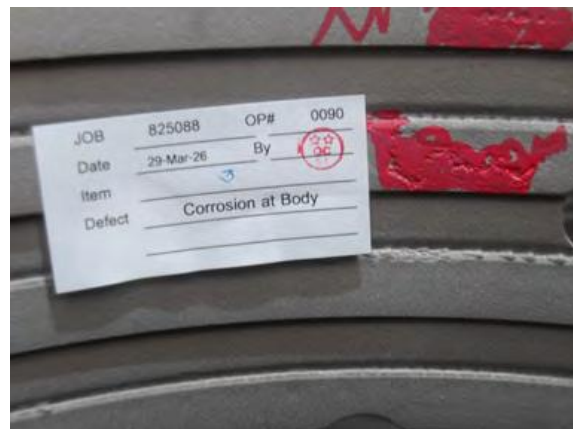
Fig. 10 — Corrosion across liner body
