## INCOMING INSPECTION REPORT

| Customer P.O. No. | WO1003986864 | Component | 1st Stage Nozzle |
| Engine Type | MS6001FA (GE Frame 6FA) | Part Number (Ring) | 143E5711G02 |

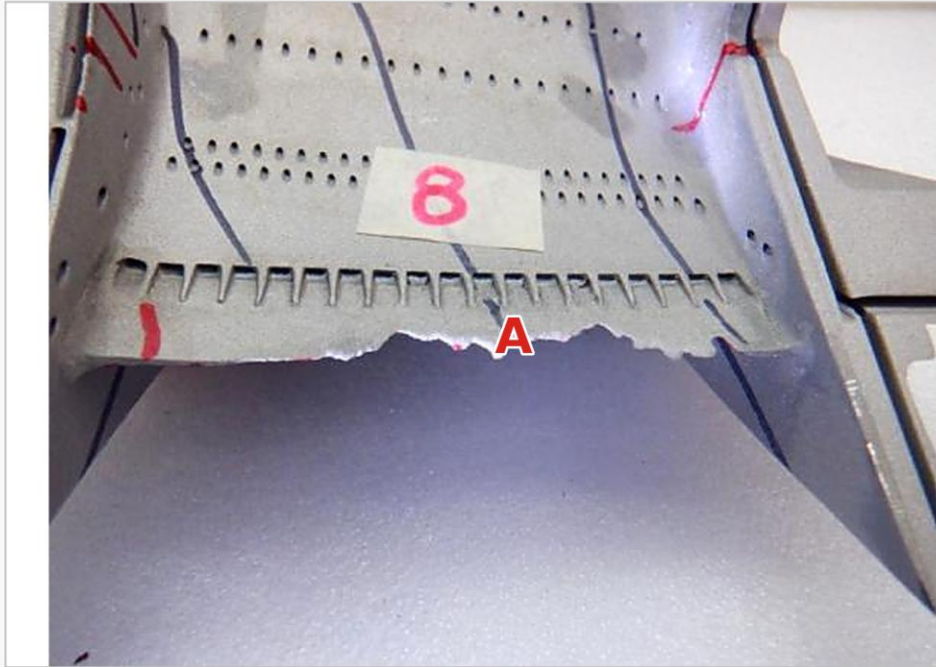
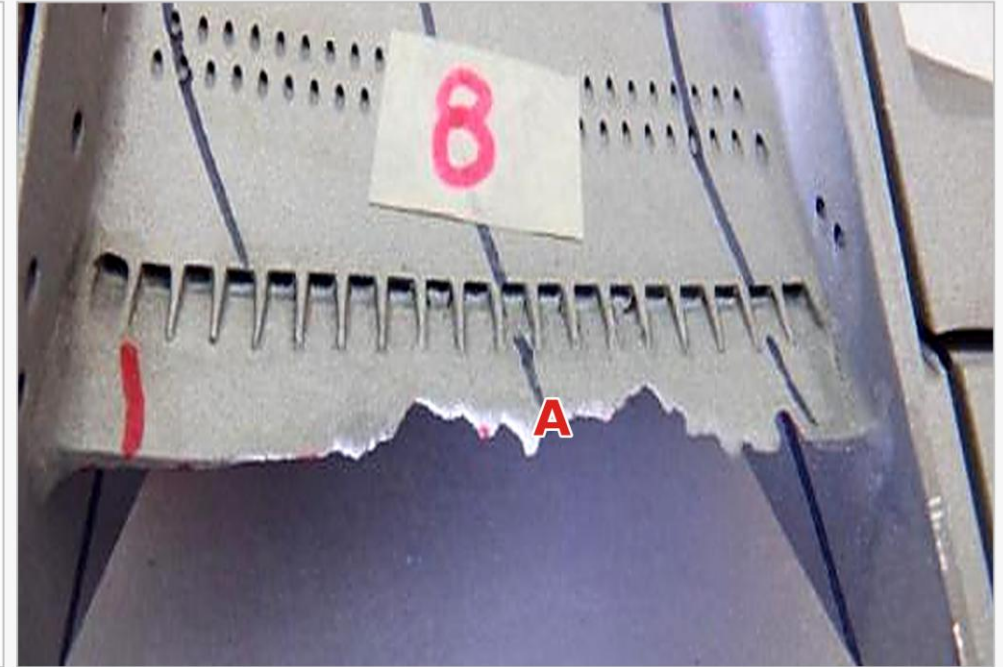
## FIG. 11 - TRAILING-EDGE CRACKING / THROUGH-WALL LOSS (ITEM 8)

**DOCUMENTED DAMAGE SIZE: 8 x 100 mm THROUGH-WALL LOSS (ITEM 8)**

Through-wall loss at the nozzle trailing edge is structural damage in the hot-gas path, not a surface defect. Repair requires degraded-metal removal, weld build-up, EDM and/or PSP restoration, and dimensional requalification.

The two T1/T2 positions on Item 8 were unmeasurable; this condition approaches the repairability limit.

- Item 8 (S/N A1FC 04955) additionally shows missing material at the trailing edge (8x100 mm), confirming through-wall material loss. Through-wall loss is the condition that defines the approach to the repairability limit.

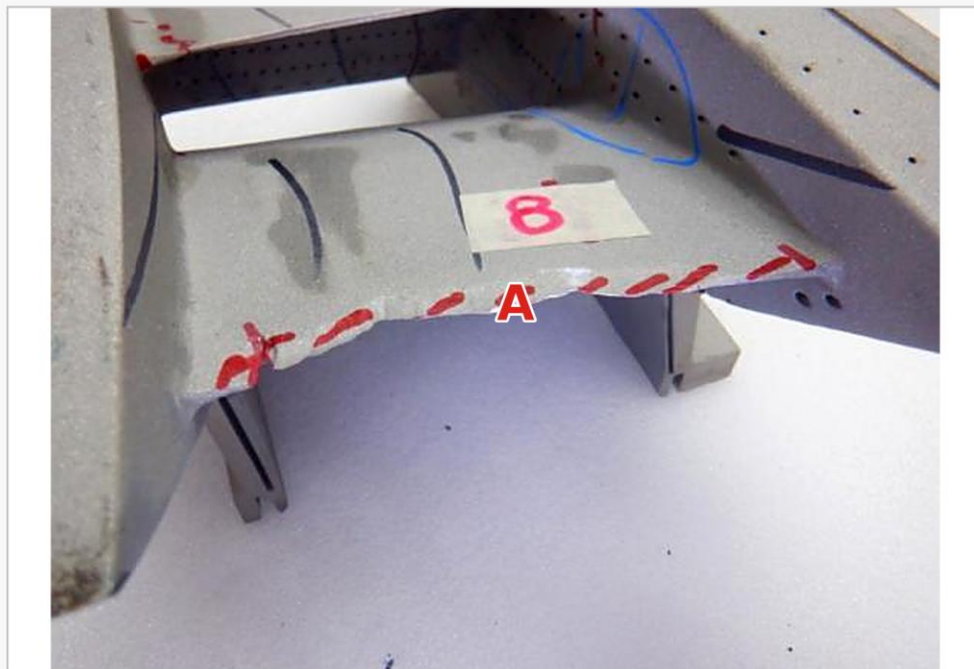
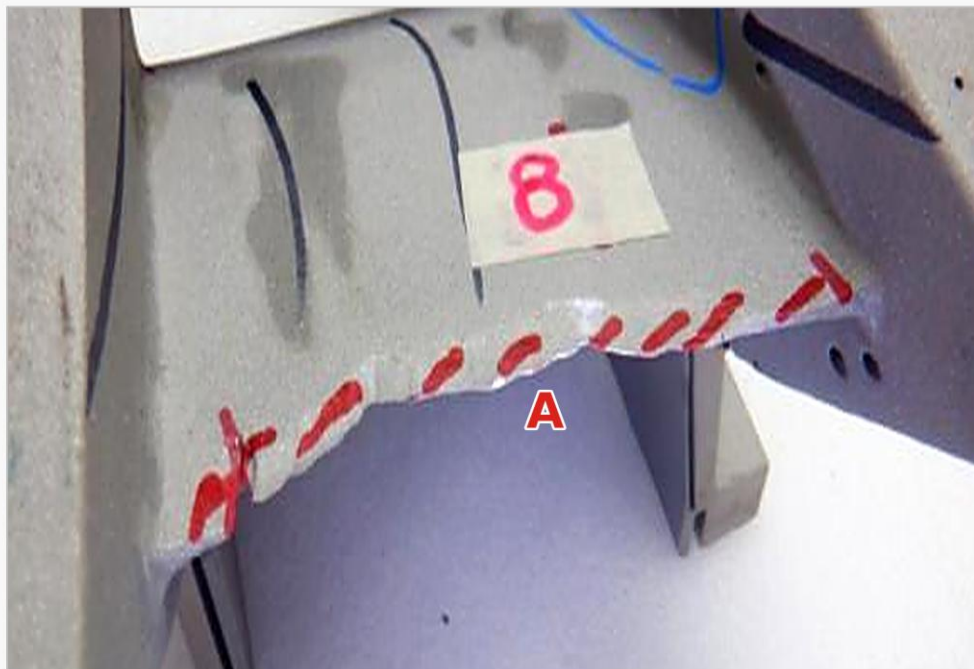
## FIG. 12 - TRAILING-EDGE CRACKING / THROUGH-WALL LOSS (ITEM 8)

**DOCUMENTED DAMAGE SIZE: 8 x 100 mm THROUGH-WALL LOSS (ITEM 8)**

This second view confirms the extent of material loss along the critical trailing-edge wall.

Local blending cannot replace missing wall structure or recover the required aerodynamic edge geometry.

Heavy Repair requires weld reconstruction and PSP/EDM restoration followed by full inspection and requalification.

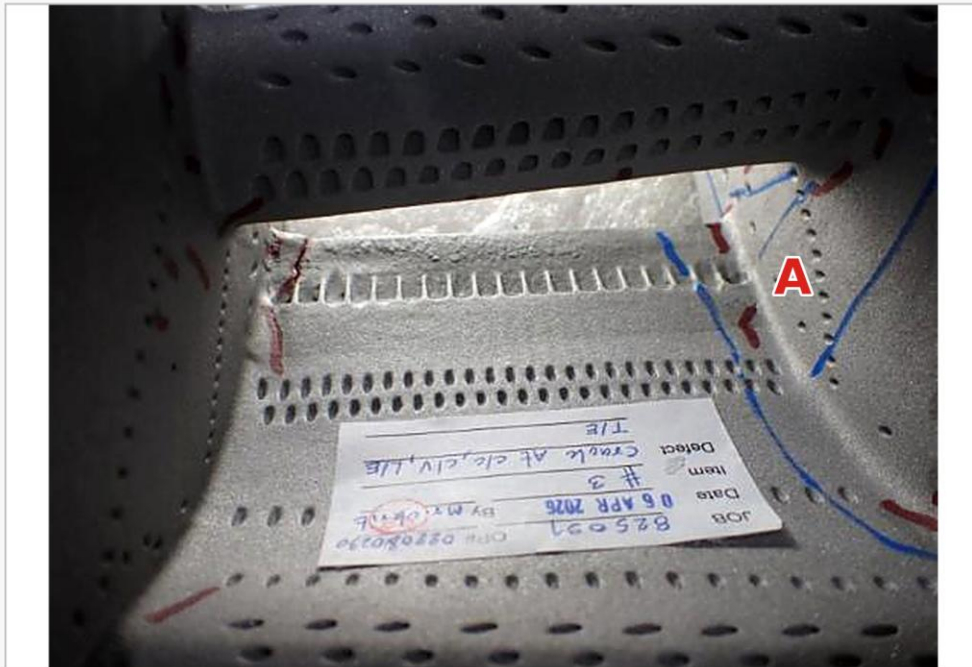
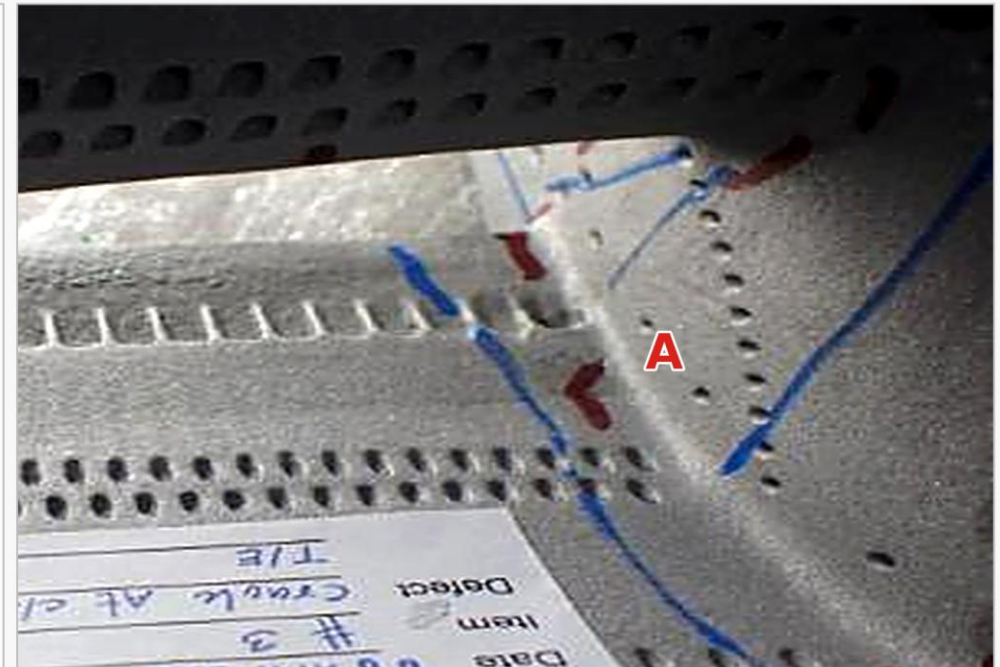
## FIG. 13 - EXTENSIVE TRAILING-EDGE CRACKING AND HOT CORROSION

**DOCUMENTED TRAILING-EDGE CRACK RANGE (ALL 24): O/D 5-75 mm | I/D 5-25 mm**

Cracking is located on high-temperature trailing-edge walls and is present on all 24 nozzle segments. The full-set crack distribution requires GTAW structural repair, TPR, and subsequent vacuum solution heat treatment. Heavy Repair is controlled by the critical location, pervasive extent, and restoration scope - not one crack length alone.

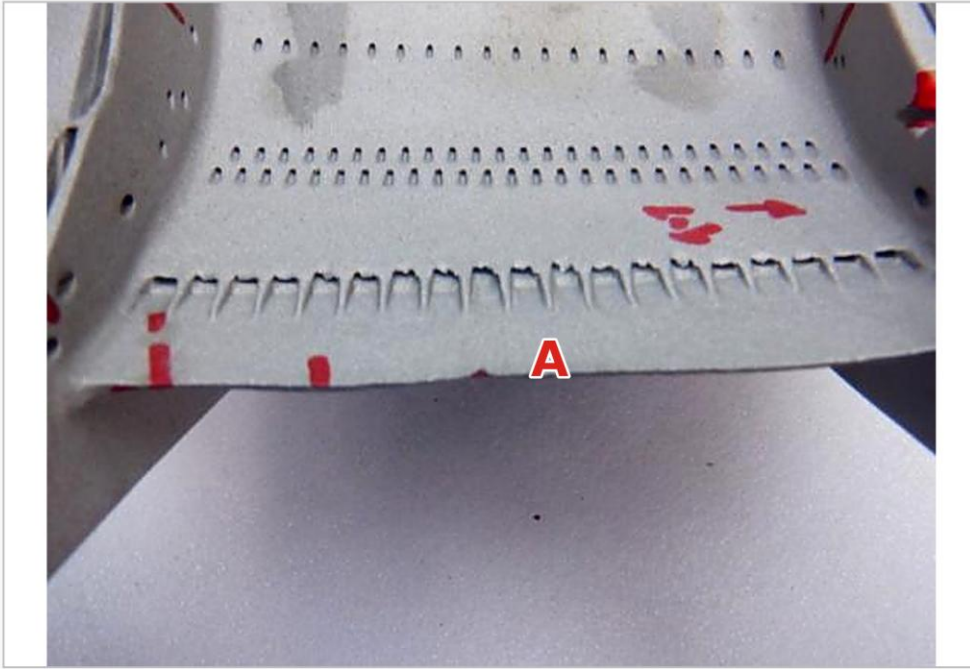
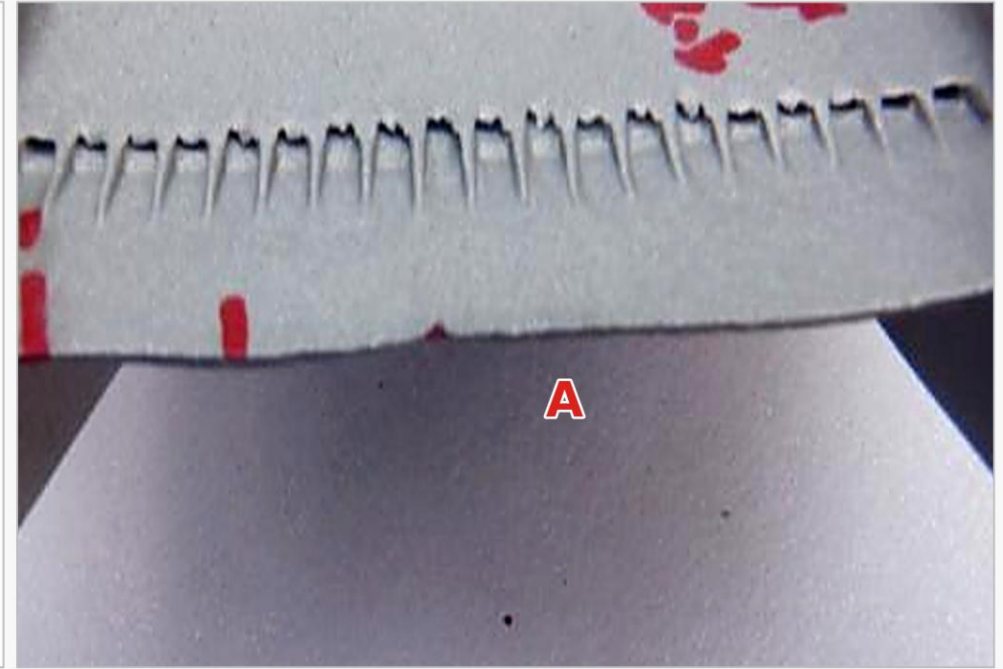
## FIG. 14 - HEAVY CORROSION - CONCAVE AIRFOIL AND TRAILING EDGE

**SET-WIDE WALL DATA: 2.03 mm MIN. | LOWEST 1.12 mm | MEAN 1.57 mm**

Hot corrosion at the concave airfoil and trailing edge causes structural metal loss in the gas-path region. All 48 airfoil trailing edges were rejected; 89 of 94 measurable T1/T2 readings were below the minimum. PSP wall restoration, corrosion removal, dimensional requalification, and full coating renewal are required.

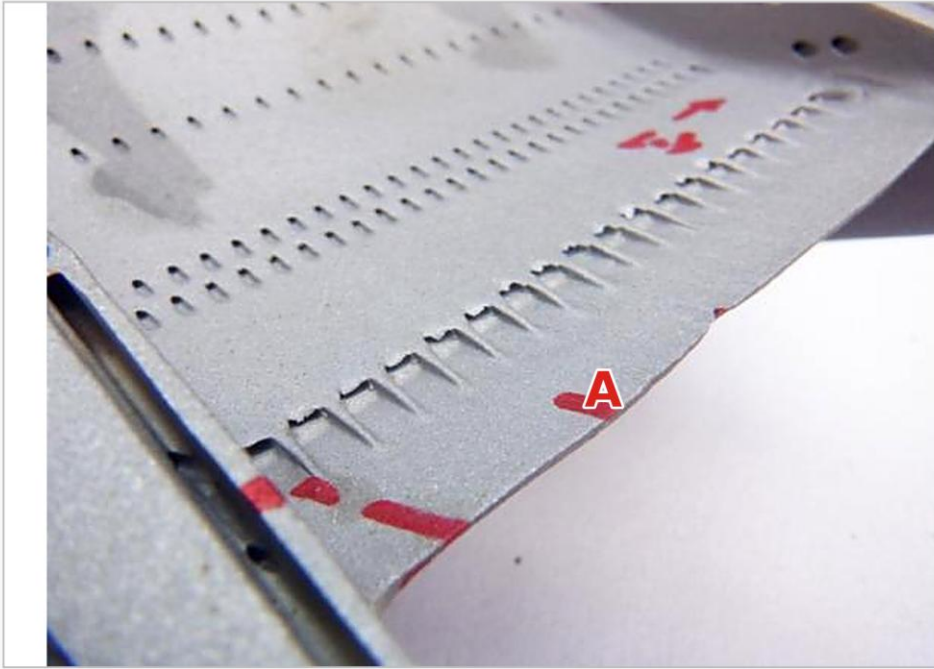
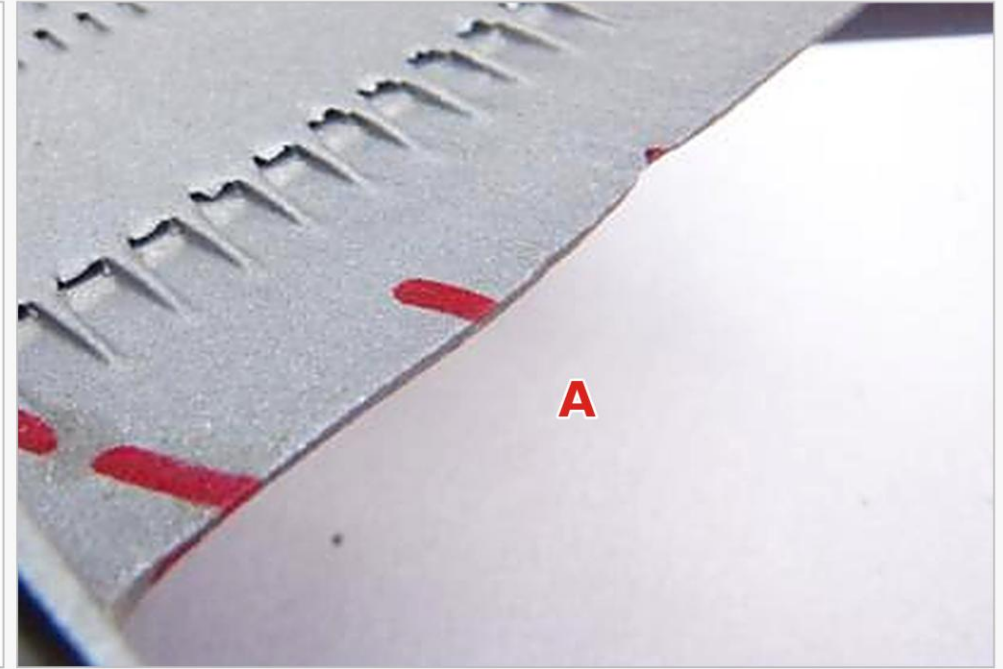
## FIG. 15 - HEAVY CORROSION - CONCAVE AIRFOIL AND TRAILING EDGE

**SET-WIDE WALL DATA: 2.03 mm MIN. | LOWEST 1.12 mm | MEAN 1.57 mm**

The classification is based on measured metal loss and restoration extent, not coating deterioration by itself.

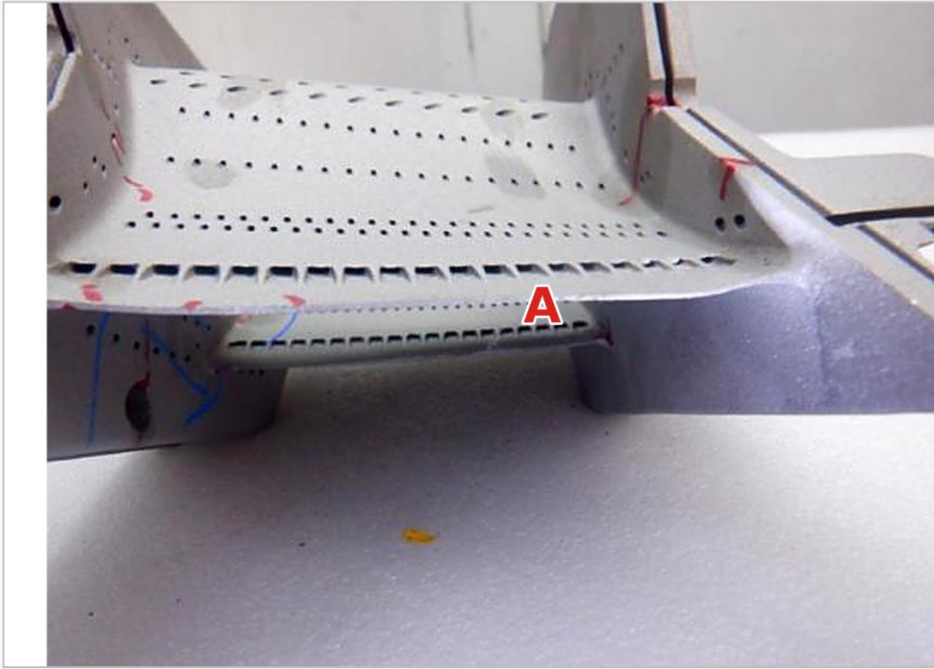
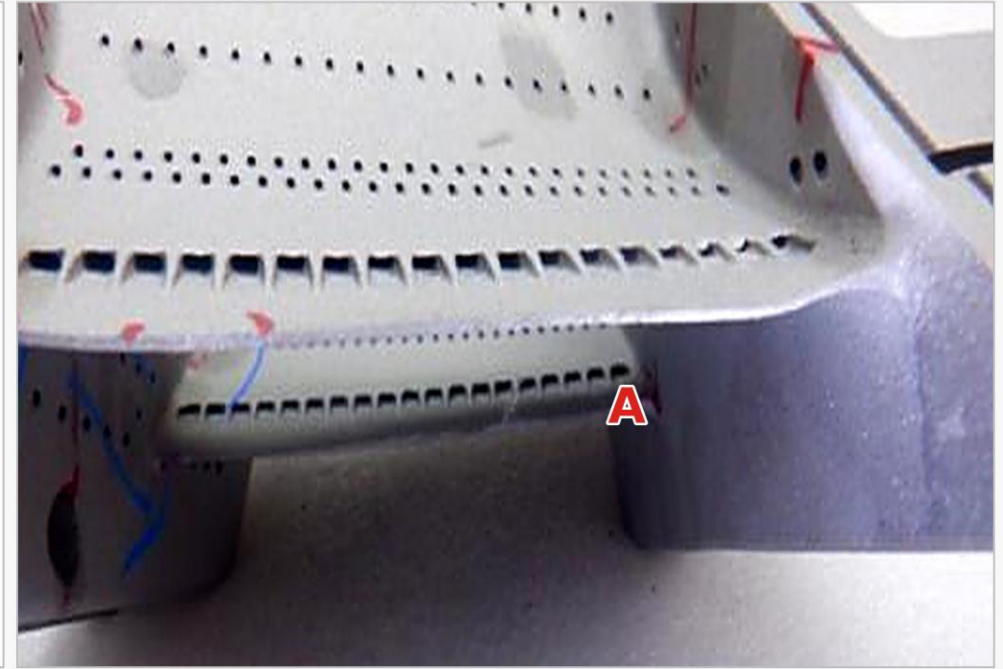
## FIG. 16 - CRITICAL TRAILING-EDGE BOWING AND THIN WALL

**SET-WIDE: 48/48 TRAILING EDGES REJECTED | 1.12 mm vs 2.03 mm MINIMUM**

Visible bowing is permanent flow-path deformation combined with critical trailing-edge wall thinning. Blending cannot restore alignment or thickness; cold straightening/plannishing plus PSP restoration is required. Recorded step deviation reaches -1.21 mm, requiring complete post-repair dimensional requalification.

Visible bowing and permanent deformation of the trailing edge walls were documented in Fig. 16, with accompanying annotation confirming the thin wall condition requiring PSP. Cold straightening and planishing will be performed on all affected trailing edge and airfoil sections prior to weld repair.

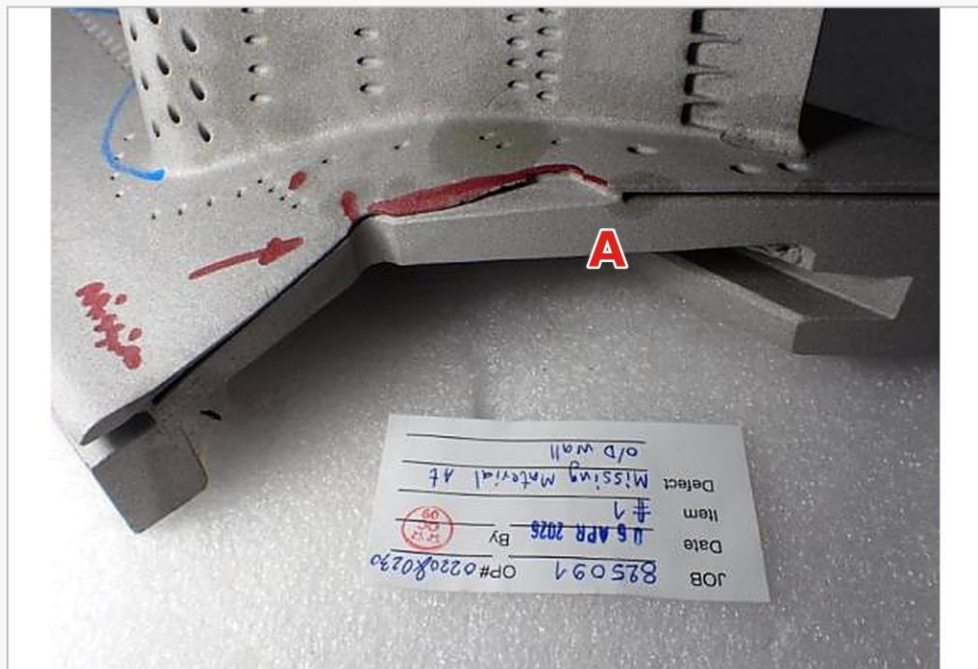
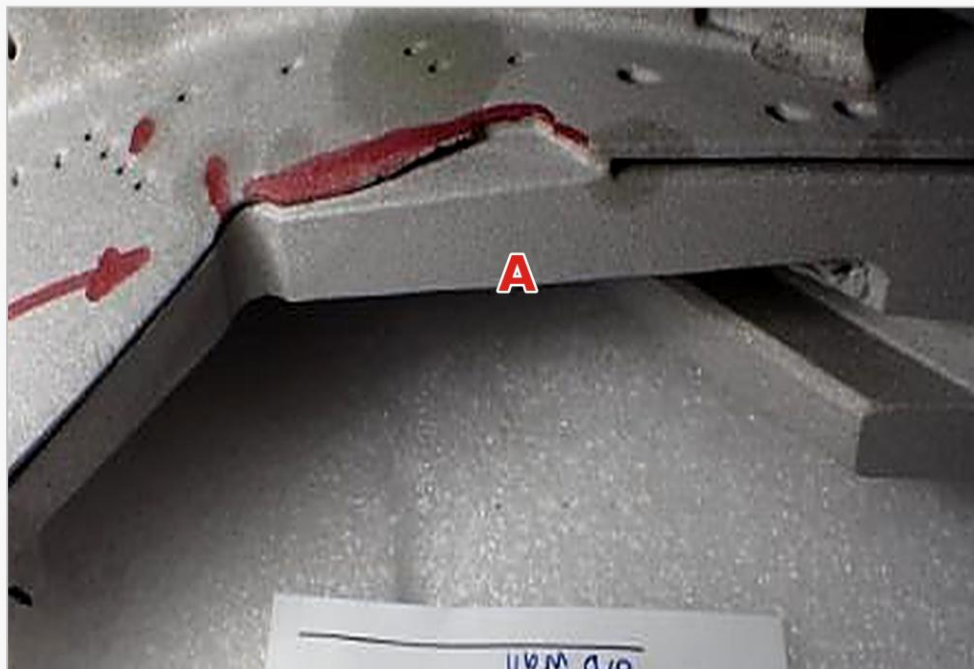
## FIG. 17 - OUTER SHROUD WALL CORROSION / MATERIAL LOSS

**DOCUMENTED O/D WALL RANGE: 5 x 30 TO 8 x 50 mm LOSS | 8-15 mm CRACKS**

Outer-shroud damage affects load-bearing and sealing surfaces; severity therefore depends strongly on location. Nine segments have missing-material patches requiring GTAW build-up; O/D wall cracks require TPR/GTAW where present. Heavy Repair is based on structural restoration of the shroud wall and full-set corrosion, not surface coating renewal alone.

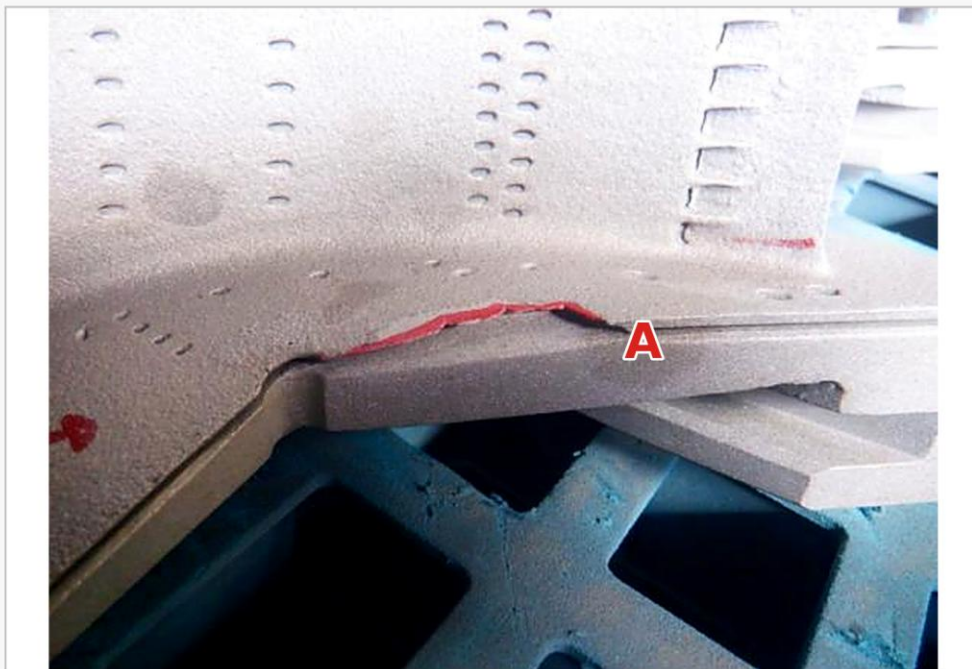
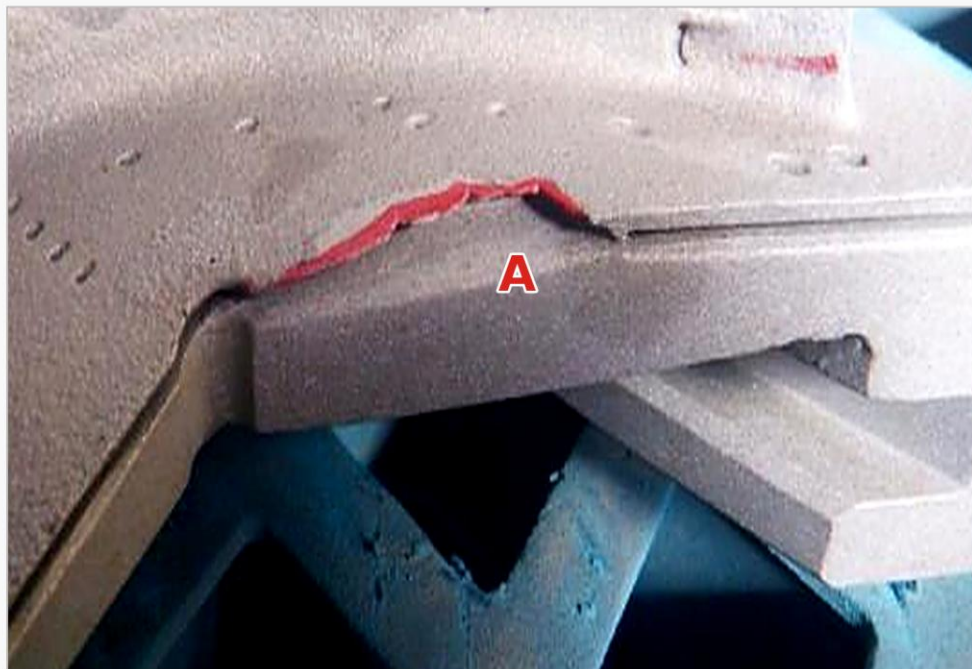
## FIG. 18 - OUTER SHROUD WALL CORROSION / MATERIAL LOSS

**DOCUMENTED O/D WALL RANGE: 5 x 30 TO 8 x 50 mm LOSS | 8-15 mm CRACKS**

The magnified view shows damage at the shroud-wall junction, a structural and sealing interface. Even a locally short crack is Heavy Repair when excavation and weld reconstruction are required at this critical location. The complete repair includes corrosion removal, GTAW/TPR restoration as applicable, dimensional checks, and full recoat.

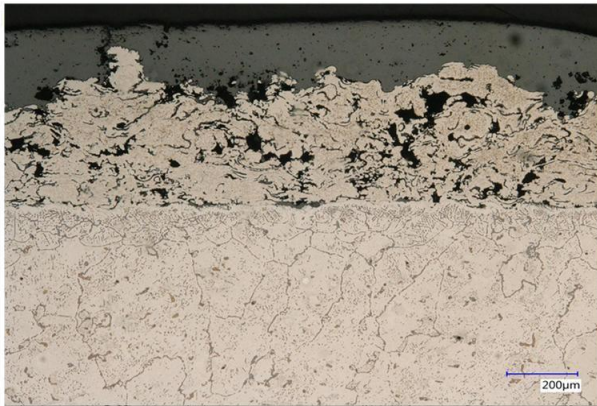
Fig. 1: Heavy coating degradation exposing base metal

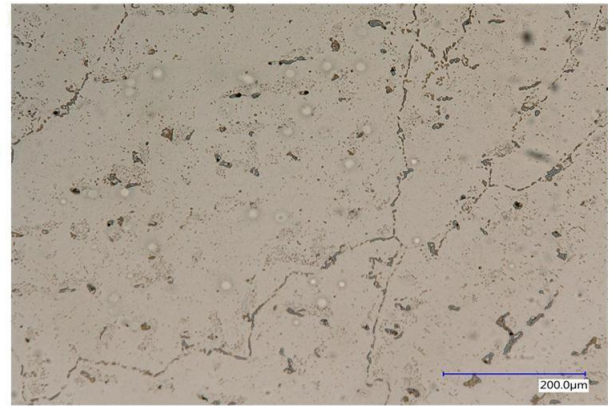
Fig. 2: Heavy grain boundary damage at high magnification (Etched)

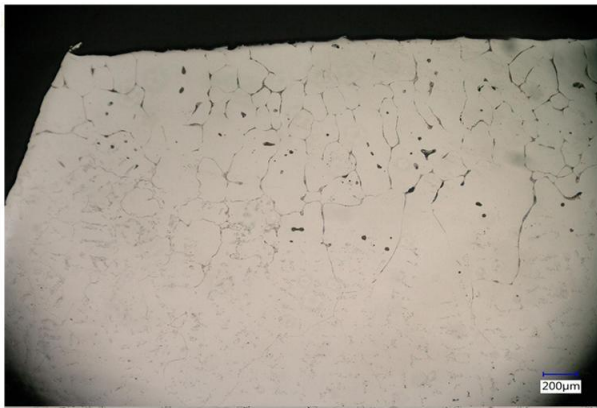
Fig. 1: Heavy microstructural damage requiring mandatory heat treatment intervention (Etched)

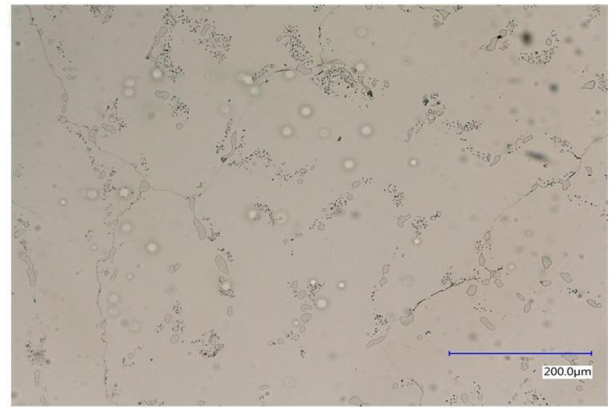
Fig. 2: Severe grain boundary attack and carbide deterioration at high magnification (Etched)

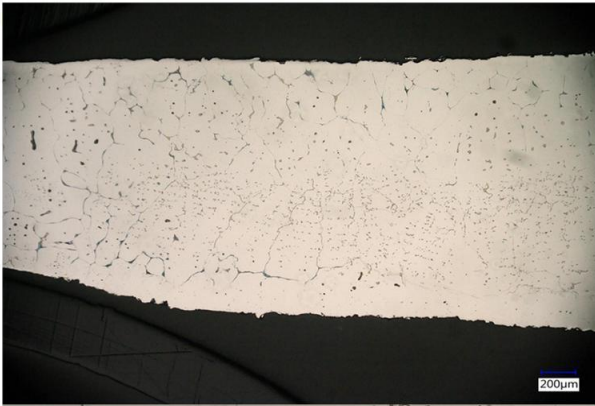
Fig. 1: Critical base metal damage condition prior to heat treatment (Etched)

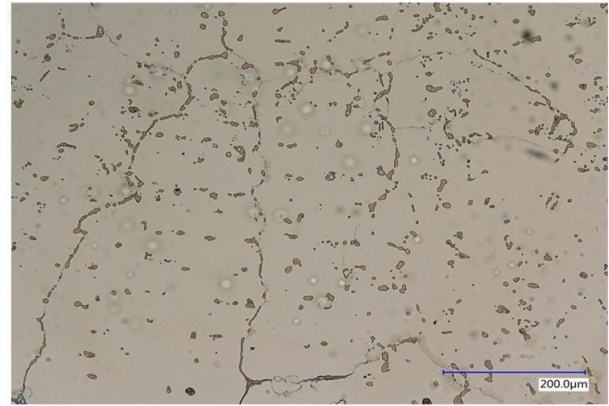
Fig. 2: Critical base metal damage confirmed at high magnification (Etched)

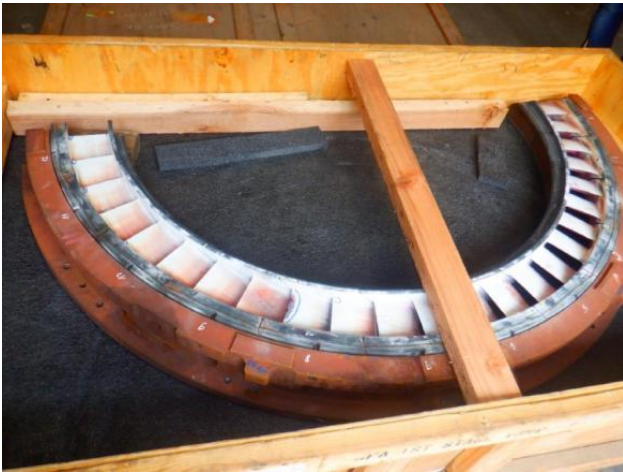
Fig.1 Received as heavy damage condition

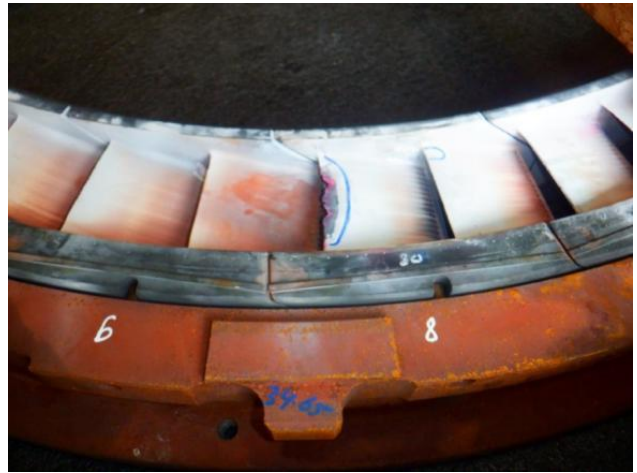
Fig.2 Received as heavy damage condition

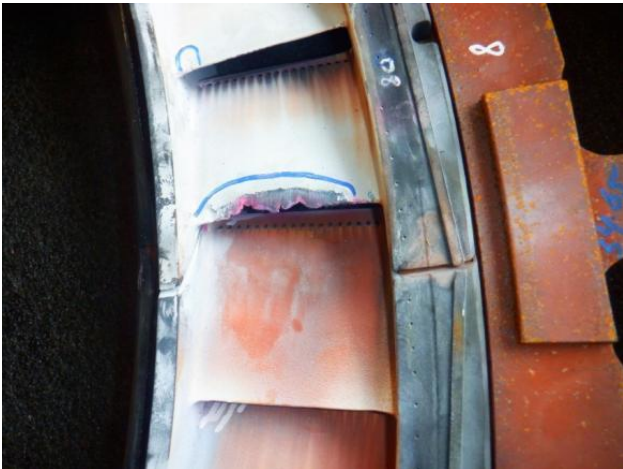
Fig.3 Received as heavy damage condition

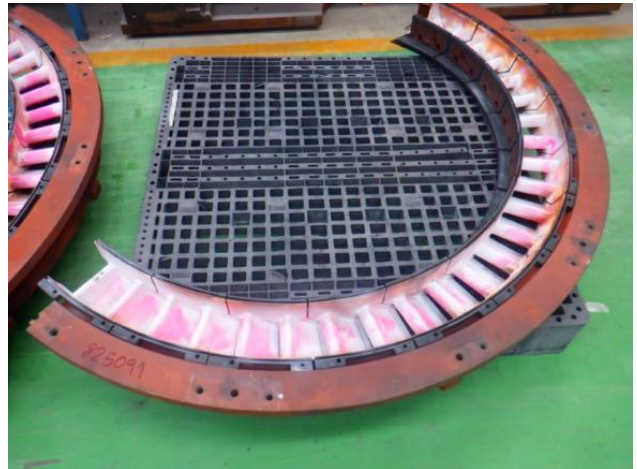
Fig.4 Received as heavy damage condition

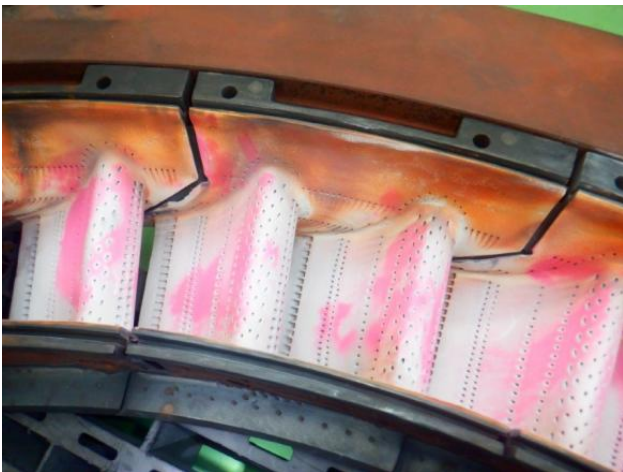
Fig.5 Received as heavy damage condition

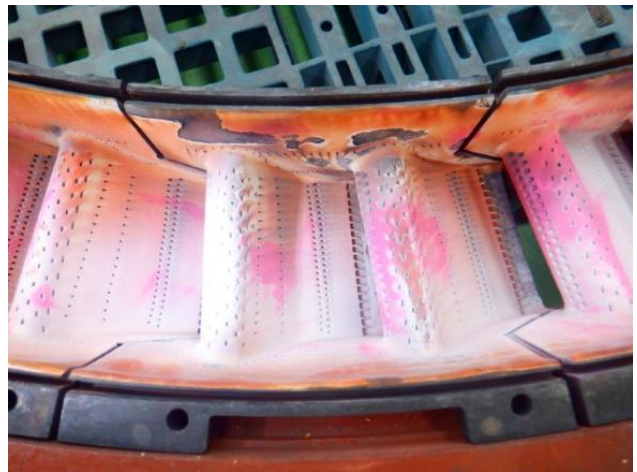
Fig.6 Received as heavy damage condition

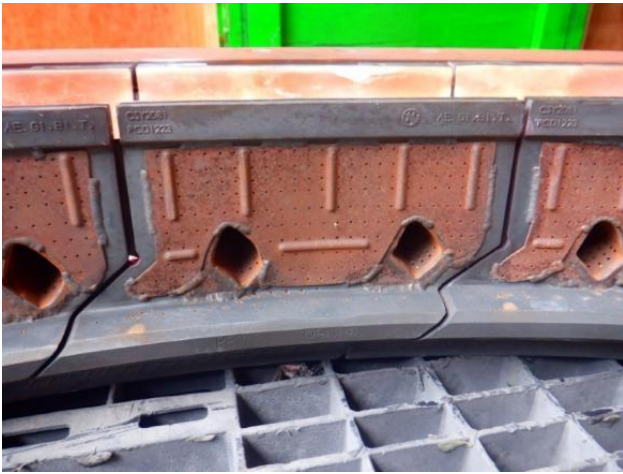
Fig.7 Received as heavy damage condition

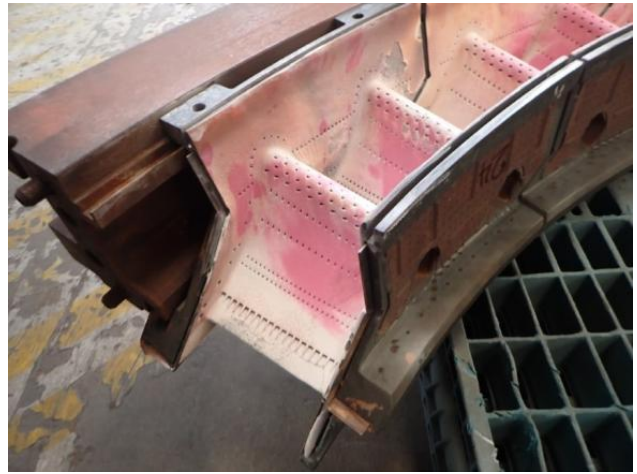
Fig.8 Received as heavy damage condition

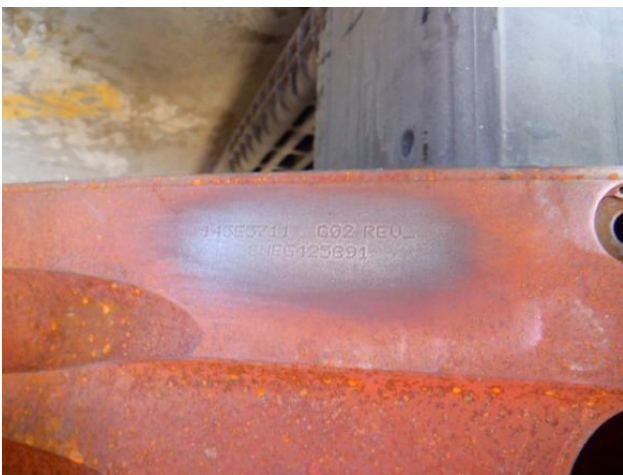
Fig.9 Received as heavy damage condition

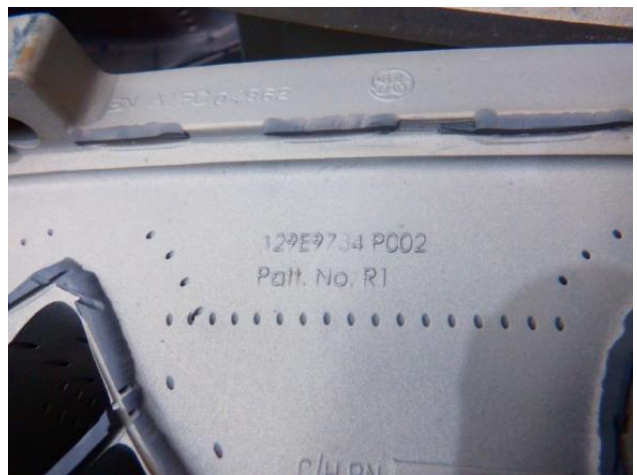
Fig.10 Received as heavy damage condition

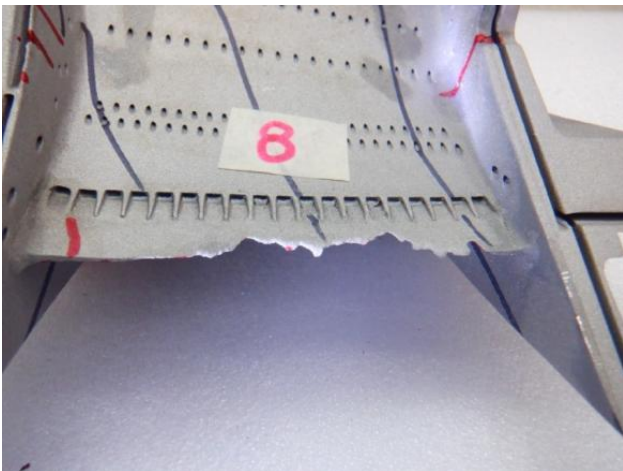
Fig.11 Extensive crack and heavy corrosion on trailing edge

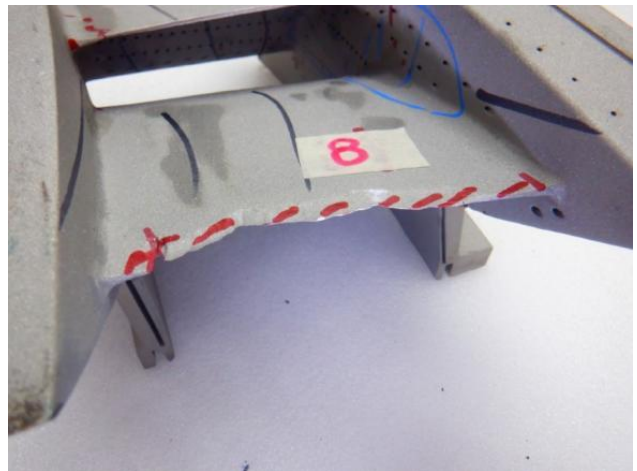
Fig.12 Extensive crack and heavy corrosion on trailing edge

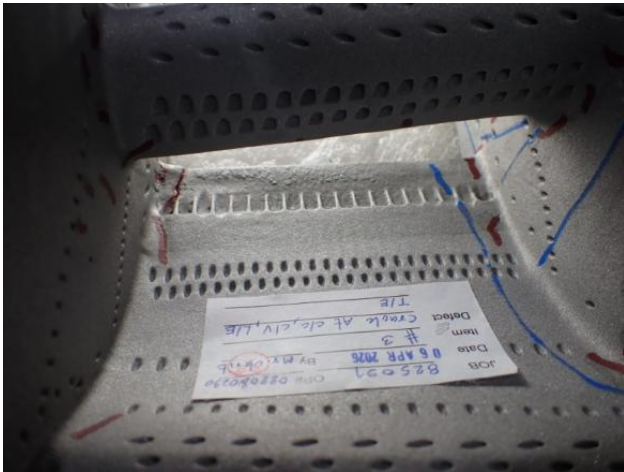
Fig.13 Extensive crack and heavy corrosion on trailing edge

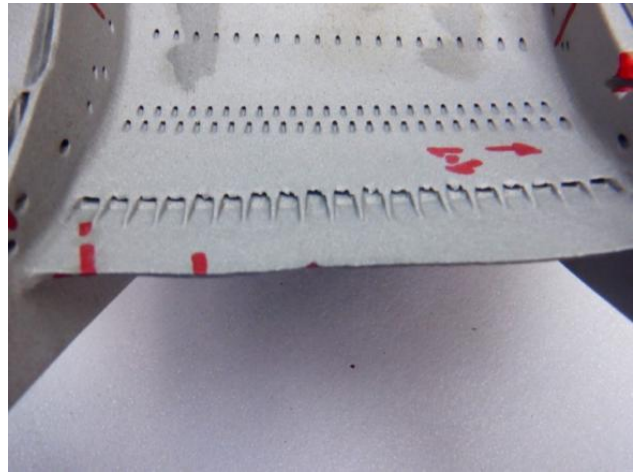
Fig.14 Heavy corrosion on concave airfoil and trailing edge

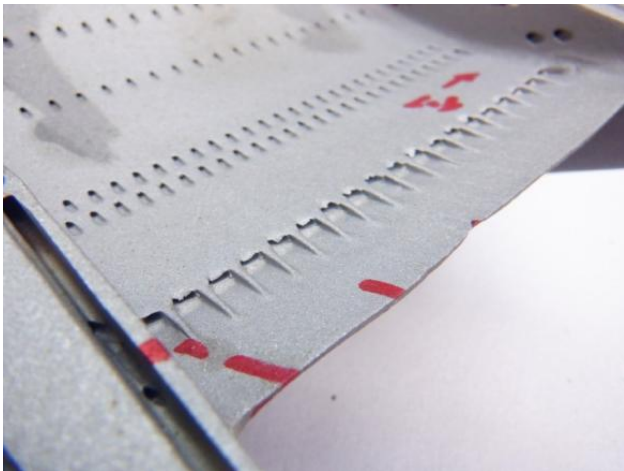
Fig.15 Heavy corrosion on concave airfoil and trailing edge

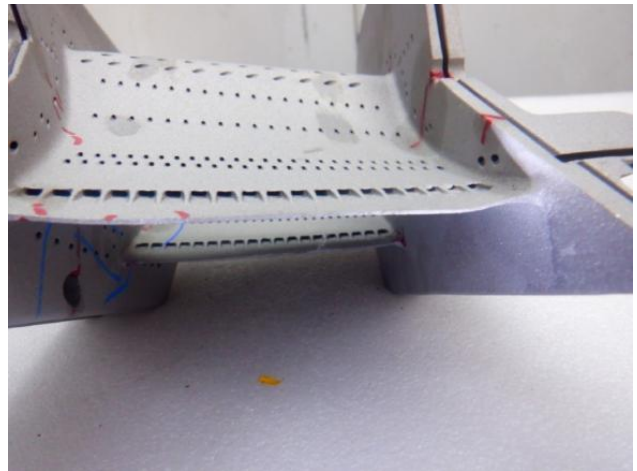
Fig.16 Critical bowing and thin wall on trailing edge

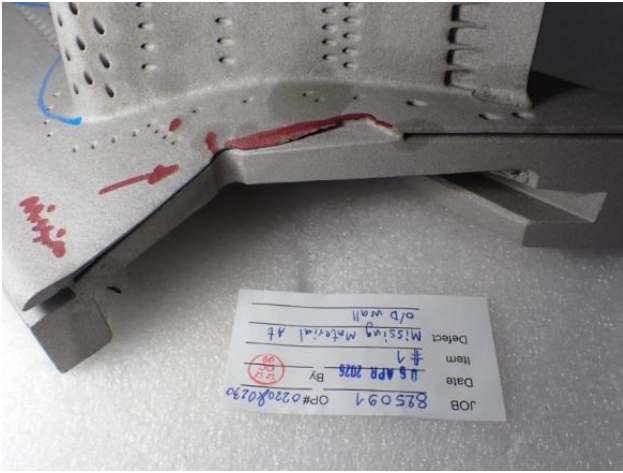
Fig.17 Heavy corrosion on outer shroud wall

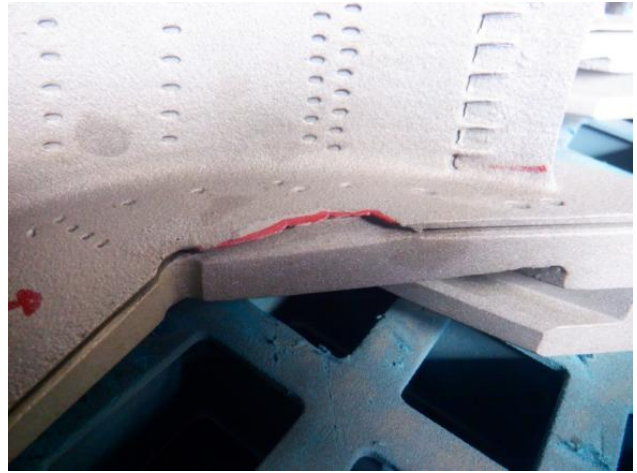
Fig.18 Heavy corrosion on outer shroud wall

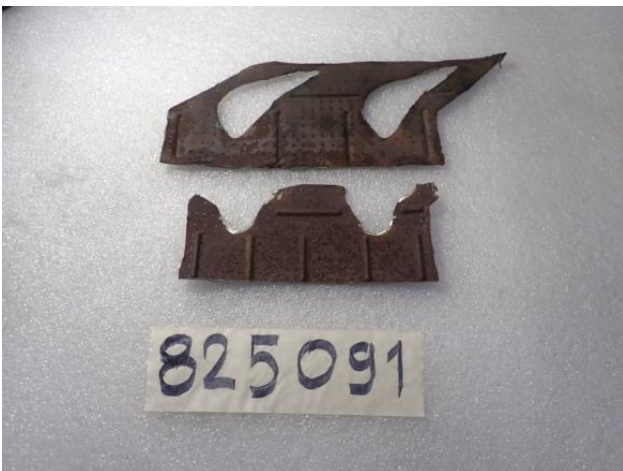
Fig.19 As received condition of Impingement Cover plates

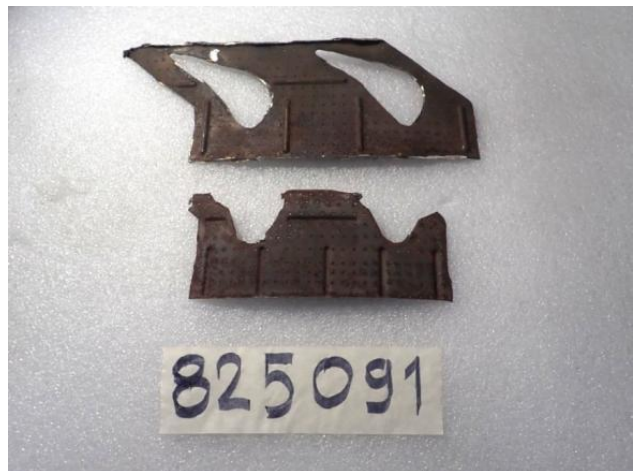
Fig.20 As received condition of Impingement Cover plates

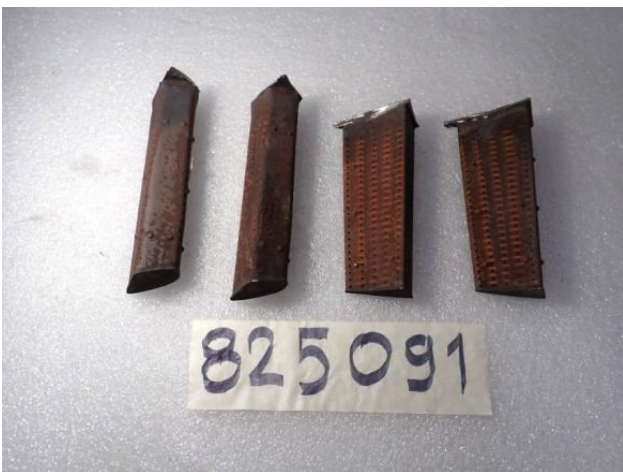
Fig.21 As received condition of core plugs

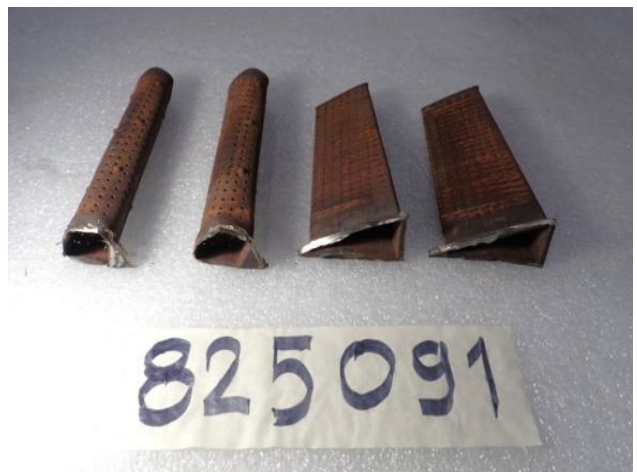
Fig.22 As received condition of core plugs
