# INCOMING INSPECTION REPORT

| <b>Customer</b> | Nghi Son Refinery & Petrochemical, LLC. | <b>Report Date</b> | 27 April 2026 |
| <b>Customer P.O. No.</b> | WO1003986864 | <b>Component</b> | MS6001FA 1st Stage Shroud Block |
| <b>Engine Type</b> | MS6001FA (GE Frame 6FA) | <b>Qty. Received</b> | 24 Units (1 Complete Set) |

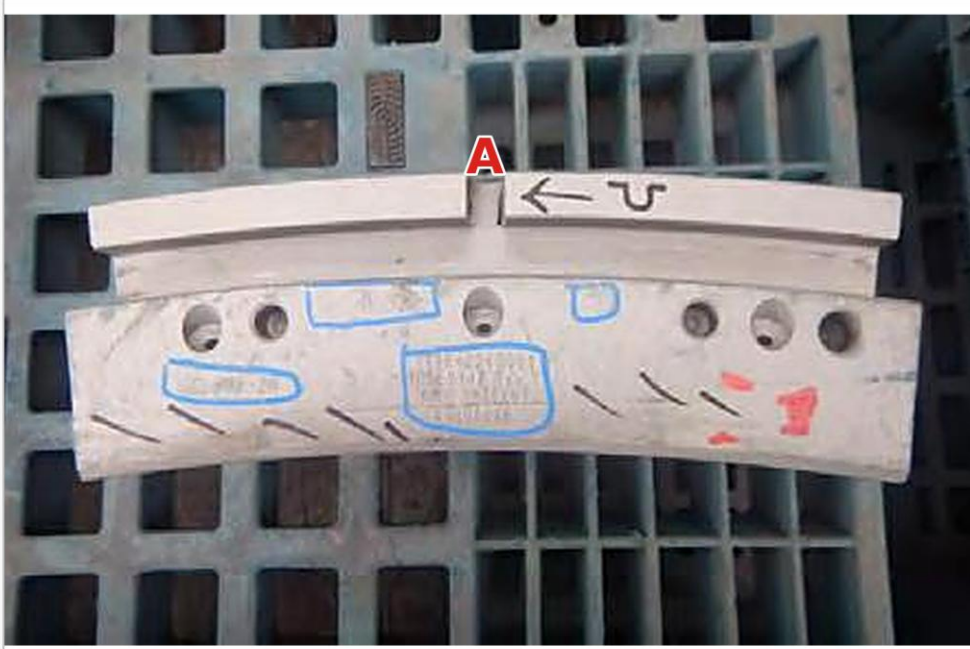
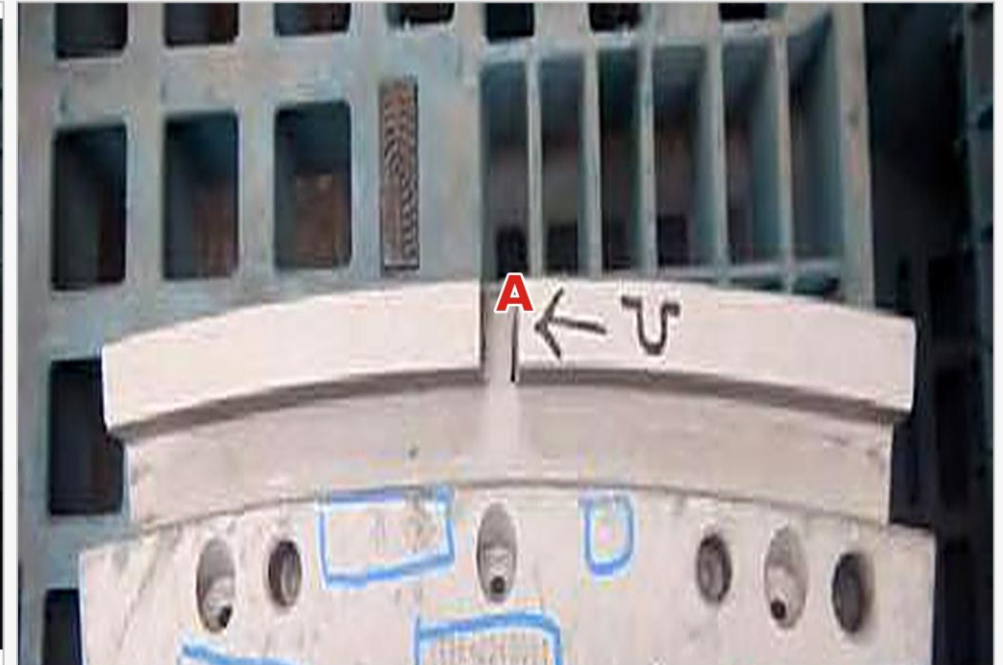
## FIG. 7 - HEAVY WEAR AND SURFACE DEGRADATION - SHROUD BODY

**DOCUMENTED EXTENT: FWD/AFT BODY FRETAGE BEYOND BLEND LIMITS ON 24/24 UNITS**

The damaged rails are load-bearing contact interfaces; loss of their geometry affects fit-up and structural stability. A discrete depth is not assigned to this photograph, but the report confirms depth and area exceed blend limits on the full set. Restoration therefore requires material removal, GTAW weld build-up, blending, re-machining, and dimensional verification.

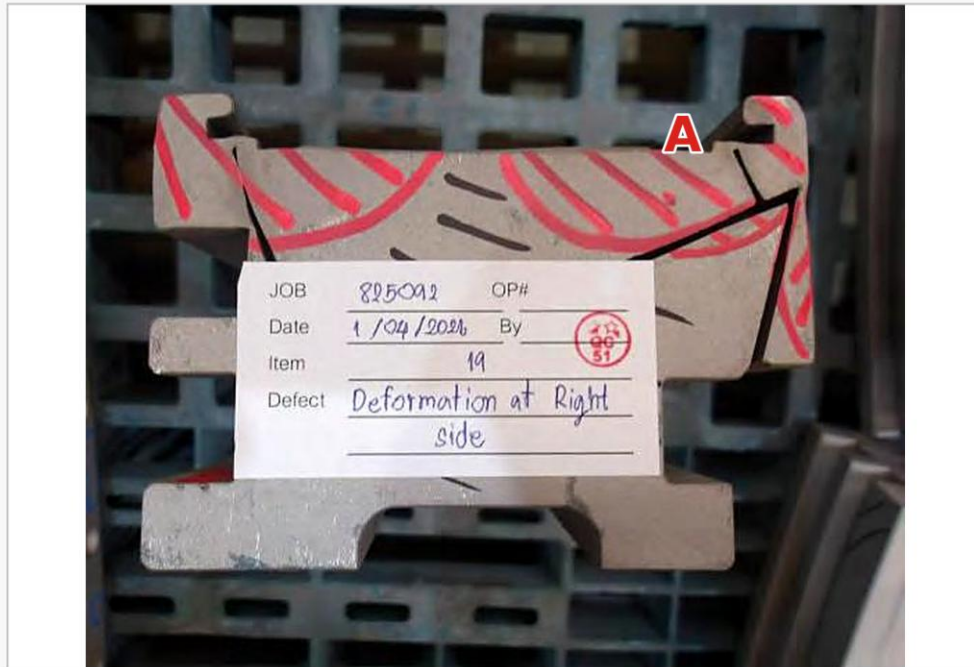
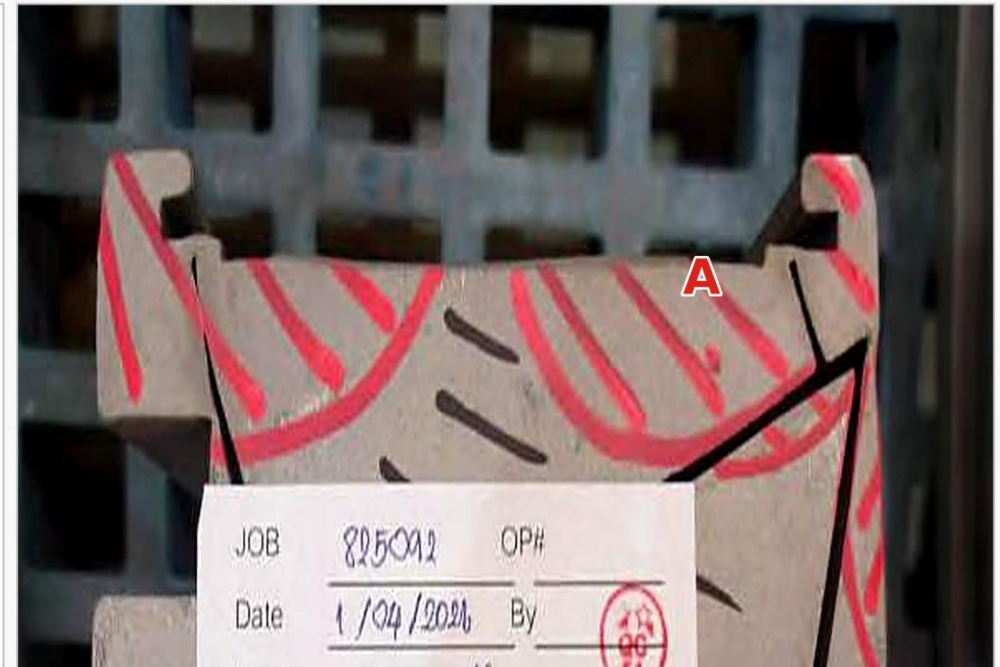
## FIG. 15 - HEAVY DEFORMATION - RIGHT SIDE OF SHROUD BODY

**FIXTURE BASIS: Z2 REJECT 24/24 | Z1 POSITION C REJECT 24/24 | ITEM 18 NOT FULLY SEATABLE**

Deformation is located at the body/inner-plate fit and sealing interface, where small geometric error is operationally critical.

The report does not assign a separate millimeter value to this photograph; the objective go/no-go fixture verdict controls.

Items 14, 17, 18, and 19 require jacking, contouring, mechanical straightening, and complete fixture requalification.

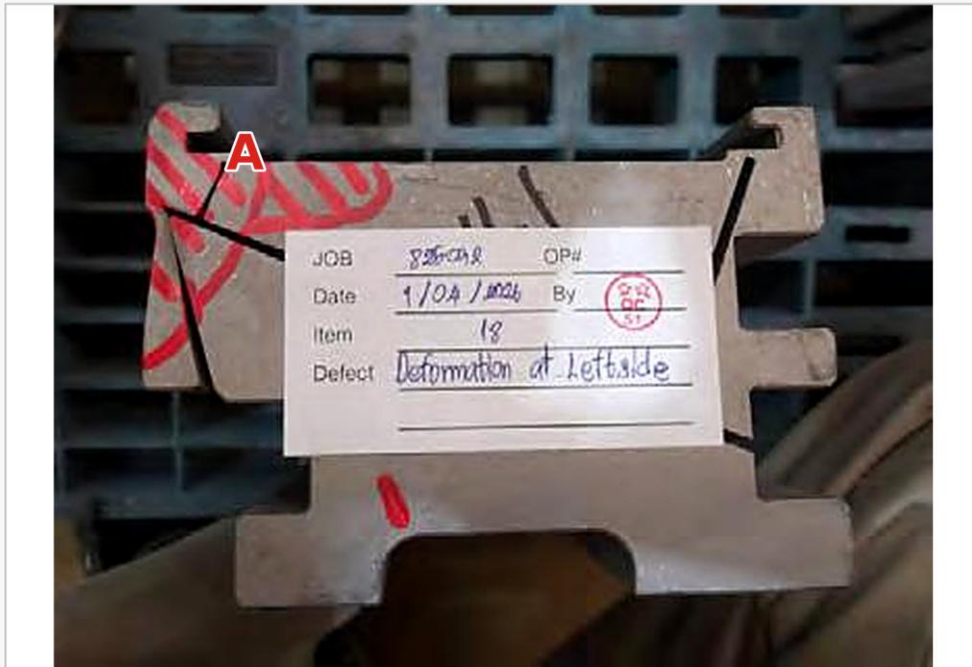
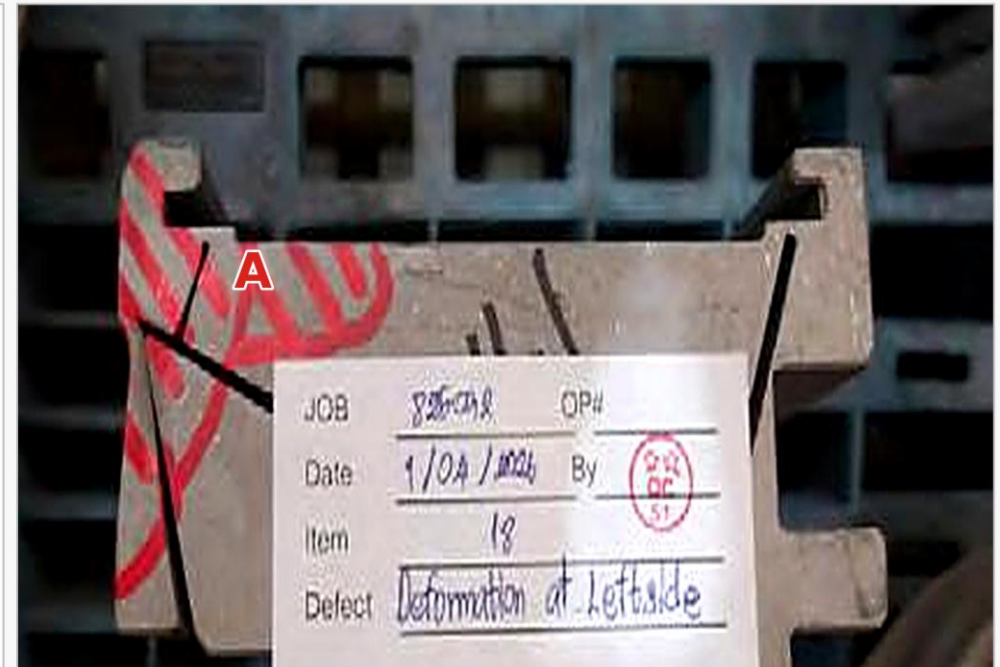
## FIG. 17 - HEAVY DEFORMATION - LEFT SIDE OF SHROUD BODY

**FIXTURE BASIS: Z2 REJECT 24/24 | Z1 POSITION C REJECT 24/24 | ITEM 18 NOT FULLY SEATABLE**

Heavy Repair is governed by failed assembled geometry and the required correction scope, not visible size alone.

Mechanical straightening must be followed by full dimensional restoration, re-machining, and fixture requalification.

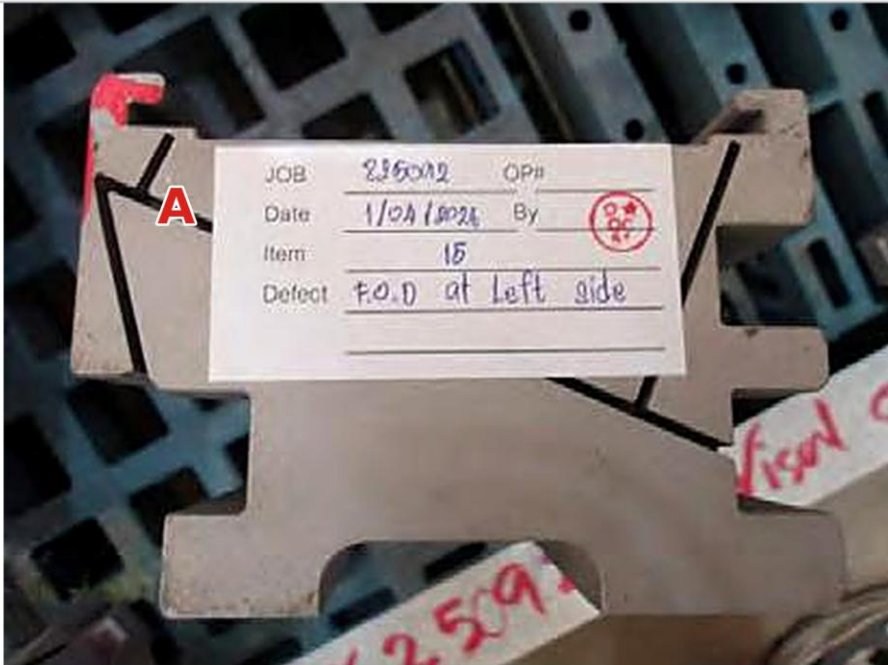
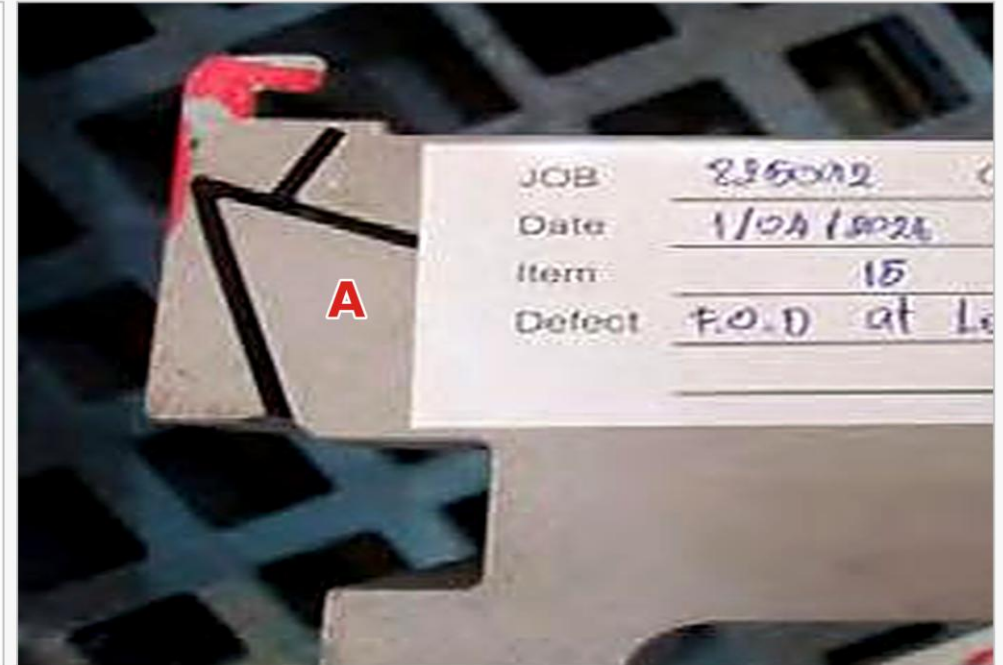
## FIG. 19 - FOREIGN OBJECT DAMAGE - LEFT SIDE OF SHROUD BODY

### DOCUMENTED FOD SCOPE: ITEMS 3, 9, 13-19, AND 21-24

FOD at the side contact region creates a local stress concentration on an already frettage-damaged structural interface. The report records no separate photo dimension; severity follows the critical location and combined material-loss condition. Complete removal, blending, and weld restoration are required before geometry and sealing can be requalified.

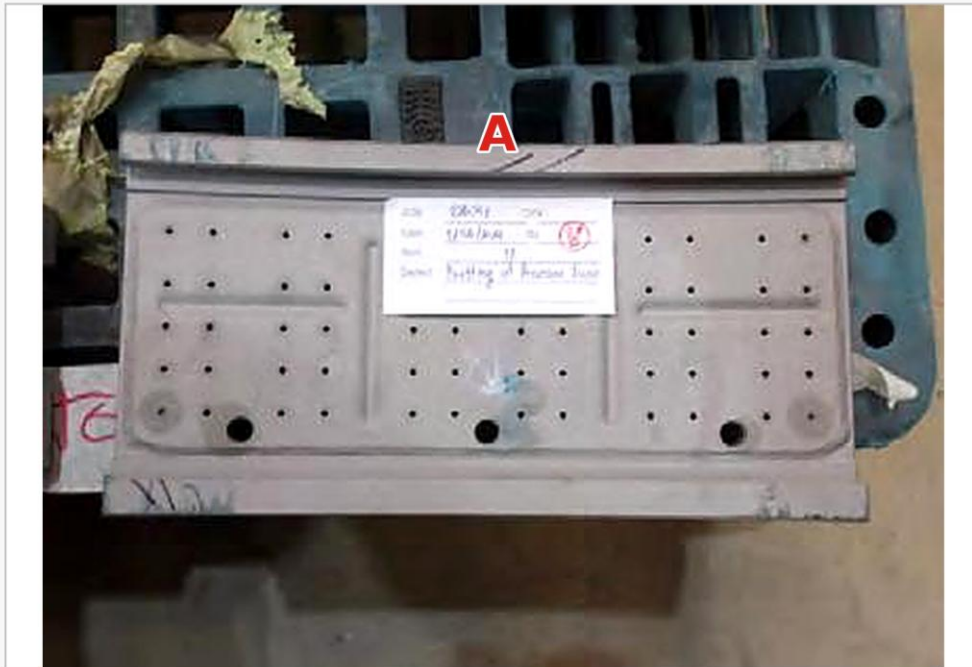
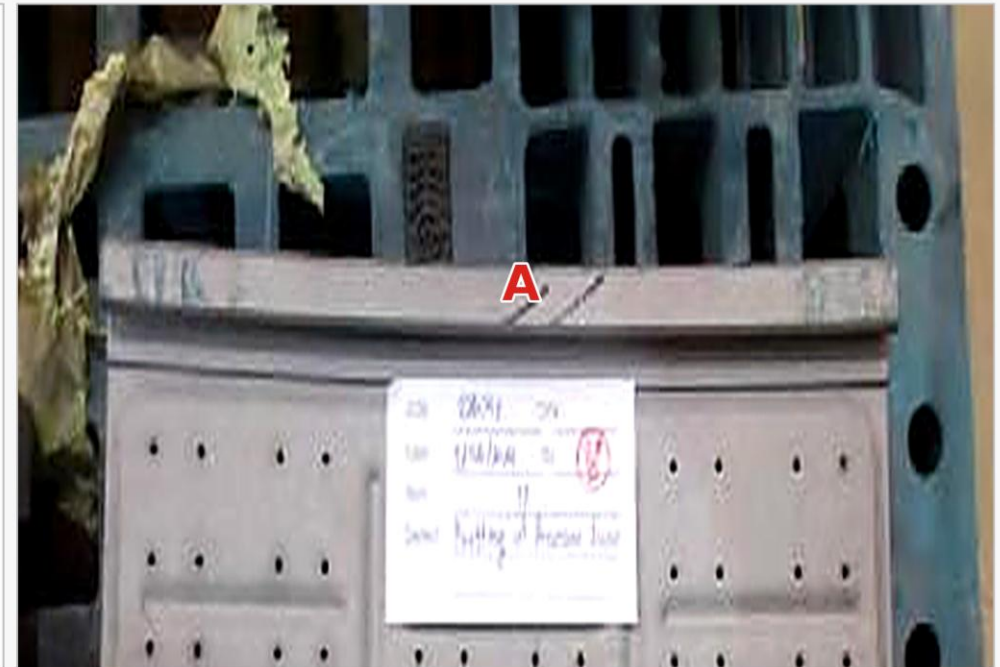
## FIG. 20 - HEAVY FRETTAGE - PRESSURE FACE OF SHROUD BODY

**PRESSURE-FACE MATERIAL LOSS: MULTIPLE UNITS | WELD BUILD-UP AND CONTOUR RESTORATION REQUIRED**

Heavy Repair requires routing, GTAW build-up, contour recovery, post-weld heat treatment, and dimensional requalification.

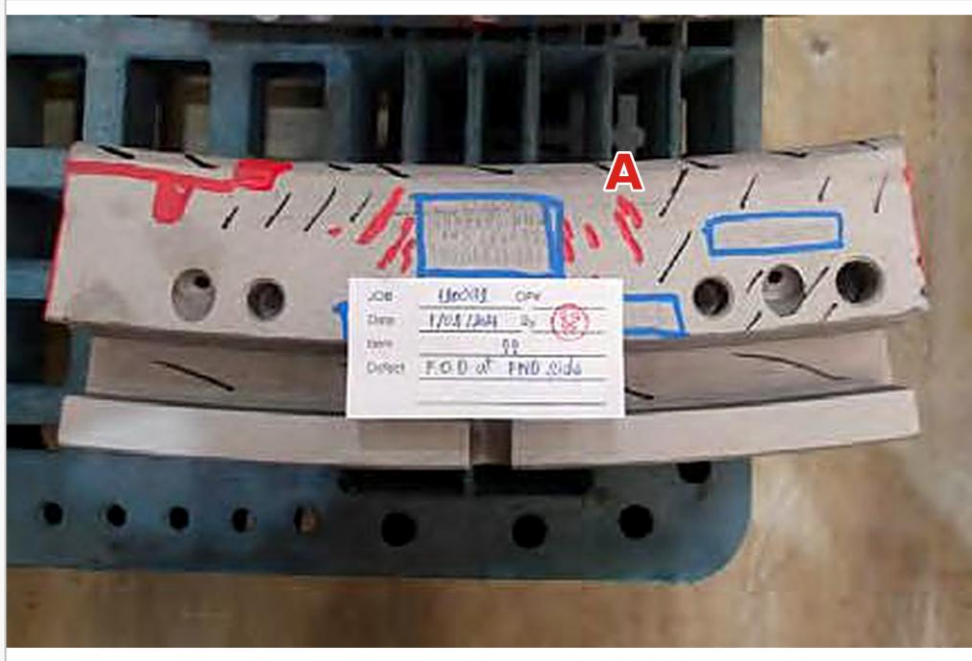
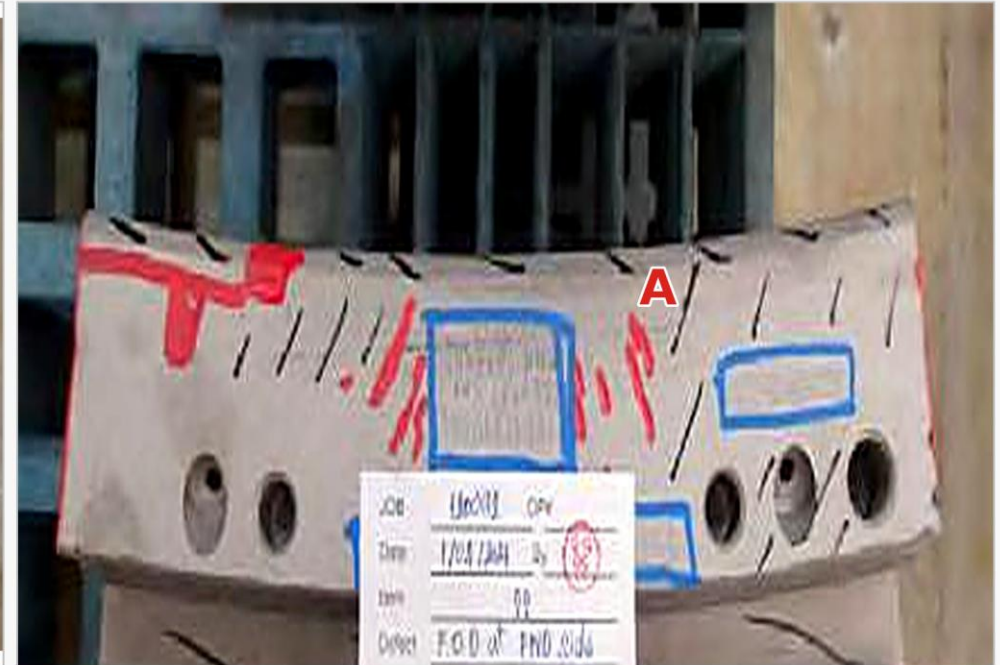
## FIG. 22 - FOREIGN OBJECT DAMAGE - FORWARD SIDE OF SHROUD BODY

### DOCUMENTED FOD SCOPE: ITEMS 3, 9, 13-19, AND 21-24

The damaged forward rail is part of the load-bearing assembly contact network and is also affected by full-set fretting.

Even localized FOD requires Heavy Repair when removal exposes insufficient geometry for blend-only restoration.

The repair sequence requires blending, weld build-up as necessary, re-machining, FPI, and final fit verification.

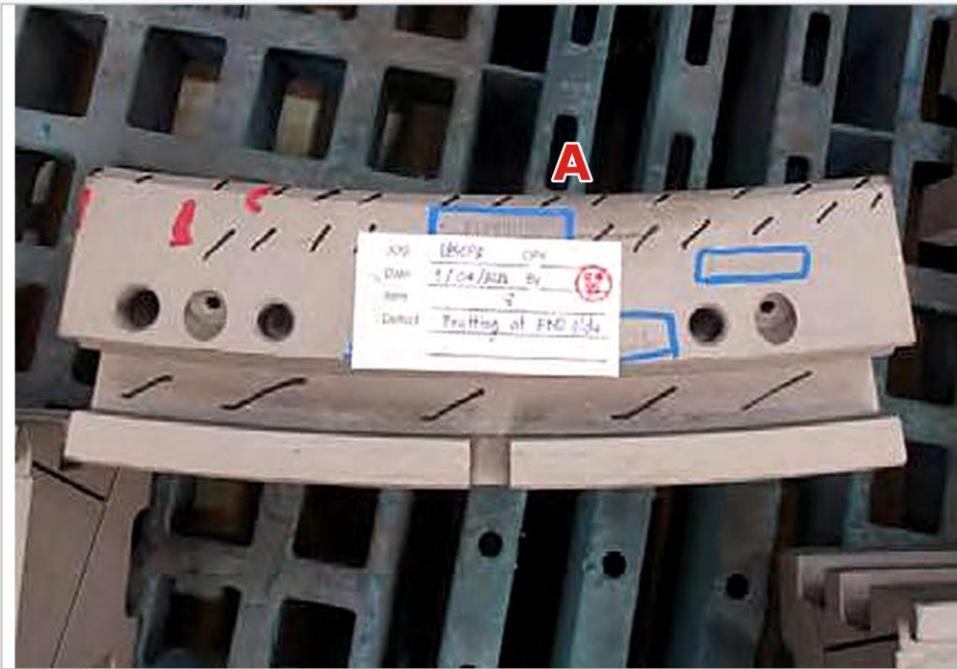
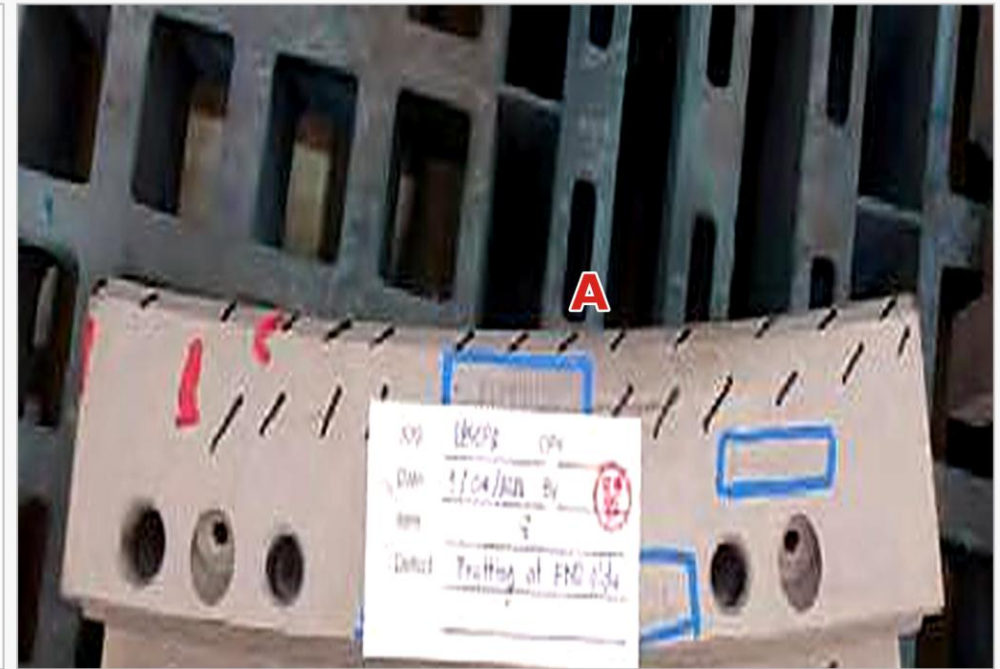
## FIG. 23 - HEAVY FRETTAGE - FORWARD SIDE OF SHROUD BODY

**DOCUMENTED EXTENT: FORWARD-SIDE FRETTAGE ON 24/24 BODIES; DEPTH/AREA BEYOND BLEND LIMITS**

Widespread forward-rail wear removes material from the interface controlling assembly position and load transfer.

Weld reconstruction and re-machining are mandatory because blend-only treatment cannot replace the lost rail geometry.

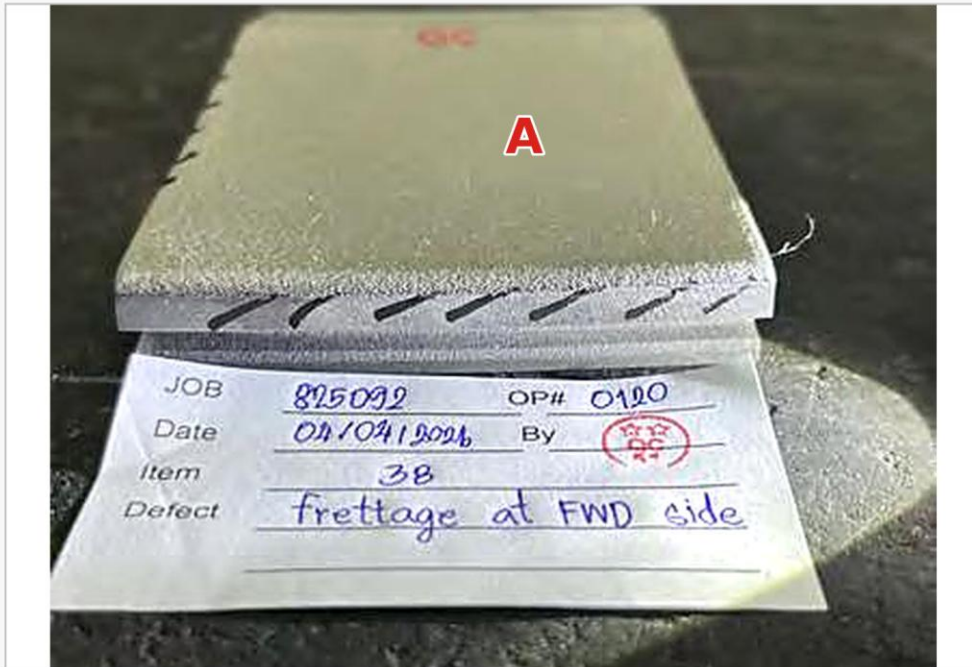
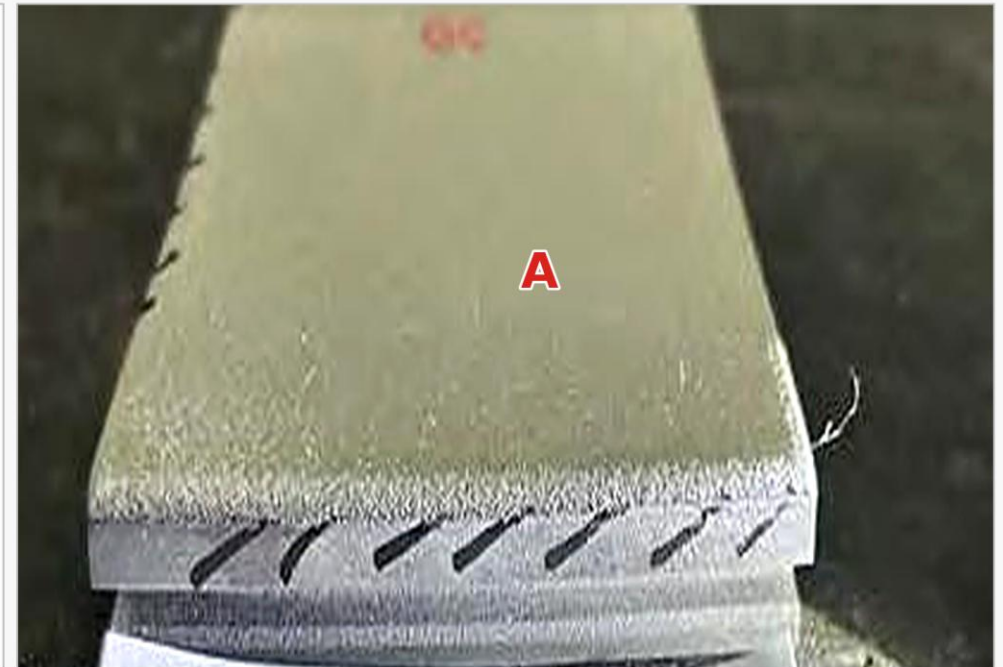
## FIG. 25 - HEAVY FRETTAGE - FORWARD SIDE OF INNER PLATE (TIP SHOE)

**SET-WIDE RAIL DATA: 1.70 mm DATUM | WORST 0.90 mm (47.1% BELOW) | 13 READINGS BELOW**

All 24 inner plates require weld build-up, re-machining, and fixture requalification; blending alone worsens fit-up.

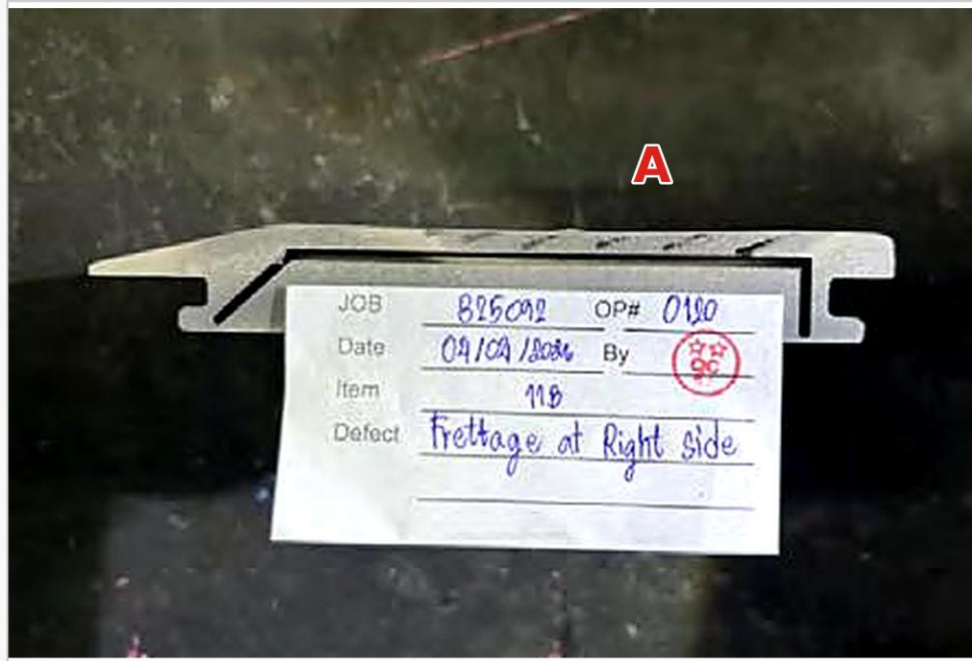
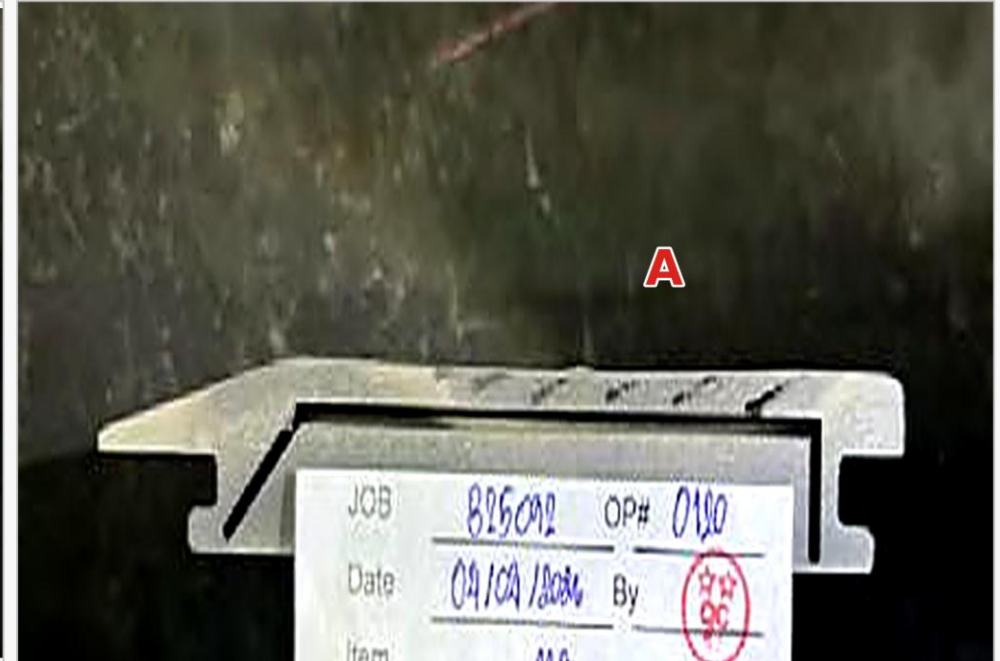
## FIG. 27 - HEAVY FRETTAGE - RIGHT SIDE OF INNER PLATE (TIP SHOE)

**SET-WIDE RAIL DATA: 1.70 mm DATUM | WORST 0.90 mm (47.1% BELOW) | 13 READINGS BELOW**

Heavy Repair requires structural build-up and precision re-machining across the contact geometry before coating and assembly.

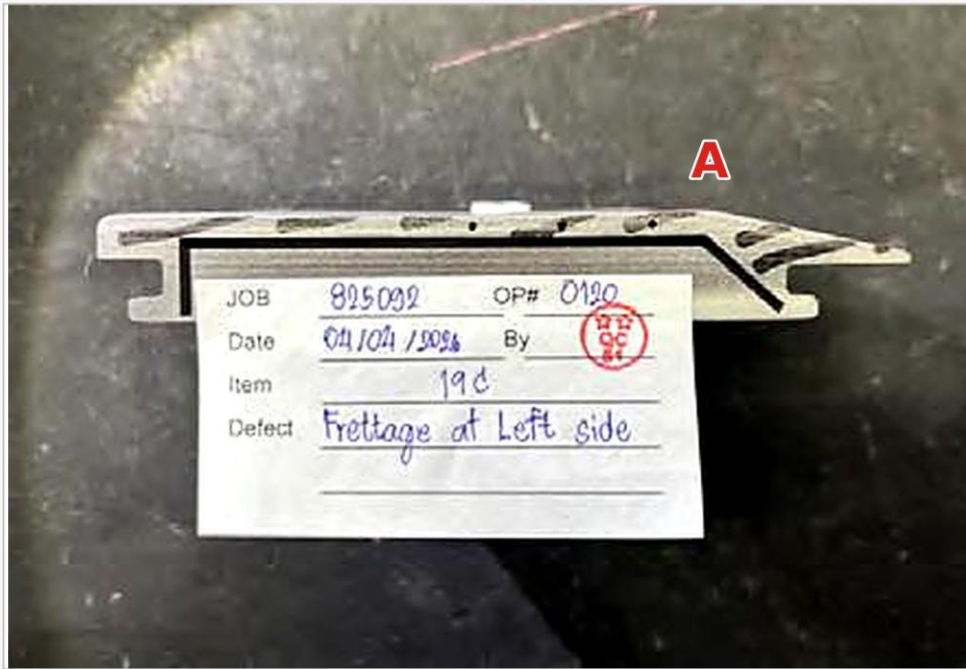
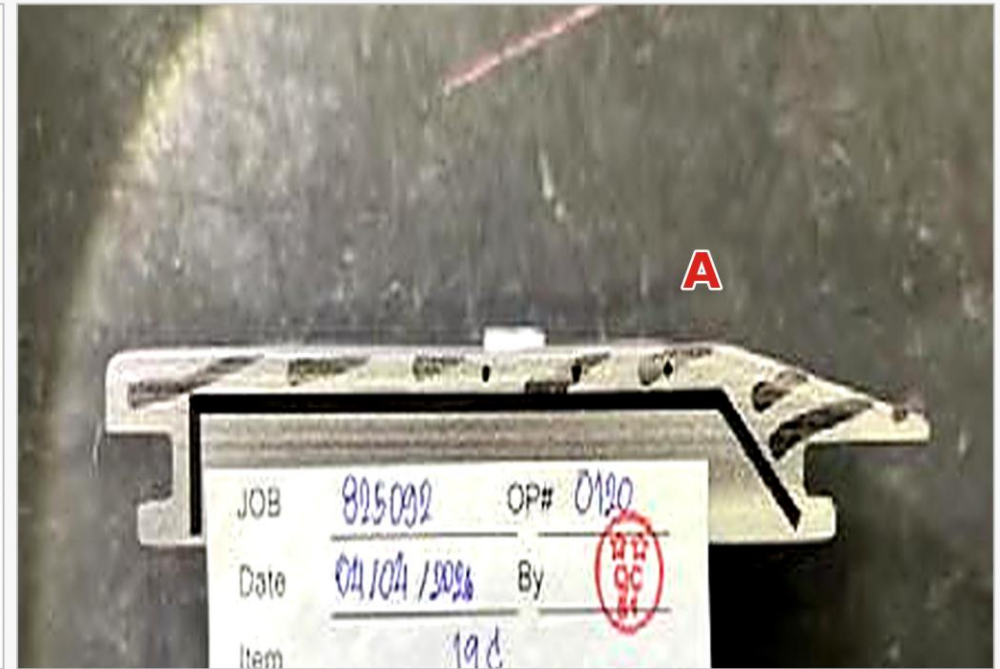
## FIG. 30 - HEAVY FRETTAGE - LEFT SIDE OF INNER PLATE (TIP SHOE)

**SET-WIDE RAIL DATA: 1.70 mm DATUM | WORST 0.90 mm (47.1% BELOW) | 13 READINGS BELOW**

Left-side rail wear is at a critical fit and sealing interface, so repair level is not determined by visual size alone.

All 24 assemblies failed the Z2 fixture check and require full dimensional restoration of the inner-plate geometry.

The required weld build-up, re-machining, heat treatment, and fixture requalification place the work in Heavy Repair.

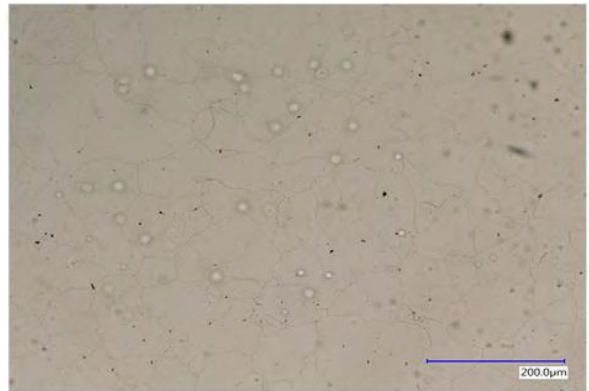
Fig. 2: Typical microstructure at higher magnification (Etched)

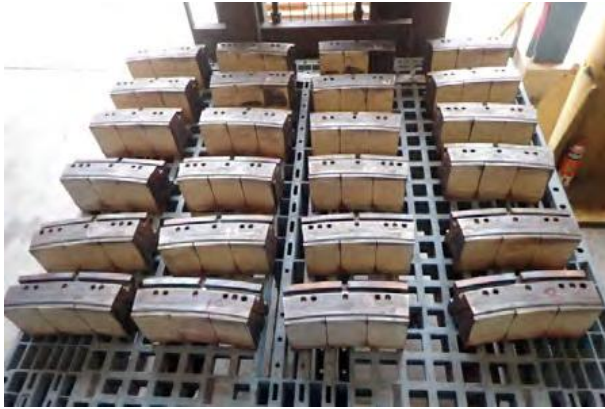
Fig. 1: As-received condition

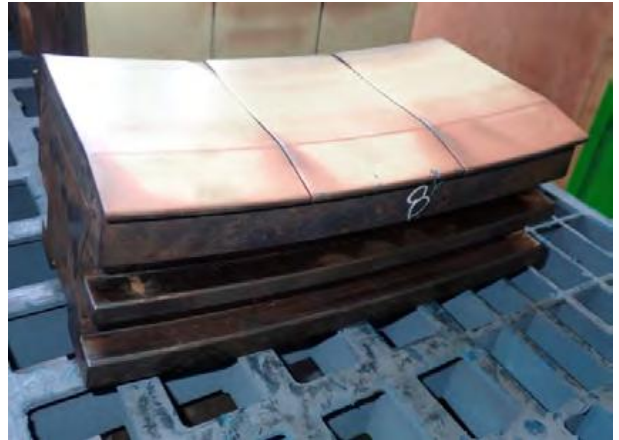
Fig. 2: As-received condition

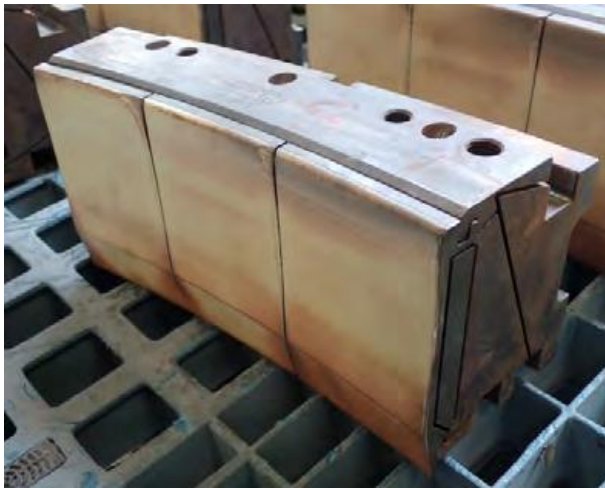
Fig. 3: Heavy damage, as-received condition

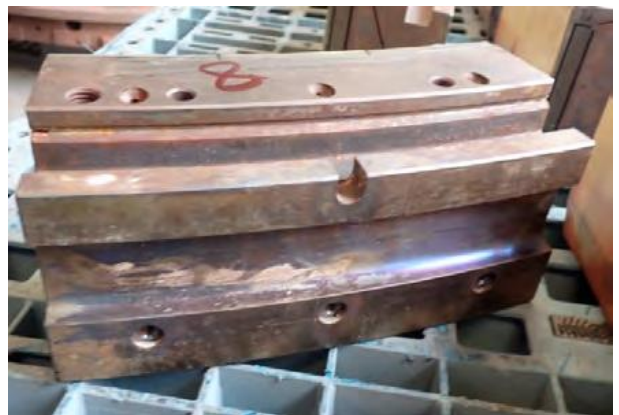
Fig. 4: Heavy damage, as-received condition

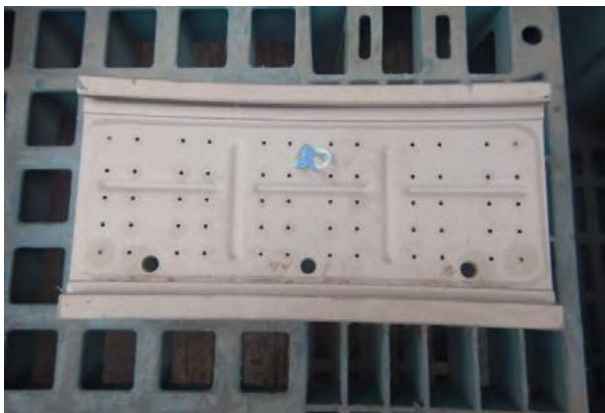
Fig. 5: Tear and wear, shroud block body

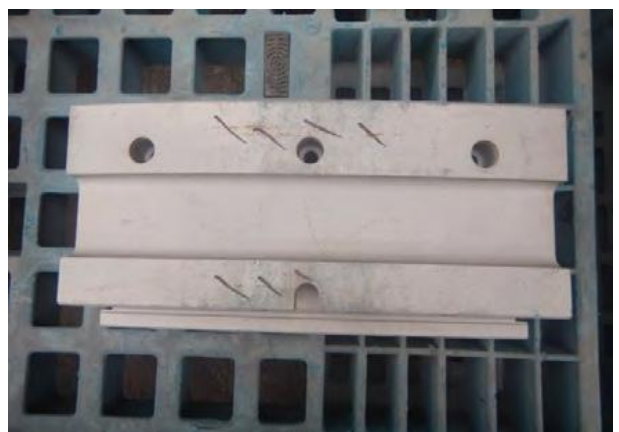
Fig. 6: Tear and wear, shroud block body

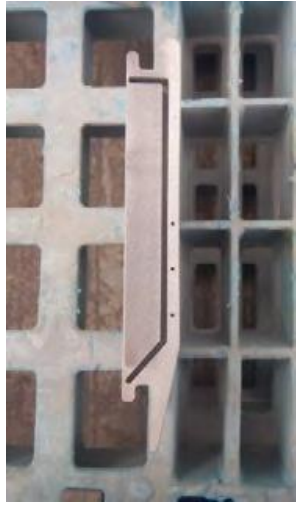
Fig. 13: Severe degradation on tip shoe (inner plate)

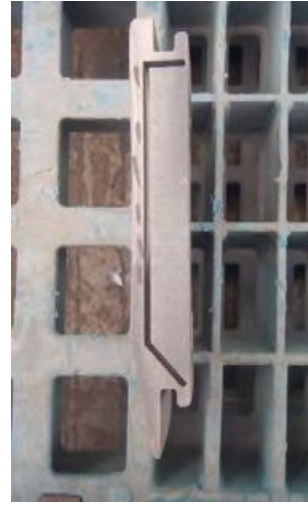
Fig. 14: Severe degradation on tip shoe (inner plate)

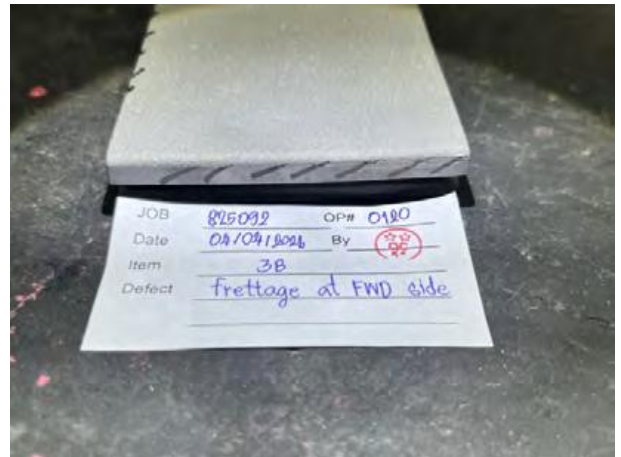
Fig. 26: Heavy frettage on FWD side, tip shoe

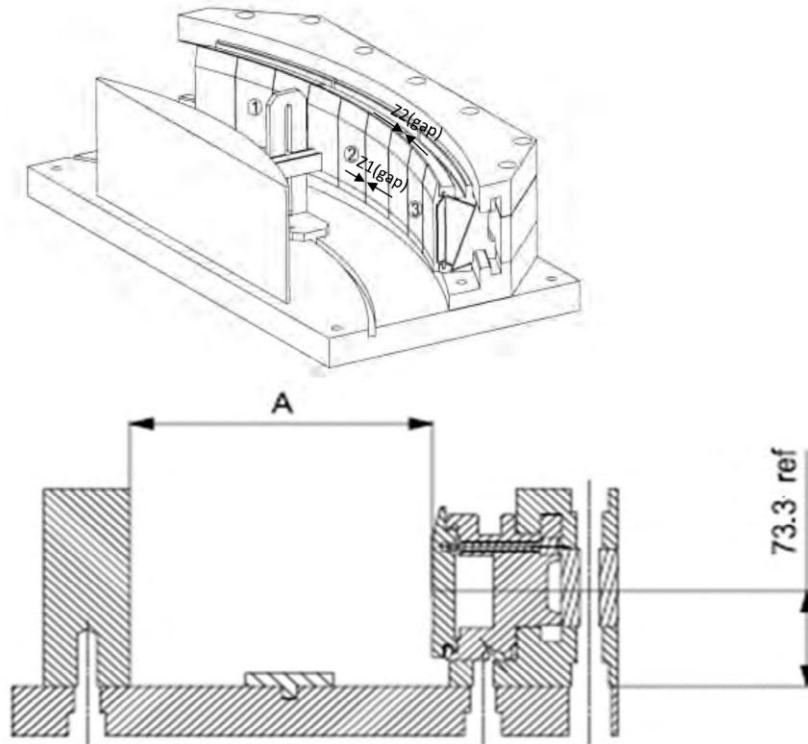
Fixture inspection:

| Fixture Check Method and Acceptance Basis | |
|---|---|
| <b>Result</b> | 24 of 24 assemblies REJECT at Z2; tip shoe position C REJECT at Z1 on 24 of 24; Item 18 rejected on failure to achieve full fixture seating |
