# INCOMING INSPECTION REPORT

### MS6001FA (GE Frame 6FA) 3rd Stage Bucket Set

Work Order WO-1004061634 / WO-1004061642

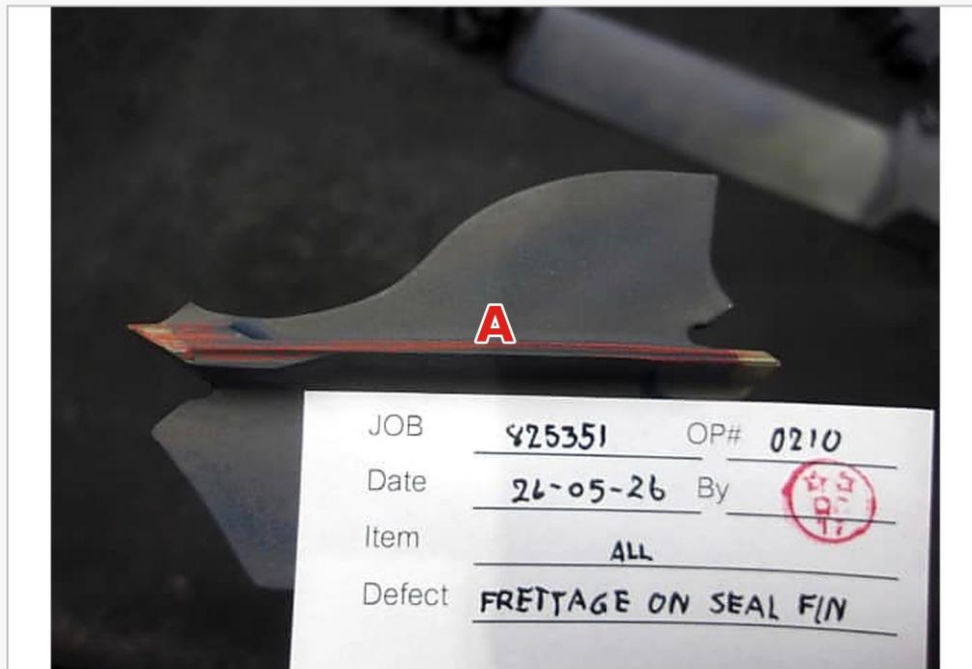
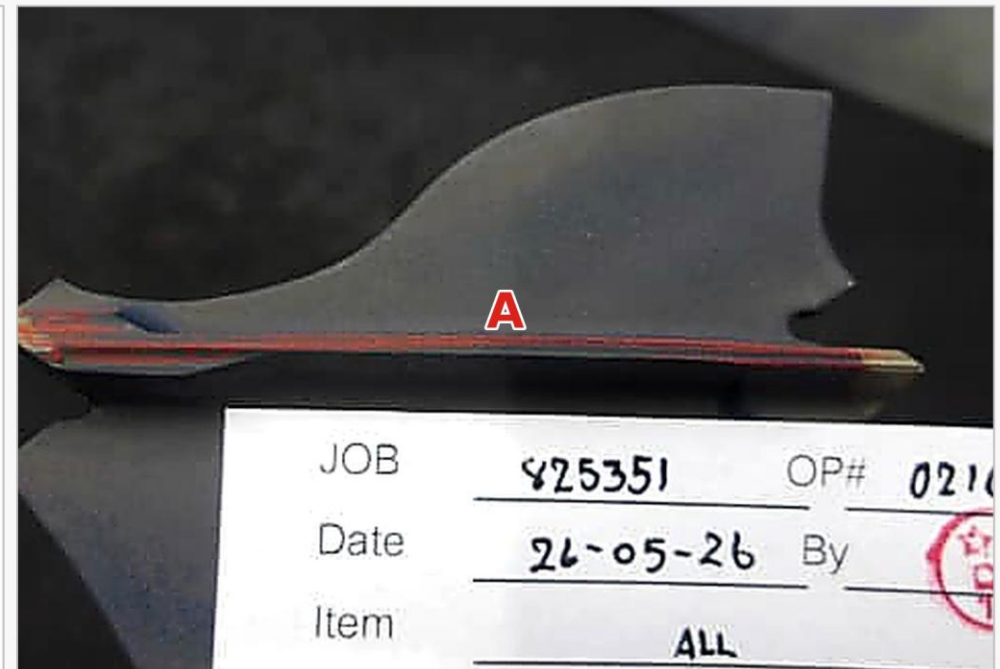
## FIG. 13 - FRETTAGE AND DIMENSIONAL LOSS - SEAL FIN

**SEAL FIN HEIGHT: 2.00 mm MIN | MEASURED 1.36-1.67 mm | 46/46 BELOW | 92/92 REJ**

Fretting affects the gas-path seal fin on 92 of 92 buckets; the measured loss is not marginal.

Mean height is 1.528 mm (23.6% below minimum); even the best measured bucket is 16.5% below.

Blend-only correction cannot restore height; weld build-up, machining, EDM, repeated FPI, and verification are required.

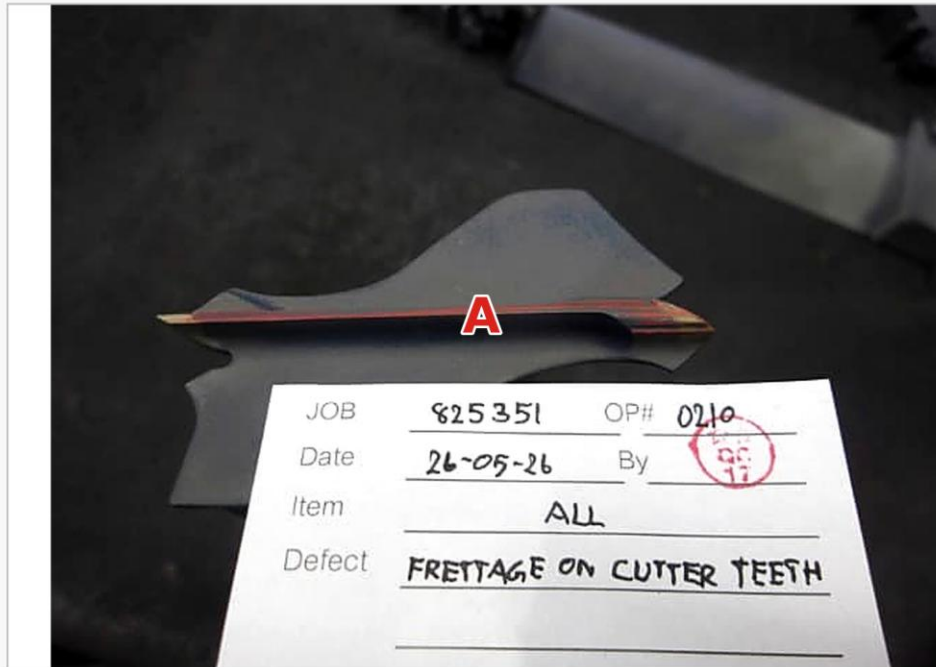
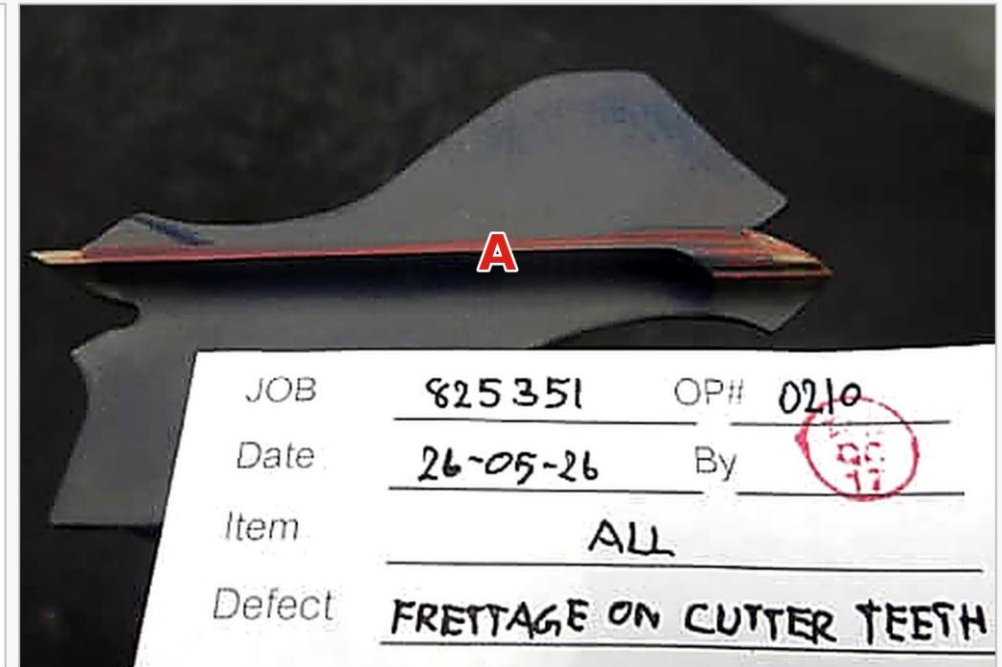
## FIG. 14 - FRETTAGE - CUTTER TEETH

### FULL-SET ROUTING: SEAL FIN / CUTTER TEETH WM ON 92/92 BUCKETS

The repair record routes all 92 buckets to Weld and Machining (WM): full-set geometry reconstruction.

Recovery requires weld build-up, precision machining/EDM, heat treatment, NDT, moment weighing, and balance control.

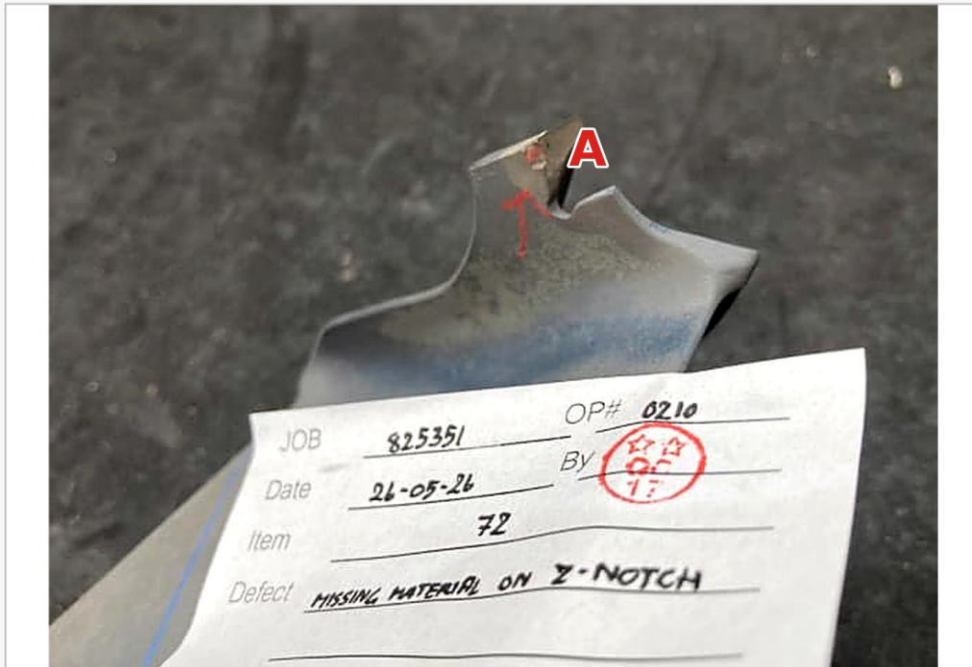
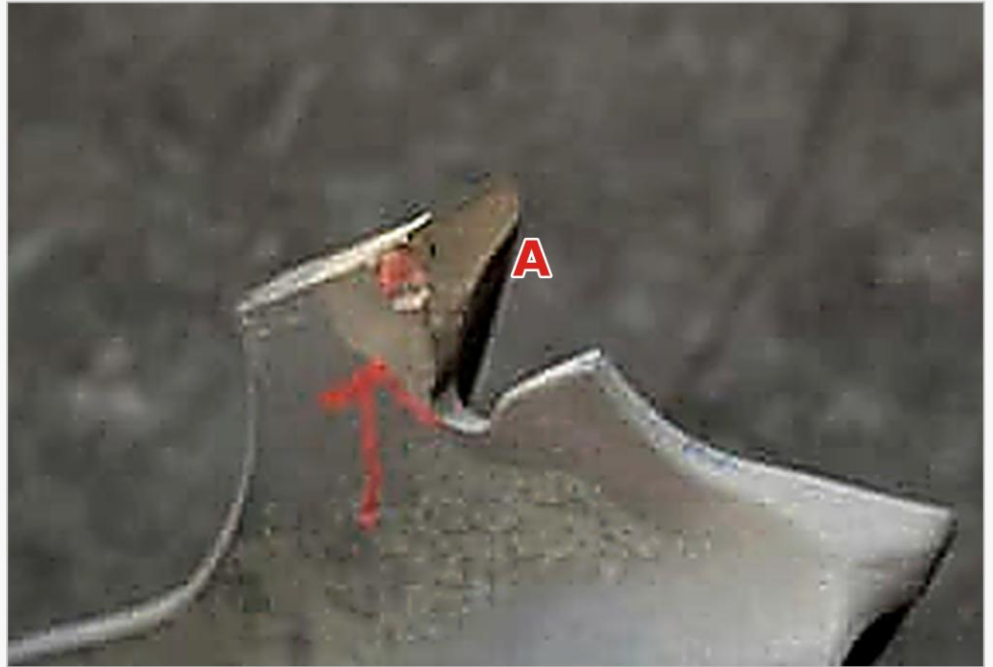
## FIG. 15 - MISSING MATERIAL - Z-NOTCH

**ITEM 72: 2 mm x 3 mm MISSING MATERIAL | 1.5 mm DEPTH > 0.5 mm BLEND LIMIT**

The Z-notch is a bucket-to-bucket engagement and load-transfer feature, not a cosmetic edge.  
The measured defect covers approximately 6 square millimetres and is three times the local blend-depth limit.  
Item 72 routes to welding and EDM; full-set Z-notch/shroud fretage requires controlled profile recreation.

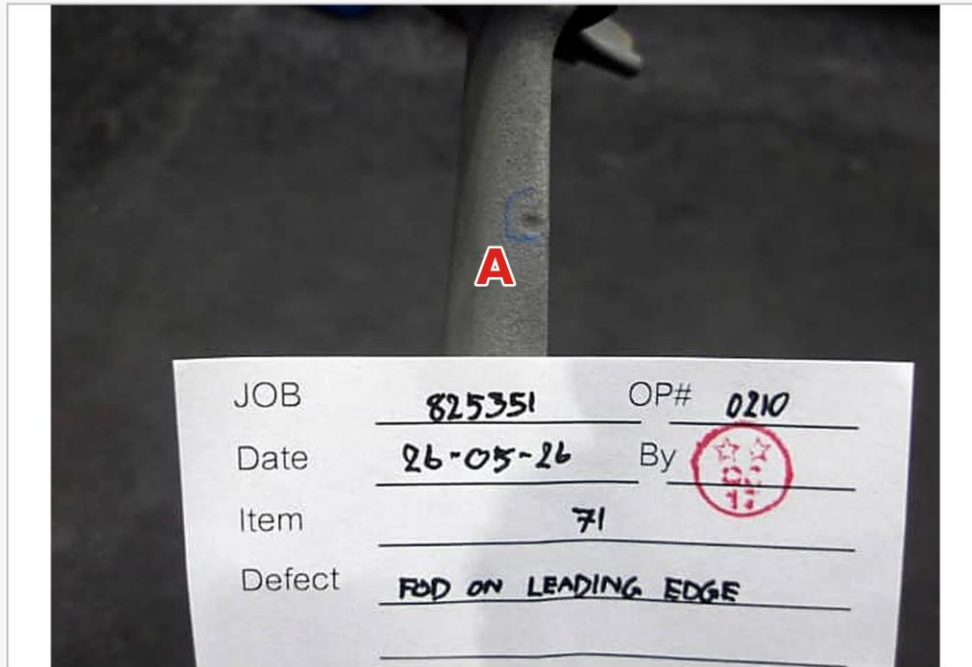
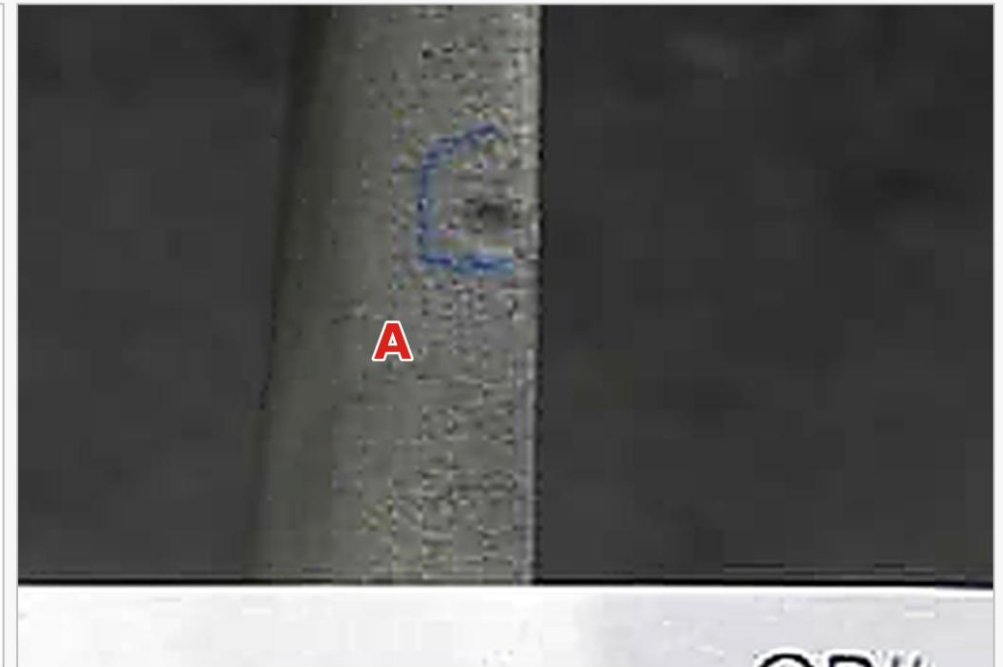
## FIG. 17 - FOREIGN OBJECT DAMAGE - LEADING EDGE

**LEADING-EDGE FOD: 7/92 | MAX 3 x 2 mm | 0.6 mm DEPTH > 0.3 mm LIMIT**

Leading-edge damage changes the aerodynamic profile and creates a crack-initiation stress concentration. This photograph records Item 71; the dimensions shown are set-wide report data, not photo-derived measurements. The maximum depth is twice the blend limit, requiring controlled removal, weld review, and post-repair FPI.

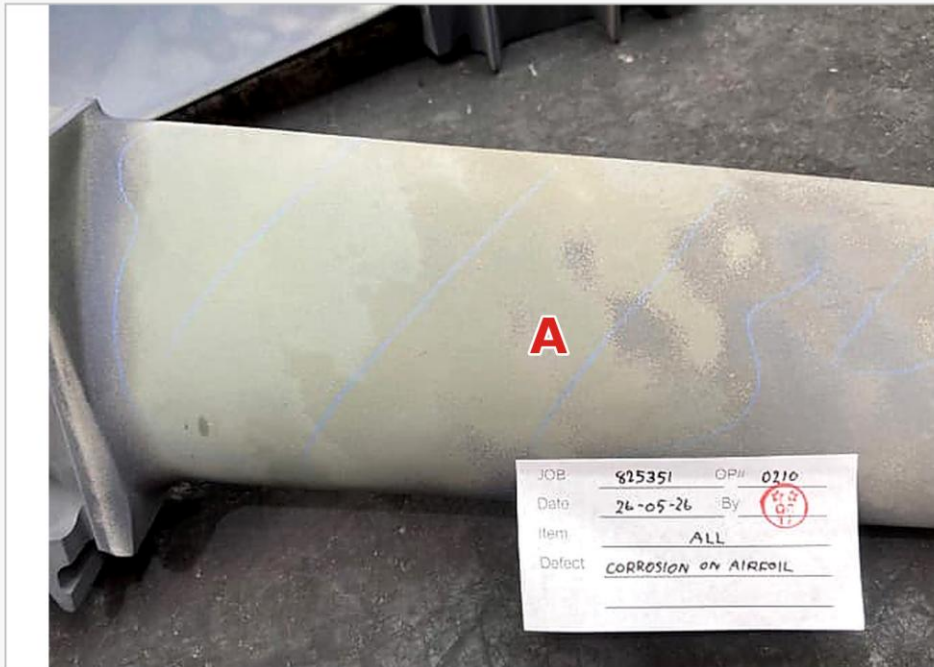
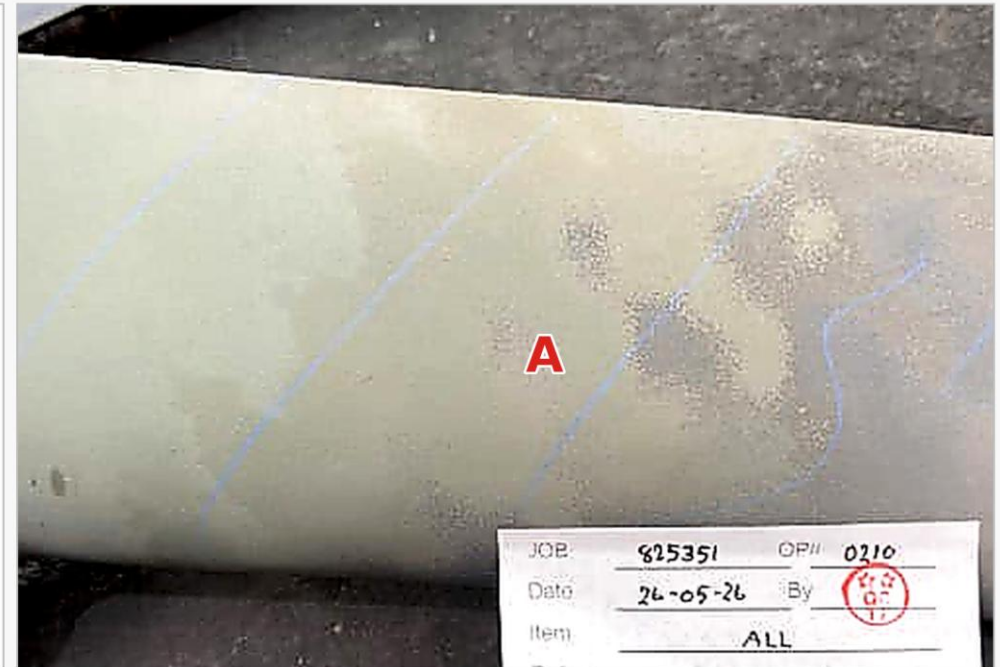
## FIG. 18 - OXIDATION-CORROSION - AIRFOIL HOT GAS PATH

**AIRFOIL CORROSION: 92/92 | SUBSTRATE DEPLETION 60-90 MICROMETRES | GTD 111, 40.2 HRC**

The uncoated hot-gas-path surface shows widespread oxidation-corrosion, confirmed by Items 42 and 92 sectioning.

Combined with full-set weld restoration and heat treatment, this base-metal condition supports Level 9.

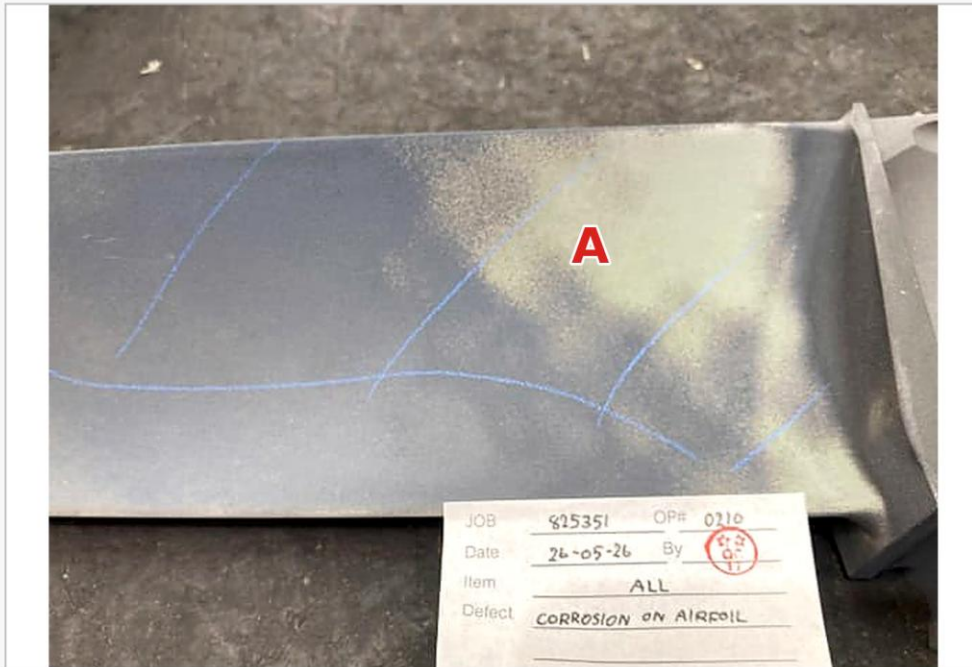
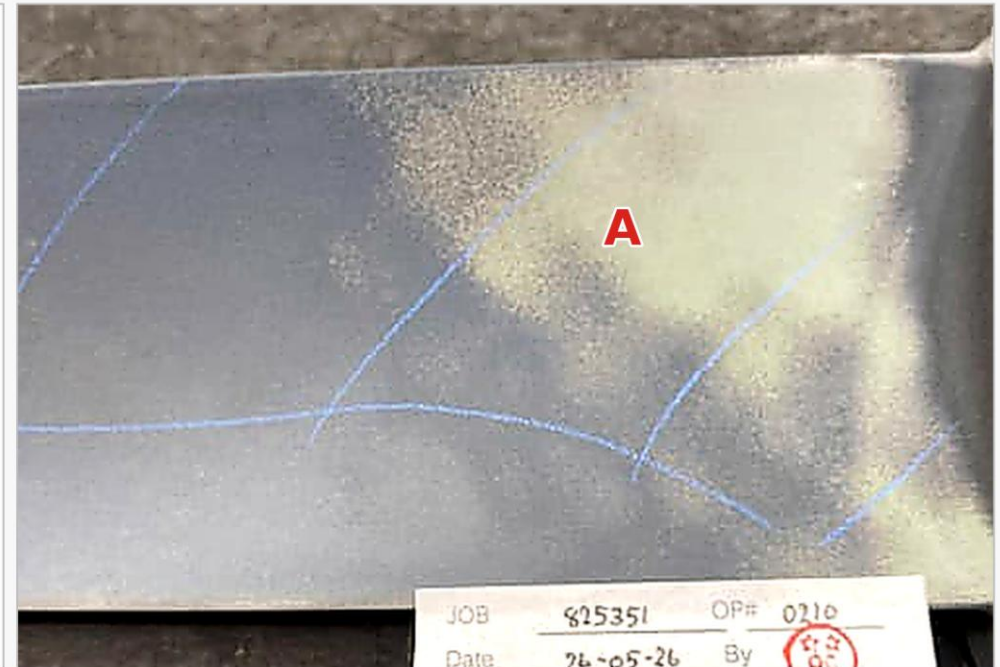
## FIG. 20 - EXTENSIVE SURFACE CORROSION - AIRFOIL

**CONFIRMED SET-WIDE CONDITION: 92/92 AIRFOILS | 60-90 MICROMETRES SUBSTRATE DEPLETION**

This alternate airfoil view documents a broad surface condition rather than one isolated spot. Visual/FPI records confirm corrosion on 92 of 92 buckets; sectioning confirms associated substrate depletion. Controlled cleaning, affected-material removal, heat treatment, and repeated NDT are required before release.

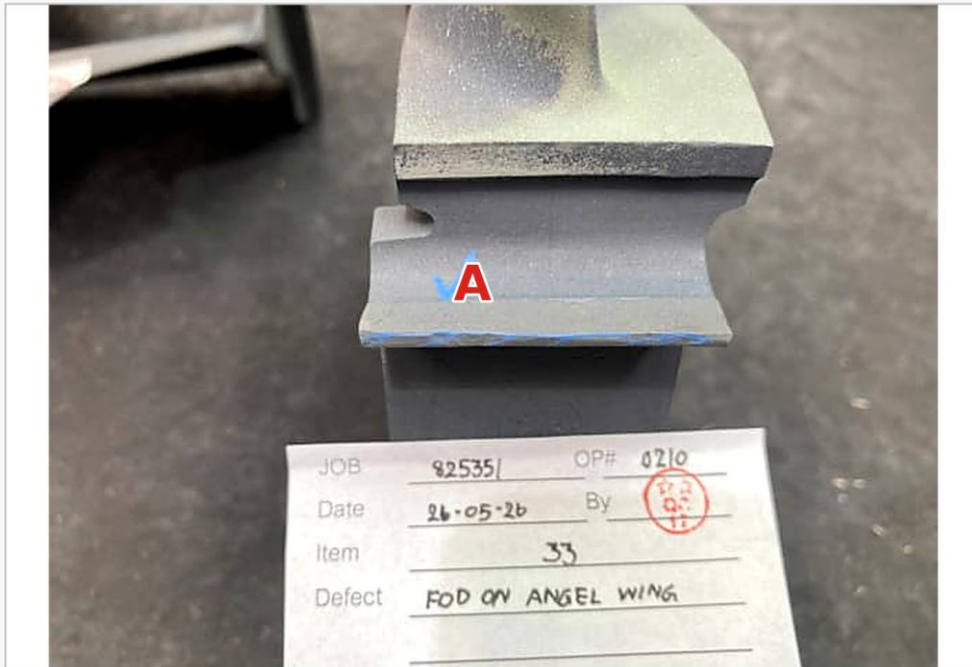
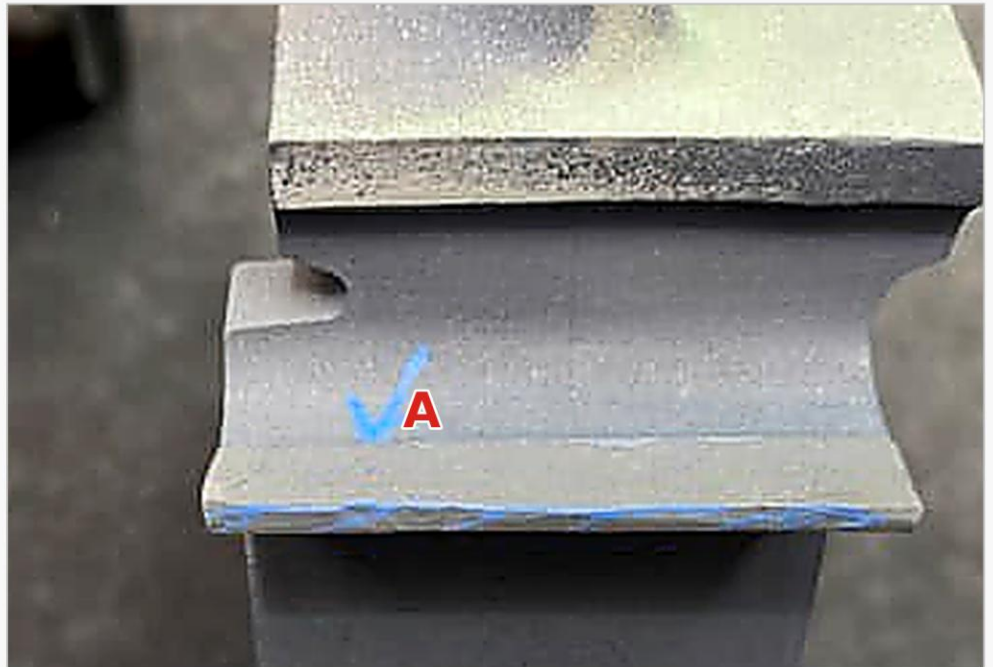
## FIG. 21 - FOREIGN OBJECT DAMAGE - ANGEL WING

**ANGEL-WING FOD: 36/92 (39.1%) | MAX 4 x 3 mm | 1.0 mm DEPTH > 0.5 mm LIMIT**

The angel wing is a critical wheel-space sealing and interface feature, so condition is not cosmetic.

Heavy restoration requires weld build-up where beyond limit, machining to recreate dimensions, and FPI/NDT.

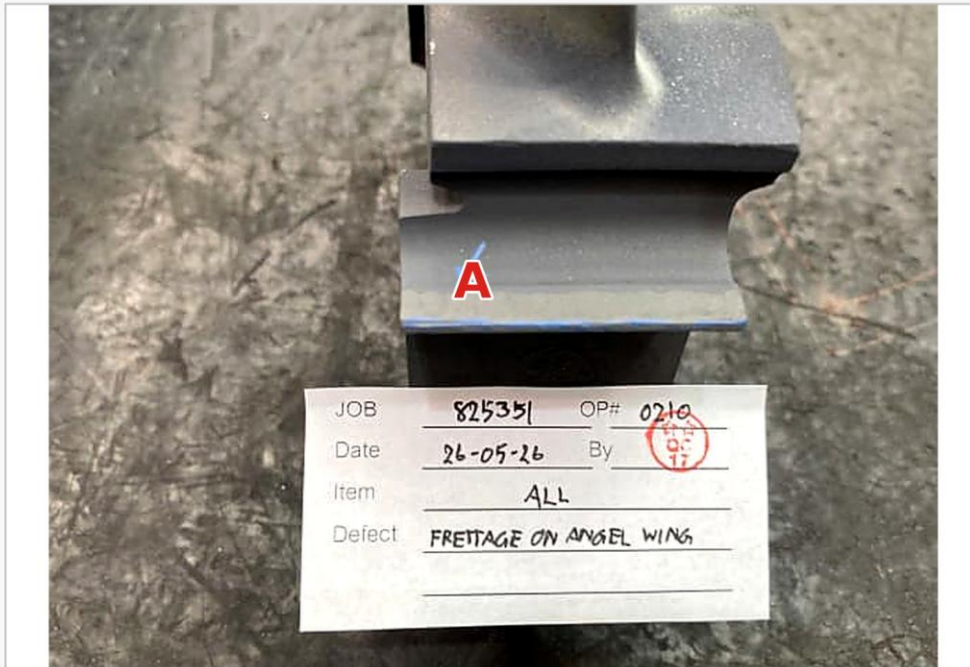
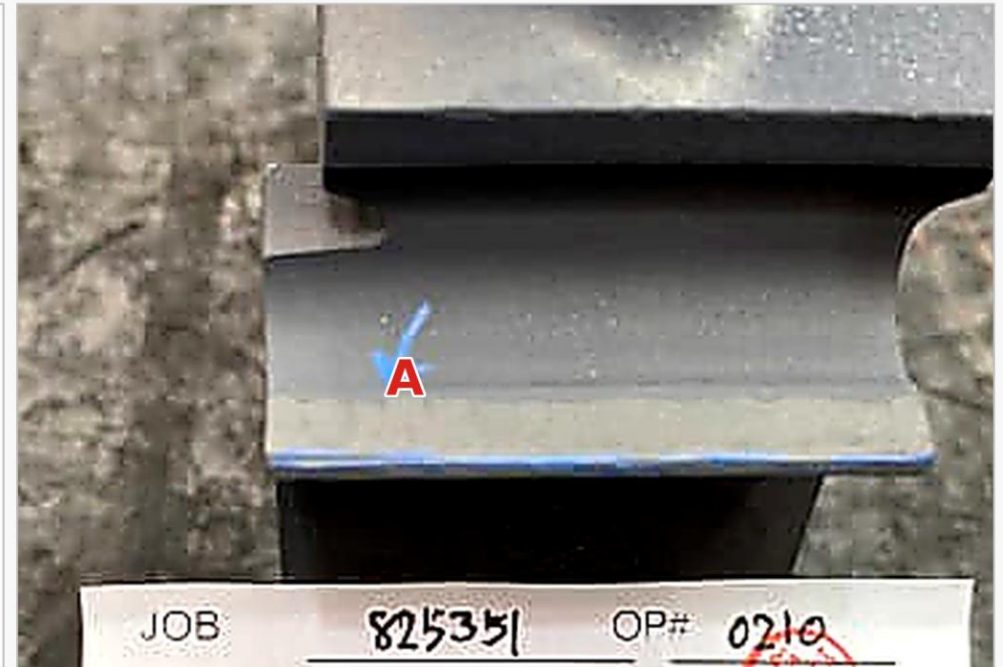
## FIG. 22 - FRETTAGE - ANGEL WING

**ANGEL-WING FRETTAGE: 92/92 | 36/92 ALSO REQUIRE WB ROUTING FOR FOD**

Surface grading does not reduce the repair class when restoring the location requires rebuilt geometry.

All 92 require profile restoration and machining; at least 36 require weld build-up for FOD beyond blend limits.

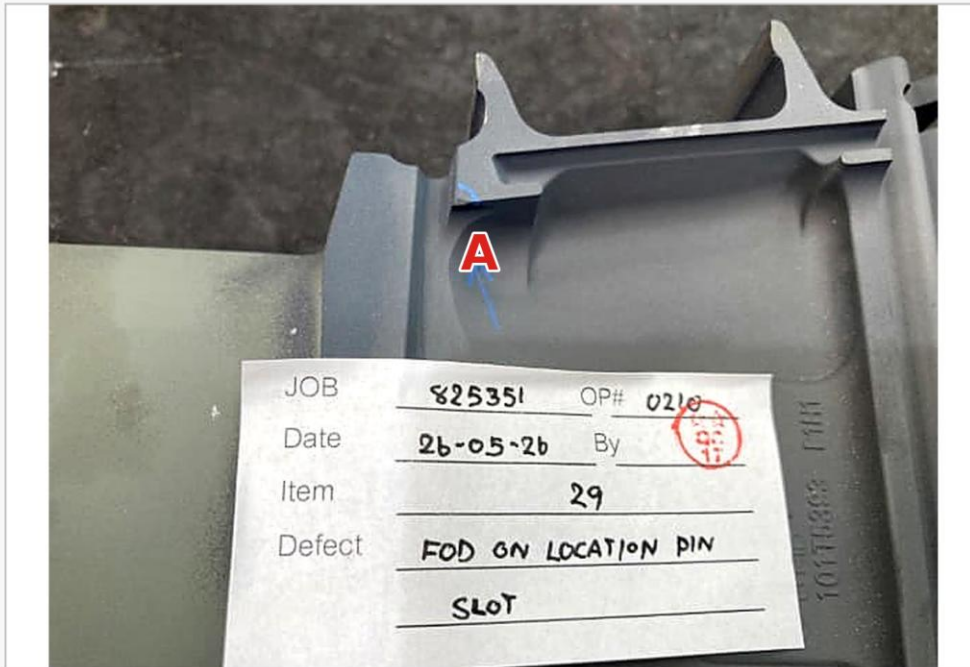
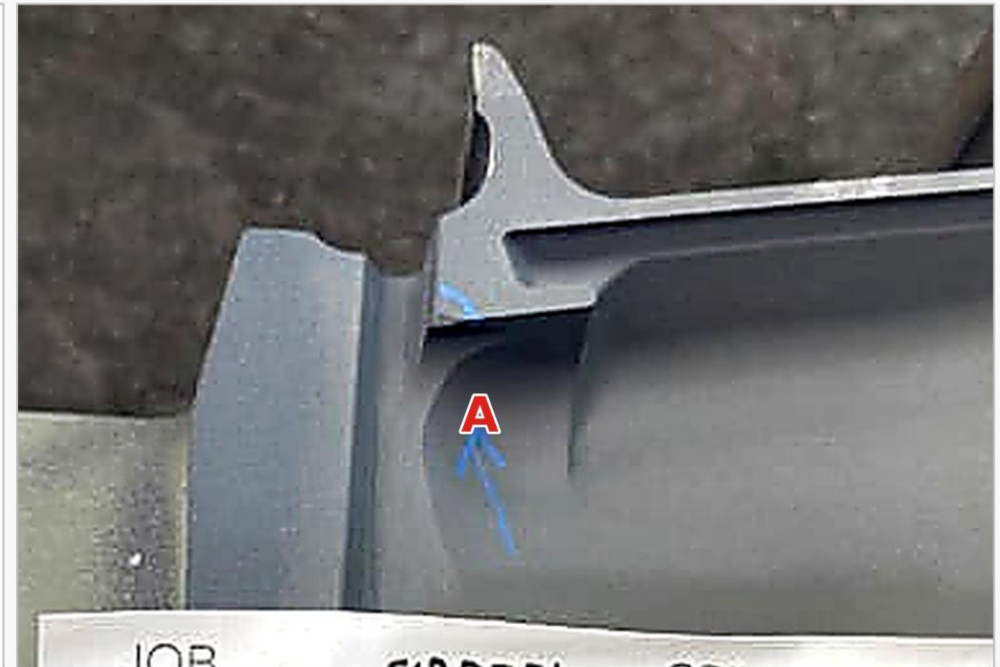
## FIG. 23 - FOREIGN OBJECT DAMAGE - LOCATION PIN SLOT

**LOCATION-PIN-SLOT FOD: 40/92 (43.5%) | MAX 5 x 3 mm | 0.8 mm DEPTH > 0.4 mm LIMIT**

Repair requires controlled removal, weld restoration where required, contact recovery, and dimensional verification.

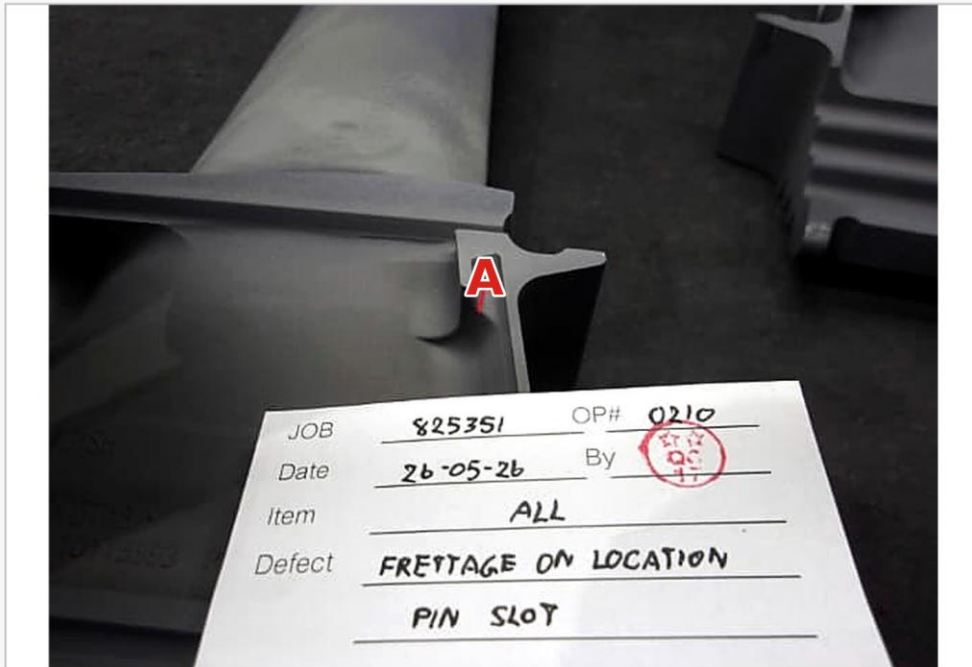
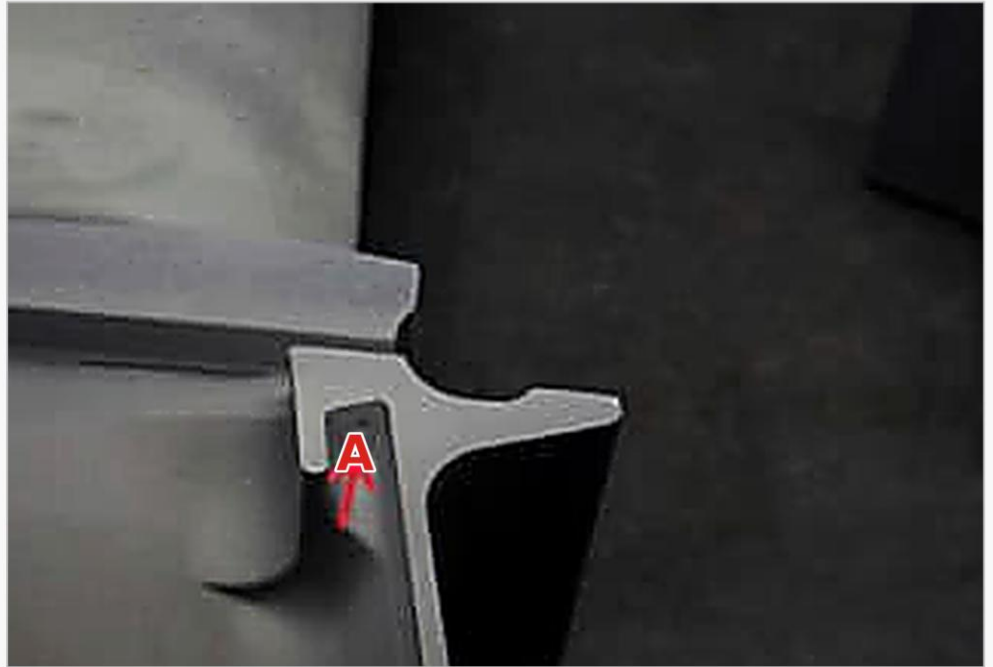
## FIG. 24 - FRETTAGE - LOCATION PIN SLOT

**LOCATION-PIN-SLOT FRETTAGE: 92/92 | 40/92 ALSO REQUIRE WB ROUTING FOR FOD**
