# INCOMING INSPECTION REPORT

## MS6001FA (GE Frame 6FA) 2nd Stage Bucket Set

| Customer | Nghi Son Refinery & Petrochemical LLC |
| Component | MS6001FA 2nd Stage Bucket |

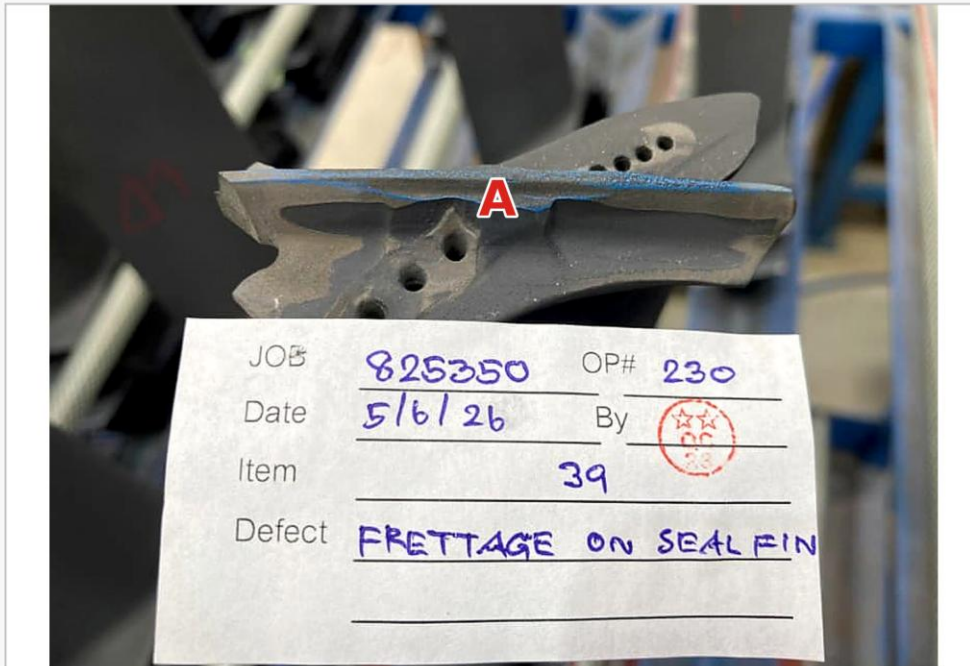
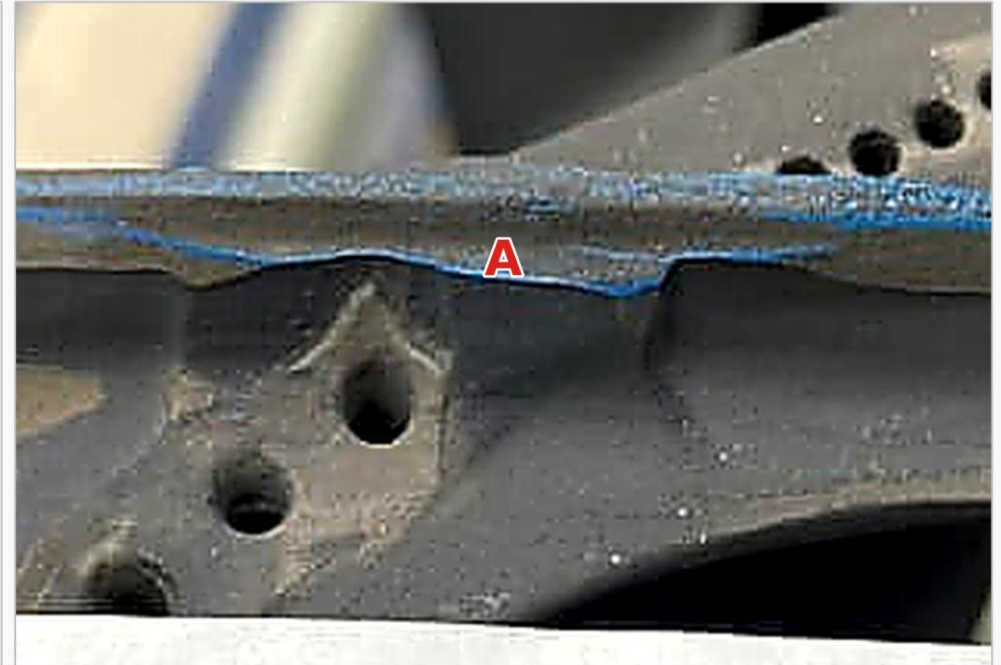
## FIG. 13 - FRETTAGE AND DIMENSIONAL LOSS - SEAL FIN

**SEAL-FIN HEIGHT: DIMENSIONALLY REJECTED ON 92/92 | FULL-SET WELD + MACHINING/EDM**

The photographed frettage is on the tip seal fin, a functional hot-gas sealing surface, not a cosmetic edge.  
The 92/92 rejection is the report's set-wide dimensional result; it is not a measurement derived from this photograph.  
Restoration requires weld build-up and precision machining/EDM to recover height and profile, followed by repeated FPI.

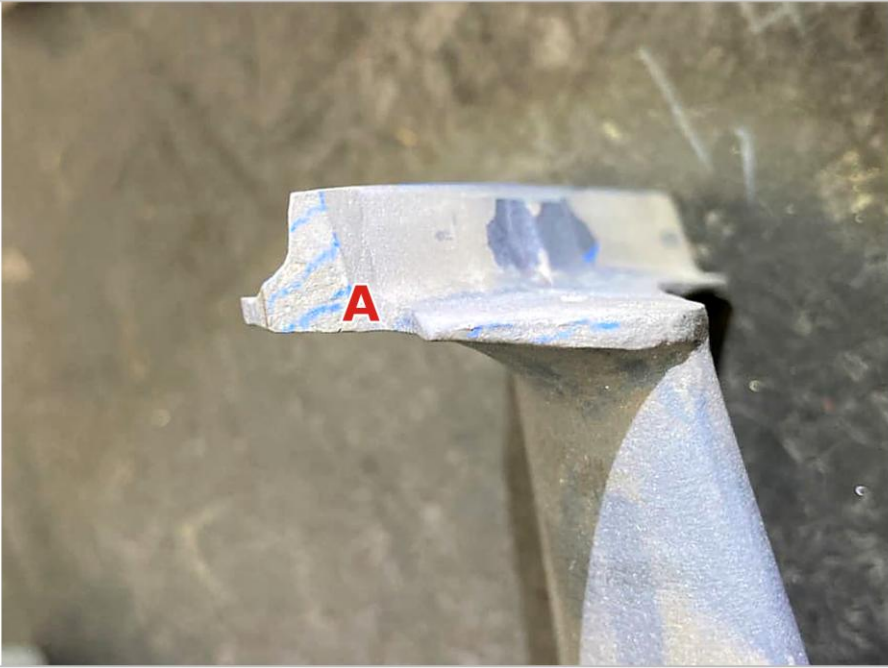
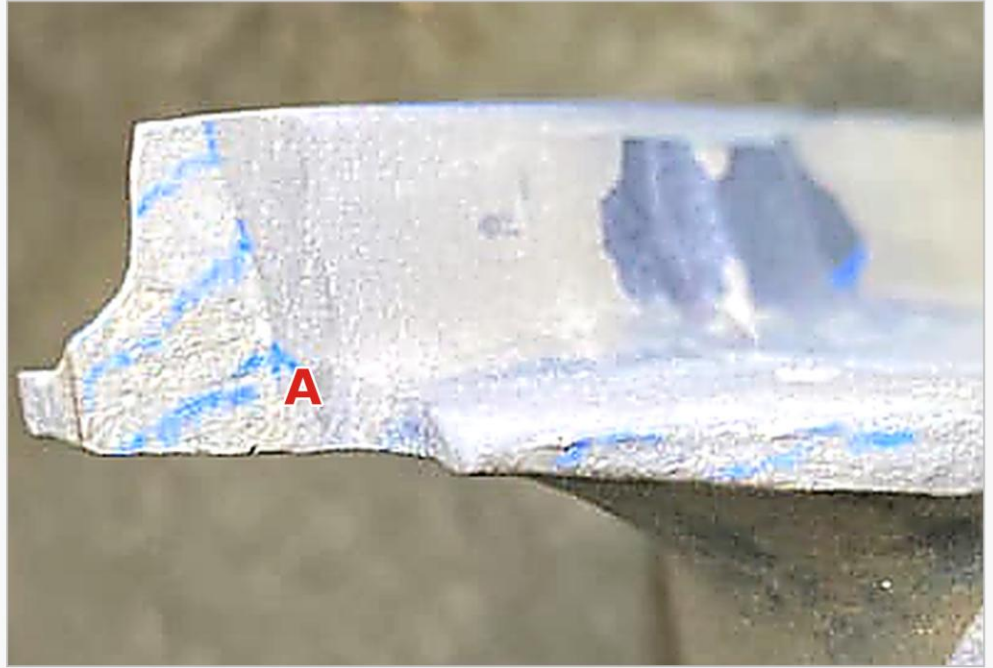
## FIG. 15 - FRETTAGE - Z-NOTCH INTERLOCK

**Z-NOTCH: DIMENSIONALLY REJECTED ON 92/92 | SHROUD ENGAGEMENT BELOW 50% ON 23/92**

The Z-notch locks adjacent bucket tips into a continuous ring that controls vibration, tip stiffness, and leakage. The full-set rejection and 23/92 engagement result are report data; this photograph documents the fretted interface. Material must be rebuilt and the mating profile recreated by weld and EDM, with dimensional and FPI/NDT verification.

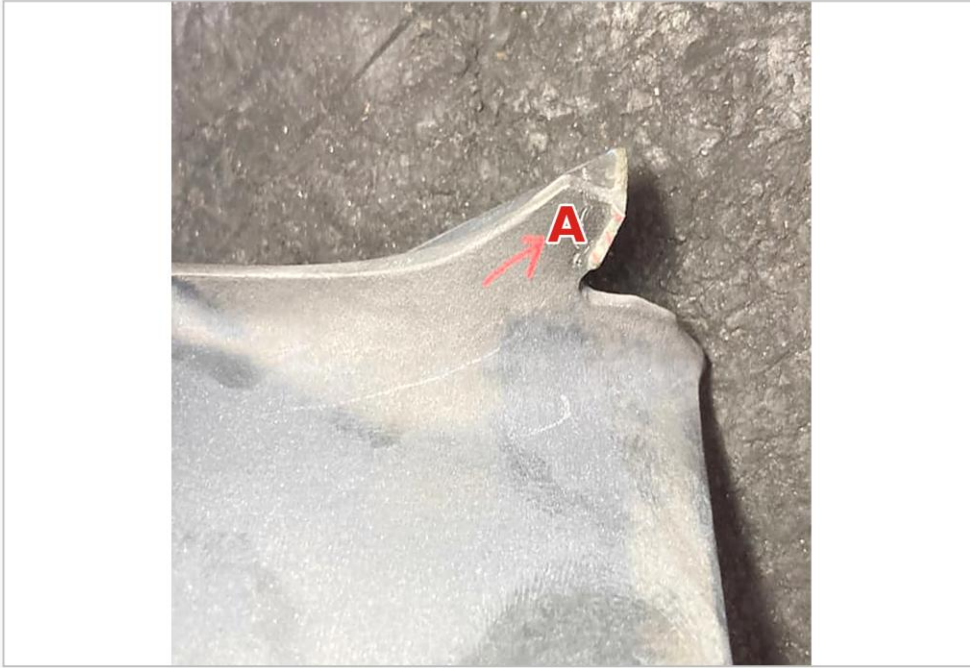
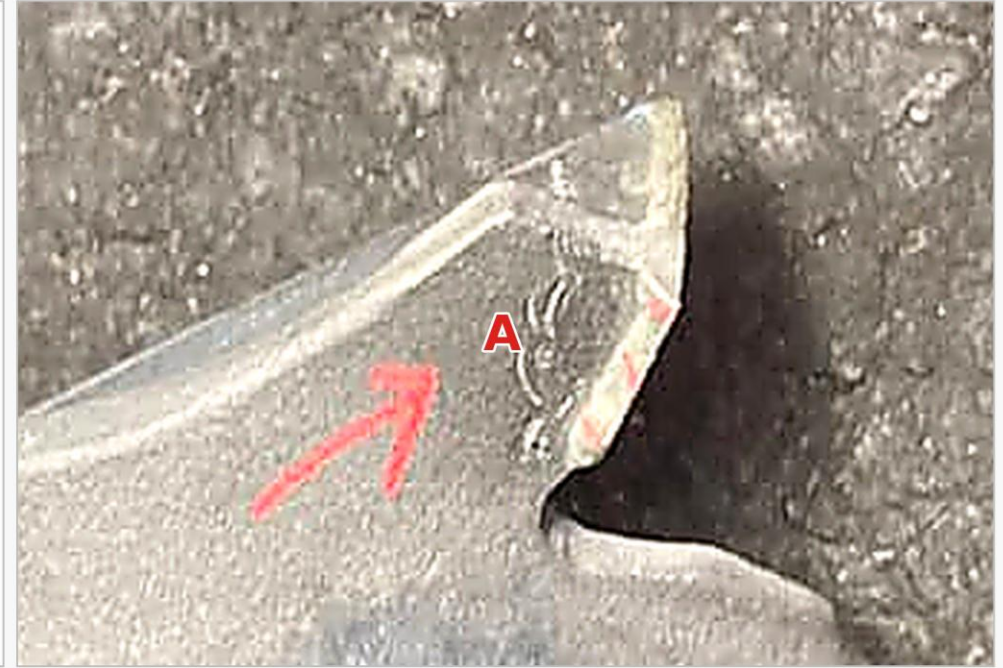
## FIG. 16 - WELDMENT AND CONTACT WEAR - Z-NOTCH

**ENGAGEMENT LIMIT: 50% | MINIMUM -20.82% AT ITEM 75 | POSITIVE INTERLOCK CONTACT LOST**

The photograph records weldment/contact wear at the Z-notch; the minimum value is the report's set-wide extreme.  
At Item 75, below-zero engagement means the interlock no longer makes positive contact with its neighbouring bucket.  
Recovery requires Z-notch contact-point build-up, EDM profile recreation, and proof of restored engagement—not blending.

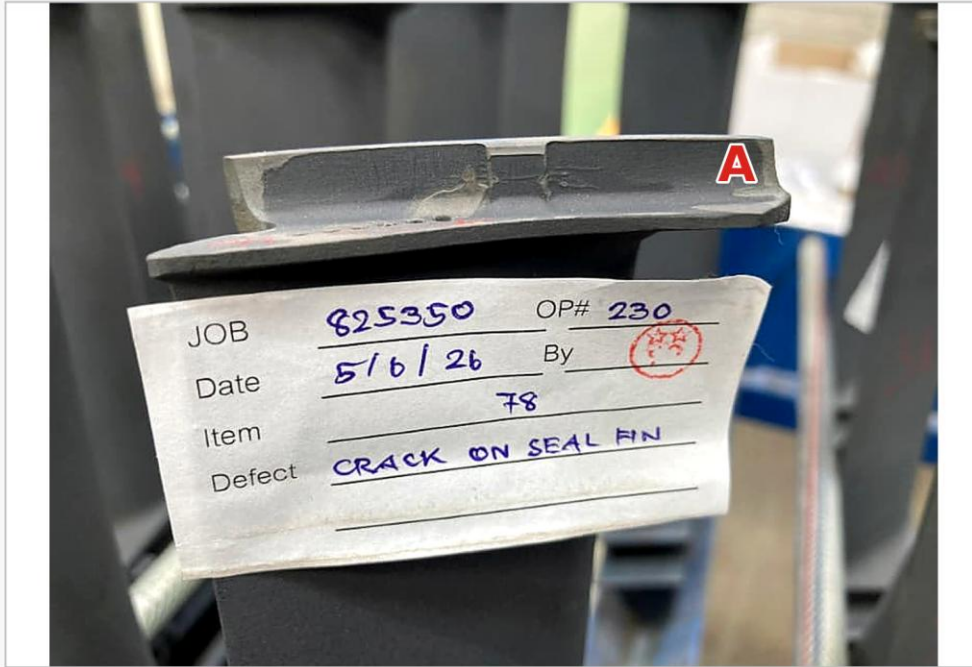
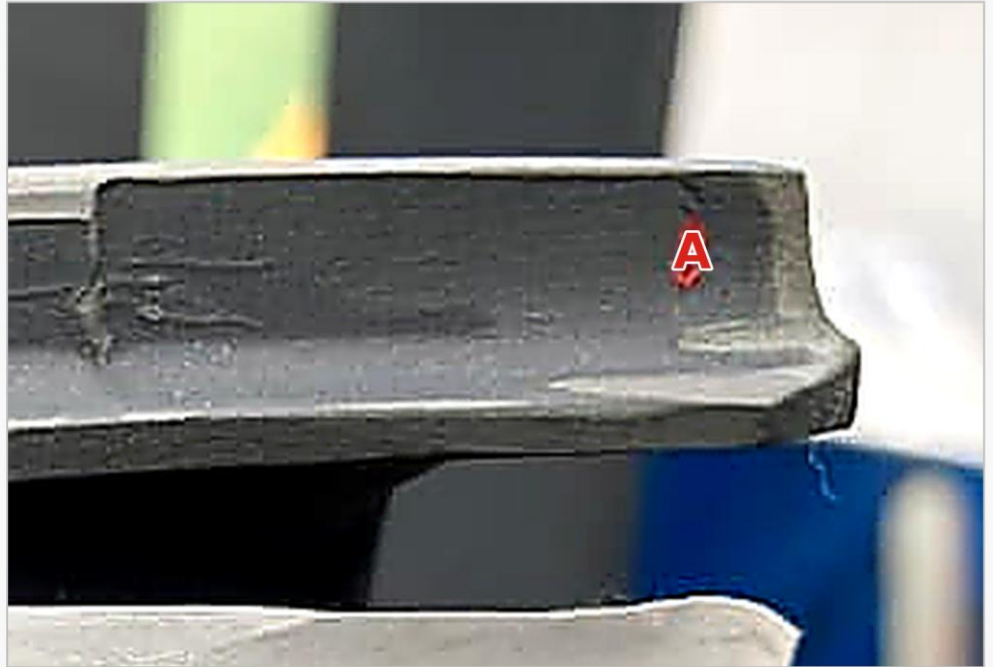
## FIG. 17 - CRACK - SEAL FIN, ITEM 78

**SEAL-FIN CRACK: ITEM 78 | DISCRETE CRACKS: 5/92 TOTAL (1 SEAL FIN + 4 ANGEL WINGS)**

The marked indication is the report-identified seal-fin crack on Item 78, confirmed during fluorescent penetrant inspection.

A crack in a critical tip-sealing feature must be excavated completely; surface blending alone cannot remove the risk.

The repair route is controlled excavation, weld restoration, profile recovery, and repeated FPI confirmation.

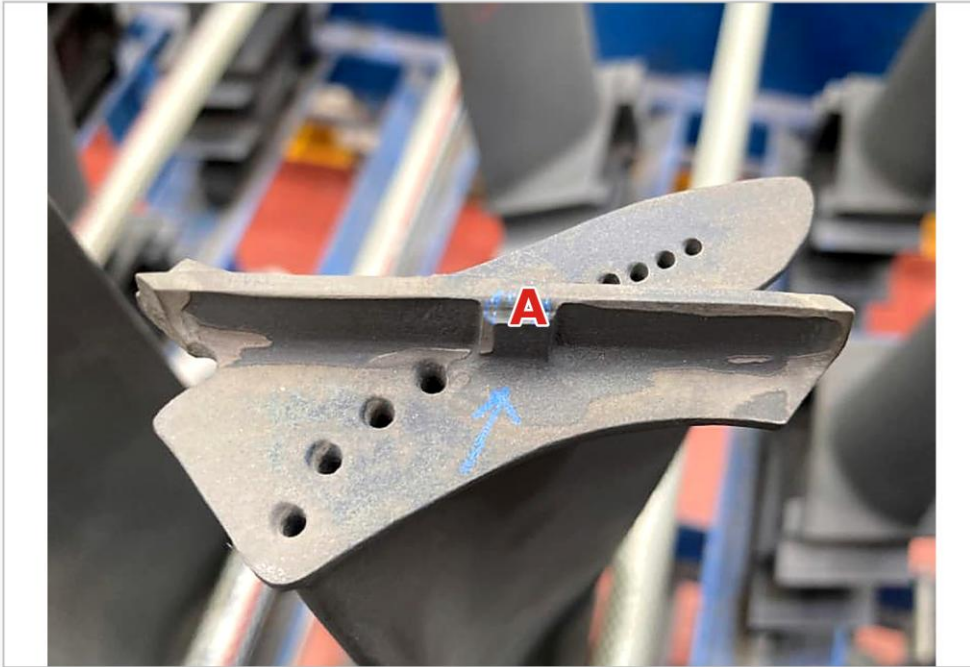
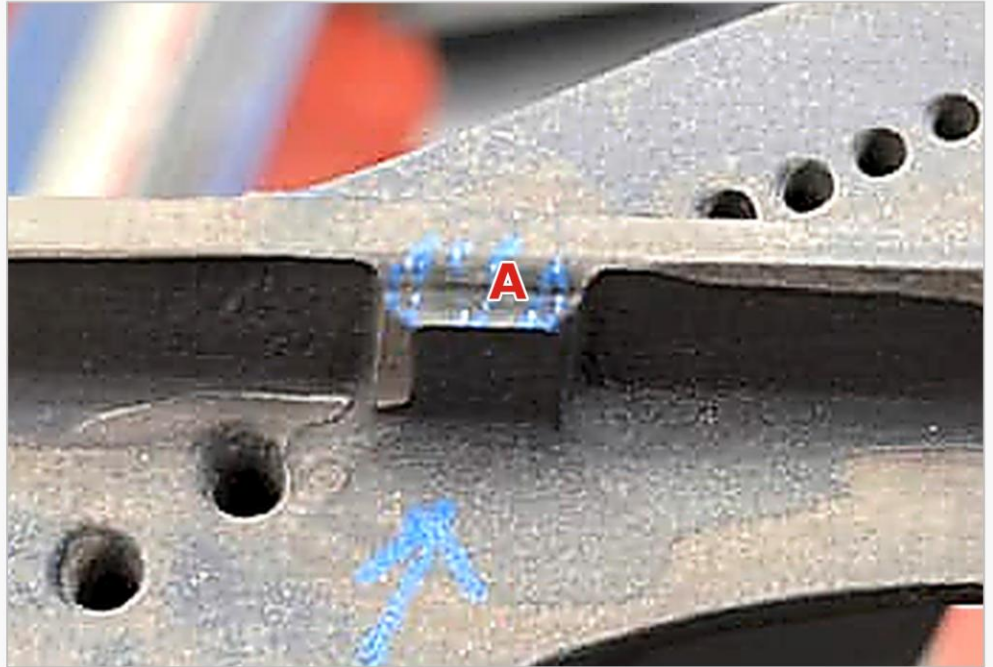
## FIG. 18 - FRETTAGE AND WEAR - CUTTER TEETH

### **SEAL FIN / CUTTER-TOOTH FRETTAGE AND WEAR: 92/92 | MULTI-FEATURE RECONSTRUCTION**

Cutter teeth establish tip clearance by cutting a controlled track in the shroud; lost geometry increases tip leakage. The 92/92 frequency is the report's full-set finding and is not inferred from the size of the photographed indication.

Weld build-up, machining/EDM, heat treatment, dimensional verification, and final balance control are required.

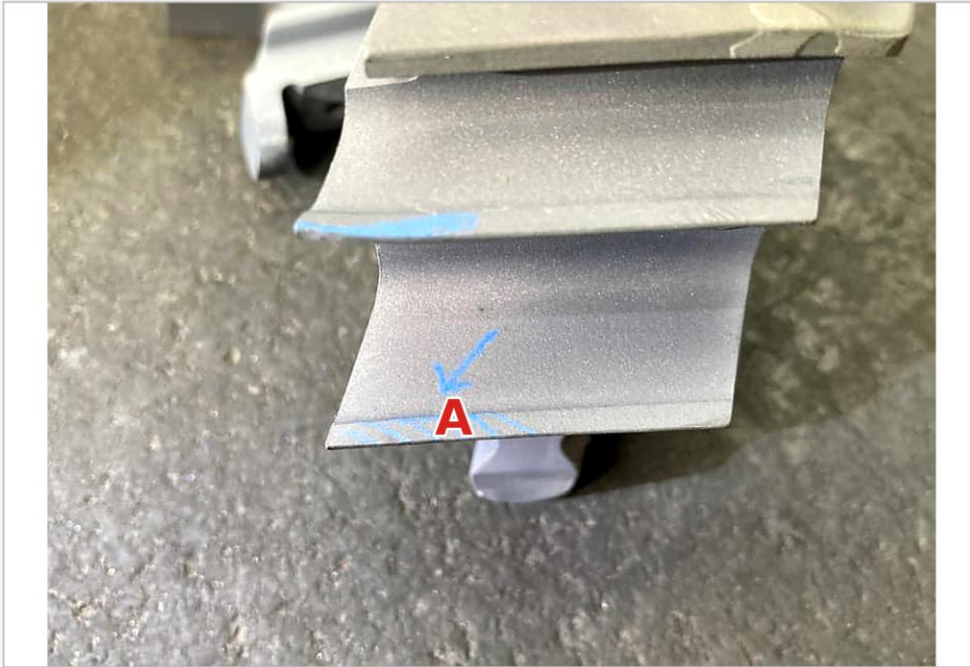
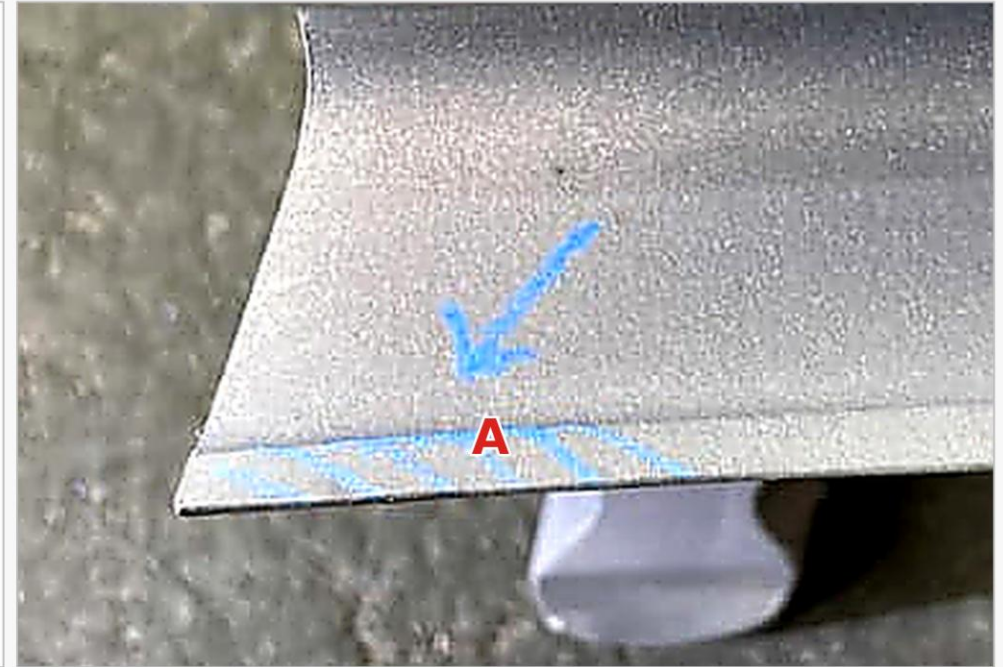
## FIG. 19 - DEFORMATION AND FRETAGE - ANGEL WING

**ANGEL-WING HEIGHT: DIMENSIONALLY REJECTED ON 92/92 | FRETAGE/DEFORMATION ACROSS FULL SET**

The angel wing is a wheelspace seal that limits hot-gas ingestion toward the rotor; its profile is function-critical. The full-set rejection is the report's dimensional conclusion; the image shows the recorded edge deformation/fretage. Weld build-up and machining are required to recreate height and profile, with crack excavation where indications exist.

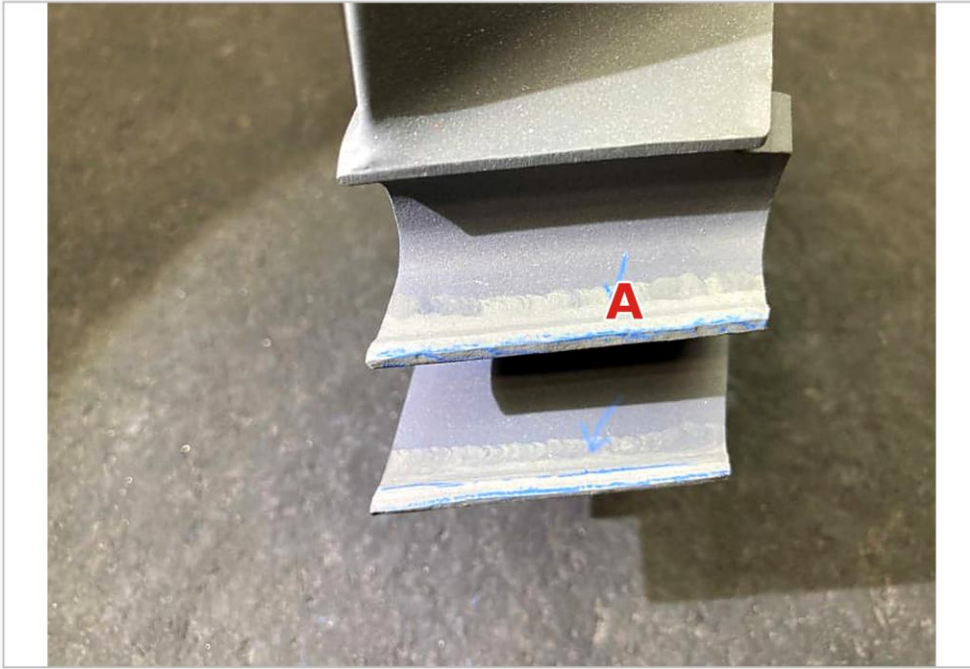
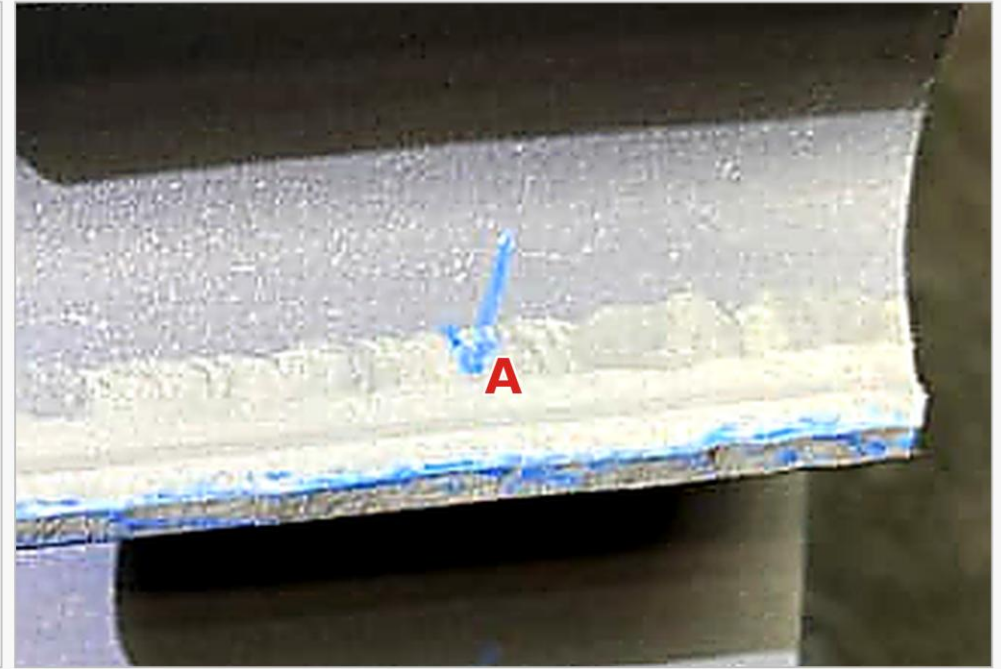
## FIG. 20 - FOREIGN OBJECT DAMAGE - ANGEL WING

**ANGEL-WING HEIGHT: REJECTED ON 92/92 | PHOTOGRAPH DOCUMENTS FOD AT A CRITICAL SEAL**

The marked surface is the report-captioned angel-wing FOD location; no defect depth is assigned from the photograph. Repair severity follows the feature's wheelspace-sealing function and the full-set dimensional rejection—not visual size alone. Engineering disposition must recover sound material and specified profile, then verify the area by FPI and dimension.

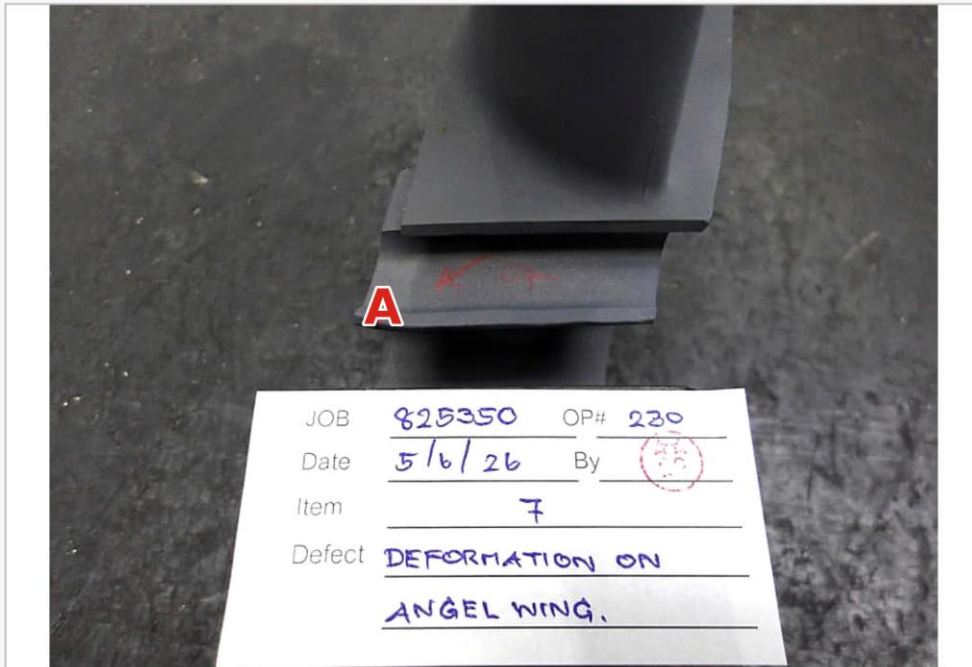
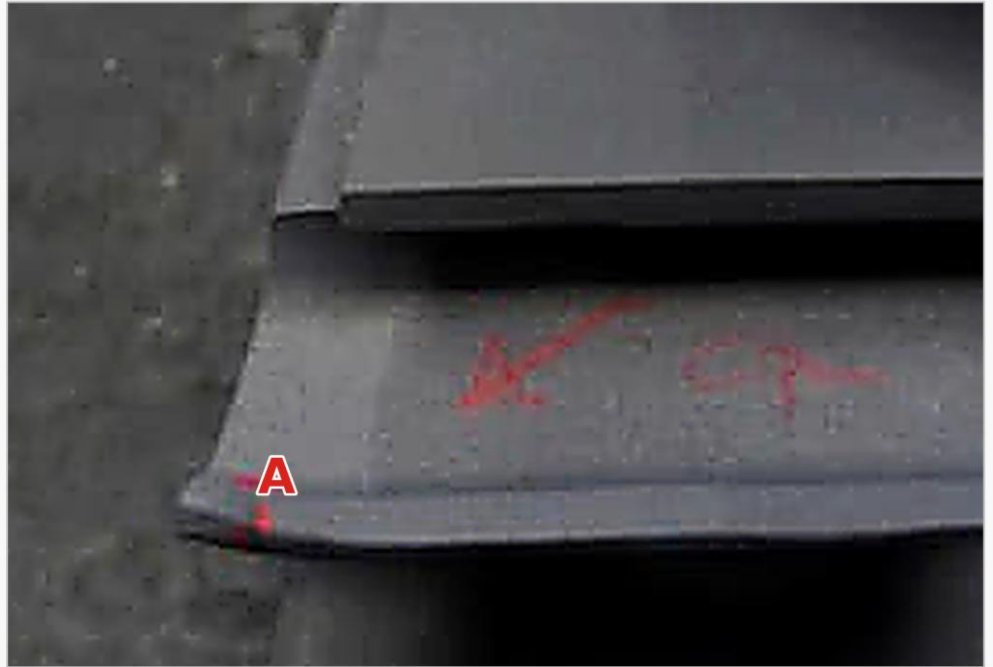
## FIG. 22 - DEFORMATION AND CRACK - ANGEL WING, ITEM 7

### **ANGEL-WING CRACKS: ITEMS 7, 28, 29 AND 33 | 4/92 | ITEM 7 SHOWN**

This report photograph identifies deformation and a crack at the Item 7 angel wing, one of four affected buckets. Crack repair is additive to the full-set angel-wing height rejection and population-wide fretting/deformation scope. The required route is complete crack excavation, weld repair, profile machining, and repeated FPI verification.

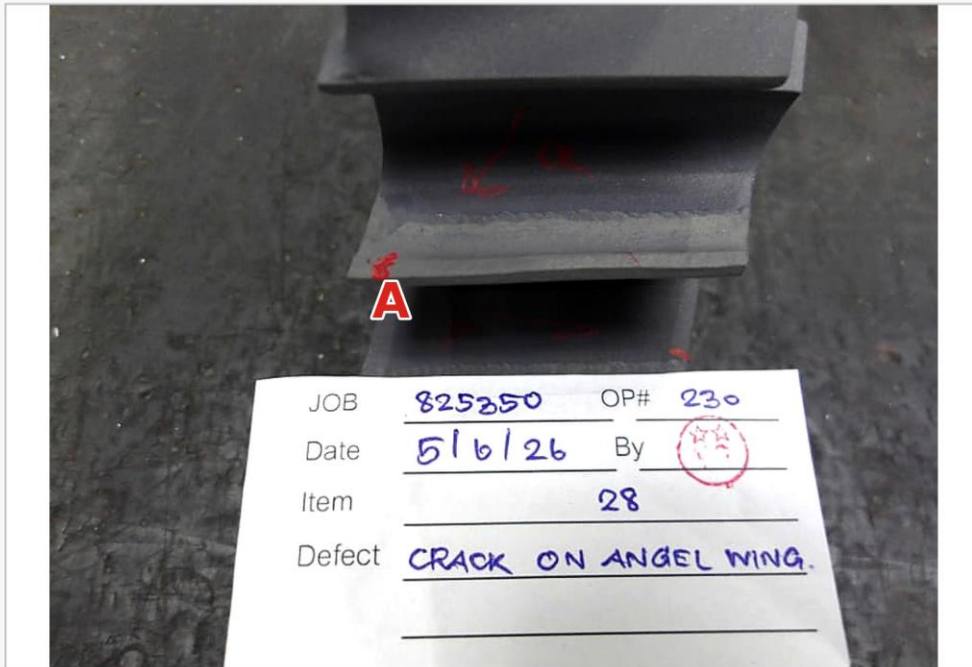
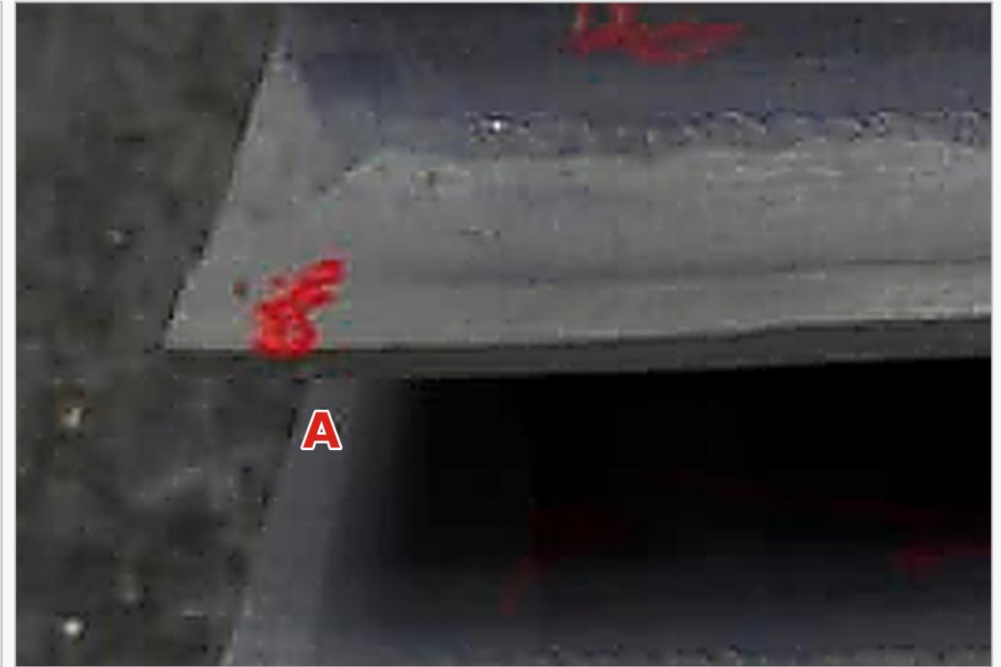
## FIG. 23 - CRACK - ANGEL WING, ITEM 28

### **ANGEL-WING CRACKS: ITEMS 7, 28, 29 AND 33 | 4/92 | ITEM 28 SHOWN**

The photograph records the Item 28 angel-wing crack, independently illustrating the report's multi-item crack burden. At a wheelspace-sealing edge, an indication must be removed to sound metal and cannot be accepted as cosmetic wear. Controlled excavation, weld restoration, machining to recover geometry, and FPI/NDT confirmation are required.

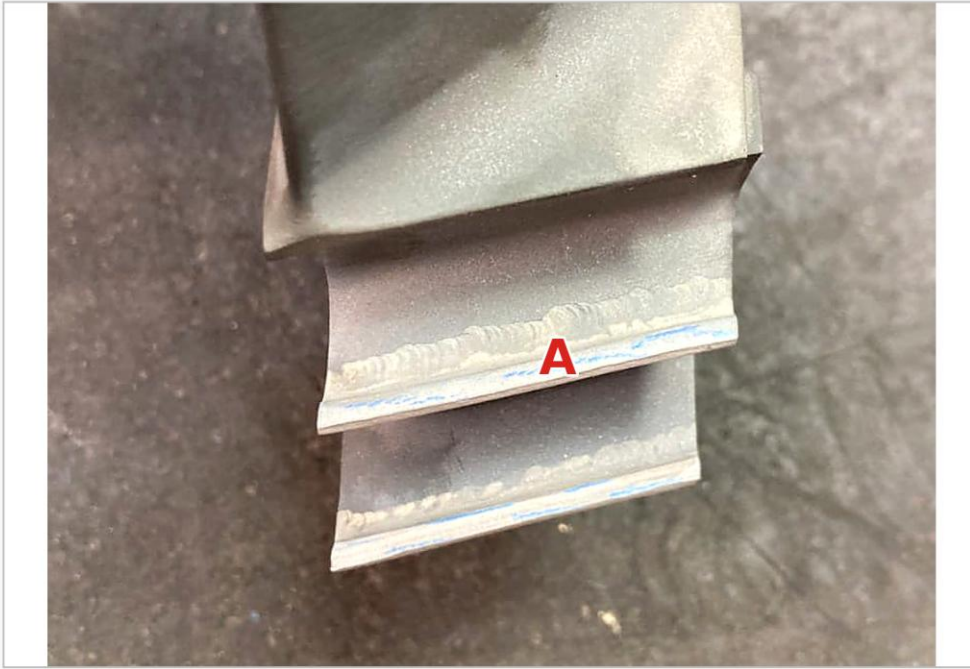
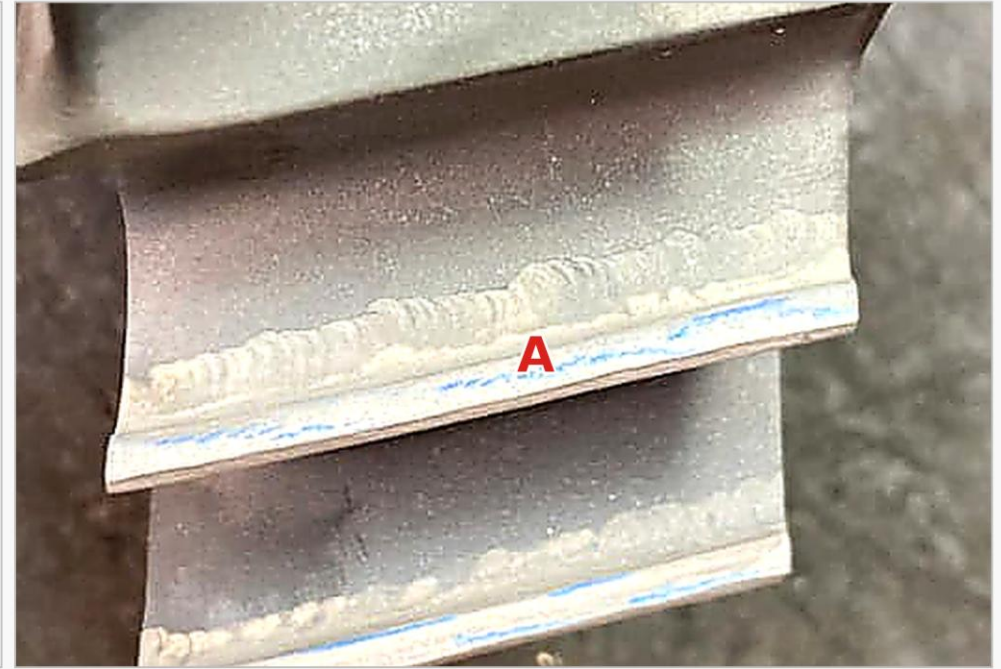
## FIG. 24 - EXISTING WELDMENT - ANGEL WING

### **FULL-SET ANGEL-WING RESTORATION | 92/92 HEIGHT REJECTION | 4 CRACK REPAIRS**

Current disposition still requires full-set dimensional recovery, plus excavation and weld repair of four cracked buckets.

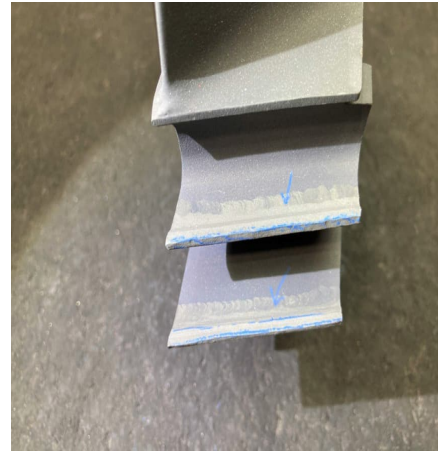
Figure 20. FOD on angel wing.

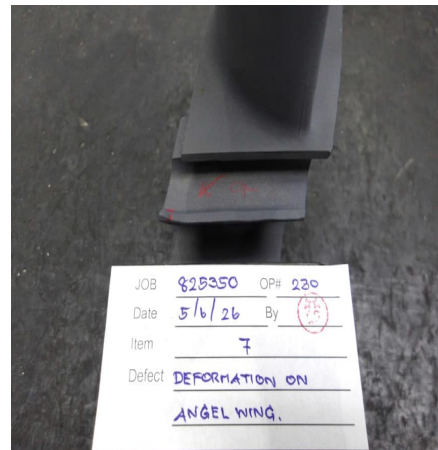
Figure 22. Deformation and crack on angel wing.

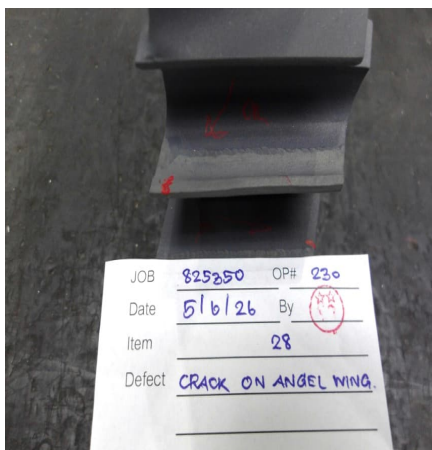
Figure 23. Crack on angel wing.

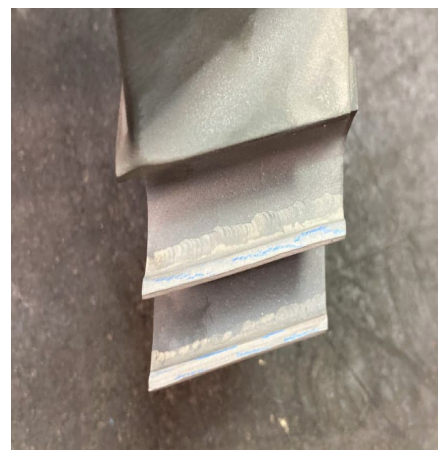
Figure 24. Weldment on angel wing.
