## INCOMING INSPECTION REPORT

<b>Customer</b>	Nghi Son Refinery & Petrochemical, LLC.	<b>UNEW Work Order No.</b>	<b>825088</b>
<b>Customer P.O. No.</b>	1003946086	<b>Report Date</b>	27 April 2026
<b>Engine Type</b>	MS6001FA (GE Frame 6FA)	<b>Component</b>	Combustion Liner MNQC
<b>Component Part No.</b>	119E9620G001	<b>Qty. Received</b>	6 Units (1 Complete Set)
<b>Material</b>	Hastelloy-X (Body, Cowl Cap, End Ring, Floating Collar, Liner Stop)   Haynes 188 (Crossfire Collar)   Inconel X-750 (Spring Seal / Hula Skirt)   SS304 (Collar Retainer)	<b>As-Received Coating</b>	TBC Coating — Inside Body & Inside Cowl Cap (Primary Fuel Nozzle Collar and Center Bore)
<b>Repair Classification</b>	<b>HEAVY REPAIR</b>	<b>Coating Requirement</b>	Chrome Carbide Coating (Hula Skirt) + Class C TBC (Internal Surface)
<b>Total Initiated Starts</b>	476	<b>Total Emergency Trips</b>	<b>125</b>

### 1. EXECUTIVE SUMMARY:

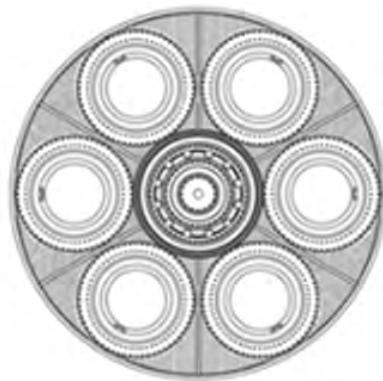
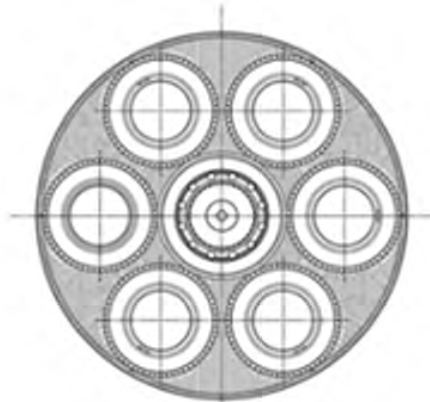
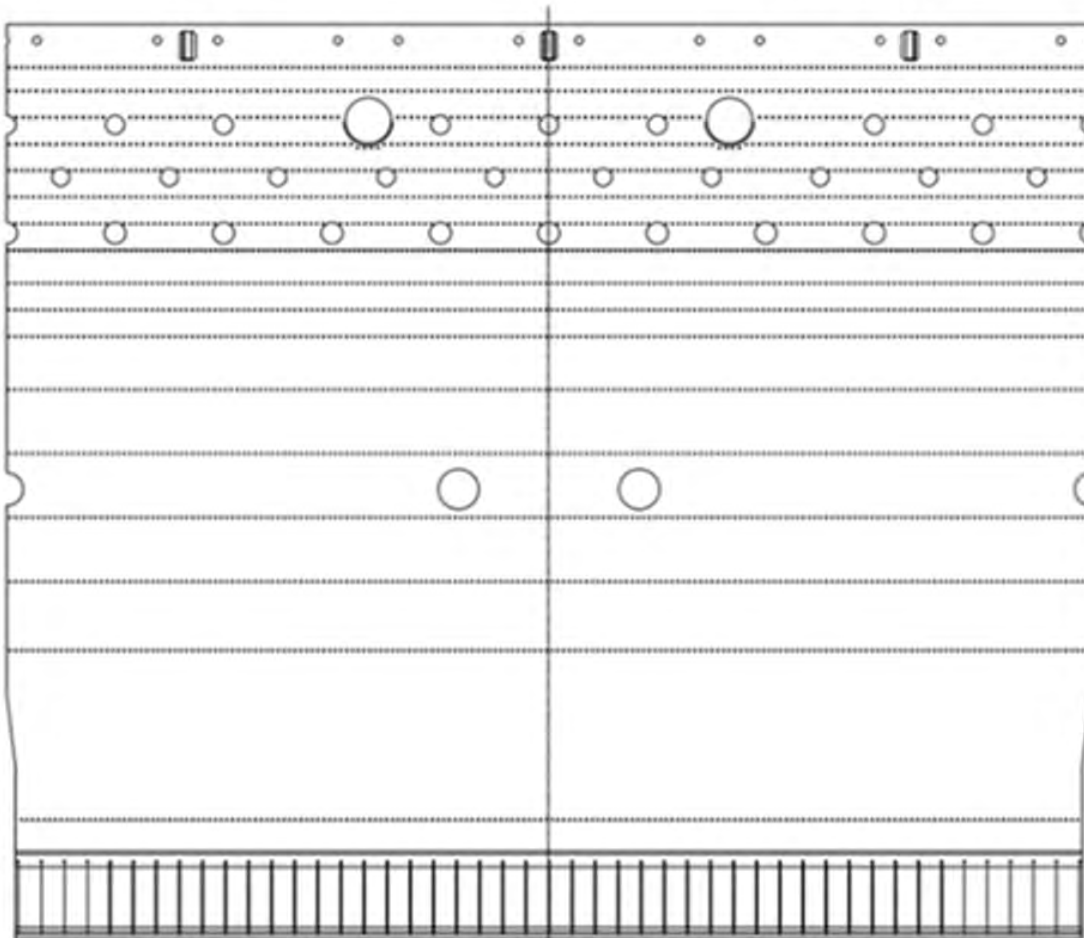
**10. DEFECT LEGEND TABLE:**

Item No.	INSPECTION FINDINGS																		
	Body				Spring seal				End ring				Cowl cap				Liner Stop		
	Cracking	Corrosion	Missing material	Deformation	Wear	Deformation	Missing material	Cracking	Wear	Deformation	Missing material	Cracking	Wear	Deformation	Cracking	Foreign Object	Wear	Cracking	Corrosion
1	WB	B/WB			B												B		
2	WB	B/WB			B														
3	WB	B/WB			B												B		
4	WB	B/WB			B														
5	WB	B/WB			B												B		
6	WB	B/WB			B												B

- B** = Blend repair to be performed in accordance with the location blend limits.
- JK** = jacking and contouring to be performed based on the deformation and distortion detected.
- WB** = Weld and Blend to be performed based on the area limits and defects detected.
- WM** = Weld and Machining to be performed to build material dimensions and restore original dimensions and contours.
- WE** = Welding and Electric discharge machining (EDM) to be performed to build material dimensions and restore original dimensions.
- TPR** = Transient Phase Restoration to be performed based on the defects detected.
- R** = Replace with new.
- ACC** = Acceptable as is.
- REJ** = Dimension unacceptable and will require repair or cause of scrap.
- S** = Non-repairable / Scrap
- L** = Light repair category
- M** = Medium repair category
- H** = Heavy repair category
- EX** = Salvation repair category

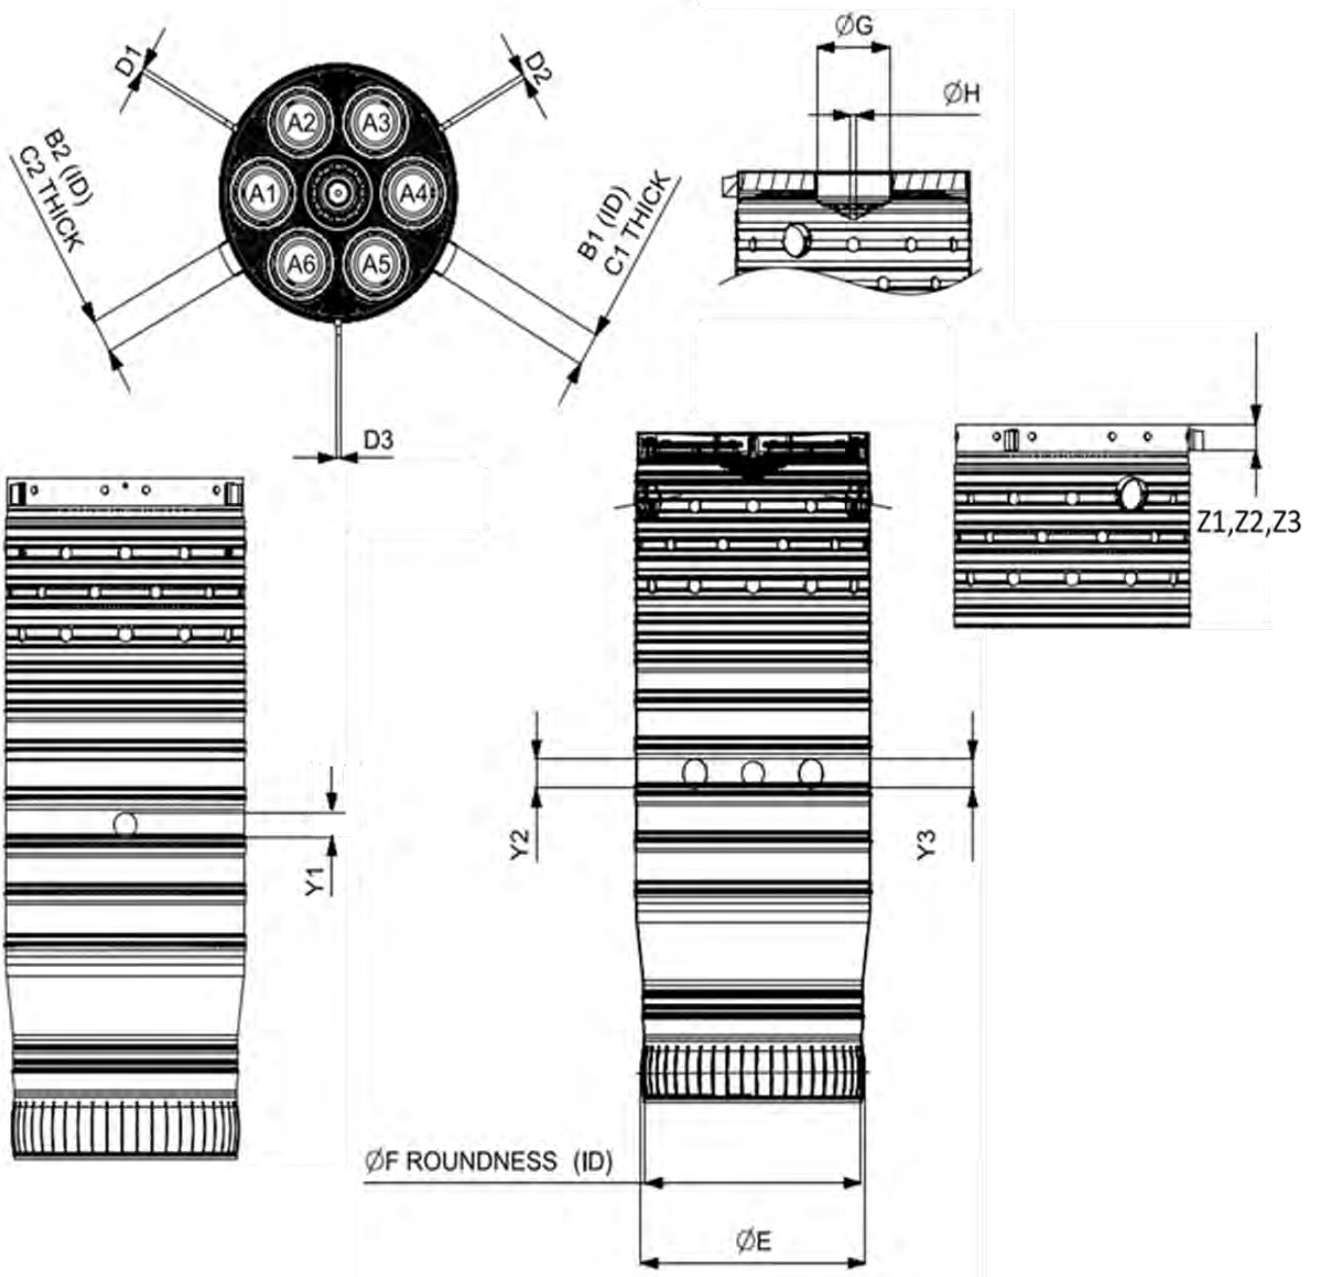
**11. DIMENSION INSPECTION:**

Item No.	INSPECTION FINDINGS															DIMENSIONAL DATA				
	Collar retainer			Crossfire collar (2 per liner)						Floating collar (6 per liner)						End ring roundness	Spring seal diameter	Crossfire ID (2)	Wall thickness	
	Wear	Cracking	Corrosion	Wear		Deformation		Cracking		Wear		Missing material		Cracking						
				Qty	Code	Qty	Code	Qty	Code	Qty	Code	Qty	Code	Qty	Code					
1	B									6	B						REJ	REJ	ACC	ACC
2	B									6	B						REJ	REJ	ACC	ACC
3	B									6	B						REJ	REJ	ACC	ACC
4	B									6	B						REJ	REJ	ACC	ACC
5	B									6	B			1	WB		REJ	REJ	ACC	ACC
6	B									6	B						REJ	REJ	ACC	ACC
