# INCOMING INSPECTION REPORT

<b>Customer</b>	Nghi Son Refinery & Petrochemical, LLC.	<b>UNEW Work Order No.</b>	825091
<b>Customer P.O. No.</b>	1003986864	<b>Report Date</b>	27 April 2026
<b>Engine Type</b>	MS6001FA (GE Frame 6FA)	<b>Component</b>	1st Stage Nozzle
<b>Part Number (Casting)</b>	129E9734 P002	<b>Part Number (Ring)</b>	143E5711G02
<b>Material</b>	FSX-414 Cobalt Superalloy	<b>Qty. Received</b>	24 Segments (1 Complete Set)
<b>As-Received Coating</b>	HVOF MCrAlY + Full TBC Top Coat	<b>Repair Classification</b>	<b>HEAVY REPAIR</b>
<b>Total Initiated Starts</b>	476	<b>Total Emergency Trips</b>	125

Twenty-four (24) MS6001FA 1st stage nozzle segments were received and inspected. The inspection identified multiple severe damage mechanisms affecting both airfoil sections and structural components, including extensive cracking, heavy corrosion, wall thinning, deformation, and coating degradation.

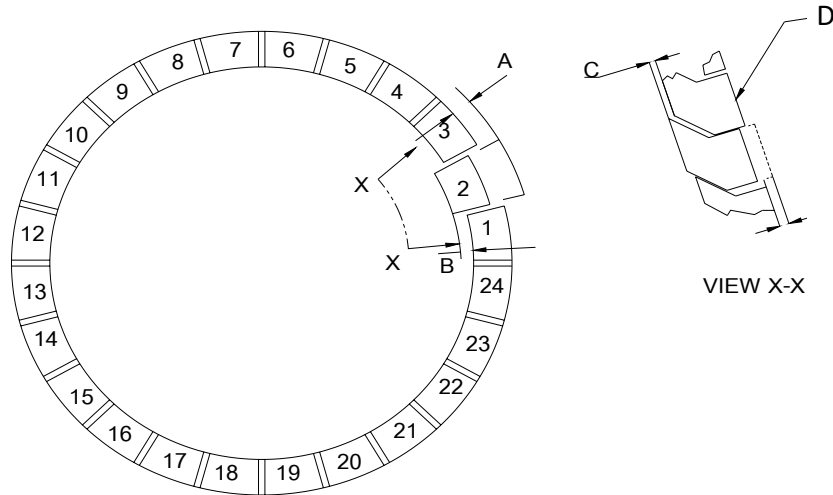
**ALIGNMENT CHECK**

SEGMENT No.	Horizontal(mm)		Vertical (mm)	
	A	B	C	D
1-2	0.27	0.55	1.04	0.84
2-3	0.17	0.46	0.54	0.98
3-4	0.48	0.17	0.85	0.97
4-5	0.29	0.47	0.80	1.06
5-6	0.48	0.42	1.01	0.75
6-7	0.19	0.33	0.64	1.01
7-8	0.39	0.28	0.92	0.97
8-9	0.29	0.56	0.70	0.79
9-10	0.49	0.33	1.01	1.03
10-11	0.01	0.40	0.70	0.75
11-12	0.22	0.29	0.77	0.67
12-13	0.69	0.78	1.10	1.15
13-14	0.27	0.24	0.91	0.72
14-15	0.34	0.18	0.67	0.70
15-16	0.40	0.11	1.14	0.76
16-17	0.44	0.36	0.93	1.13
17-18	0.45	0.12	0.98	0.93
18-19	0.40	0.36	0.73	1.08
19-20	0.31	0.46	0.85	0.71
20-21	0.20	0.41	1.04	0.93
21-22	0.49	0.28	0.66	0.98
22-23	0.35	0.35	0.93	0.82
23-24	0.39	0.11	0.48	0.64
24-1	0.88	0.71	0.93	0.78

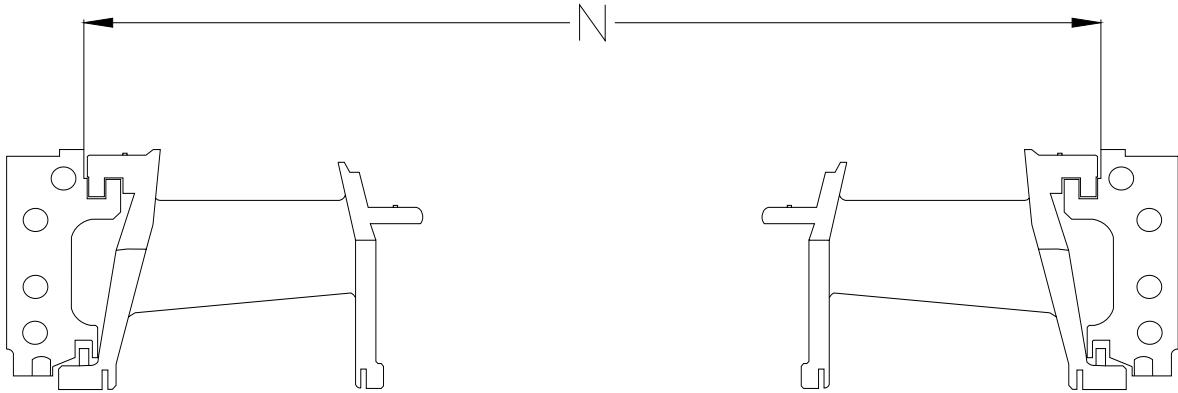
**ROUNDNESS CHECK**

No.	A-A	B-B	C-C	D-D	Roundness	Result
1	1732.70	1733.42	1733.50	1732.95	0.80	ACCEPT

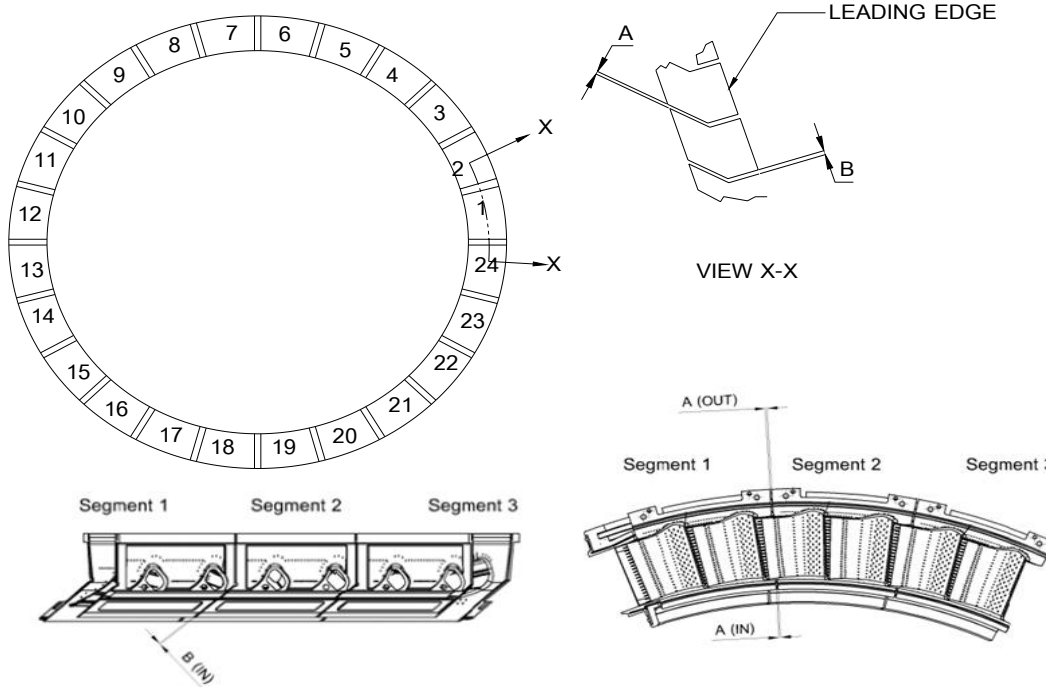
### GAP MEASUREMENT CHECK

SEGMENT NO.	I/D Wall		O/D Wall	
	A (mm.)	B (mm.)	A (mm.)	B (mm.)
1-2	2.98	4.28	2.83	3.26
2-3	3.53	3.78	3.00	3.73
3-4	3.22	4.08	3.07	5.49
4-5	3.66	4.47	3.48	4.80
5-6	3.38	3.66	2.59	4.43
6-7	3.55	3.76	3.73	5.12
7-8	3.45	3.95	2.63	4.24
8-9	3.14	3.65	2.82	5.91
9-10	3.61	3.55	3.14	3.83
10-11	3.97	4.07	2.47	3.41
11-12	4.08	4.14	2.83	5.95
12-13	4.16	5.22	2.77	6.43
13-14	3.00	3.60	2.47	4.41
14-15	3.87	4.15	3.18	4.45
15-16	2.58	4.10	2.33	5.53
16-17	3.59	4.30	3.24	4.57
17-18	3.01	3.71	2.54	4.10
18-19	3.58	4.58	3.20	4.72
19-20	3.45	4.24	2.61	3.92
20-21	3.63	4.34	3.04	3.07
21-22	3.39	4.04	3.65	3.60
22-23	3.66	3.65	3.52	3.70
23-24	3.28	3.88	2.32	4.64
24-1	3.87	4.13	3.82	5.19

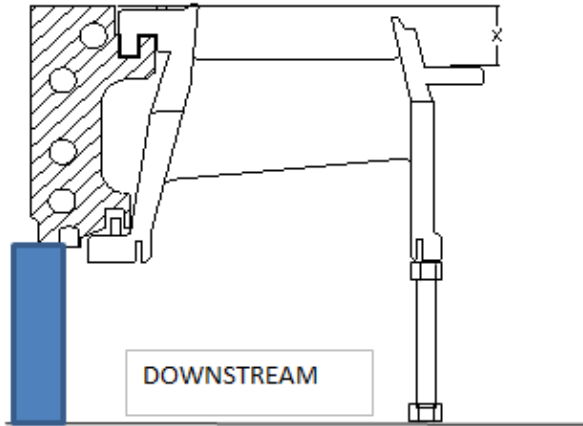
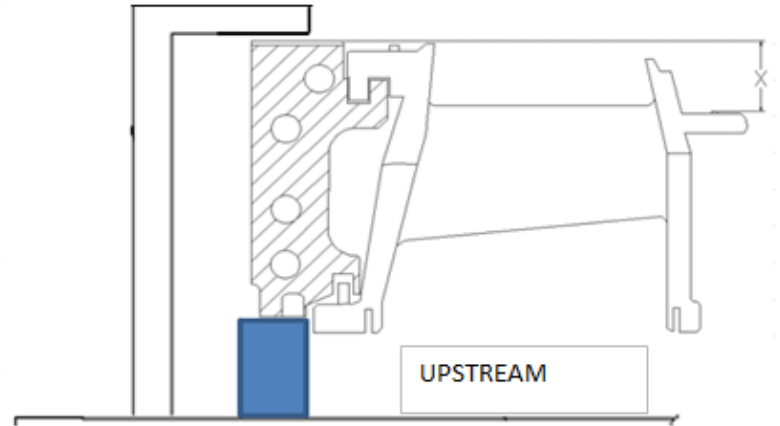
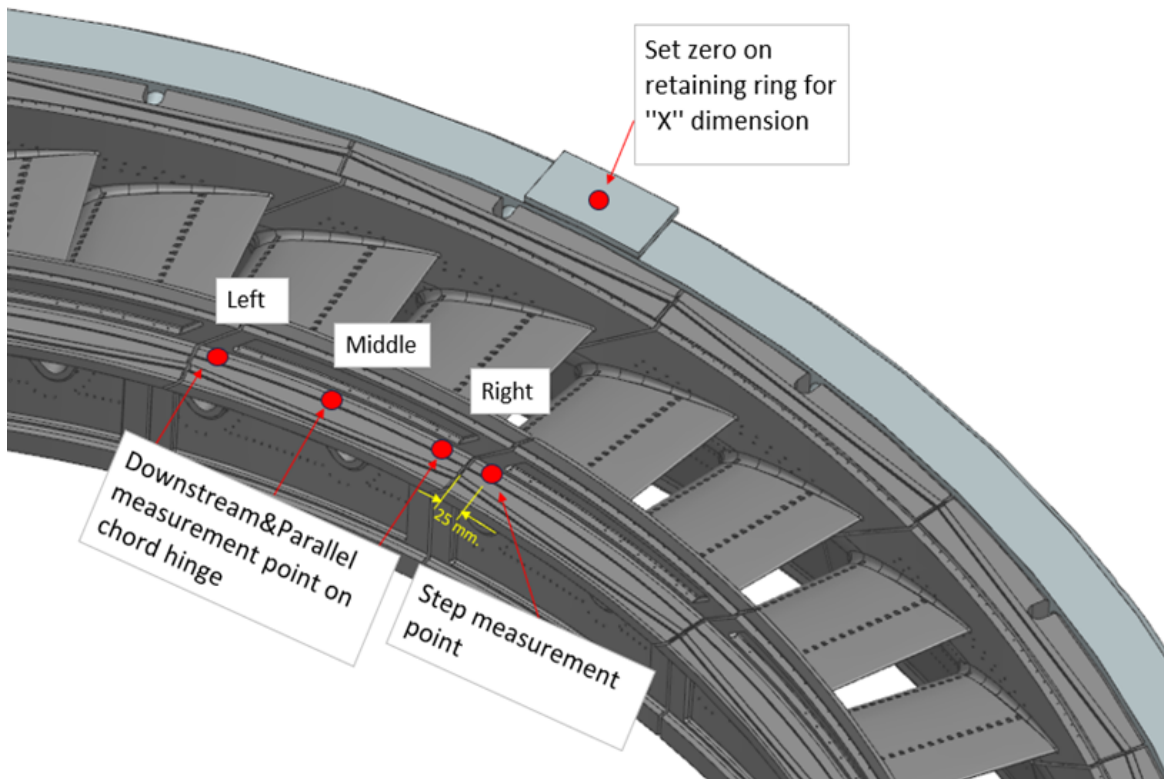
## DROP CHECK

Downstream Deflection Check (Drop Check)													
SEGMENT	X' Downstream (mm)					X' Upstream (mm)					Flexible 'X' (mm)		
	Left	Middle	Right	Parallel	Step	Left	Middle	Right	Parallel	Step	Left	Middle	Right
1	29.58	29.54	29.47	-0.11	0.19	30.73	30.13	30.46	-0.27	-0.28	1.15	0.59	0.99
2	29.28	29.47	29.23	-0.05	-0.21	30.74	30.67	30.57	-0.17	-0.06	1.46	1.20	1.34
3	29.44	29.42	29.14	-0.30	-0.40	30.63	30.46	30.32	-0.31	-0.58	1.19	1.04	1.18
4	29.54	29.57	28.91	-0.63	-0.94	30.90	30.38	30.80	-0.10	0.02	1.36	0.81	1.89
5	29.85	29.44	29.13	-0.72	-0.13	30.78	31.02	30.88	0.10	0.48	0.93	1.58	1.75
6	29.26	29.23	28.98	-0.28	-0.12	30.40	30.60	30.79	0.39	0.22	1.14	1.37	1.81
7	29.10	29.22	29.22	0.12	-0.21	30.57	30.75	30.72	0.15	-0.01	1.47	1.53	1.50
8	29.43	29.72	29.63	0.20	0.09	30.73	30.85	30.46	-0.27	-0.27	1.30	1.13	0.83
9	29.54	29.26	28.90	-0.64	-0.37	30.73	30.91	30.92	0.19	0.38	1.19	1.65	2.02
10	29.27	29.43	29.41	0.14	0.58	30.54	30.68	30.60	0.06	0.15	1.27	1.25	1.19

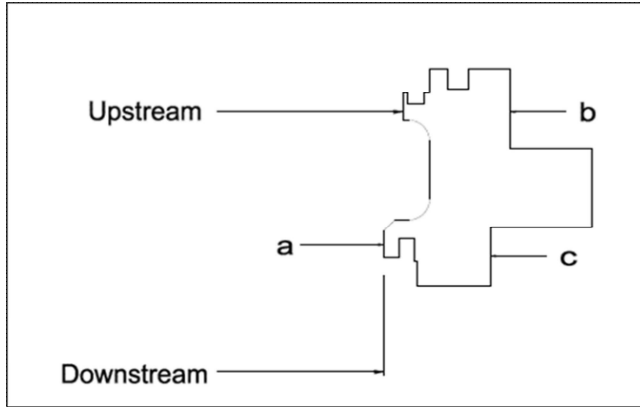
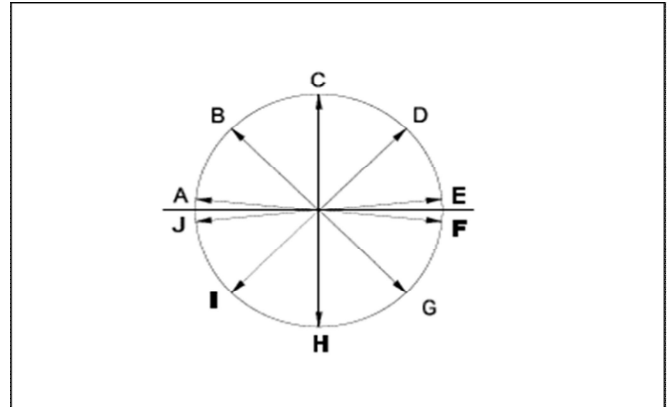
**RETAINING RING ROUNDNESS**

(Unit:mm)	A-F	B-G	C-H	D-I	E-J	Max-min
A-Upstream	1715.19	1716.01	1716.32	1715.36	1715.11	1.21
A-Downstream	1687.50	1688.24	1688.38	1687.79	1687.46	0.92

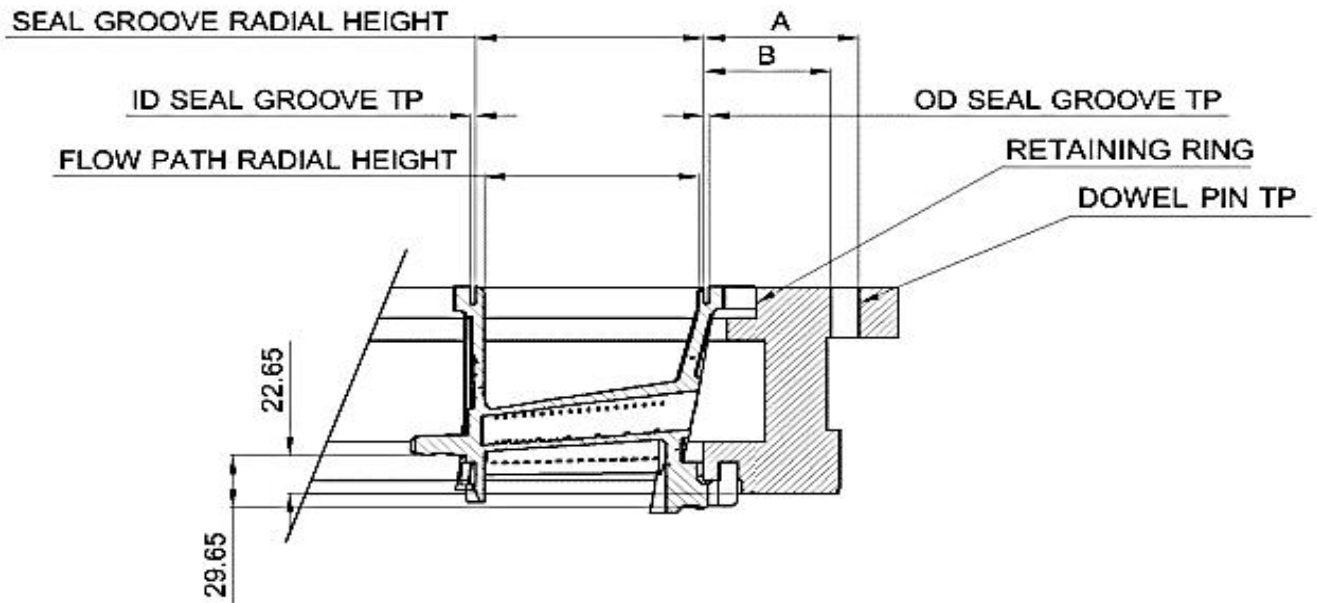
### RADIAL HEIGHTS

Item	Dowel OD to Outer seal groove	Dowel ID to Outer wall flow path
	A	B
1	86.48	70.58
2	87.78	71.74
3	86.57	70.72
4	87.06	71.56
5	86.60	70.69
6	87.14	71.05
7	86.91	71.17
8	87.04	71.30
9	86.39	70.66
10	87.24	71.59
11	86.76	70.82
12	87.13	71.85

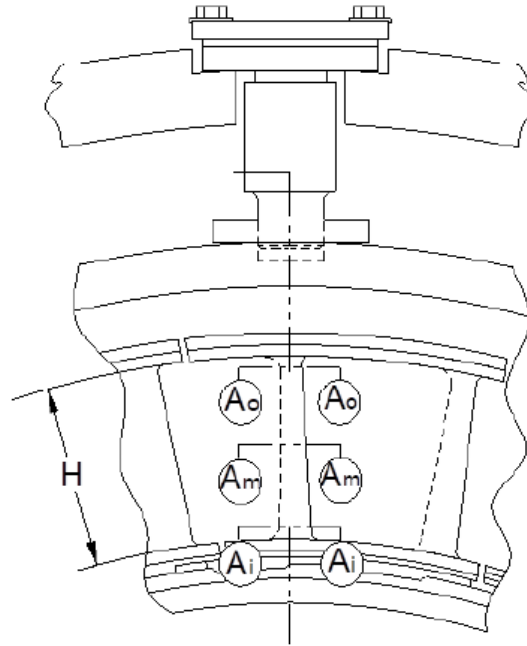
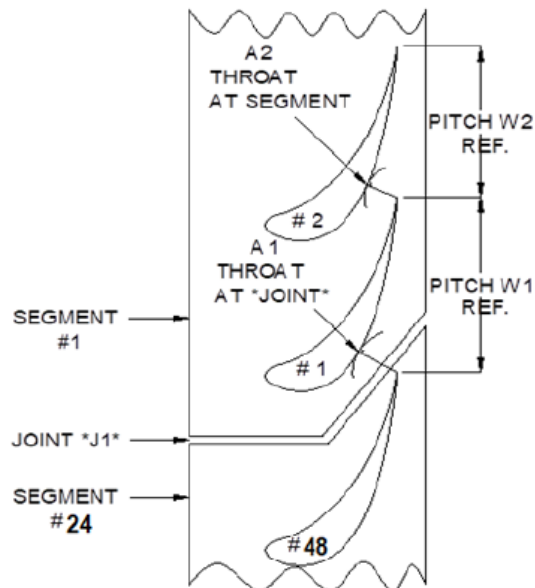
**HARMONIC**

Seg No	Gas Path Number	Throat Dimensions			H at centre	Pitch Dim.		Gas Path Area	Harmonic		Throat Dimensions			H at centre	Pitch Dim.		Gas Path Area	Harmonic		
		AO	AM	AI		WM	WO		Middle	Outer	AO	AM	AI		WO	WM		Area	Outer	Middle
		% dev	% dev	% dev		% dev	% dev		% dev	% dev	% dev	% dev	% dev		% dev	% dev		% dev	% dev	% dev
1	J 1	29.89	27.45	24.67	106.91	102.08	108.28	2925.59	0.27	0.28	2.68%	6.15%	9.11%	0.17%	1.23%	1.64%	6.00%	0.05	0.01	
	S 2	27.91	24.21	22.03	107.21	100.09	105.19	2636.29	0.24	0.27	-3.02%	-5.24%	-1.34%	0.45%	0.01%	-0.49%	-3.33%	-0.05	-0.03	
2	J 3	28.78	26.46	23.30	107.39	102.49	107.31	2818.99	0.26	0.27	-1.13%	2.32%	3.05%	0.62%	1.64%	0.73%	2.14%	0.01	-0.02	
	S 4	28.36	25.15	21.84	107.59	99.25	105.04	2703.20	0.25	0.27	-1.46%	-1.57%	-2.19%	0.81%	-0.83%	-0.63%	-0.88%	-0.01	-0.01	
3	J 5	29.23	26.43	23.04	107.63	101.00	106.84	2828.79	0.26	0.27	0.41%	2.20%	1.90%	0.84%	0.16%	0.29%	2.49%	0.02	0.00

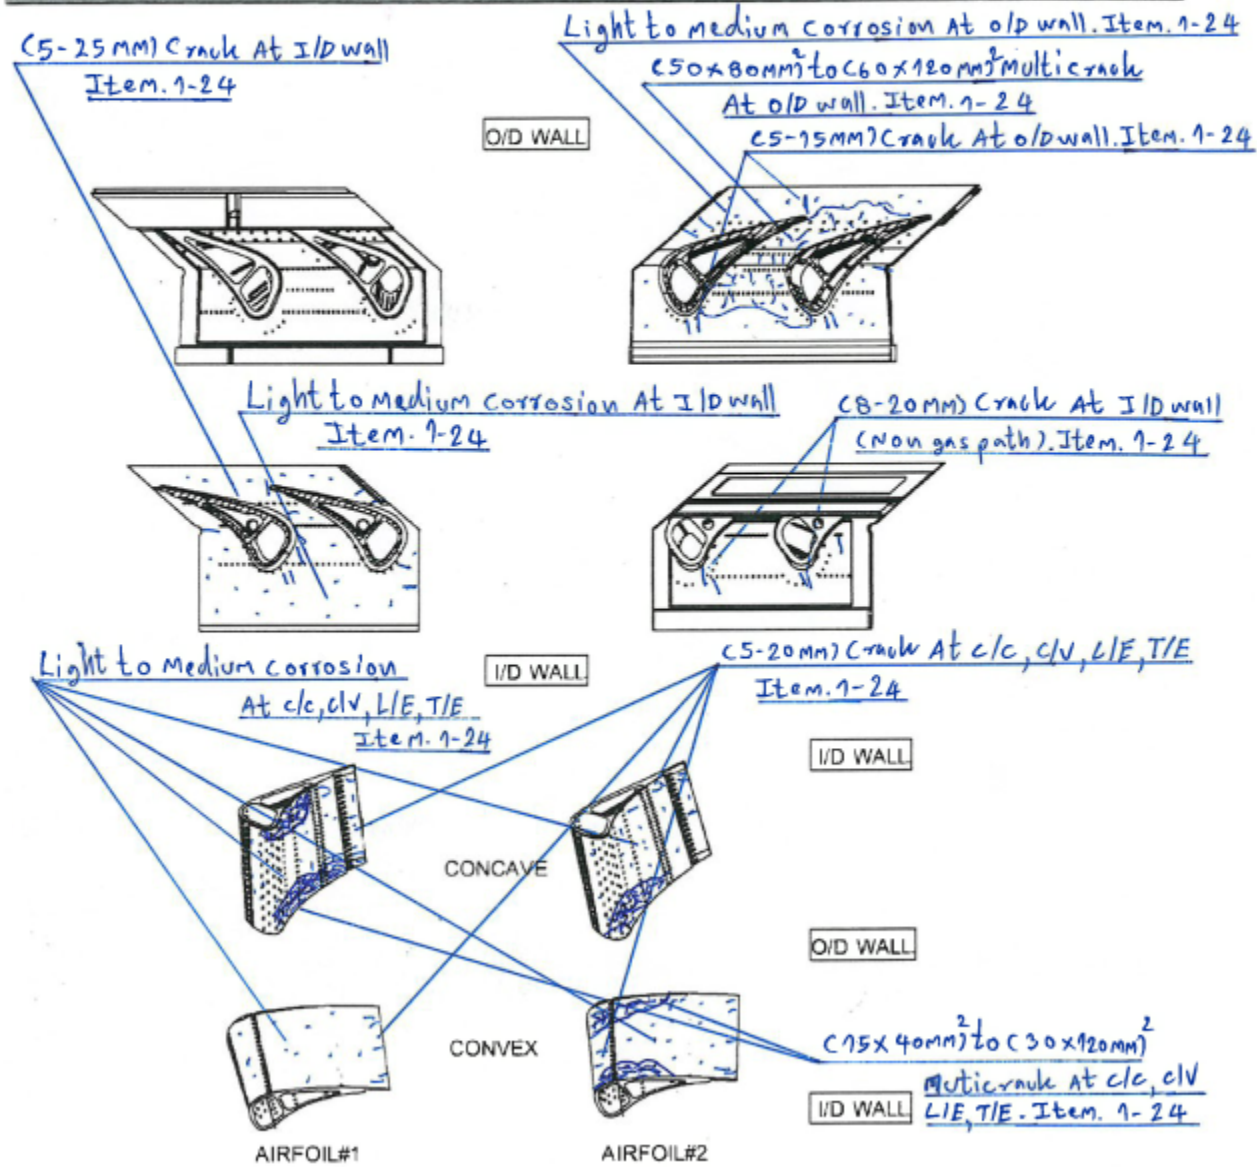
**DEFECT MAP RECORD SHEET**

(8-15MM) Crack At o/d wall (Non gas path). Item. 1,22,23,3

(5x30mm<sup>2</sup> to 8x50mm<sup>2</sup>) Missing material At o/d wall  
Item. 1, 2, 4, 5, 6, 11, 14, 15 17

(50mm) Crack At c/c  
Item. 19

(8x100mm<sup>2</sup>) Missing material  
At T/E. Item. 8
