INCOMING INSPECTION REPORT

Customer	Nghi Son Refinery & Petrochemical LLC	UNEW Work Order No.	825092
Customer P.O. No.	1003986864	Report Date	27 April 2026
Engine Type	MS6001FA (GE Frame 6FA)	Component	MS6001FA 1st Stage Shroud Block
Component Part No.	Body: 119E4234 G001 Inner plate (Tip shoe): 176D3829 P001	Qty. Received	24 Units (1 Complete Set)
Material	Body: SS310 Inner plate (Tip shoe): Inconel 738	As-Received Coating	Body: No coating Inner plate (Tip shoe): TBC Abradable coating
Repair Classification	HEAVY REPAIR	Coating Requirement	TBC Abradable plus ceramic compound
Total Initiated Starts	476	Total Emergency Trips	125

Twenty-four (24) MS6001FA 1st stage shroud blocks were received from Nghi Son Refinery and Petrochemical LLC and subjected to full incoming inspection, including visual inspection, fluorescent penetrant inspection (FPI), dimensional measurement, and metallurgical evaluation of both the shroud body and inner plate (tip shoe) components.

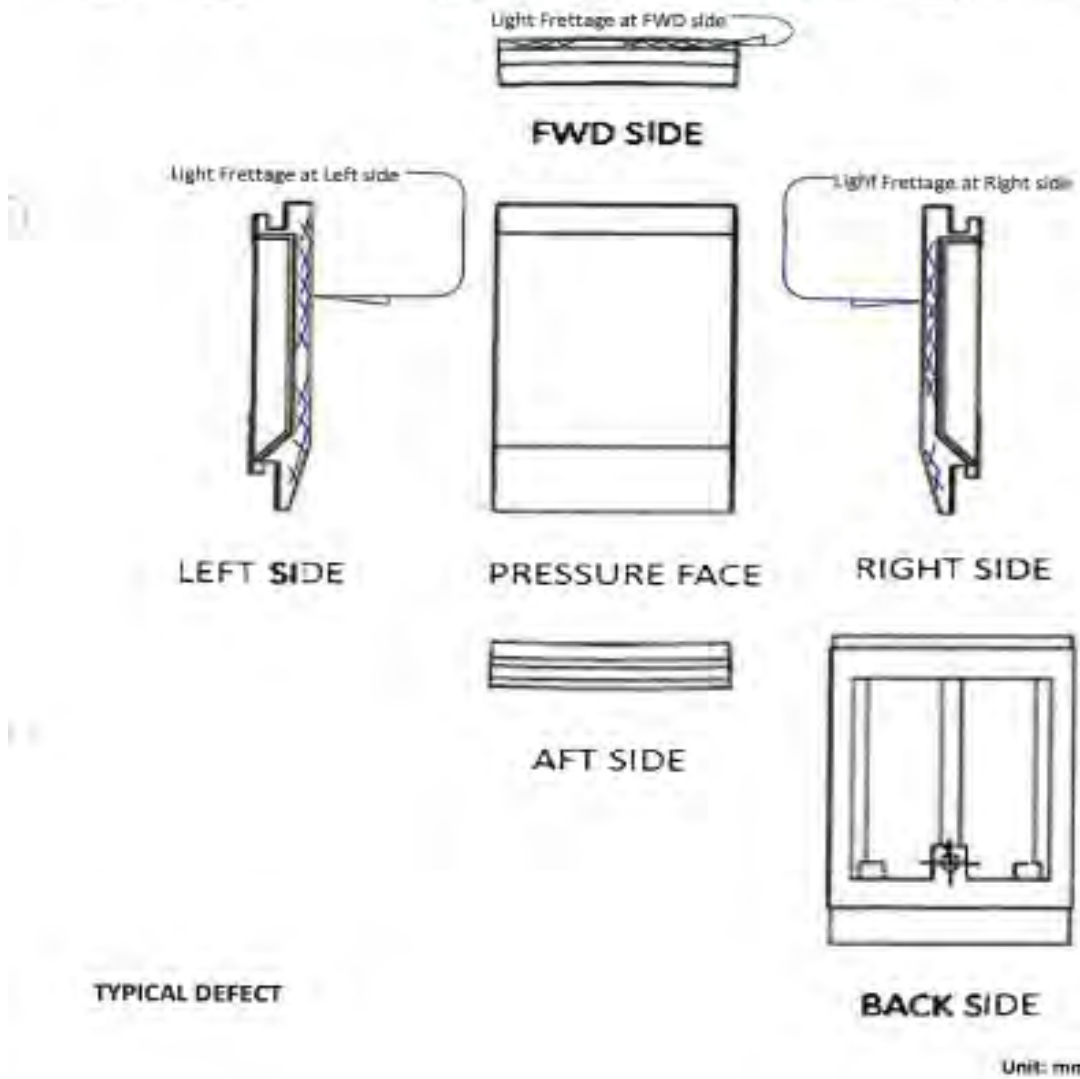
Mapping of FPI and Visual Inspection

Crack (red)
 Foreign Object Damage (LAWN)
 Pitting (LAWN)
 Corrosion (LAWN)
 Missing Material (red)

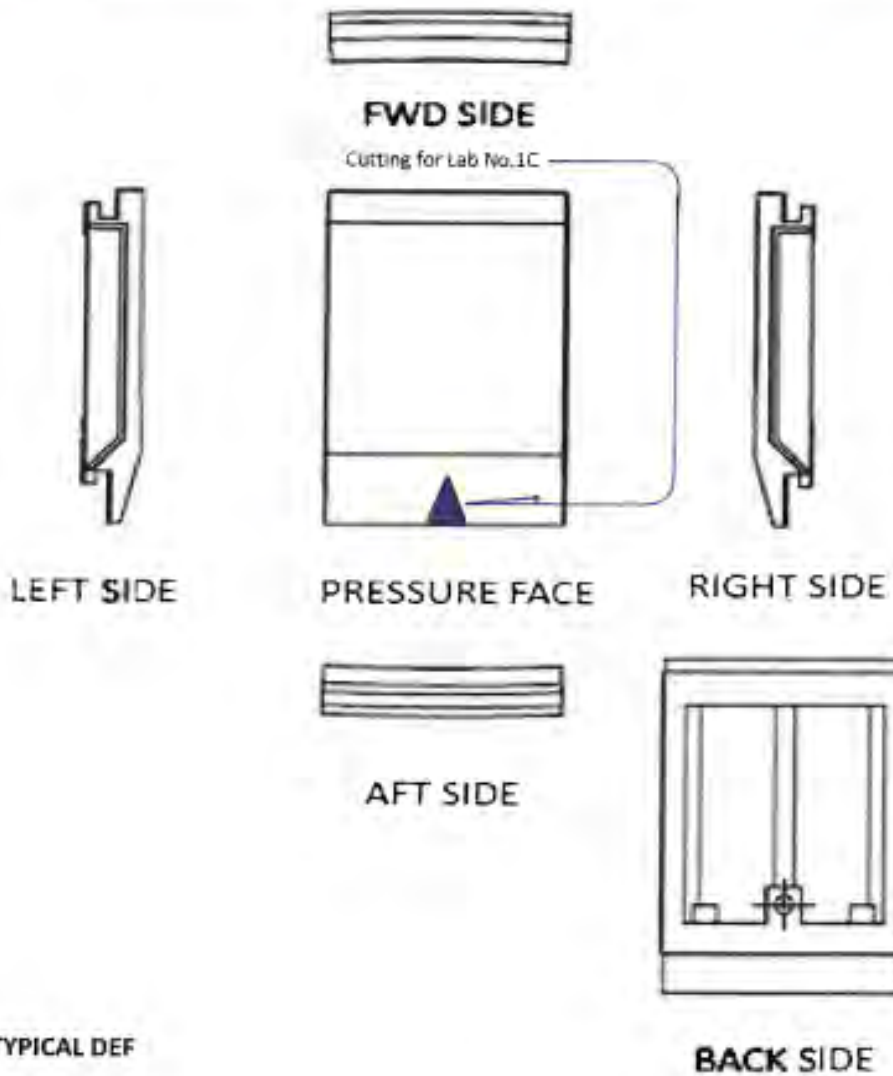
Mapping of FPI and Visual Inspection

Crack (mm)
 Porosity (Spot Diameter (L/WH))
 Porosity (L/WH)
 Oxidation (mm²)
 Corrosion (L/WH)
 Missing Material (mm²)

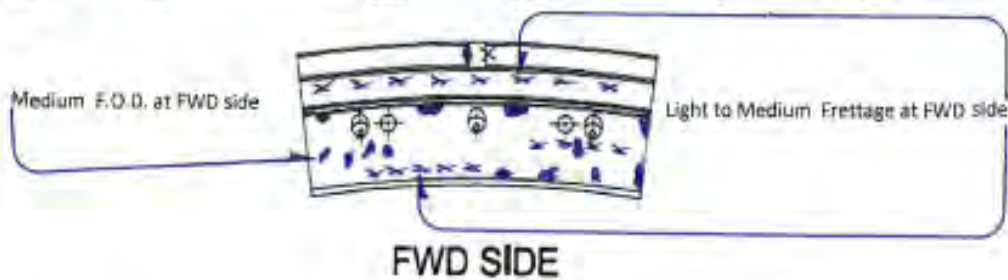
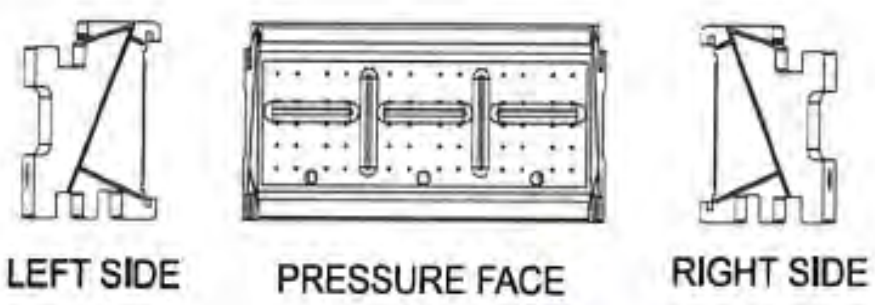
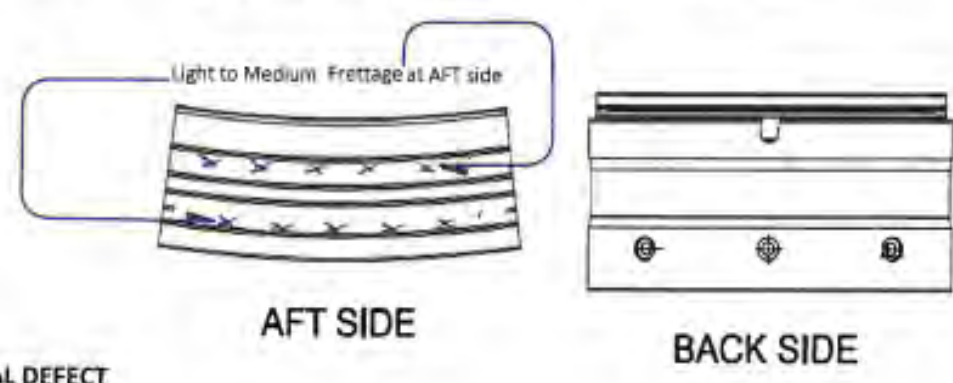
Mapping of FPI and Visual Inspection

- Crack (mm)
- Foreign Object Damage (LMM)
- Fretting (LMM)
- Abrasion (LMM)
- Corrosion (LMM)
- Missing Material (mm²)

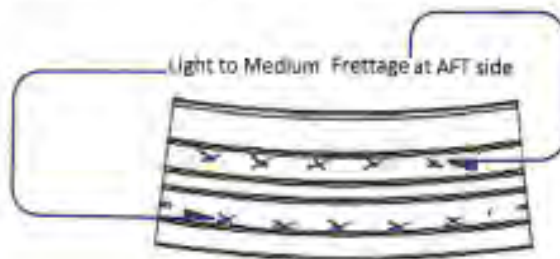
AFT SIDE

TYPICAL DEFECT
