FINAL INSPECTION REPORT & CERTIFICATE OF CONFORMANCE

Customer Name: Nghi Son Refinery & Petrochemical, LLC.

Component type: MS6001FA 1st STAGE BUCKET

Date of Report: October 15, 2025

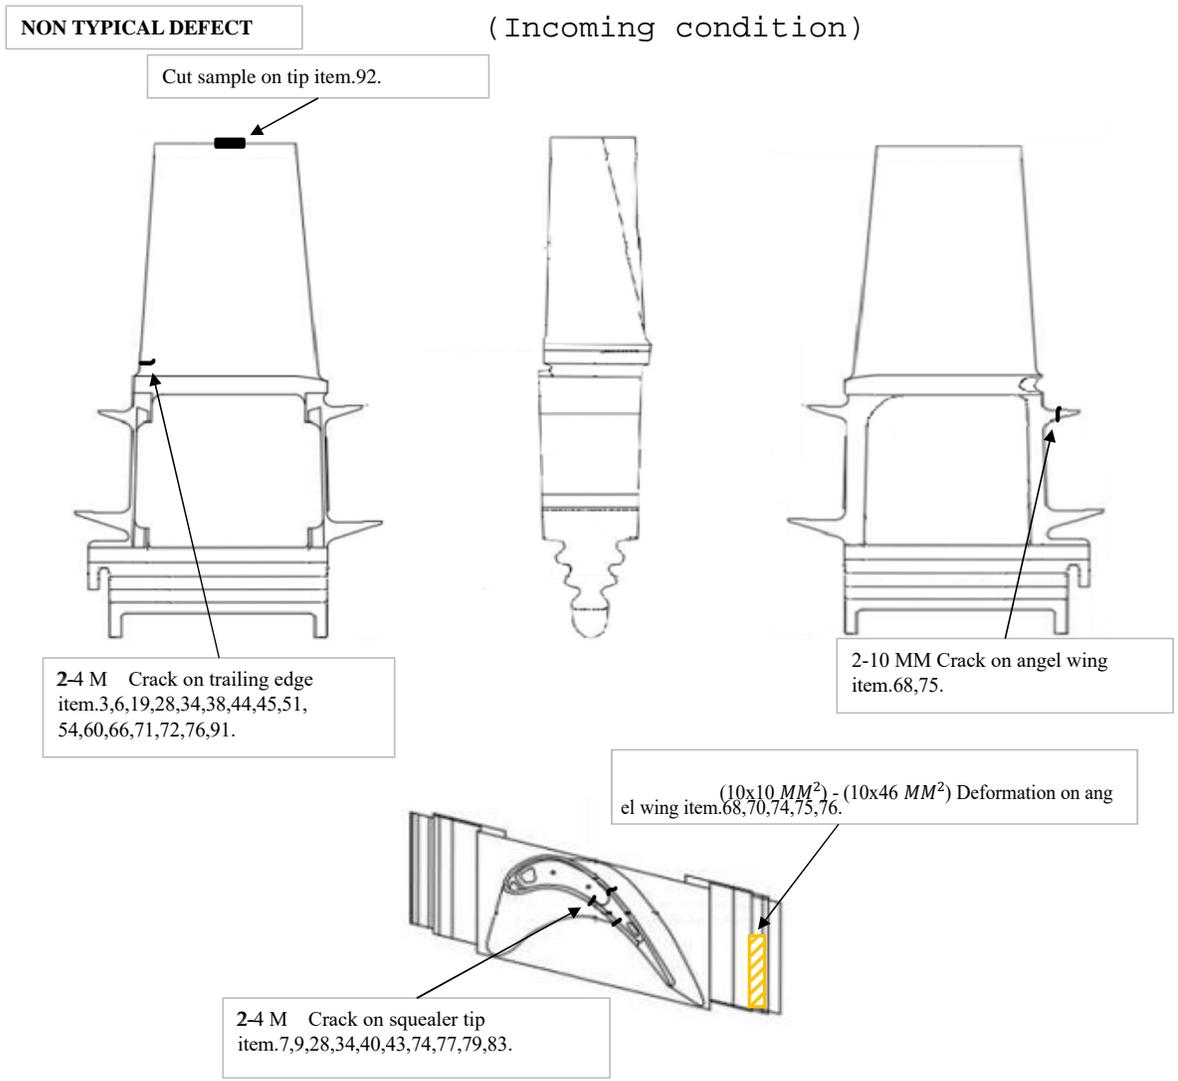
13.0 DEFECT MAP (CONTINUE)

INSPECTION AND PROCESS RECORD SHEET	MS6001FA 1st SATGE BUCKET		IPRS NO. 3065-40
	PART NUMBER : GEBL01M6FA		REV. 00
CUSTOMER :	Nghi Son Refinery &	CUSTOMER PO :	PO04102025-HGP
JOB NUMBER :	824025	OP.	240
INSPECTED BY :	Anirut D.	DATE :	07/08/2025

mm Crack (mm)
 Foreign Object Damage (L/M/H)
 Fretage (L/M/H)
 Deformation area(mm²)
 Corrosion (L/M/H)
 Missing Material (mm²)

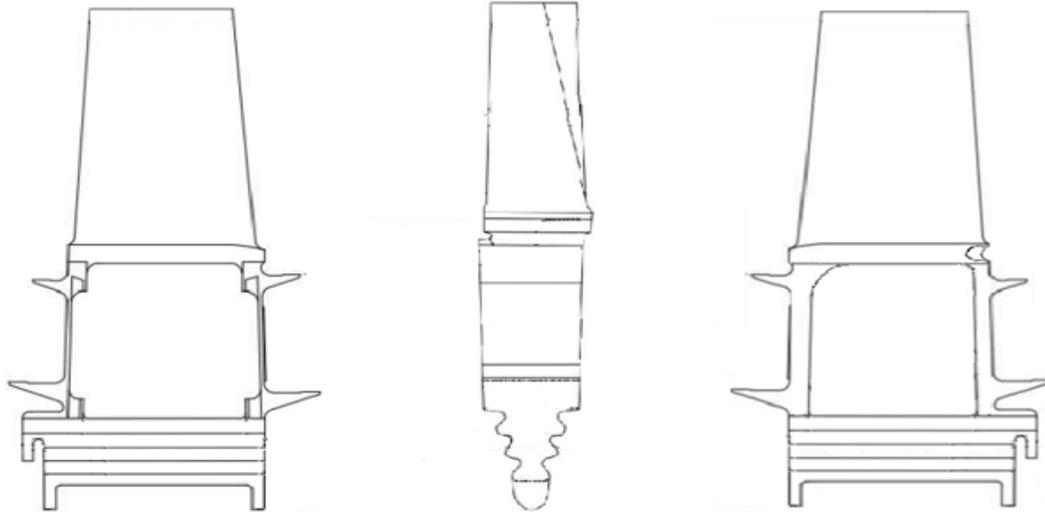
13.0 DEFECT MAP (CONTINUE)

INSPECTION AND PROCESS RECORD SHEET	MS6001FA 1st SATGE BUCKET		I PRS NO.	3065-40	
	PART NUMBER : GEBL01M6FA		REV.	00	
CUSTOMER :	Nghi Son Refinery &	CUSTOMER PO :	PO04102025-HGP		
JOB NUMBER :	824025	OP.	FINAL		
INSPECTED BY :	Supasit K.	DATE :	13-Oct-25		
Crack (mm)	Foreign Object Damage (L/MH)	Fretage (L/MH)	Deformation area(mm ²)	Corrosion (L/MH)	Missing Material (mm ²)

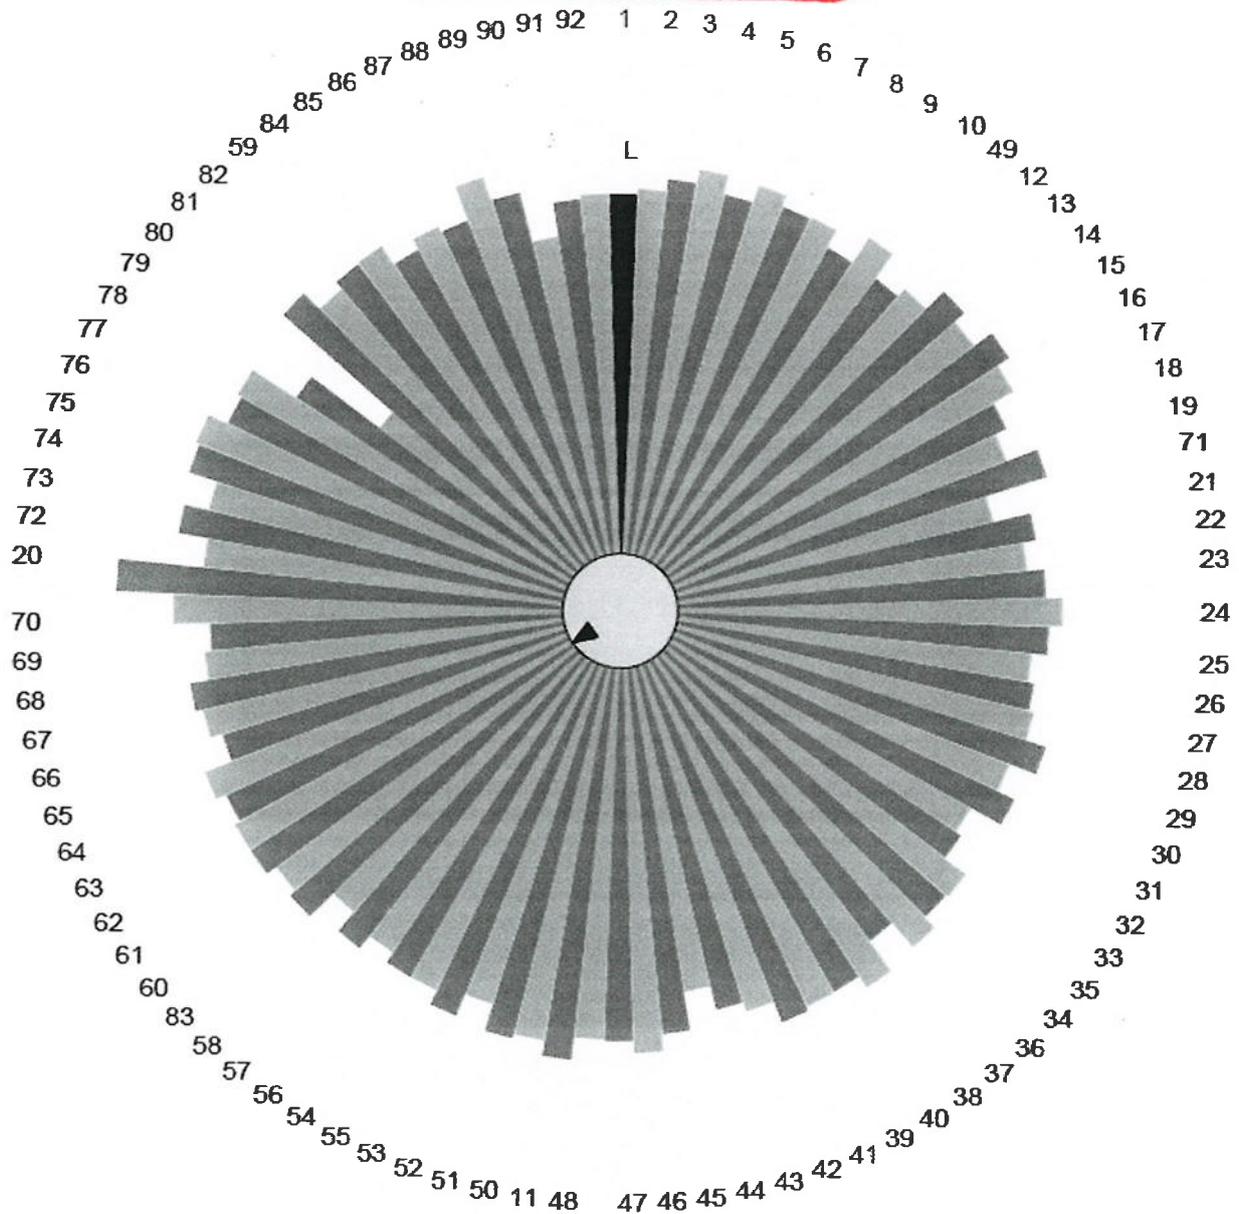
Blade Set: **824025**

Predistribution Pattern:	7 - Sequence of Weighing
Calculated Unbalance:	8 gmm
Calculated Angle:	236 deg
State of Blade Set:	In Tolerance (1000 gmm)
	In reduced Tolerance (10 gmm)
