FINAL INSPECTION REPORT & CERTIFICATE OF CONFORMANCE

Customer Name: Nghi Son Refinery & Petrochemical, LLC.

Component type: MS6001FA 2nd STAGE NOZZLE

Date of Report: October 30, 2025

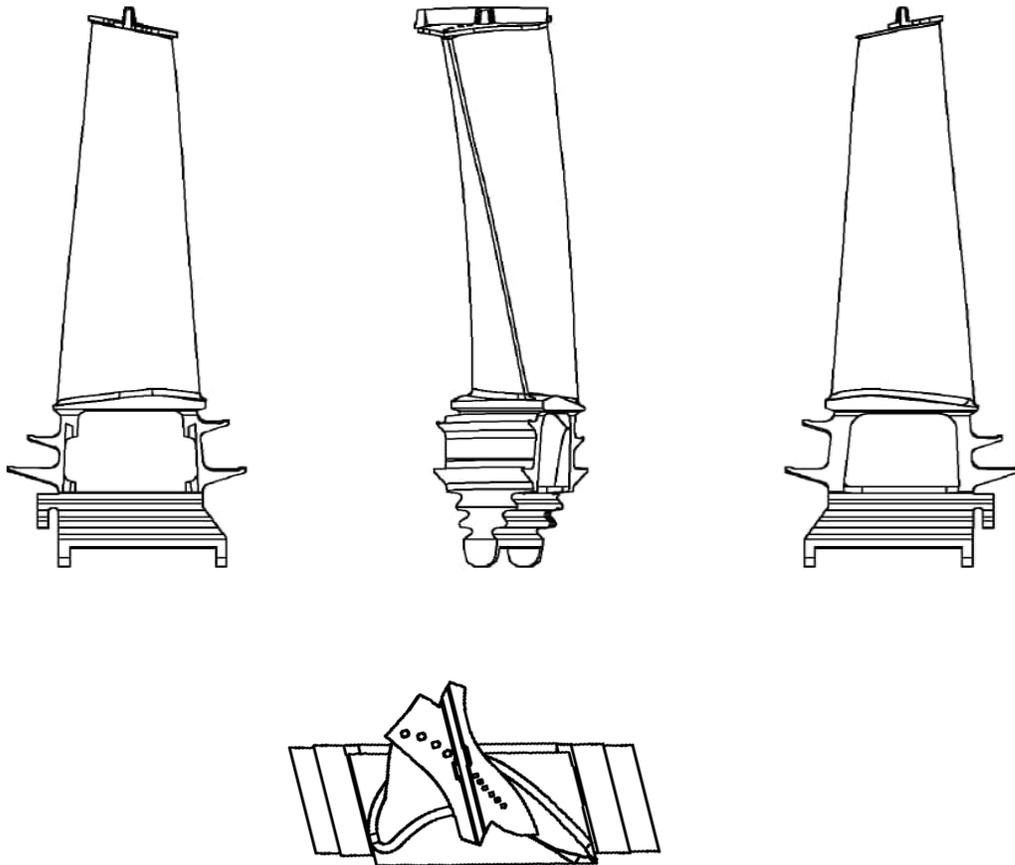
INSPECTION AND PROCESS RECORD SHEET	MS6001FA 2nd STAGE BUCKET	IPRS NO.	3066-40						
	PART NUMBER : GEBLO2M6FA	REV.	00						
CUSTOMER :	Nghi Son Refinery &	CUSTOMER PO :	PO04102025-HGP						
JOB NUMBER :	824026	OP.	FINAL						
INSPECTED BY :	ANUCHID K.	DATE :	27/09/2025						
<table style="width: 100%; font-size: small;"> <tr> <td style="width: 15%;"> Crack (mm)</td> <td style="width: 15%;"> Foreign Object Damage (L/M/H)</td> <td style="width: 15%;"> Fretage (L/M/H)</td> <td style="width: 15%;"> Deformation area(mm²)</td> <td style="width: 15%;"> Corrosion (L/M/H)</td> <td style="width: 15%;"> Missing Material (mm²)</td> </tr> </table>				Crack (mm)	Foreign Object Damage (L/M/H)	Fretage (L/M/H)	Deformation area(mm ²)	Corrosion (L/M/H)	Missing Material (mm ²)
Crack (mm)	Foreign Object Damage (L/M/H)	Fretage (L/M/H)	Deformation area(mm ²)	Corrosion (L/M/H)	Missing Material (mm ²)
