## FINAL INSPECTION REPORT & CERTIFICATE OF CONFORMANCE

**Customer Name: Nghi Son Refinery & Petrochemical, LLC.**

**Component type: MS6001FA 3rd STAGE NOZZLE**

**Date of Report: October 30, 2025**

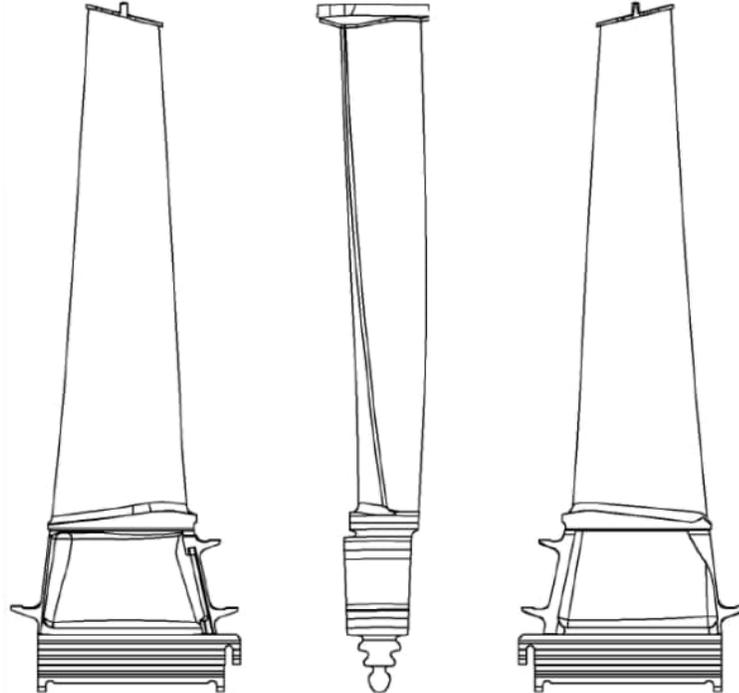
**12.0 DEFECT MAP (CONTINUE)**

INSPECTION AND PROCESS RECORD SHEET	MS6001FA 3rd STAGE BUCKET	IPRS NO.	3067-40
	PART NUMBER : GEBL03M6FA	REV.	00
CUSTOMER :	Nghi Son Refinery &	CUSTOMER PO :	PO04102025-HGP
JOB NUMBER :	824027	OP.	<b>FINAL</b>
INSPECTED BY :	ANUCHID K.	DATE :	26/09/2025

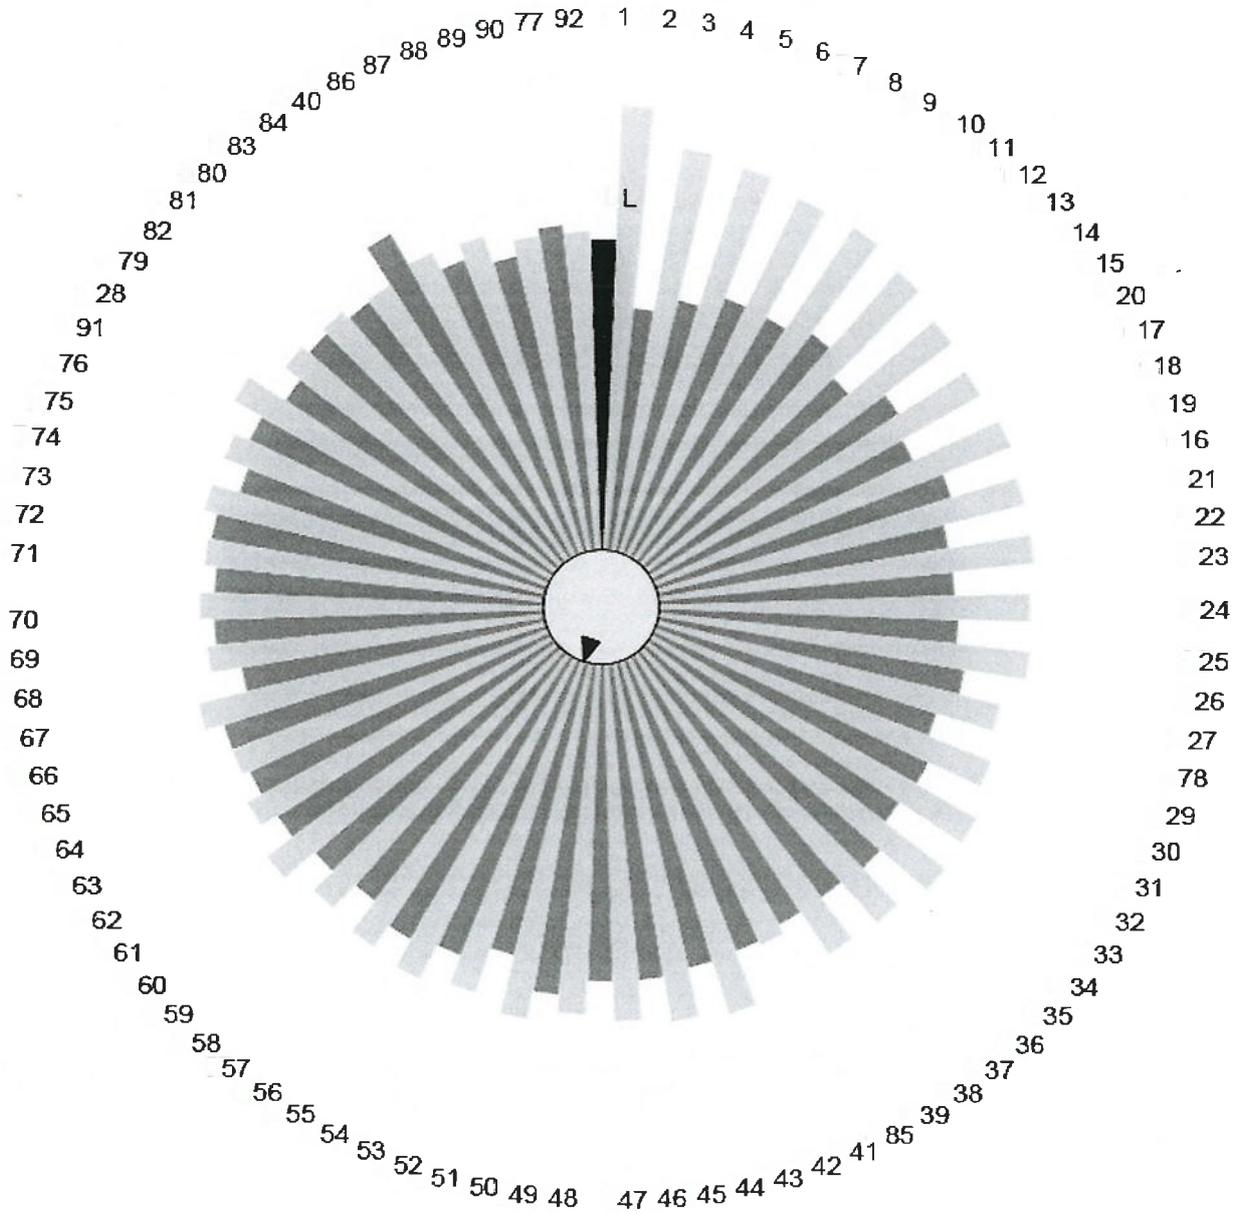
Blade Set: **824027**

Predistribution Pattern:	7 - Sequence of Weighing
Calculated Unbalance:	18 gmm
Calculated Angle:	198 deg
State of Blade Set:	In Tolerance (1000 gmm) In reduced Tolerance (20 gmm)

**Caution:**  
Buckets/Blades need to be installed by  
"Pos. No." in order to minimize any  
vibration issues!
