**FINAL INSPECTION REPORT
&
CERTIFICATE OF CONFORMANCE**

Customer Name: Nghi Son Refinery & Petrochemical, LLC.
Component type: MS6001FA 2nd STAGE NOZZLE 824029
Date of Report: October 30, 2025

FINAL INSPECTION REPORT

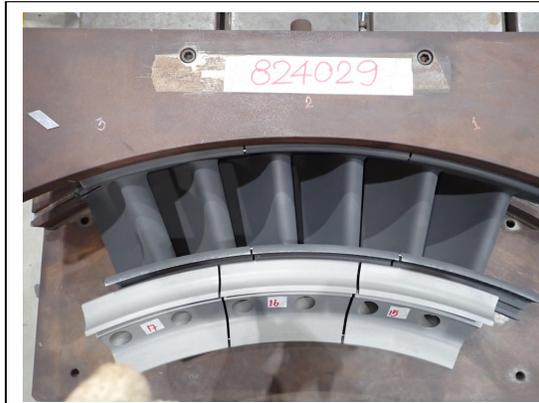
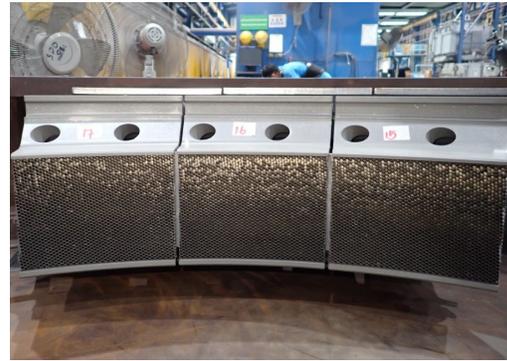
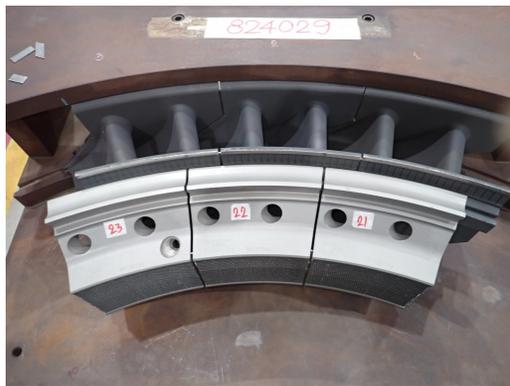
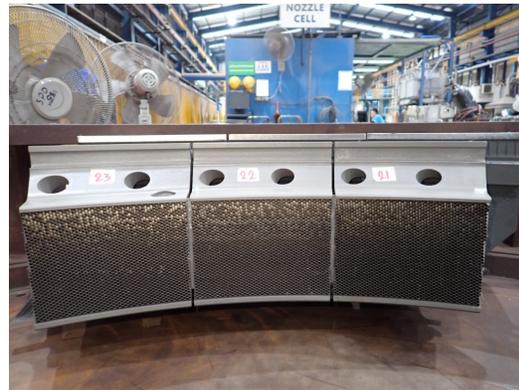
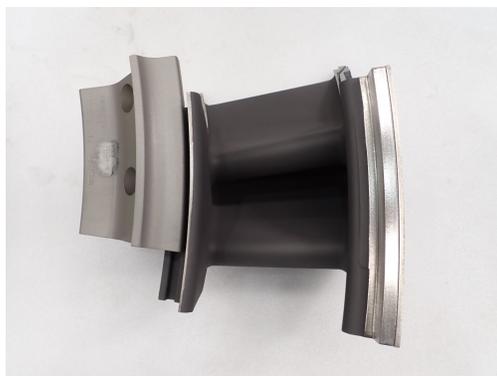
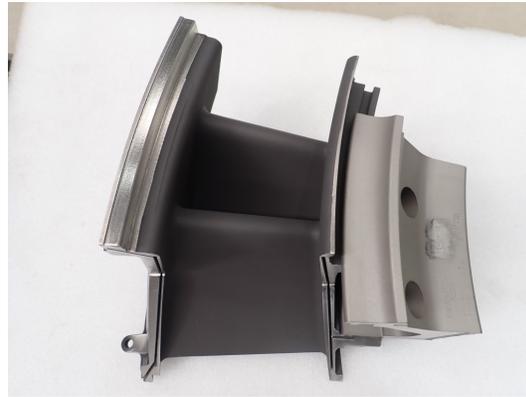
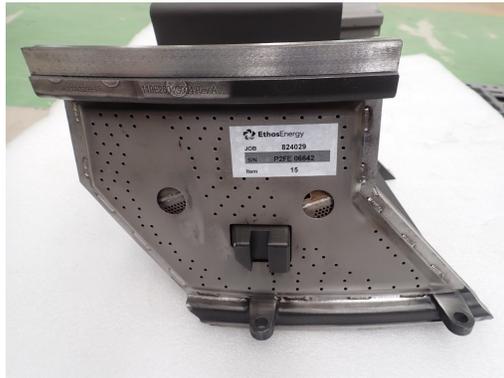
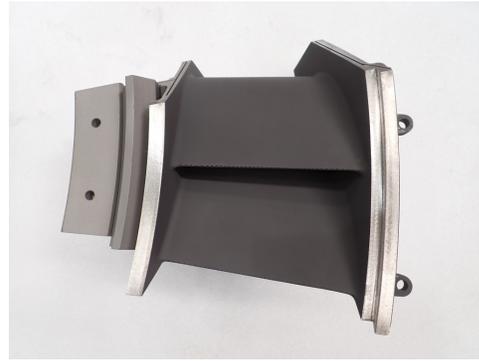
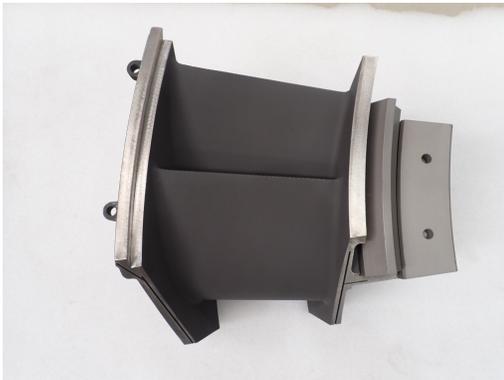
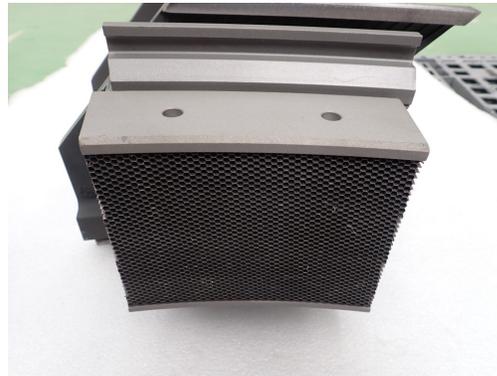
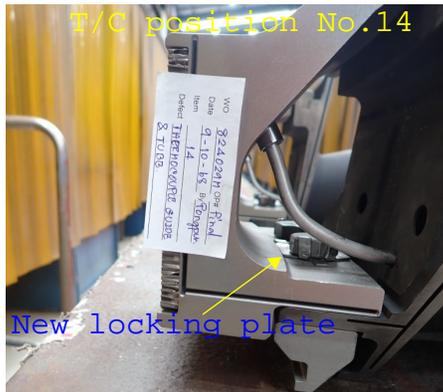
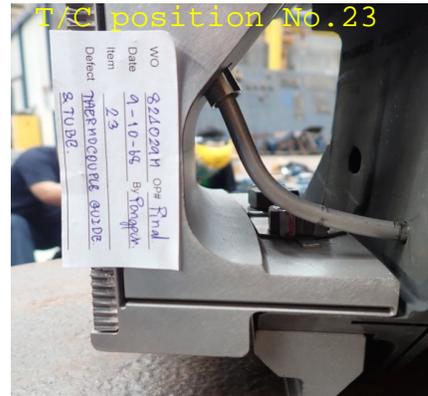
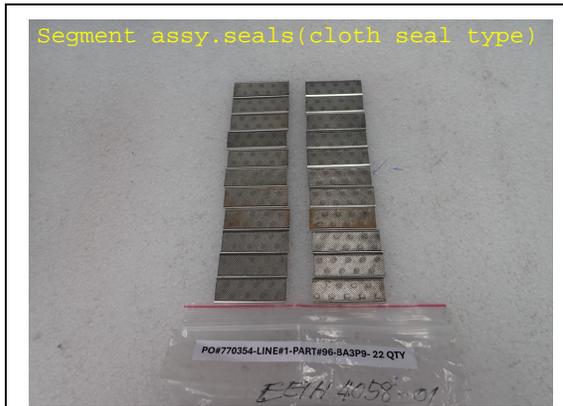
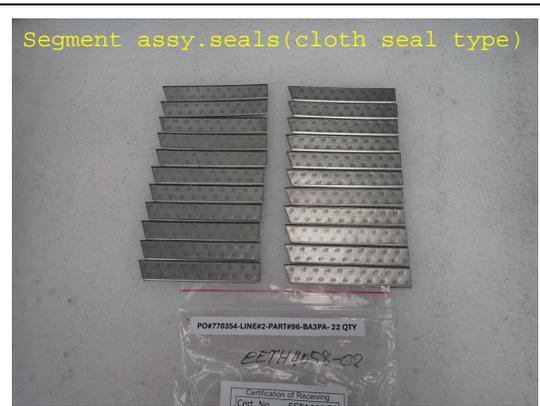
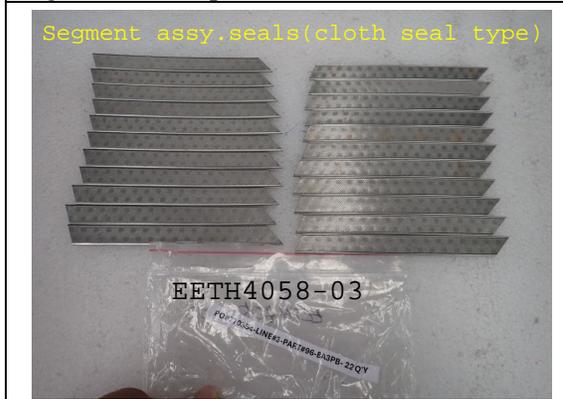
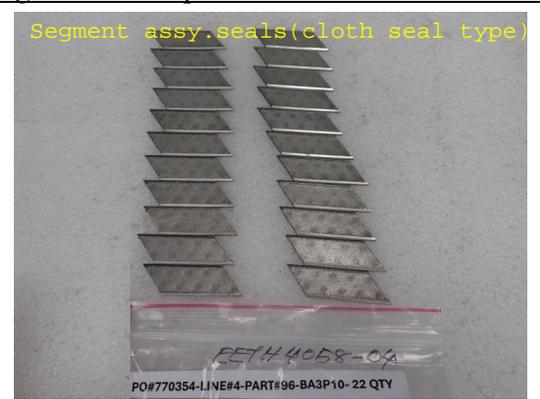
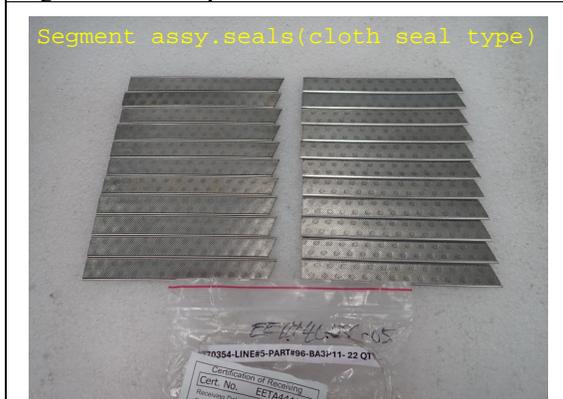
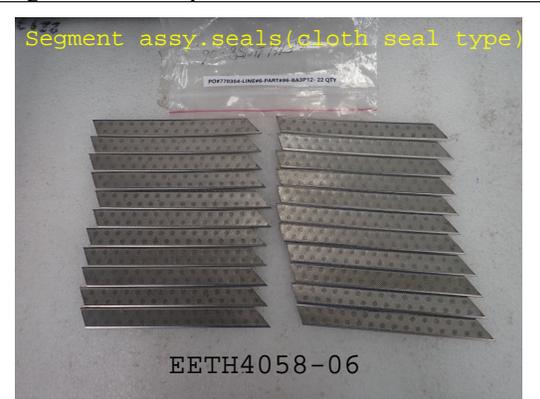
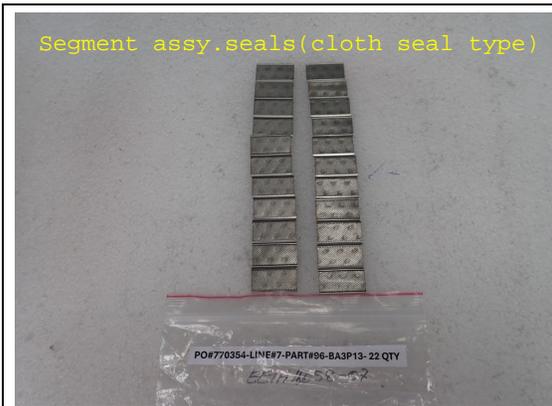
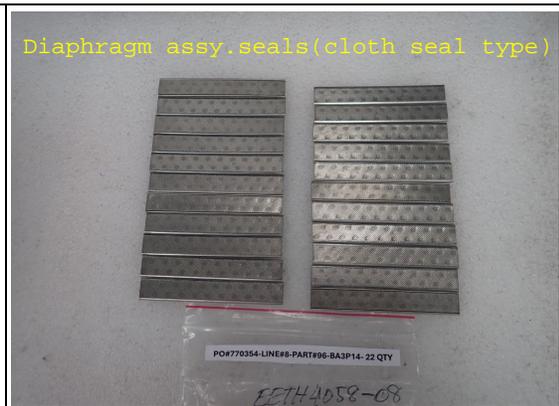
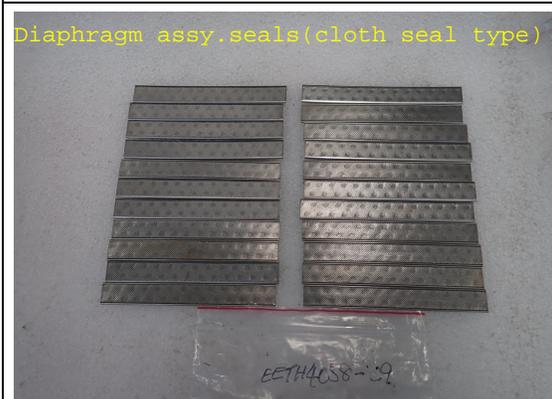
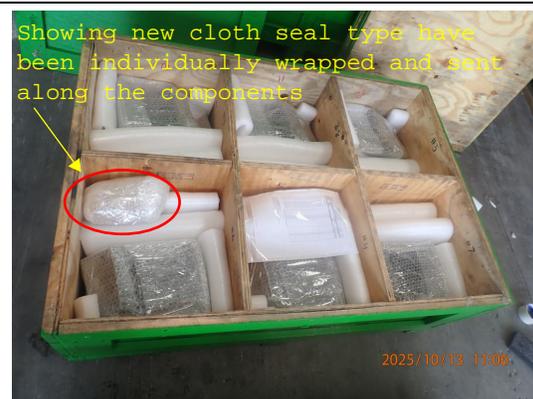
The repaired assemblies were verified by FPI, dimensional, and flow tests, coated with **diffused aluminide**, and certified **serviceable for reinstallation**.

Fig.1 Final inspection.
