FINAL INSPECTION REPORT & CERTIFICATE OF CONFORMANCE

Customer Name: Nghi Son Refinery & Petrochemical, LLC.

WORK ORDER #: PO04102025-HGP

Component type: MS6001FA 1st STAGE SHROUD

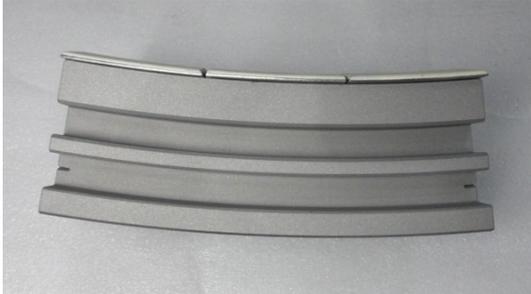
<p>Fig.1 Final inspection/repair.</p>	<p>Fig.2 Final inspection/repair.</p>

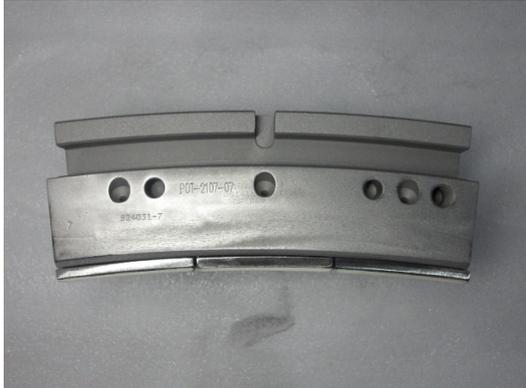
<p>Fig.3 Final inspection/repair.</p>	<p>Fig.4 Final inspection/repair.</p>

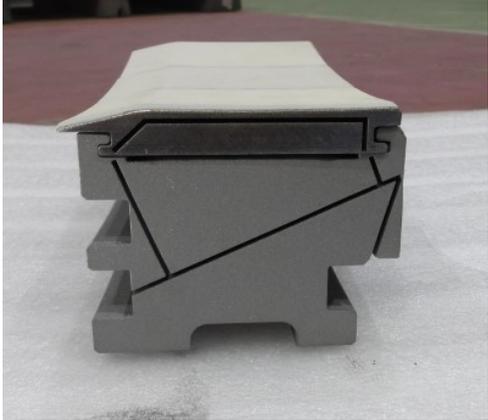
<p>Fig.5 Final inspection/repair.</p>	<p>Fig.6 Final inspection/repair.</p>

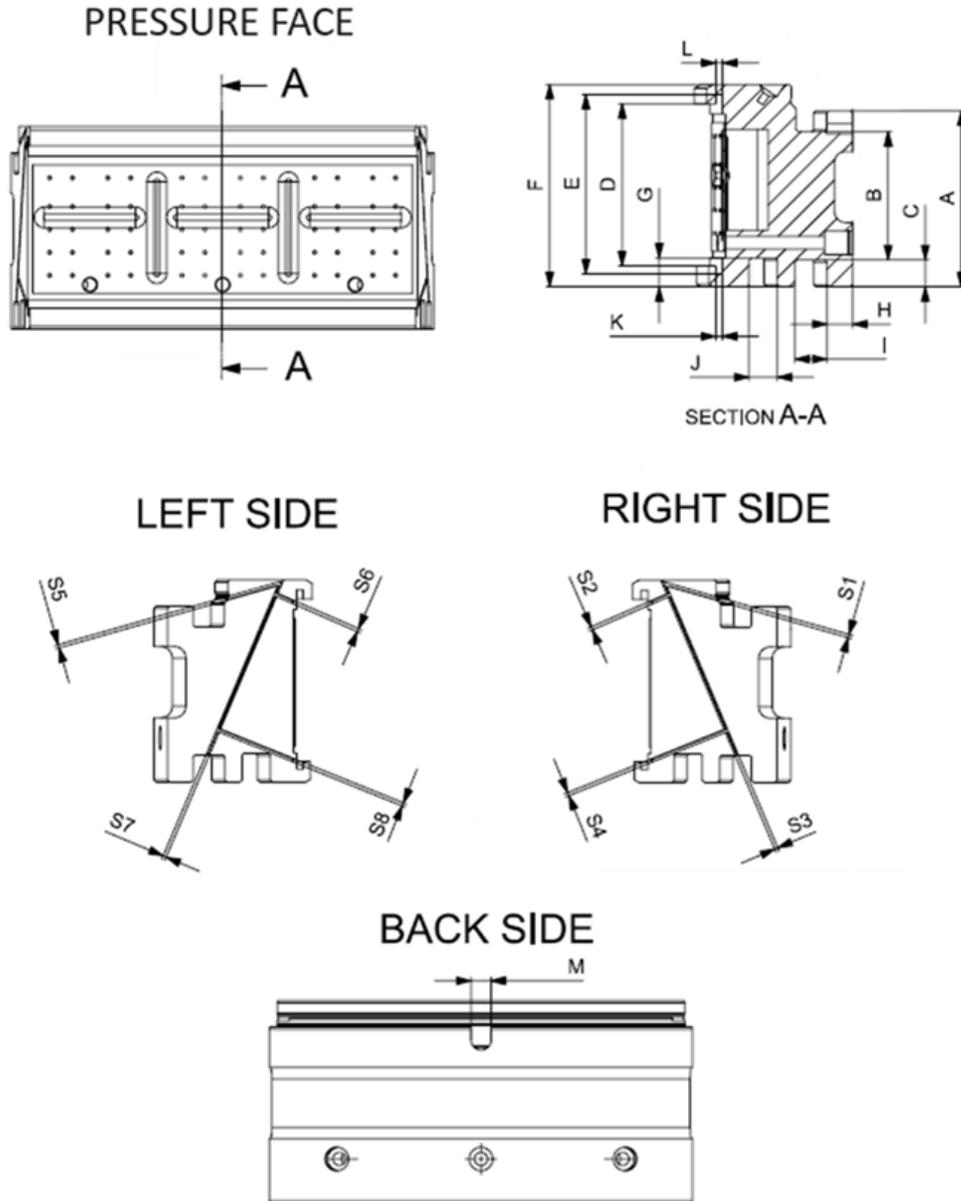
13. DIMENSION INSPECTION:(Body)

Dimension Inspection (Unit: mm)												
ITEM	POSITION											Result
	A	B	C	D	E	F	G	H	I	J	K	
1	97.43	71.02	14.92	89.63	99.17	111.89	15.93	14.21	17.51	15.73	3.83	ACC
2	97.57	71.08	14.91	89.69	99.12	112.04	16.07	14.57	17.56	15.84	3.85	ACC
3	97.65	71.05	14.99	89.55	99.03	111.90	16.09	14.29	17.58	15.76	3.86	ACC
4	97.50	71.02	15.05	89.61	99.14	111.92	16.03	14.27	17.57	15.86	3.78	ACC
5	97.56	71.04	15.13	89.71	99.15	112.14	16.28	14.29	17.52	15.70	3.86	ACC
6	97.56	71.08	15.14	89.67	99.14	111.94	16.22	14.21	17.52	15.84	3.71	ACC
7	97.50	71.10	14.97	89.62	99.04	112.08	16.27	14.25	17.56	15.84	3.84	ACC
8	97.64	71.13	14.93	89.64	99.08	111.85	16.06	14.31	17.50	15.82	3.88	ACC
9	97.62	71.10	14.91	89.63	99.04	111.94	16.27	14.28	17.50	15.85	3.83	ACC
10	97.48	71.04	15.23	89.64	99.12	111.84	16.17	14.29	17.53	15.84	3.83	ACC
11	97.60	70.95	14.88	89.65	99.14	111.87	16.02	14.33	17.58	15.78	3.86	ACC
12	97.51	71.03	15.23	89.63	99.04	111.82	16.18	14.38	17.52	15.87	3.86	ACC

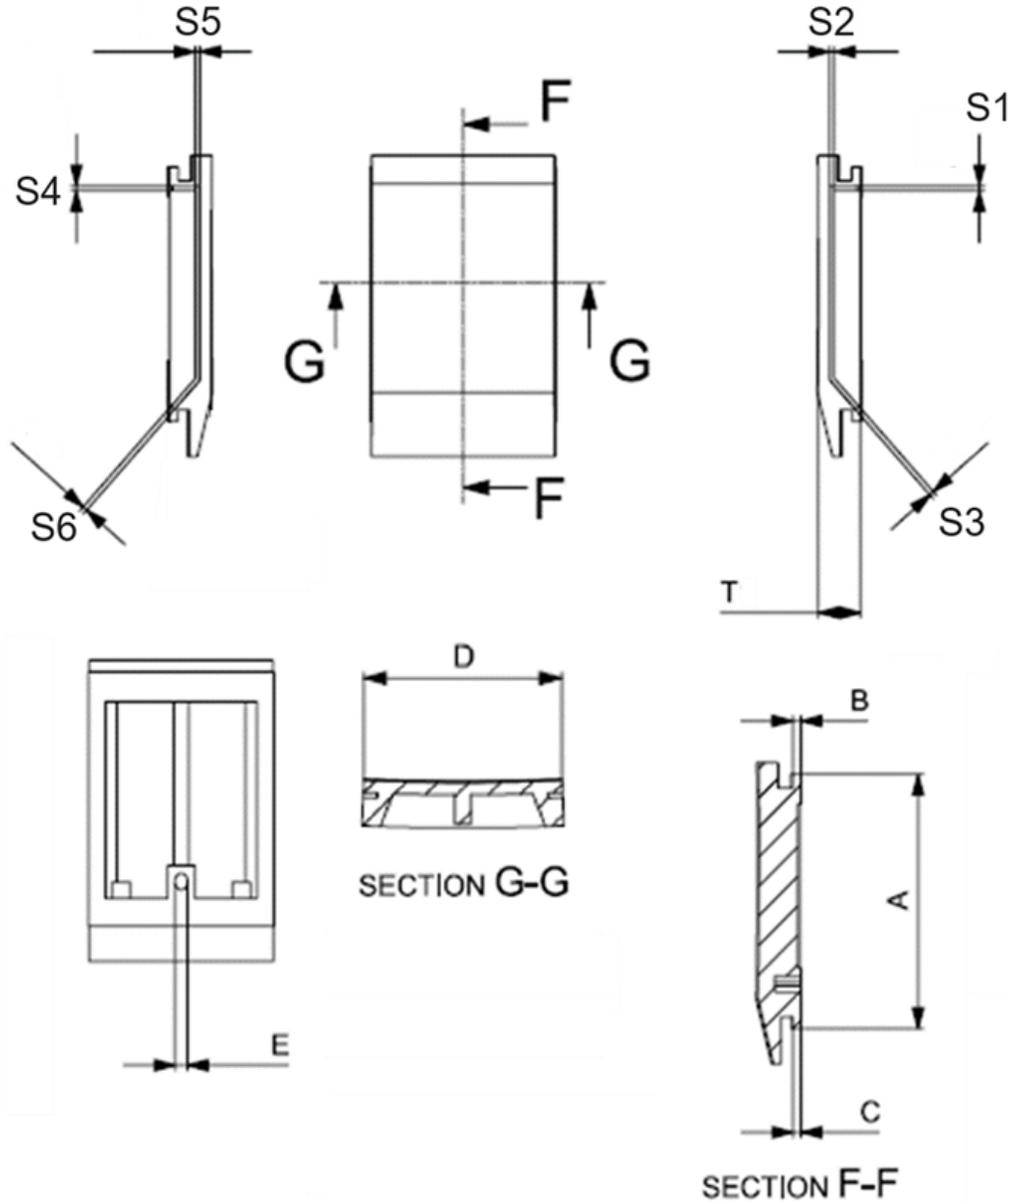
13. DIMENSION INSPECTION:(Inner plate)

Dimension Inspection (Unit: mm): Segment A													
ITEM	POSITION												Result
	A	B	C	S1	S2	S3	S4	S5	S6	D	T	E	
1	97.98	3.43	3.49	1.80	1.80	1.80	1.80	1.80	1.80	71.34	16.66	4.70	ACC
2	98.00	3.50	3.46	1.80	1.80	1.80	1.80	1.80	1.80	71.39	16.74	4.70	ACC
3	98.07	3.43	3.49	1.80	1.80	1.80	1.80	1.80	1.80	71.38	17.00	4.70	ACC
4	98.00	3.49	3.48	1.80	1.80	1.80	1.80	1.80	1.80	71.27	16.97	4.70	ACC
5	98.00	3.42	3.44	1.80	1.80	1.80	1.80	1.80	1.80	71.37	16.97	4.70	ACC
6	98.02	3.50	3.49	1.80	1.80	1.80	1.80	1.80	1.80	71.38	16.67	4.70	ACC
7	97.93	3.39	3.50	1.80	1.80	1.80	1.80	1.80	1.80	71.37	16.90	4.70	ACC
8	98.00	3.46	3.50	1.80	1.80	1.80	1.80	1.80	1.80	71.24	16.96	4.70	ACC
9	98.03	3.42	3.49	1.80	1.80	1.80	1.80	1.80	1.80	71.38	16.64	4.70	ACC
10	98.05	3.42	3.50	1.80	1.80	1.80	1.80	1.80	1.80	71.36	16.96	4.70	ACC
11	98.00	3.40	3.50	1.80	1.80	1.80	1.80	1.80	1.80	71.13	16.90	4.70	ACC
12	98.03	3.46	3.48	1.80	1.80	1.80	1.80	1.80	1.80	71.38	16.96	4.70	ACC

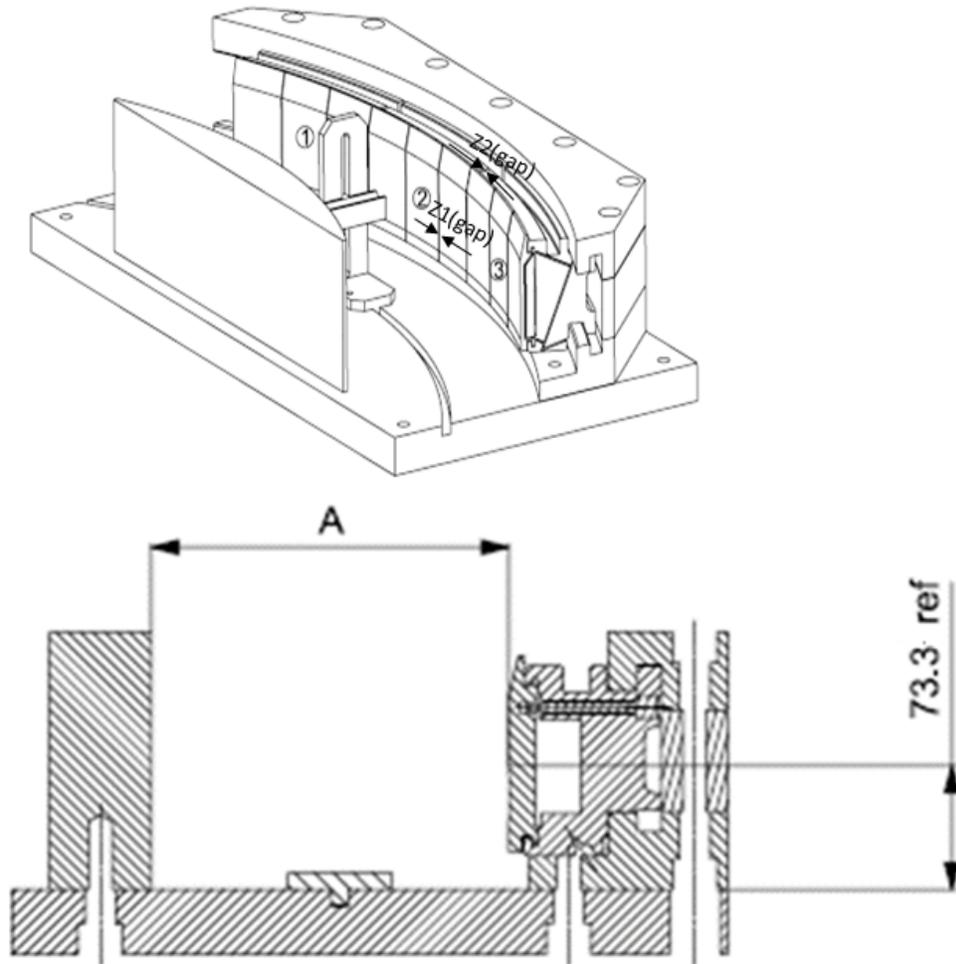
13. DIMENSION INSPECTION:(Fixture inspection)

Dimension Inspection (Unit: mm)											
Item no.	Tip shoe/ Inner plate	POSITION			Result	Item no.	Tip shoe/ Inner plate	POSITION			Result
		A	Z1	Z2				A	Z1	Z2	
1	A	207.89	ACC	ACC	ACC	11	A	207.65	ACC	ACC	ACC
	B	207.70	ACC				ACC				
	C	207.81	ACC				ACC				
2	A	207.90	ACC	ACC	ACC	12	A	207.82	ACC	ACC	ACC
	B	207.77	ACC				ACC				
	C	207.80	ACC				ACC				
3		207.78	ACC	ACC	ACC	13	A	207.80	ACC	ACC	ACC
	B	207.90	ACC				ACC				
	C	207.90	ACC				ACC				
4	A	207.88	ACC	ACC	ACC	14	A	207.80	ACC	ACC	ACC
	B	207.89	ACC				ACC				
	C	207.66	ACC				ACC				
5	A	207.78	ACC	ACC	ACC	15	A	207.85	ACC	ACC	ACC
	B	207.89	ACC				ACC				
	C	207.90	ACC				ACC				
6	A	207.88	ACC	ACC	ACC	16	A	207.90	ACC	ACC	ACC
	B	207.88	ACC				ACC				
	C	207.87	ACC				ACC				
7	A	207.82	ACC	ACC	ACC	17	A	207.79	ACC	ACC	ACC
	B	207.90	ACC				ACC				
	C	207.86	ACC				ACC				
8	A	207.68	ACC	ACC	ACC	18	A	207.90	ACC	ACC	ACC
	B	207.79	ACC				ACC				
	C	207.90	ACC				ACC
