GAS TURBINE INSPECTION REPORT

Combustion Inspection

Gas Turbine Model: GE 6FA.03, MNQC
Unit: GTG2 (Serial Number: 875123)
Plant: Nghi Son Refinery and Petrochemical, LLC

Report Date: July, 2025

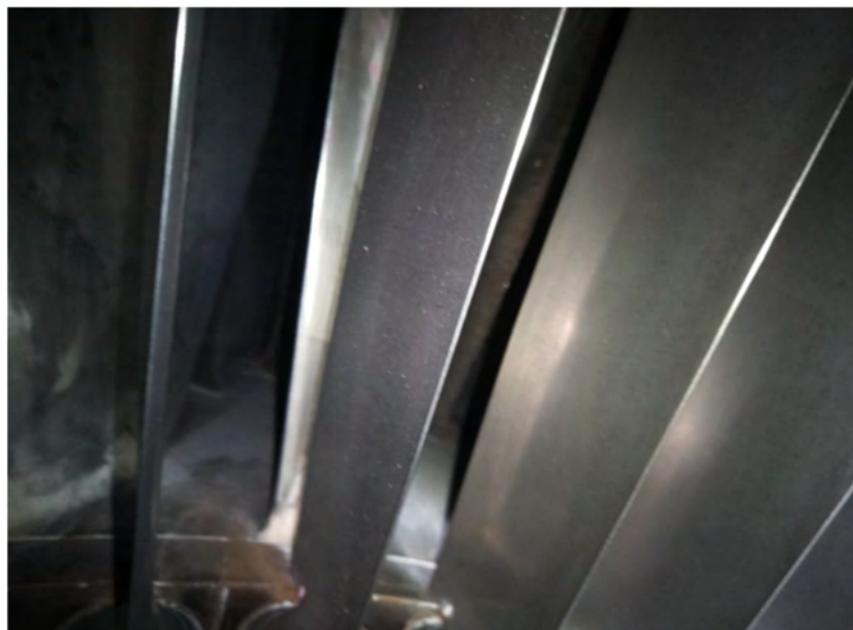
VIGVs after Final Cleaning

- VIGV was cleaned, NDT carried out. IGV clearances recorded in the respective check sheet and jointly signed, kept in service.
- Instruments tubing connected to CPD, Fuel Gas and Atomizing headers removed and installed back after flashed cleaning. It's recommended keep few quantities of Straight connectors, tubing and ferrules with nut for future replacement as the joints are being opened and fixed several times since commissioning. The probabilities of leakage through the ferrule joints expected to increase due to multiple opening and fittings.

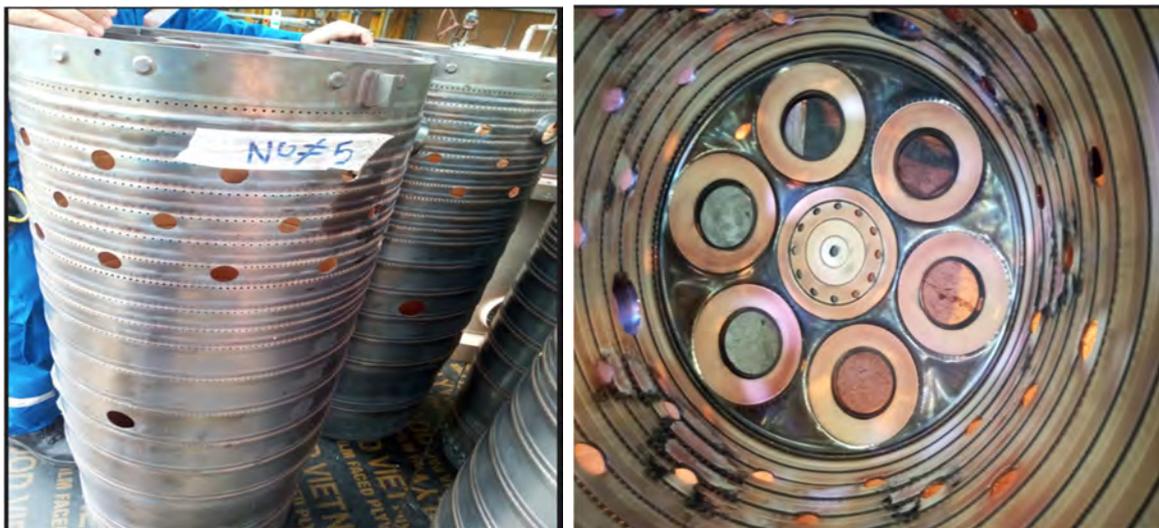
Figure 08: Removed Liners

- Combustion liners removed and replaced with refurbished set.
- Outer cross-fire tubes removed along with fixing adapter flange. Same installed back after proper cleaning and with new packing ring gaskets.

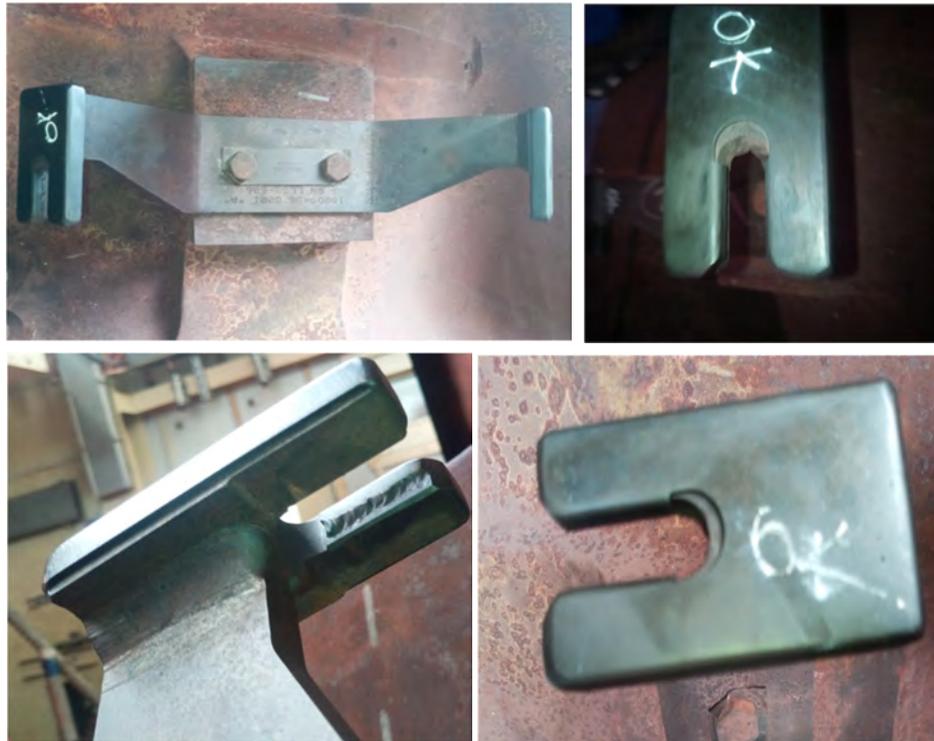
Figure 16: Bull Horns/ TP Forward Support

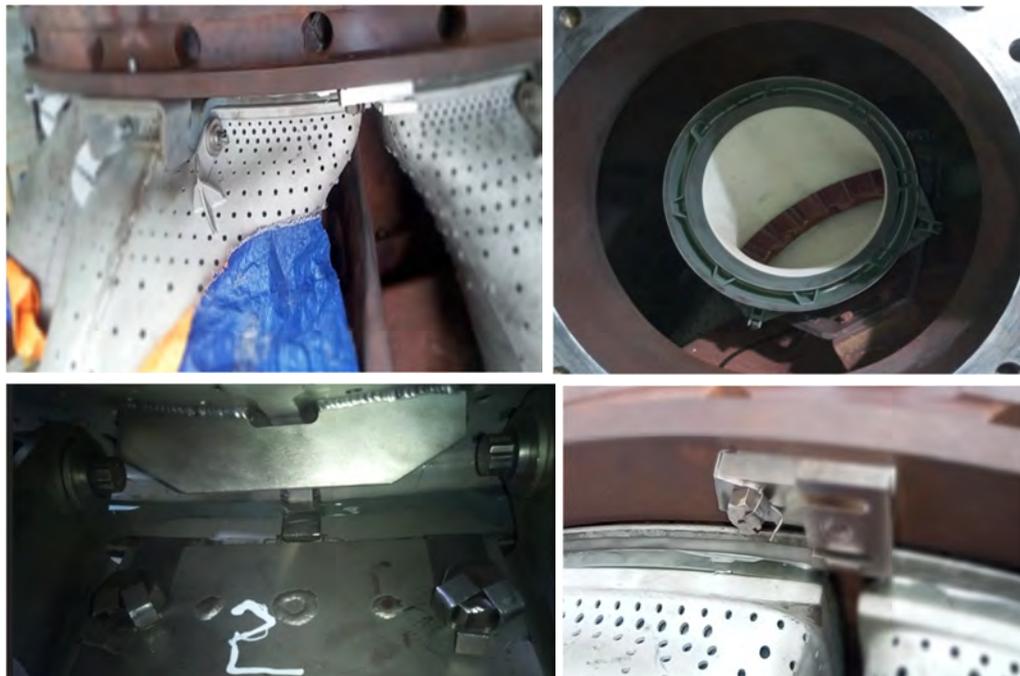
Figure 17: Installed Transition Pieces with New Hardware

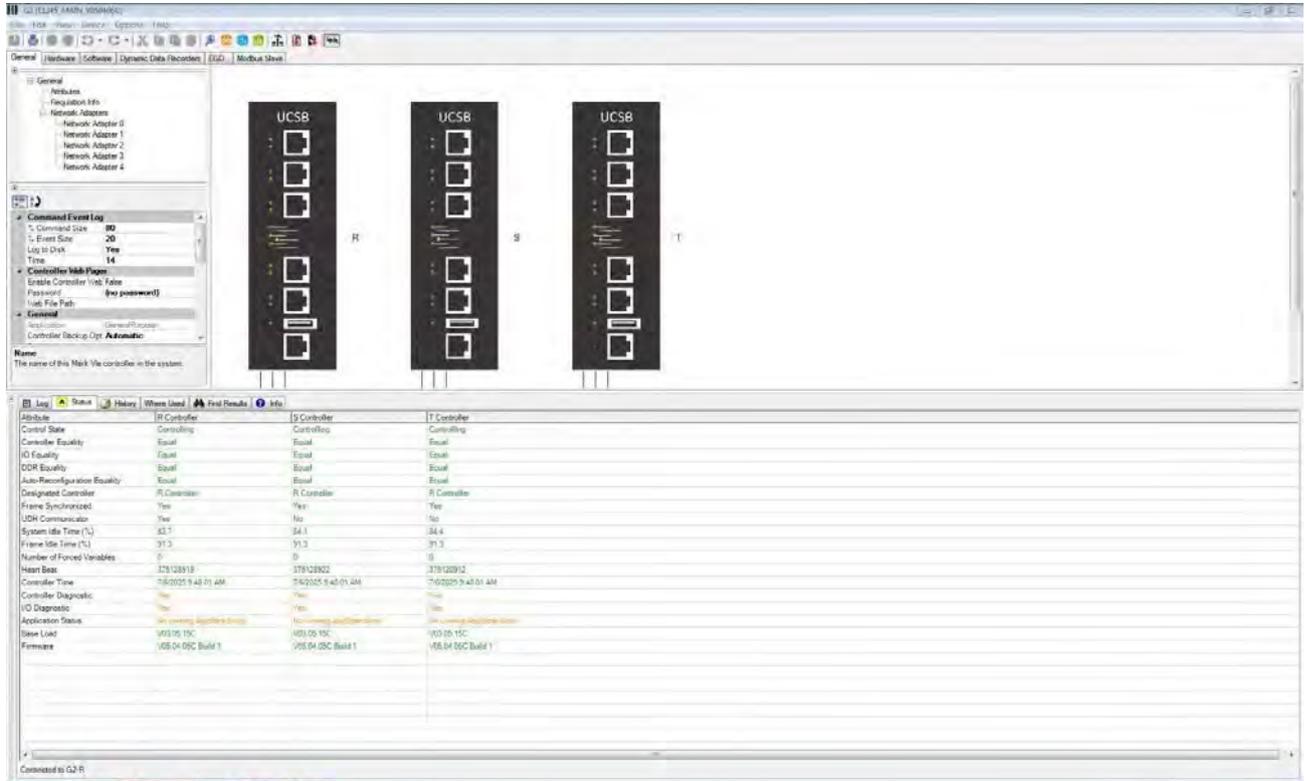
Control Status

The screenshot displays a network management interface with three UCSB controllers labeled R, S, and T. Below the controllers is a table showing the status of various parameters for each controller.
