# INCOMING INSPECTION REPORT

## MS6001FA (GE Frame 6FA) Combustion Liner MNQC — Complete Set

| Engine Type | MS6001FA (GE Frame 6FA) | Component | Combustion Liner MNQC |
| Component Part No. | 119E9620G001 | Qty. Received | 6 units (1 complete set) |

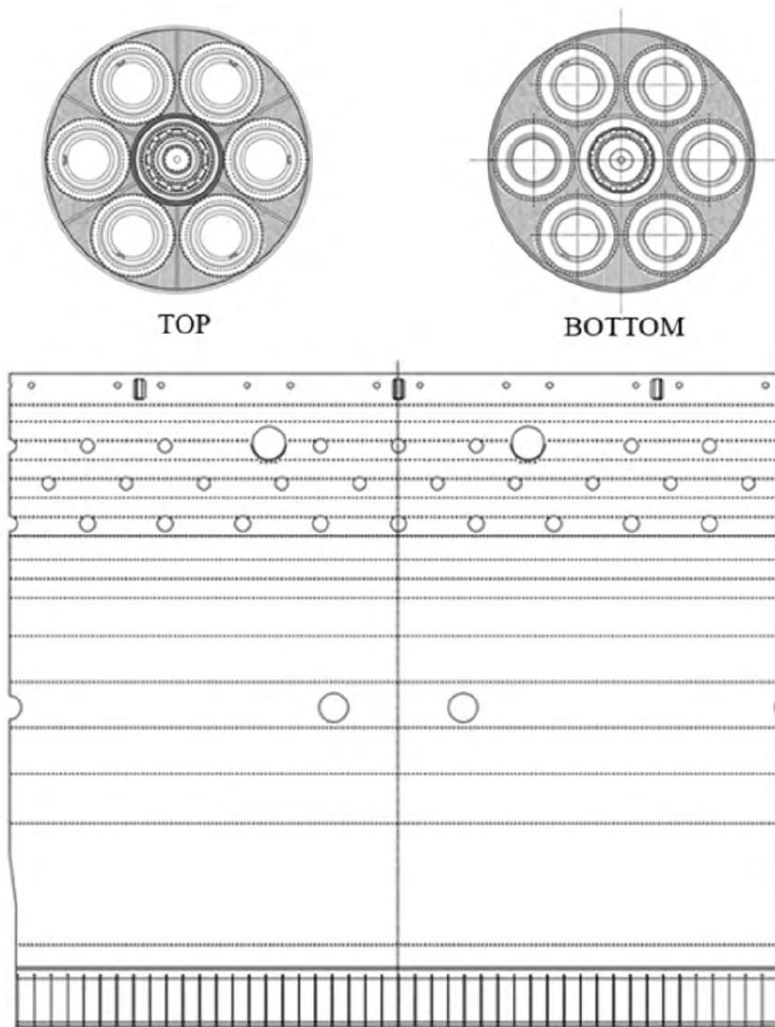
### 13. COMPONENT INSPECTION ZONES

The following reference drawing shows the combustion liner inspection zones (top view, bottom view, and developed body view) used for defect recording during incoming inspection.

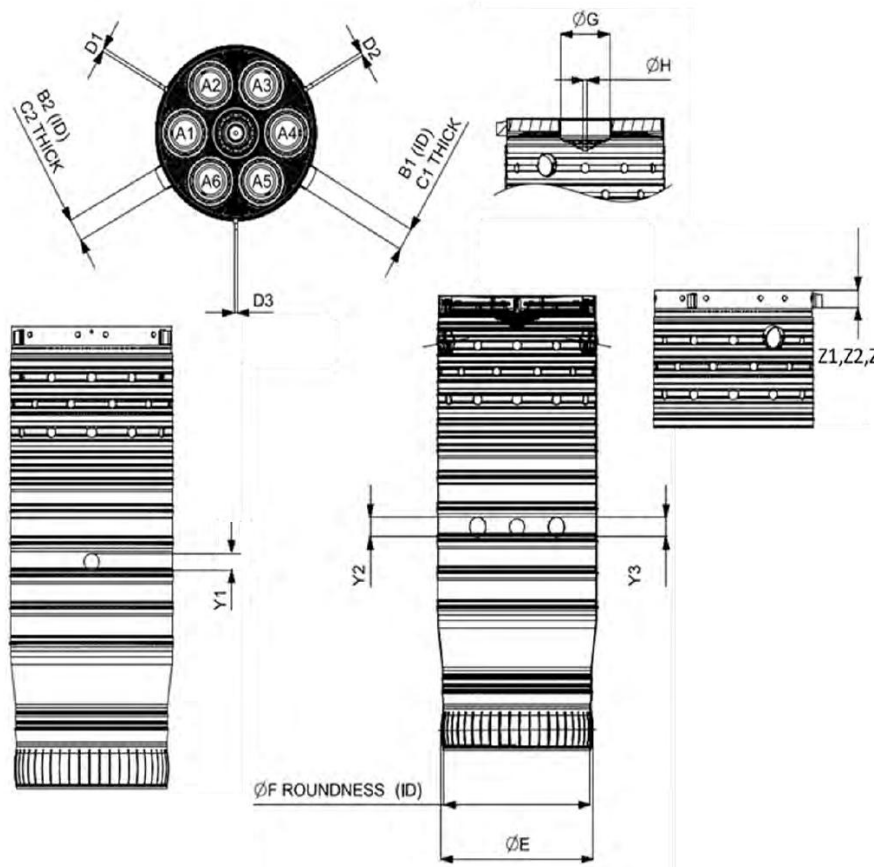
## 14. DIMENSION INSPECTION REFERENCE

Measurement positions for the dimensional record in Section 6.1 are defined in the reference drawing below. All values are in mm.
