## INCOMING INSPECTION REPORT

| Customer | Nghi Son Refinery & Petrochemical, LLC. | Report Date | 27 April 2026 |
| Customer P.O. No. | WO1003986864 | Component | 1st Stage Nozzle |
| Engine Type | MS6001FA (GE Frame 6FA) | Part Number (Ring) | 143E5711G02 |

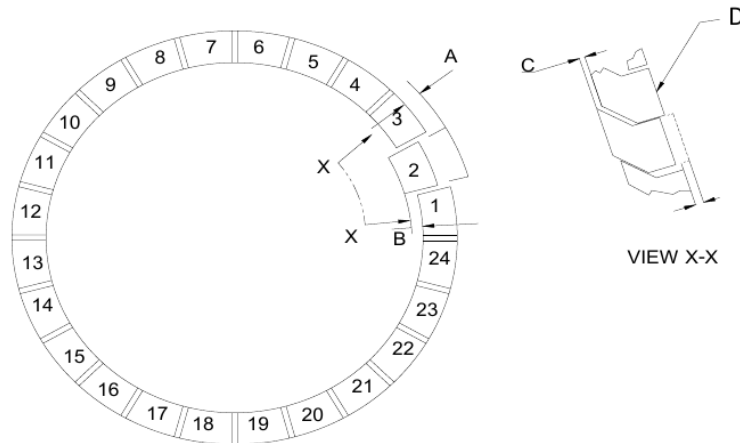
#### ALIGNMENT CHECK

Segment numbering and measurement positions A, B (horizontal) and C, D (vertical) are shown below. All values in mm.

*Note: Alignment step deviations are recorded against nominal (zero) datum as the incoming baseline.  
Straightening and dimensional requalification to final fits and clearances form part of the Heavy Repair scope;  
final acceptance is verified at post-repair dimensional inspection.*

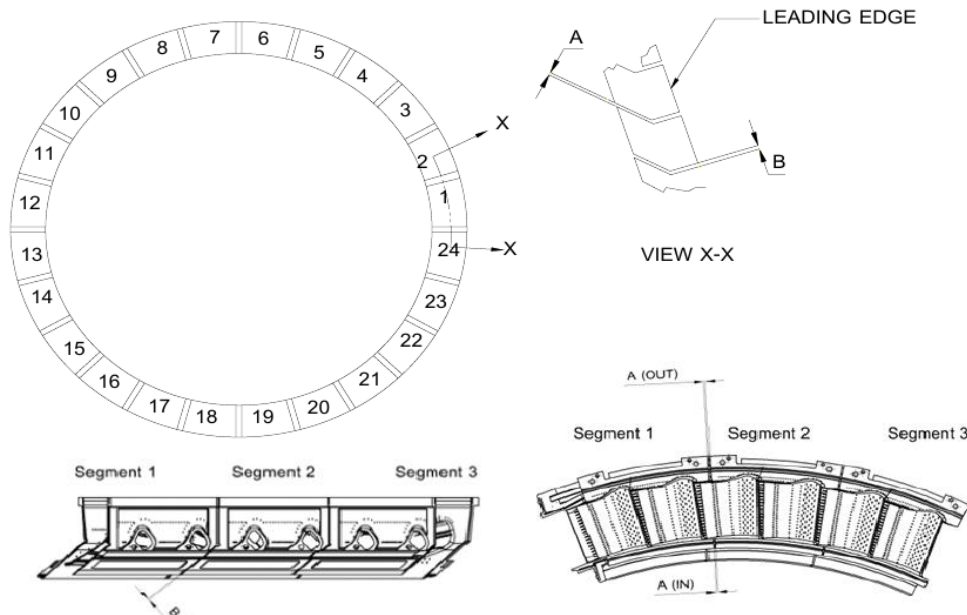
#### GAP MEASUREMENT CHECK

Gap measurements at I/D and O/D walls, positions A and B. All values in mm.

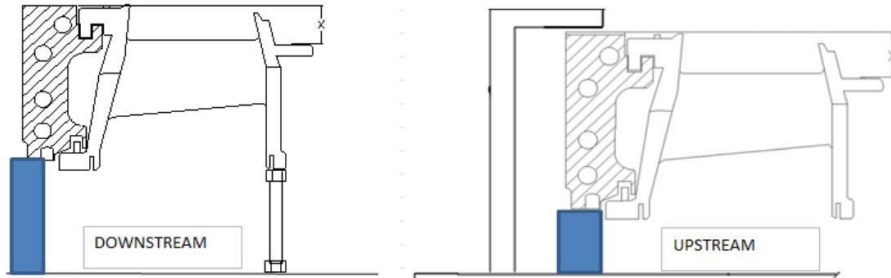
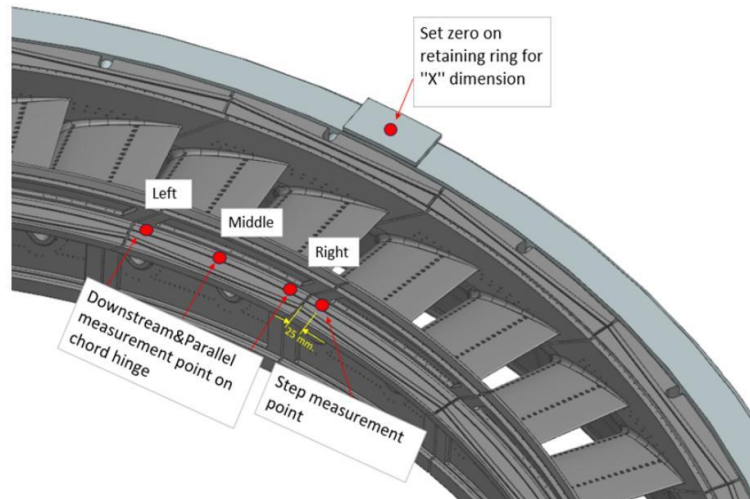
### DROP CHECK

Measurement positions on the chord hinge (Left, Middle, Right) with zero set on the retaining ring for the X dimension. All values in mm.

*Note: Drop check deflection and parallelism values are recorded against nominal (zero) datum as the incoming baseline; final acceptance is verified at post-repair dimensional requalification.*

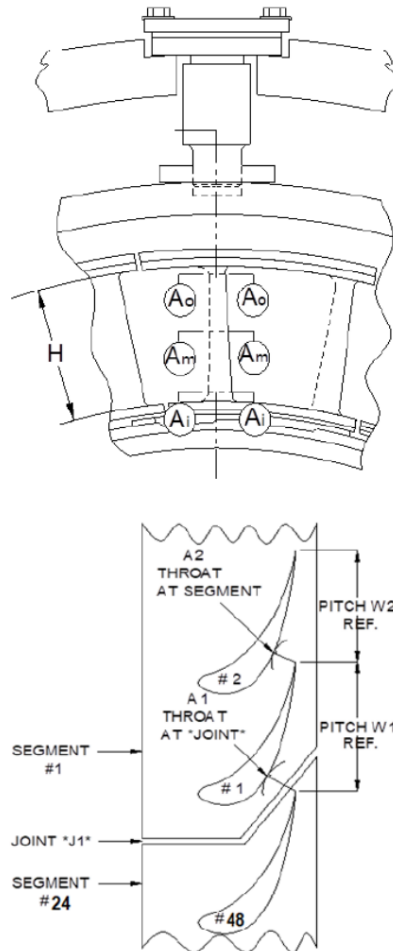
### HARMONIC

Throat dimensions, pitch, and gas path areas were measured at all 48 throat positions (24 joints and 24 segments). Summary results:

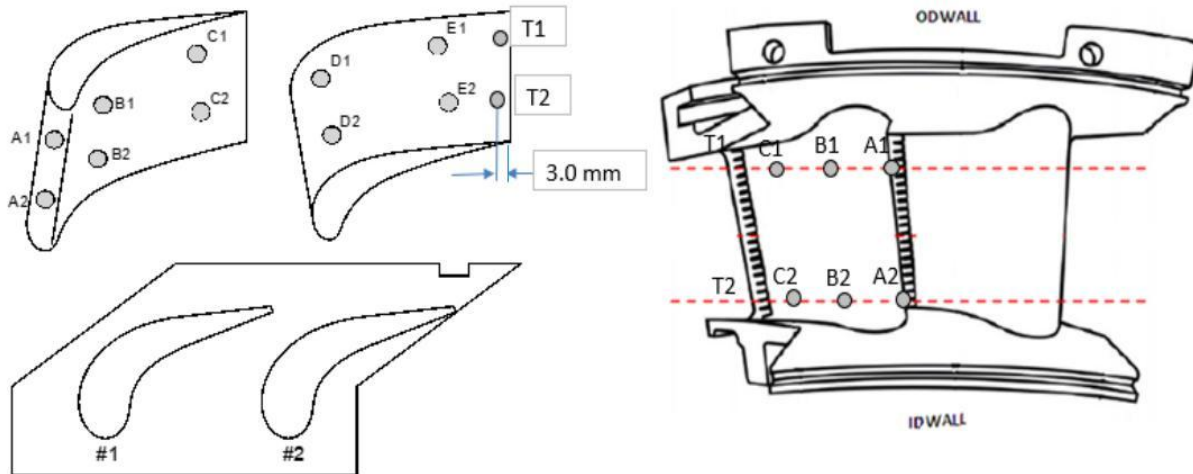
### WALL THICKNESS CHECK

Ultrasonic wall thickness measurement positions A1 to E2 and trailing edge positions T1 and T2 (minimum limit 2.03 mm at T1 and T2). All values in mm.
