# INCOMING INSPECTION REPORT

| <b>Customer P.O. No.</b> | WO1003986864 | <b>Component</b> | MS6001FA 1st Stage Shroud Block |
| <b>Engine Type</b> | MS6001FA (GE Frame 6FA) | <b>Qty. Received</b> | 24 Units (1 Complete Set) |

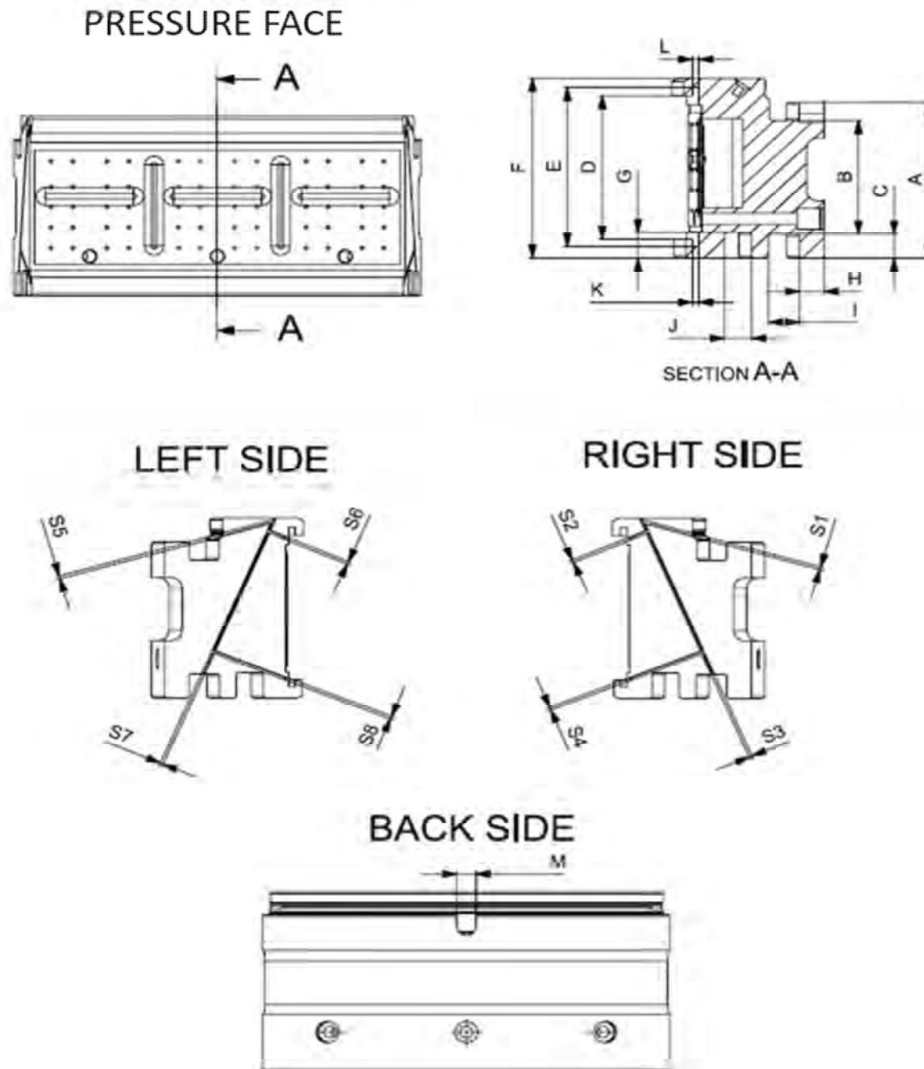
Shroud body measurement positions A through K, L, M and inner plate side rail positions S1 through S8 are shown in the reference drawings below. All values in mm.

*Note: Shroud body linear dimensions are recorded against the incoming population as baseline for post-repair verification. Local deviations recorded at Item 13 (C = 16.05), Item 20 (C = 16.16), and Item 19 (D = 89.40, E = 98.88). Final acceptance is verified at post-repair dimensional requalification.*

Note: Highlighted values are below the 1.70 mm minimum repair datum at positions S1 to S8. The 1.70 mm side rail value is used as the minimum repair datum for this inspection because it represents the required contact rail geometry for fixture fit-up and final assembly requalification. Item 19 records the most severe deviation: L = 3.45 mm, 0.39 mm (10.2%) below the lowest conforming L value in the set (3.84 mm), and 7 of 8 side rail positions non-conforming. Item 16 records critically low values at S5 and S7 (1.00 mm).
