## INCOMING INSPECTION REPORT

| <b>Report No.</b> | UNEW-NSRP-825355-SB2-IIR-Rev01 | <b>UNEW Job No.</b> | 825355 |
| <b>Customer P.O. No.</b> | WO-1004061634-100406 | <b>Component</b> | MS6001FA 2nd Stage Shroud Block |

### 1. EXECUTIVE SUMMARY

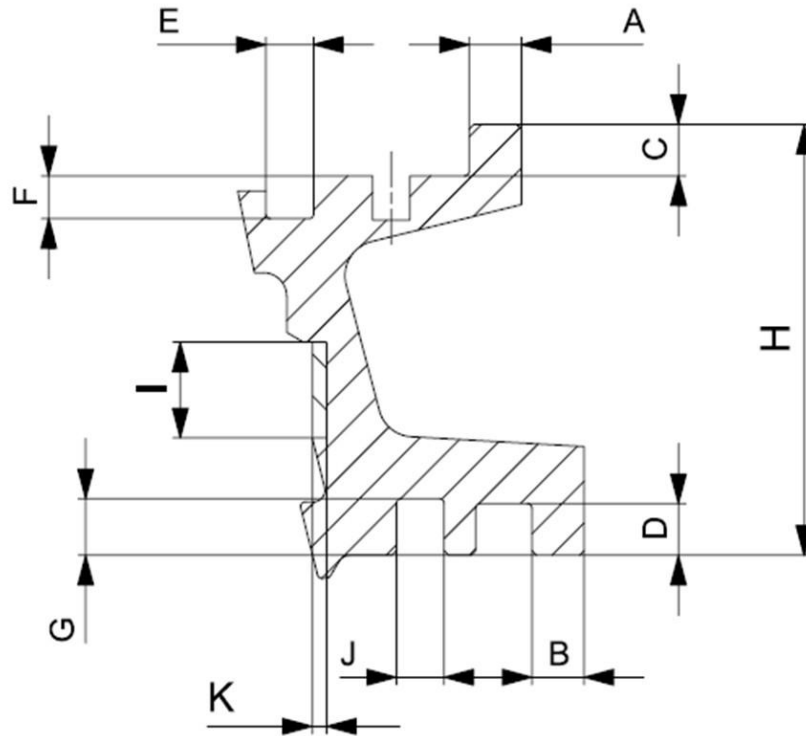
Reference positions A through K are defined on the drawing below. The complete incoming dimensional record for all 24 components is repeated here against the drawing for direct reference. Unit: mm.
