# INCOMING INSPECTION REPORT

## MS6001FA (GE Frame 6FA) 2nd Stage Bucket Set

| Customer | Nghi Son Refinery & Petrochemical LLC |
| Component | MS6001FA 2nd Stage Bucket |

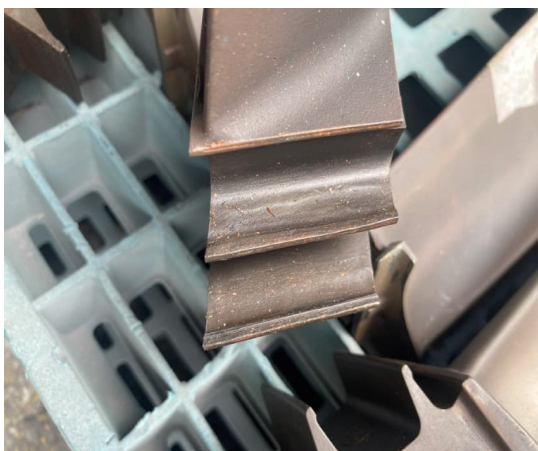
Figure 5. As-received condition.

| Figure | Documented Condition |
|---|---|
| 5 | Crack on seal fin (item 78) |

\* Buckets with a discrete crack indication (items 7, 28, 29, 33, and 78) additionally require crack excavation and weld repair at the affected feature.

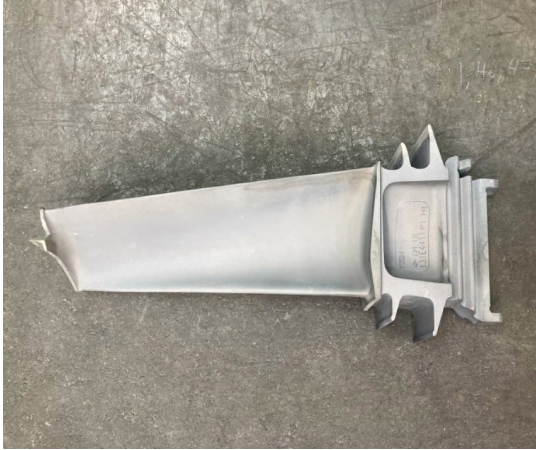
Figure 7. Condition after incoming inspection.

| Figure | Documented Condition |
|---|---|
| 7 | Weldment and contact wear on Z-notch |

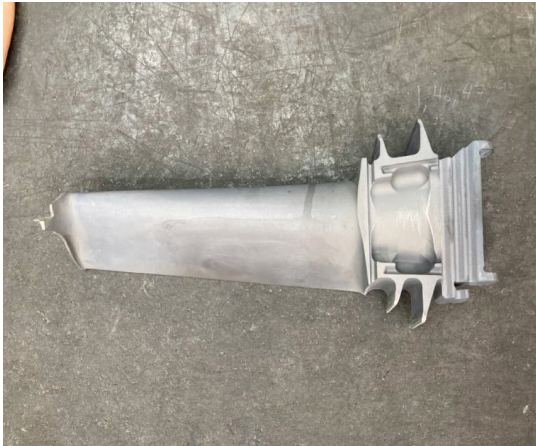
Figure 9. Condition after incoming inspection.

| Figure | Documented Condition |
|---|---|
| 9 | Foreign object damage on angel wing |

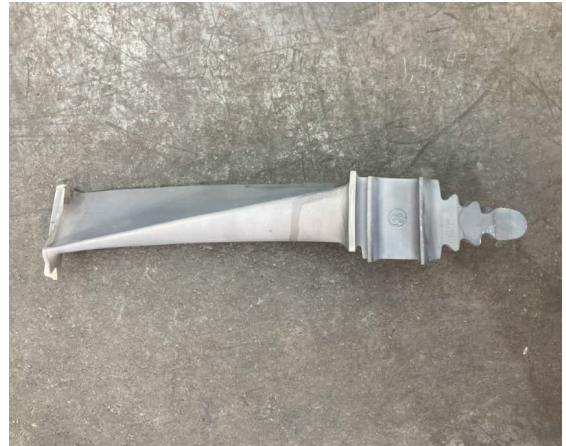
Figure 10. Condition after incoming inspection.

| Figure | Documented Condition |
|---|---|
| 10 | Crack on angel wing (items 7, 28, 29, 33) |

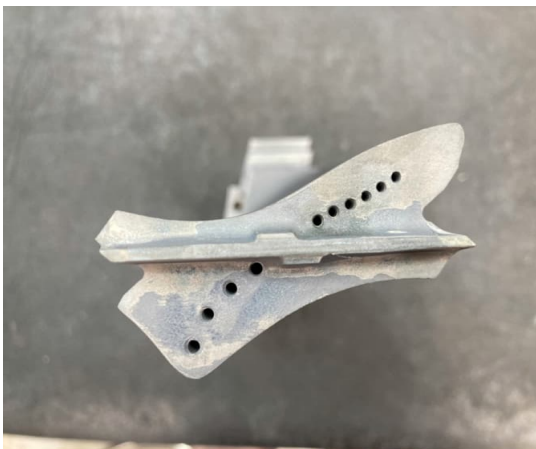
Figure 11. Condition after incoming inspection.

| Figure | Documented Condition |
|---|---|
| 11 | Weldment on angel wing |

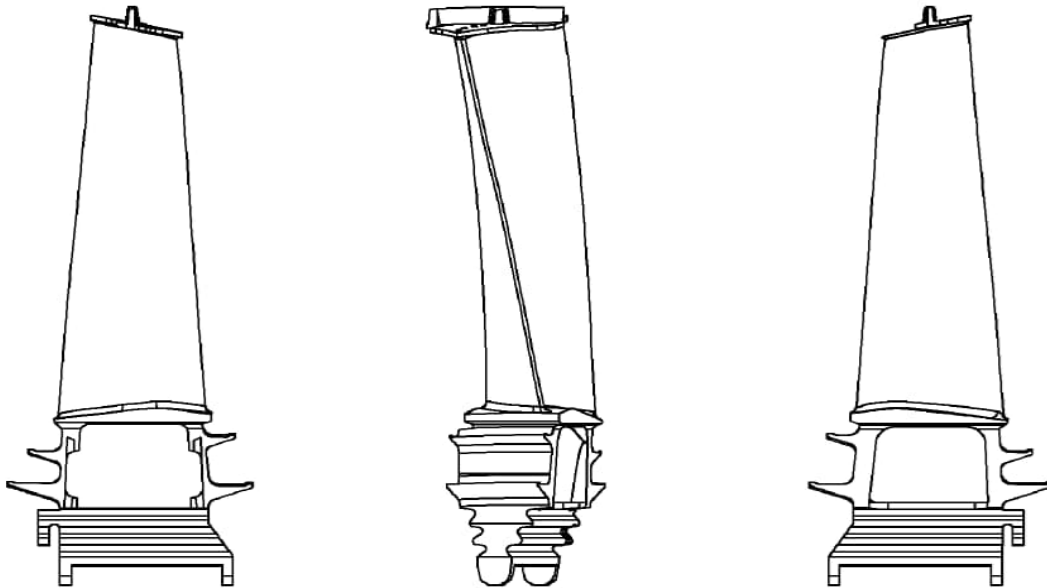
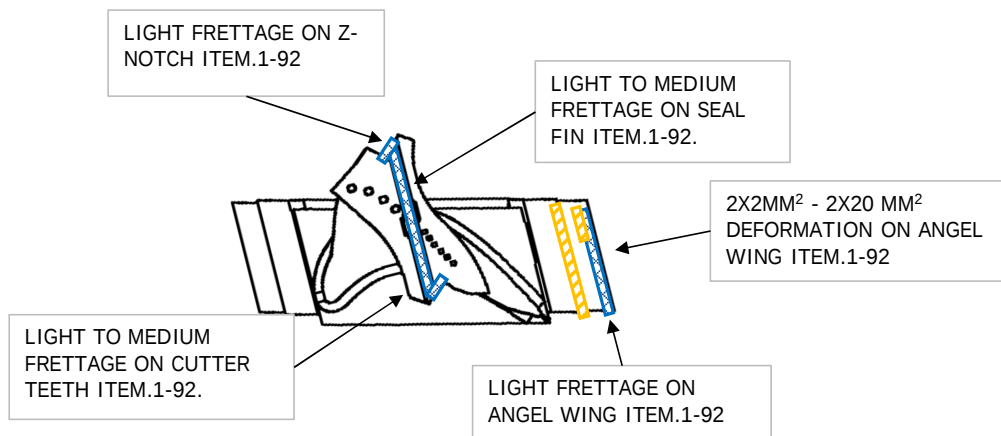
## 21.0 DEFECT MAP

Crack (mm) 
 Foreign Object Damage (L/M/H) 
 Fretting (L/M/H) 
 Deformation area(mm²) 
 Corrosion (L/M/H) 
 Missing Material (mm²)

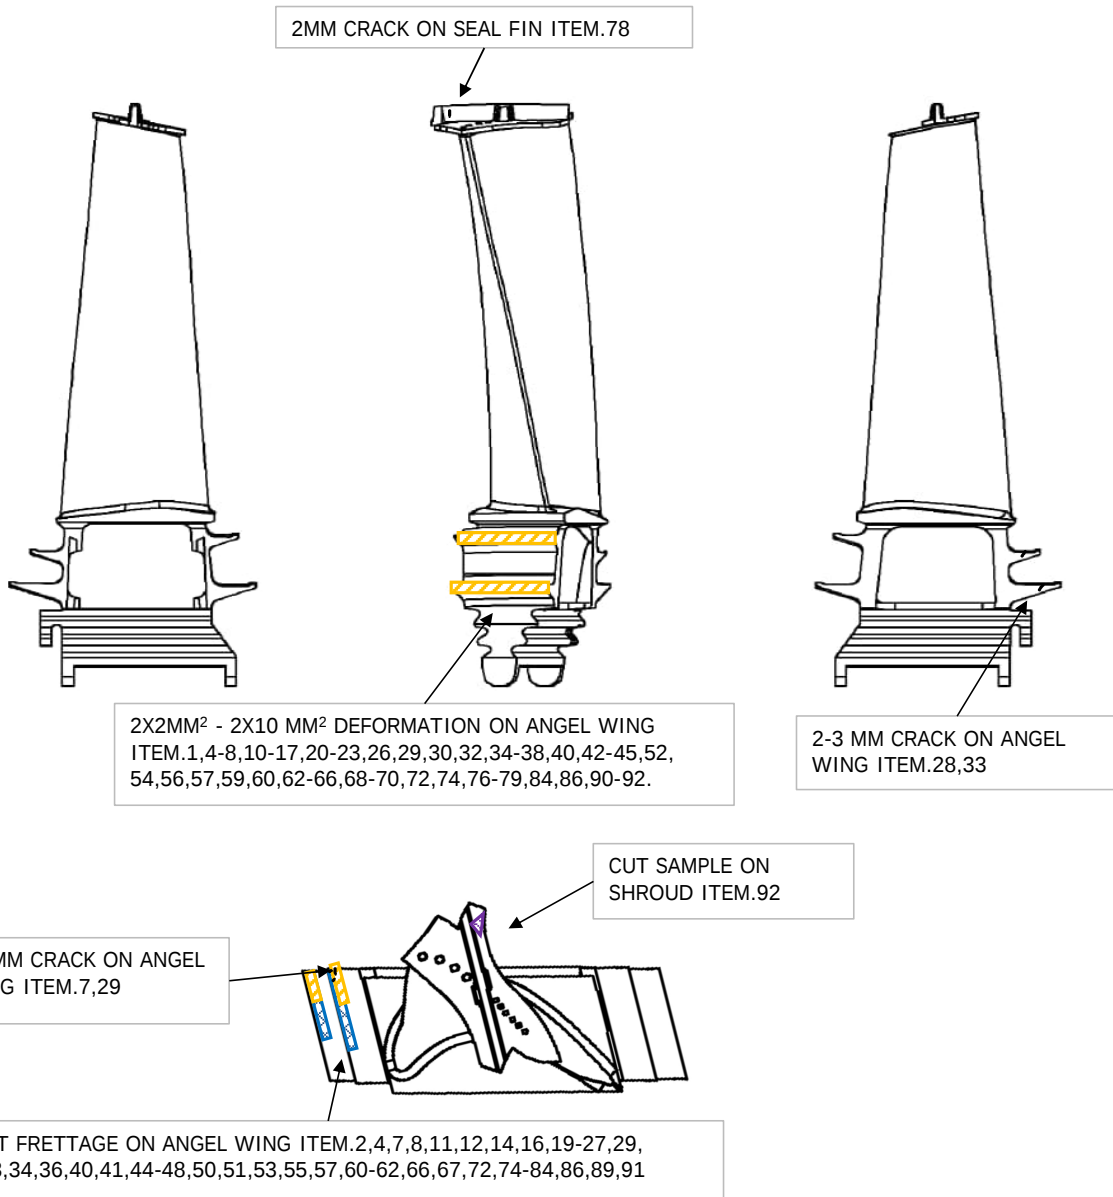
## 13.0 DEFECT MAP (CONTINUE)

Crack (mm) 
 Foreign Object Damage (L/M/H) 
 Fretage (L/M/H) 
 Deformation area(mm<sup>2</sup>) 
 Corrosion (L/M/H) 
 Missing Material (mm<sup>2</sup>)
