## INCOMING INSPECTION REPORT

| Customer P.O. No. | WO1003986864 | Component | 1st Stage Nozzle |
| Engine Type | MS6001FA (GE Frame 6FA) | Part Number (Ring) | 143E5711G02 |

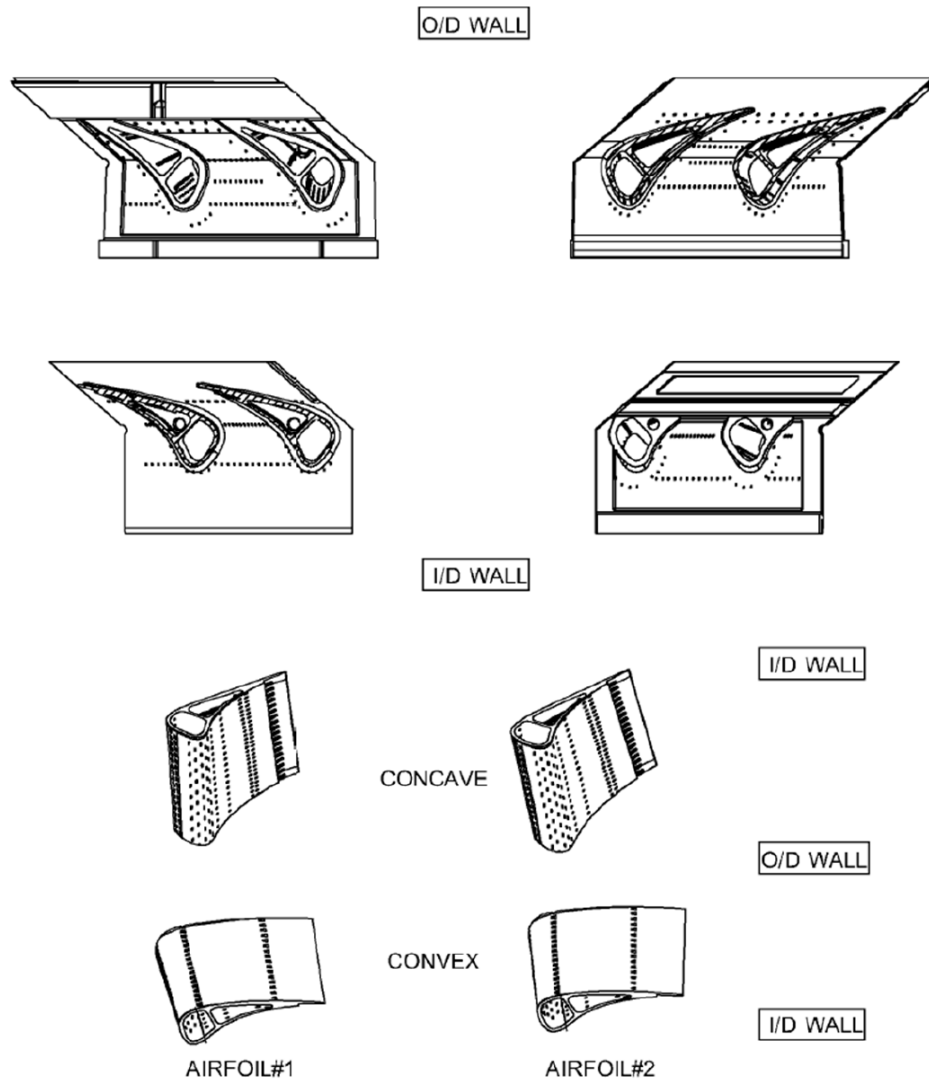
## 11. COMPONENT INSPECTION ZONES

The following reference drawing shows the nozzle segment inspection zones (O/D wall, I/D wall, concave and convex airfoil surfaces) used for defect recording during incoming inspection.

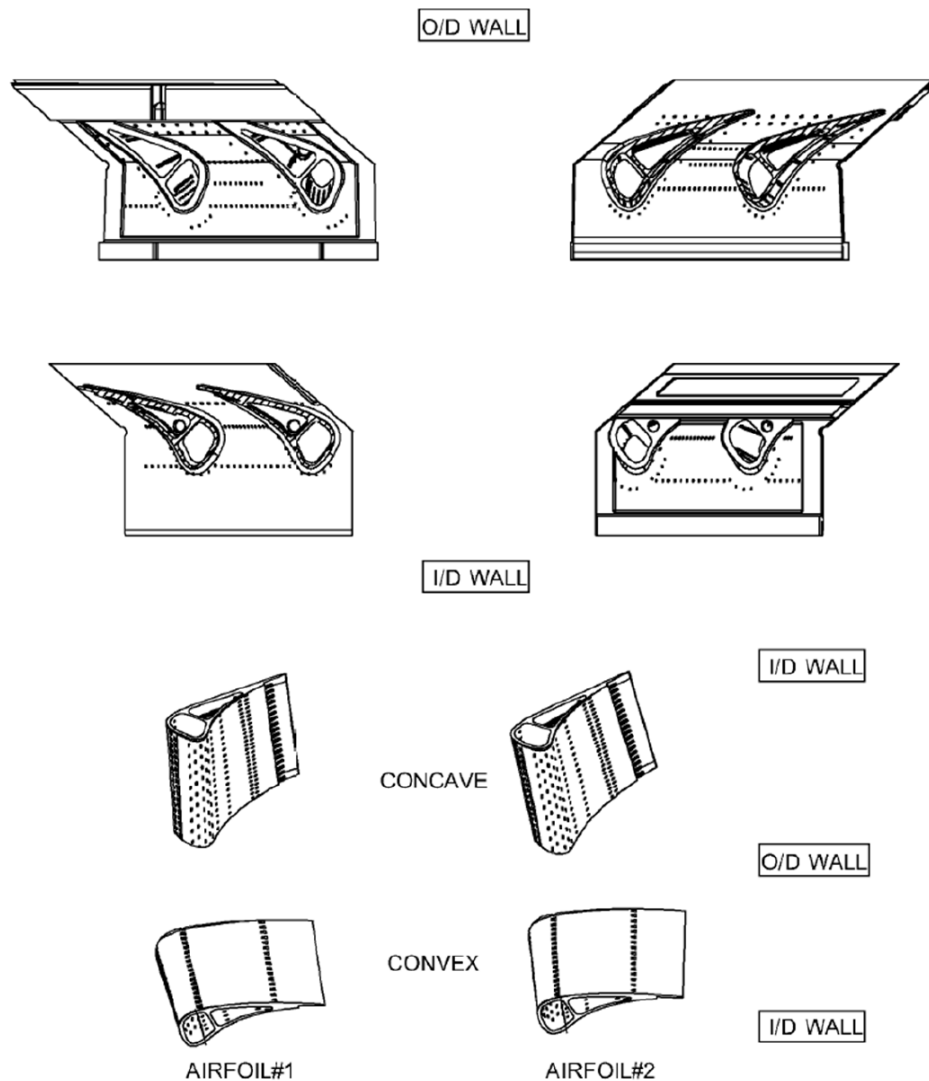
## 14. DEFECT MAP RECORD

Defect locations recorded during incoming inspection are summarized below against the component inspection zone reference of Section 11. This record consolidates the incoming defect mapping for the complete set of 24 segments.

| Zone / Location | Defect / Condition | Size Range | Items Affected |
|---|---|---|---|
| Trailing edge, O/D wall side | Cracking | 5 to 75 mm | Items 1 to 24 |
| Trailing edge, I/D wall side | Cracking | 5 to 25 mm | Items 1 to 24 |
| Airfoil body (concave, convex, LE, T/E) | Multi-crack networks | 15x40 to 30x120 mm <sup>2</sup> | Items 1 to 24 |
| I/D wall, non-gas path | Cracking | 8 to 20 mm | Items 1 to 24 |
| O/D wall, non-gas path | Cracking | 8 to 15 mm | Items 1, 3, 22, 23 |
| O/D wall | Missing material | 5x30 to 8x50 mm | Items 1, 2, 4, 5, 6, 11, 14, 15, 17 |
| Trailing edge | Through-wall missing material | 8x100 mm | Item 8 |
| Concave airfoil face | Crack | 50 mm | Item 19 |
| Concave airfoil, trailing edge, and outer shroud wall | Heavy oxidation and hot corrosion | Widespread | Items 1 to 24 |
| I/D wall, non-gas path | Light to medium corrosion | Surface | Items 1 to 24 |
| All gas path surfaces | Coating deterioration (TBC + MCrAlY) | Full gas path | Items 1 to 24 |
