# INCOMING INSPECTION REPORT

## MS6001FA (GE Frame 6FA) 2nd Stage Bucket Set

| Customer | Nghi Son Refinery & Petrochemical LLC |
| Component | MS6001FA 2nd Stage Bucket |

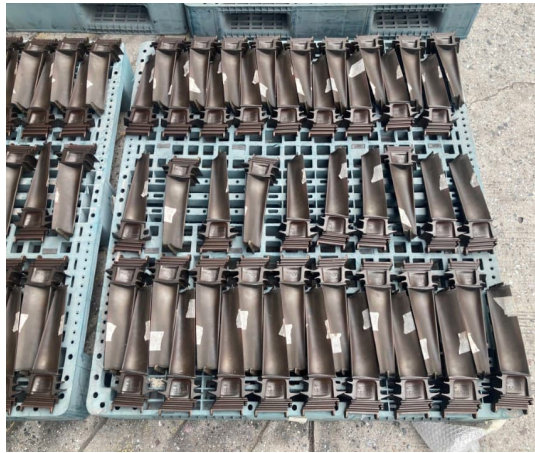
Figure 1. As-received condition.

| Figure | Documented Condition |
|---|---|
| 1 | As received condition of the bucket set (multiple views) |

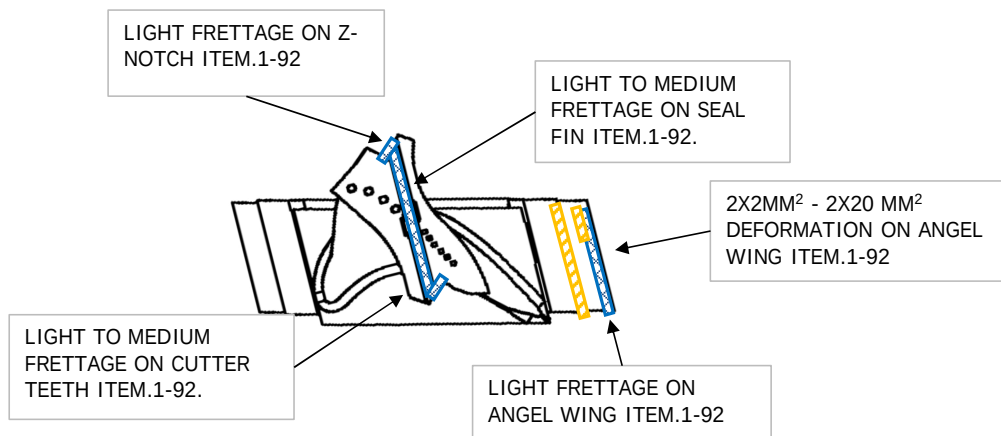
## 21.0 DEFECT MAP

Crack (mm) 
 Foreign Object Damage (L/M/H) 
 Fretting (L/M/H) 
 Deformation area(mm²) 
 Corrosion (L/M/H) 
 Missing Material (mm²)

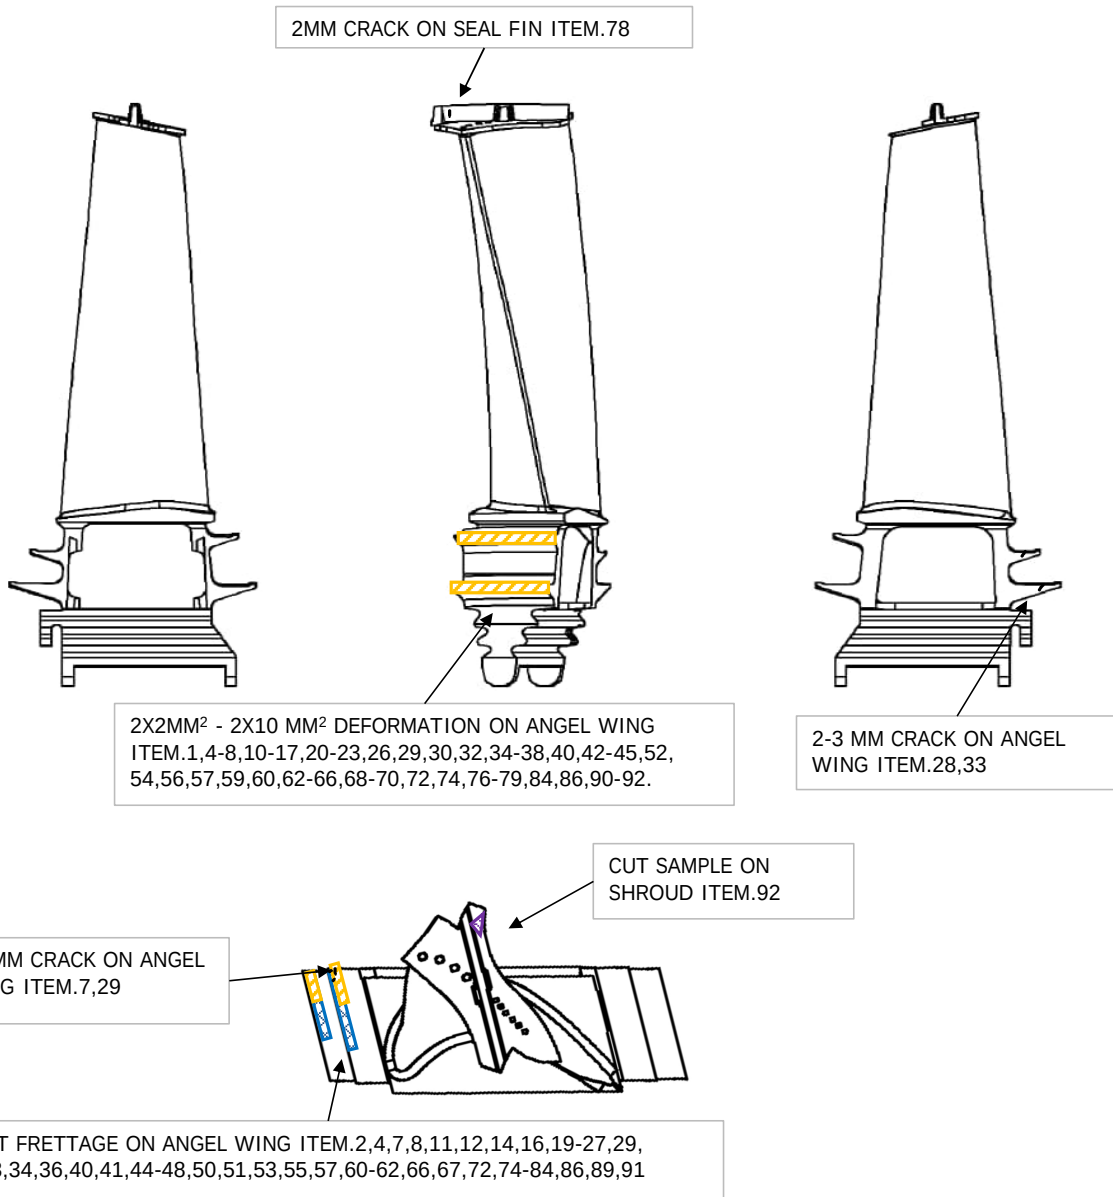
## 13.0 DEFECT MAP (CONTINUE)

Crack (mm) 
 Foreign Object Damage (L/M/H) 
 Fretage (L/M/H) 
 Deformation area(mm<sup>2</sup>) 
 Corrosion (L/M/H) 
 Missing Material (mm<sup>2</sup>)
